**PRELIMINARY DESKTOP REVIEW –
GEOTECHNICAL**
Gillieston Public School redevelopment and
new Public Preschool

Prepared for:
Department of Education

Prepared by:
Stantec Australia Pty Ltd

Project Number:
304100928

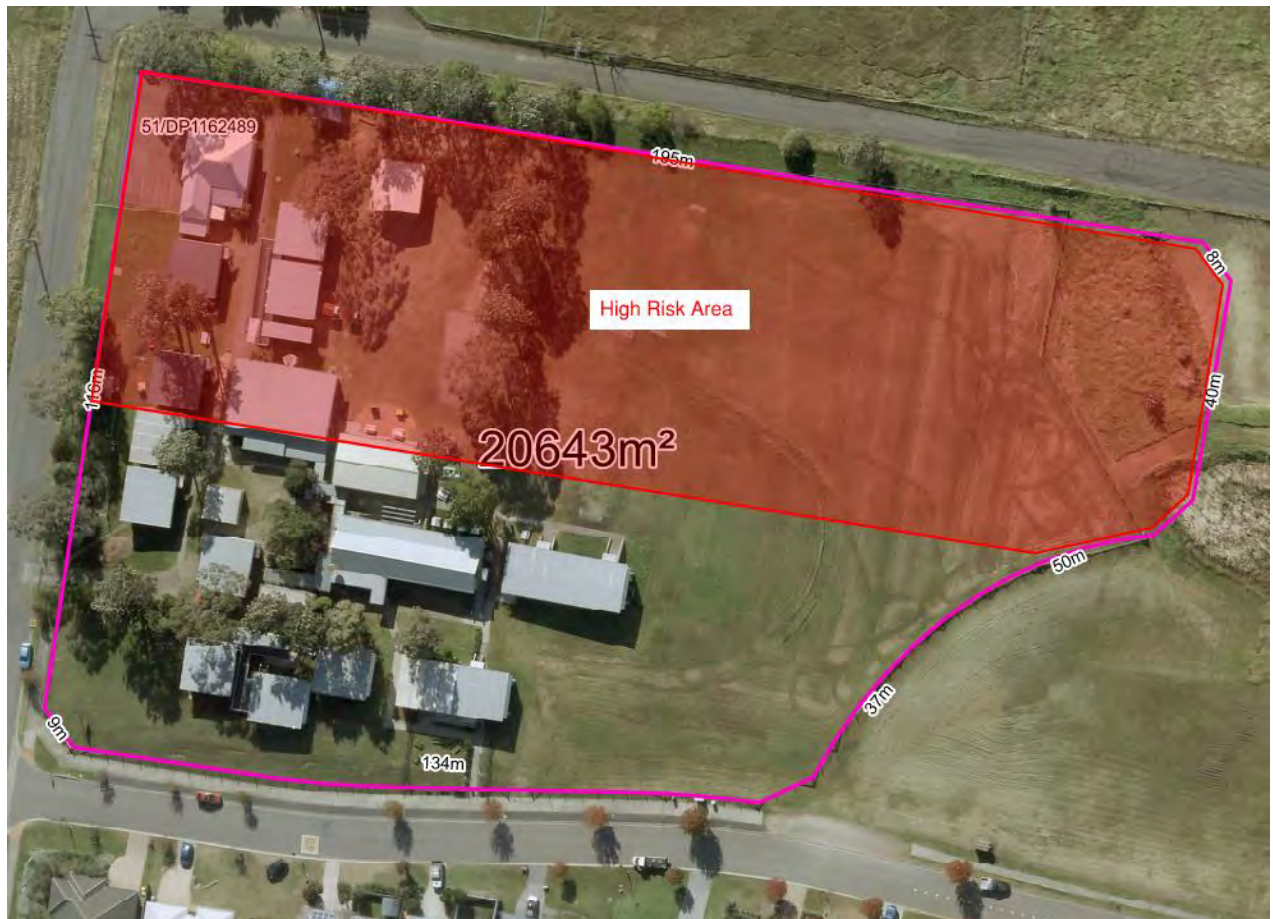
Figure 3-1: Site Risk Assessment

High Risk Area	
Cut and Fill operation	Minor levelling only across the site. Cut and fill operation will be required.
Subsurface condition	Possible relative thicker fill profile, overlying residual and sandstone. Residual soil is relative thicker and may encounter alluvial deposit at the north-western end of the site.
Expected foundation	Possible deep piers foundation required for foundation, pending to the fill and residual soil thickness.
Acid sulphate and Salinity	Low risk for ASS. Moderate to high salinity potential
Contamination	Higher potential due to the thicker fill profile and existing utilites.

High Risk Area	
Conclusion	This area is considered as high risk for variable subsurface conditions and associated geotechnical constraints, such as variable structural foundation requirement, and vibration impact to nearby receivers.

Site risk assessment are listed below for DoE consideration and site plan is shown on the Appendix A.

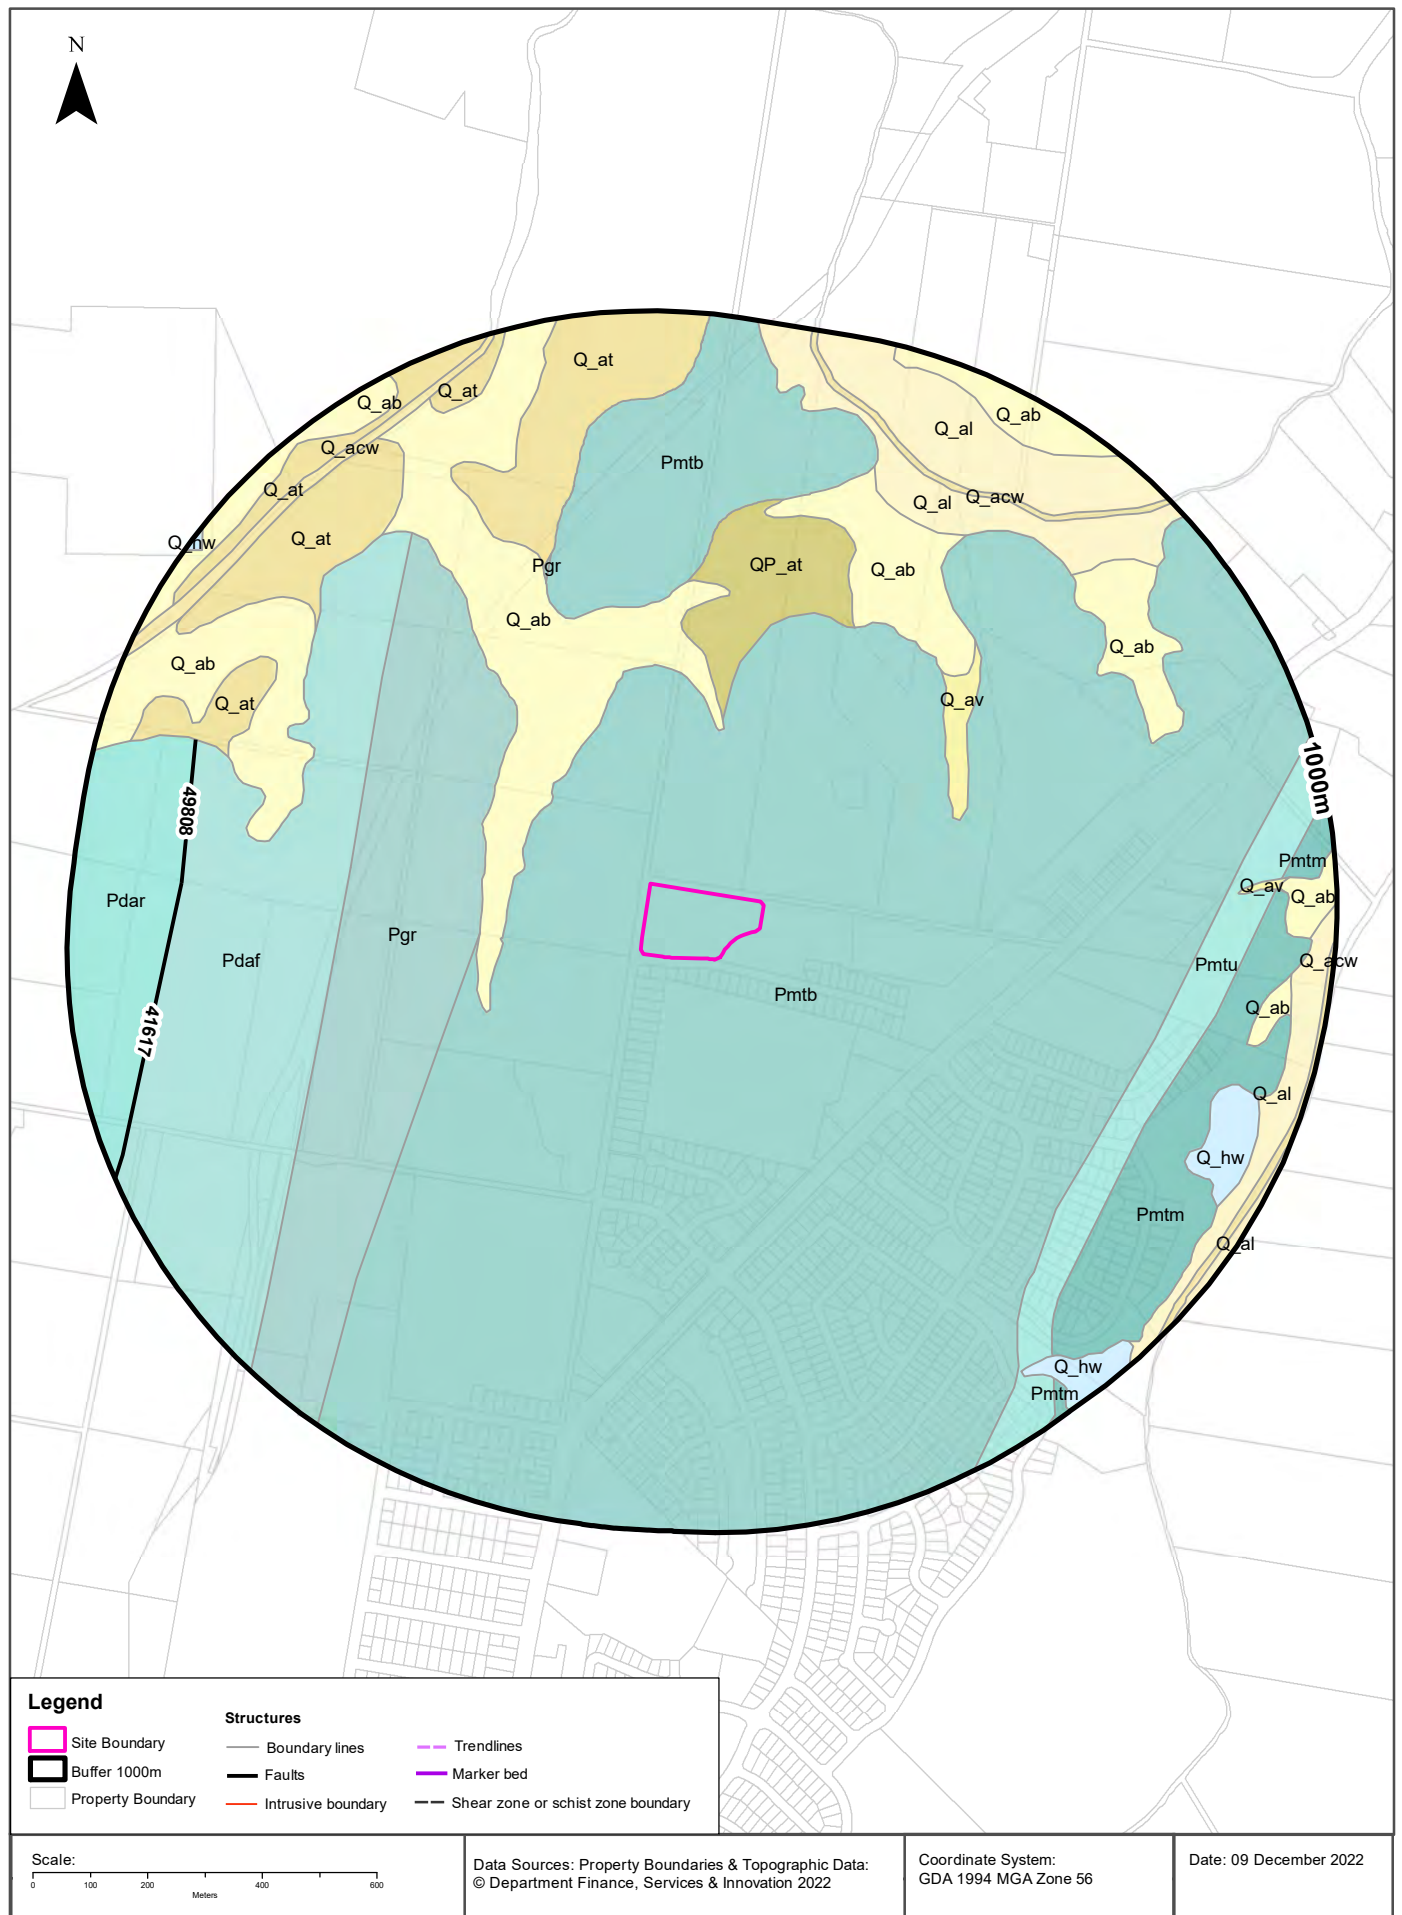
Geology

The 1:100,000 Geological Series Sheet provided in **Appendix – B** indicates that the site is underlain by Branxton Formation (Pmtb) with the lithology of conglomerate, sandstone, siltstone from Maitland Group. The site is also adjacent to:

- Alluvial backswamp deposits (Q_ab) to the north west, described as Organic-rich mud, peat, silt, clay, and
- Alluvial terrace deposits (QP_at) to north, described as silt, clay, (fluvially- deposited) fine to medium grained quartz-lithic sand, polymictic gravel from Quaternary age, and
- Alluvial valley deposits (Q_av) to north east, described as silt, clay, (fluvially deposited) lithic to quartz-lithic sand, gravel from Quaternary age, and
- Greta Coal Measures (Pgr) to west, described as sandstone, siltstone, pellet claystone, coal, chert, sporadic conglomerate from Permian age, and
- Muree Sandstone (Pmtu) to east, described as fine- to coarse-grained sandstone, conglomerate, minor claystone from Radian age.

- > Referenced to regional 1:100,000 Geological Series Sheet, the site is underlain by Branxton Formation (Pmtb) with the lithology of conglomerate, sandstone, siltstone from Maitland Group.

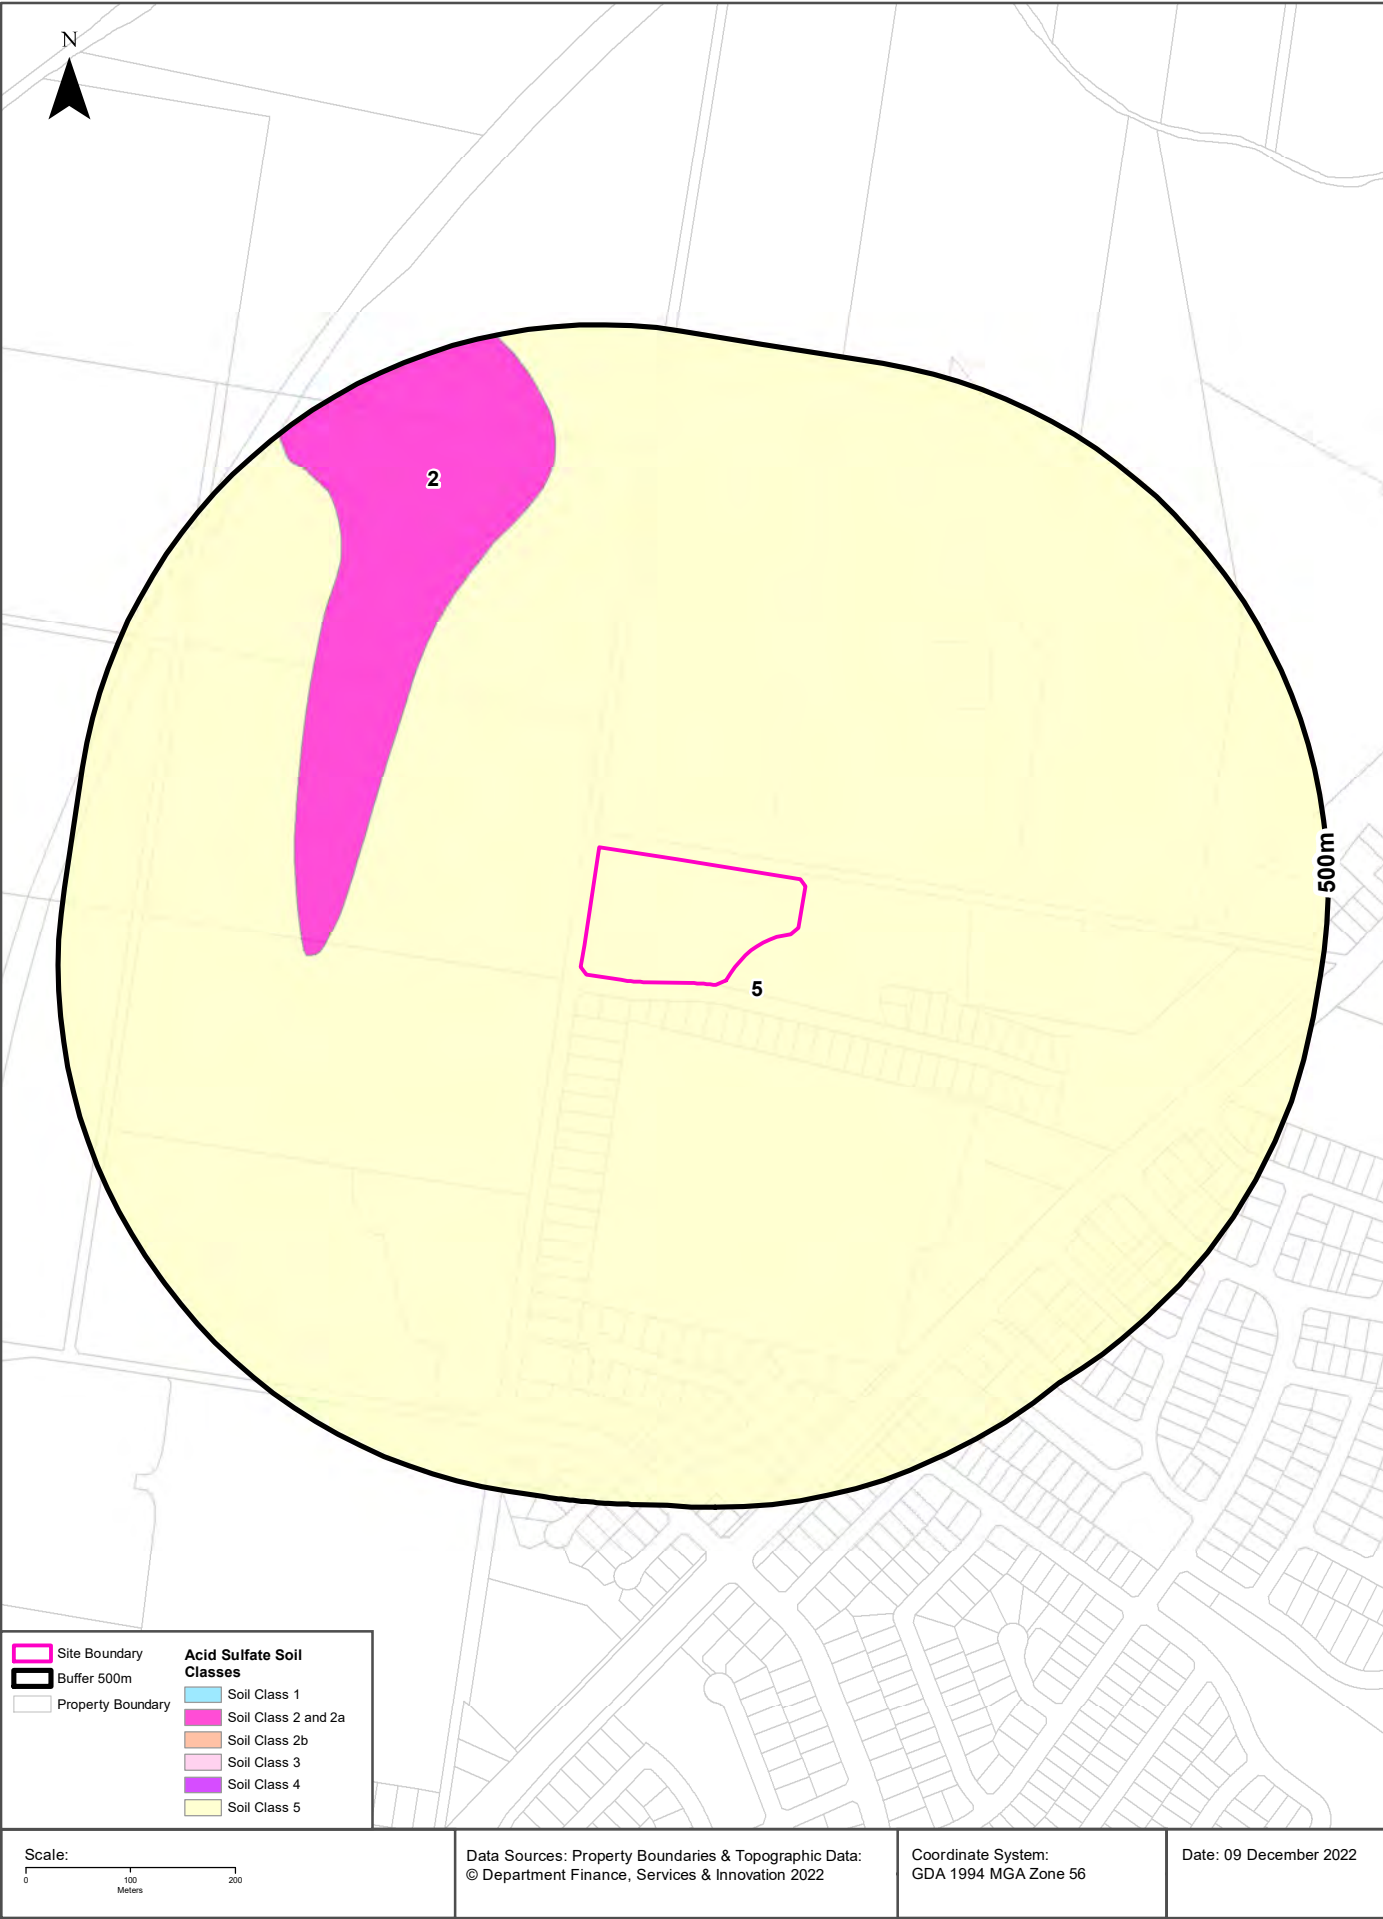
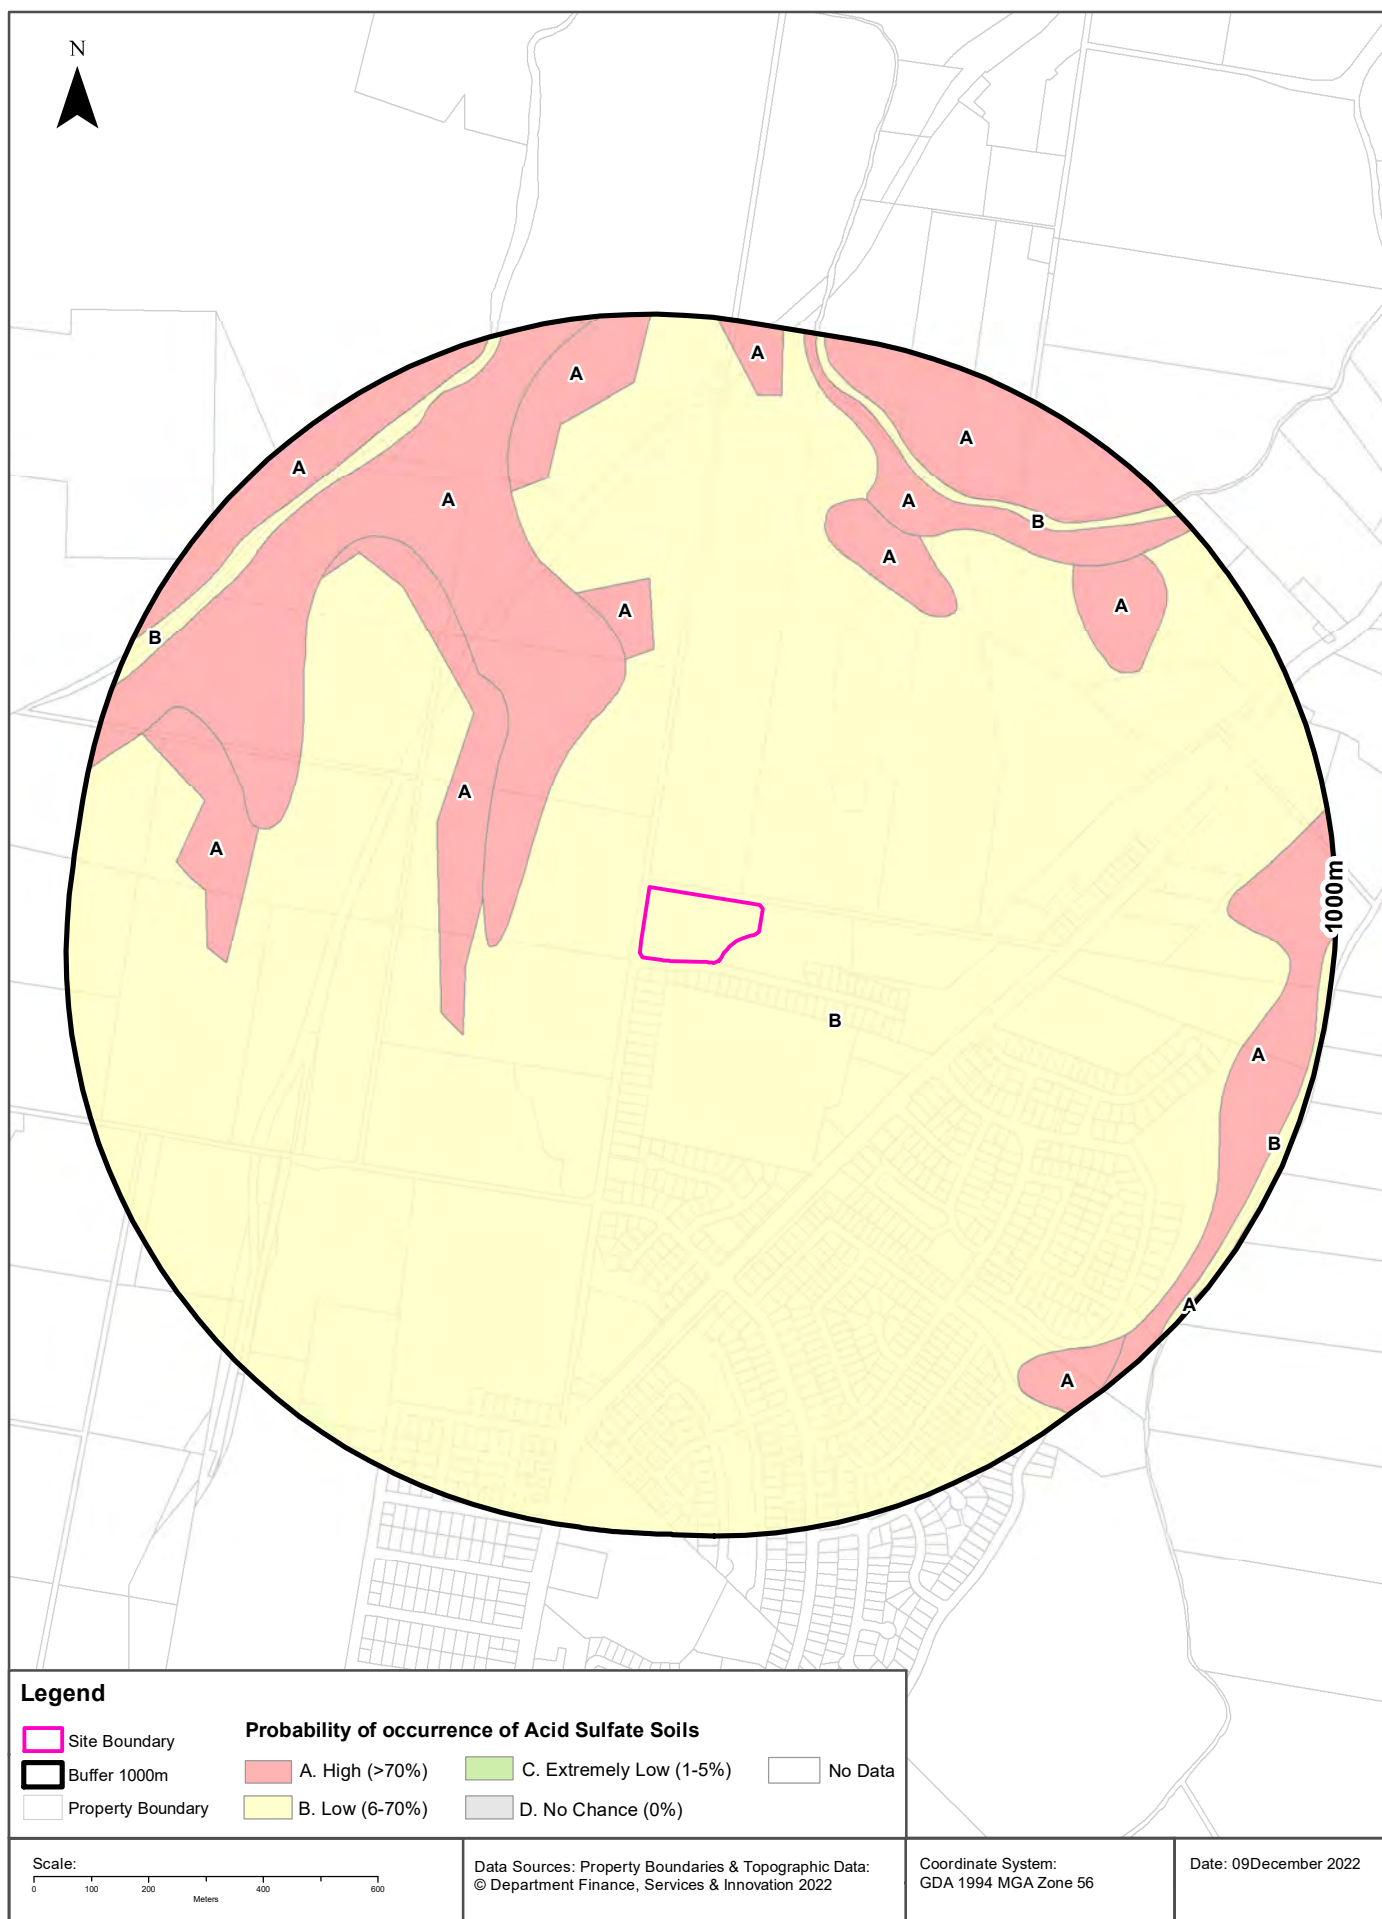
Acid Sulfate Soils

With referenced to the Atlas of Australian Acid Sulfate Soils, it classifies the site as Class B depicting as low probability of occurrence, 6-70% chance of occurrence with occurrences in small, localised areas within proposed activity site. Acid Sulfate Soil risk map is provided in **Appendix E**.

- > The site is classified as the area of moderately salinity potential and acid sulfate Class B depicting as low probability of occurrence of 6 - 70 %.
