**INTRUSIVE GEOTECHNICAL
INVESTIGATION REPORT**

Gillieston Public School redevelopment and
new public preschool

Prepared by:
Stantec Australia Pty Ltd

Project Number:
304100928

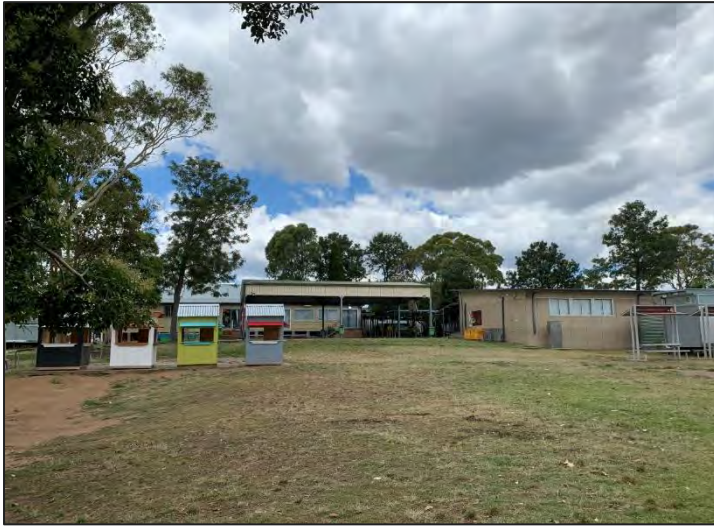
Photo 1 – Existing school site

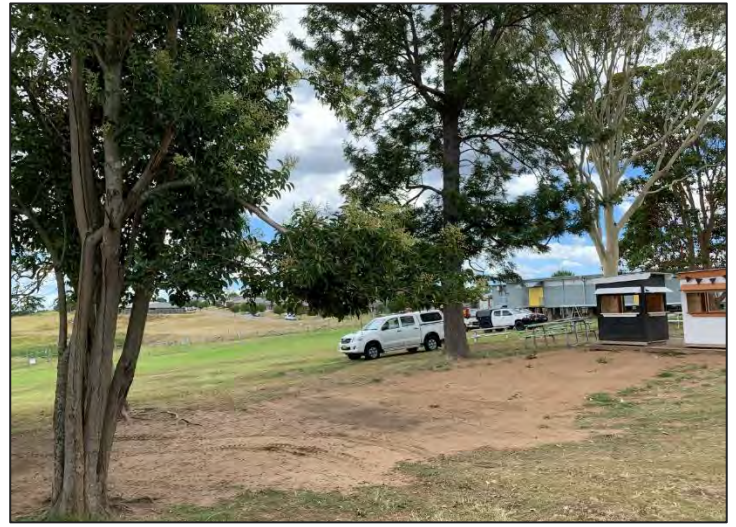
Photo 2 – Existing school site looking west

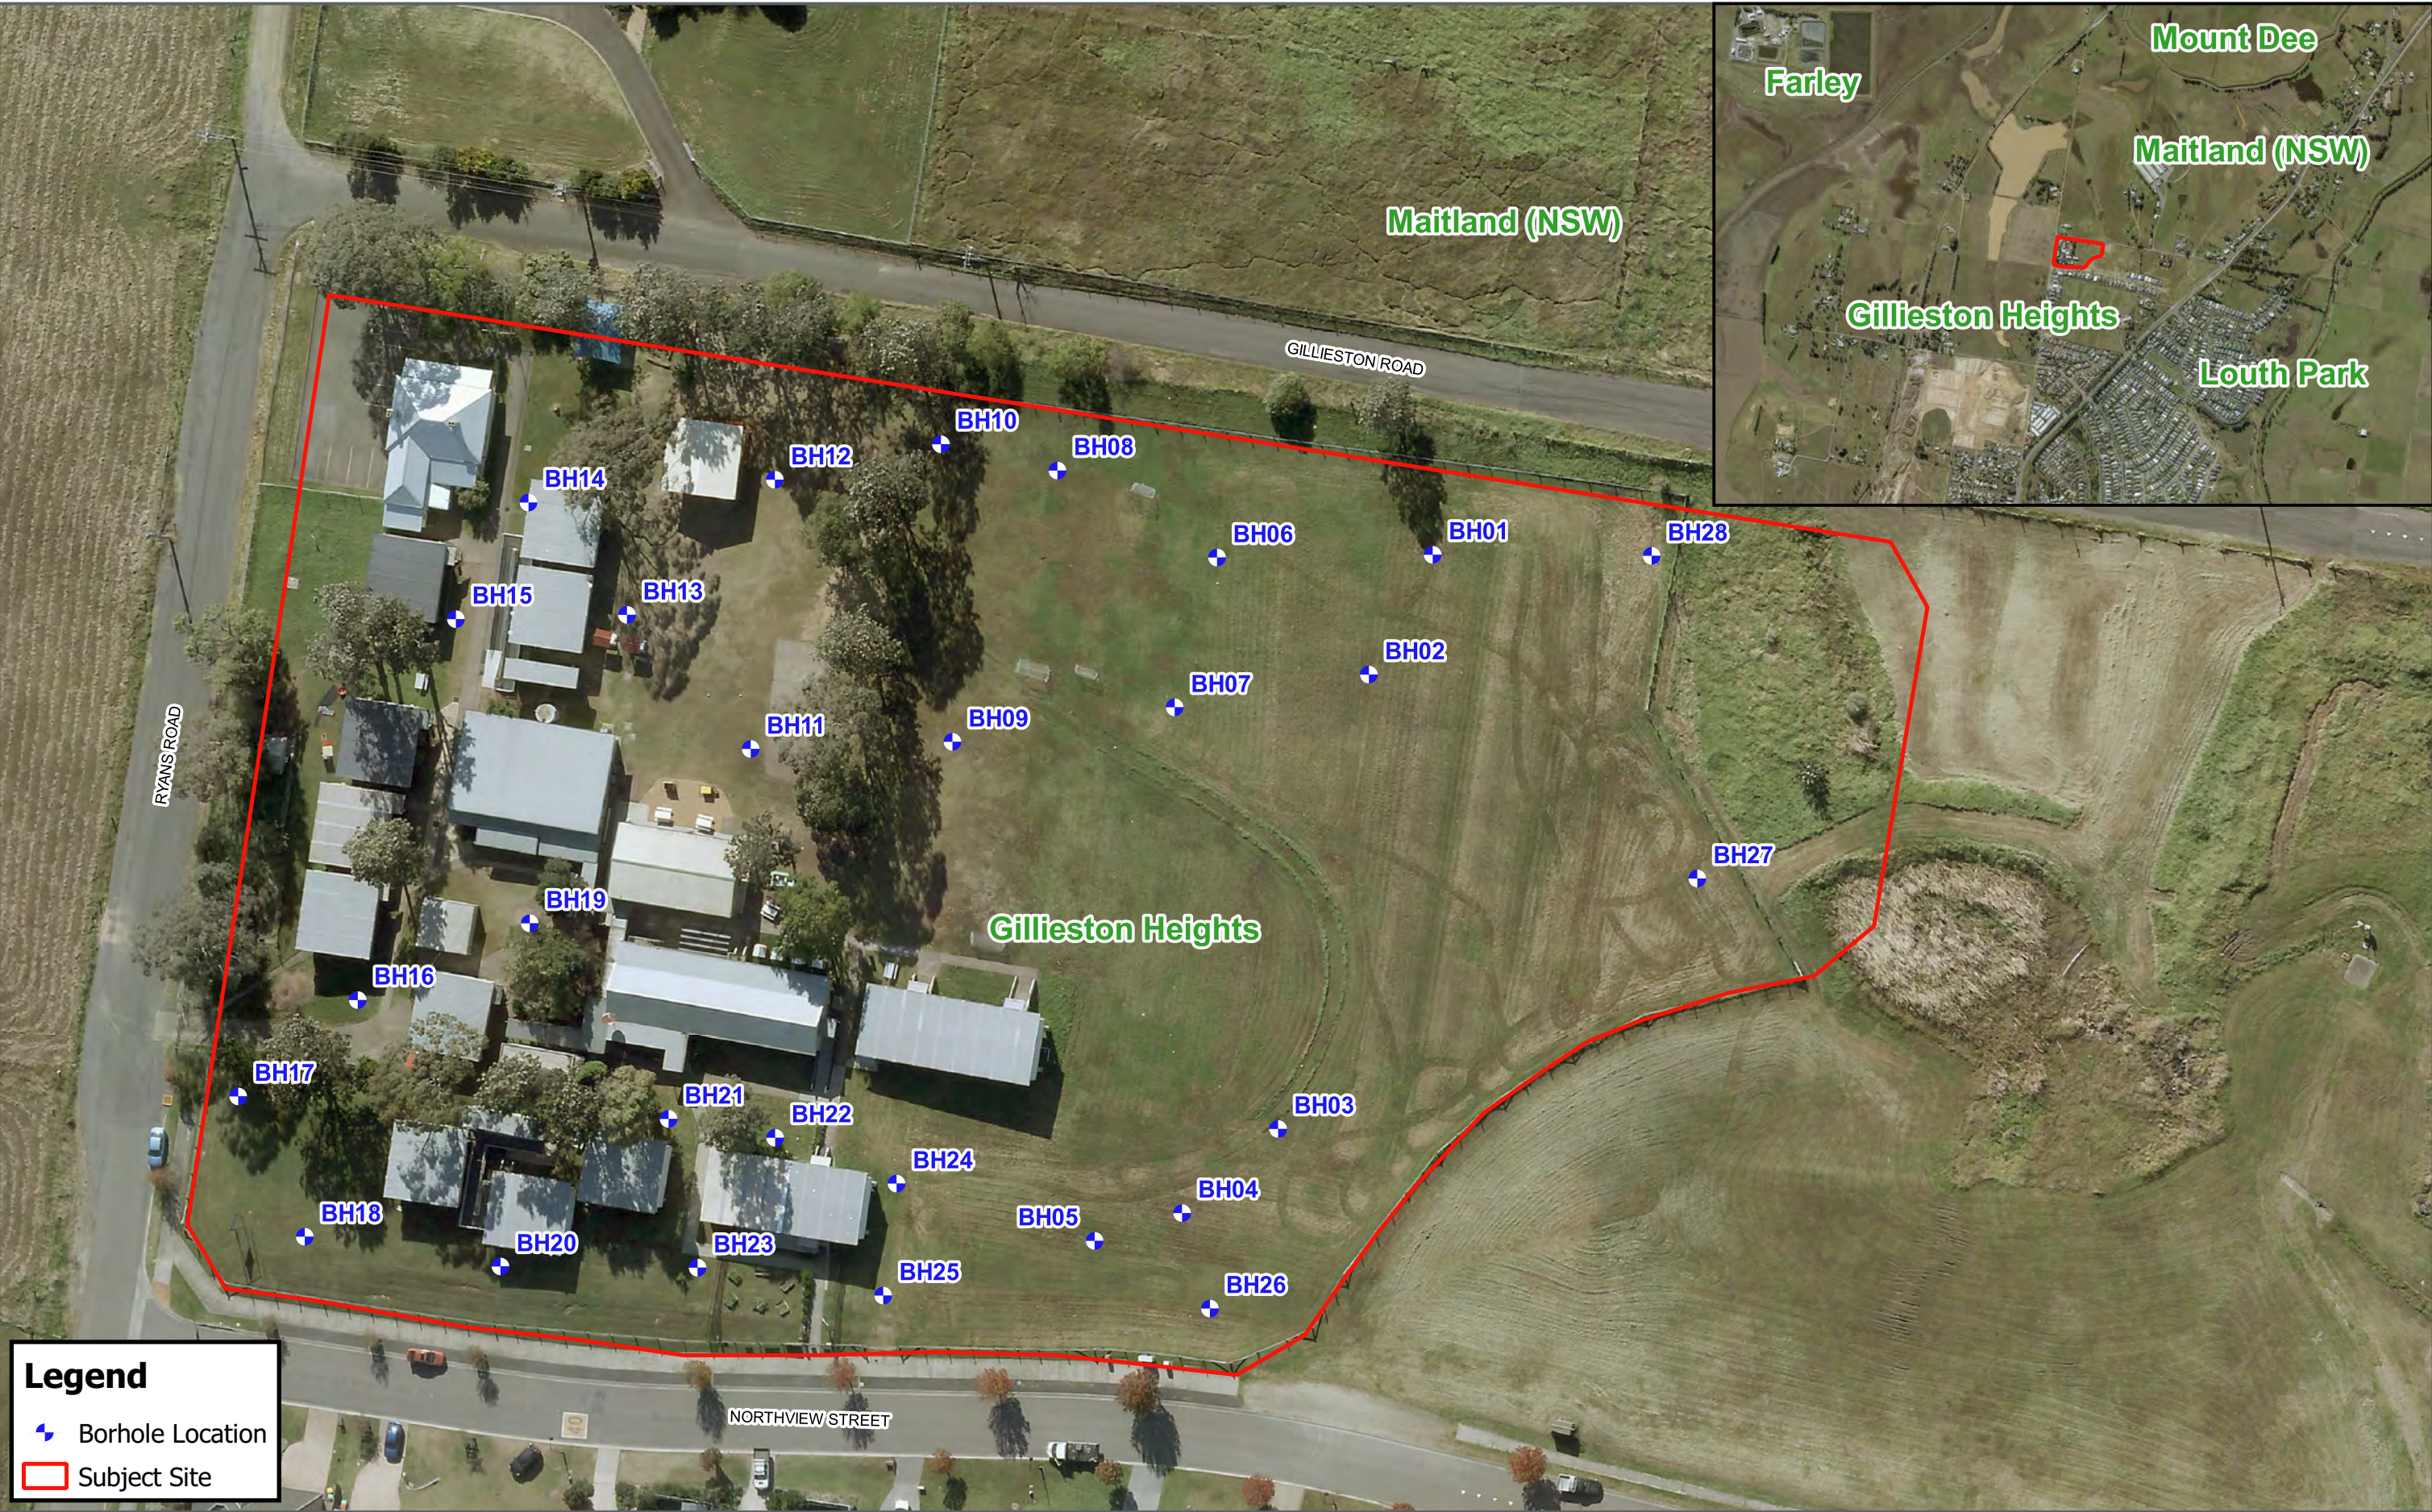
Geotechnical Investigation-Site Plan

- A detailed walkover inspection of the site and surrounds.
- Drilling of a total of twenty-eight (28) auger boreholes (BH1 to BH28 inclusive) within the footprint of the proposed redevelopment, using a track mounted drill rig provided by Stratacore Drilling.
- DCP/SPT tests were carried out at regular interval to determine the soil consistency.
- Three (3) selected boreholes were advanced into rock coring (BH8, BH14, and BH25) in order to assess the subsurface bedrock conditions.
- Selection of representative soil samples to external NATA accredited labs for geotechnical lab testing.

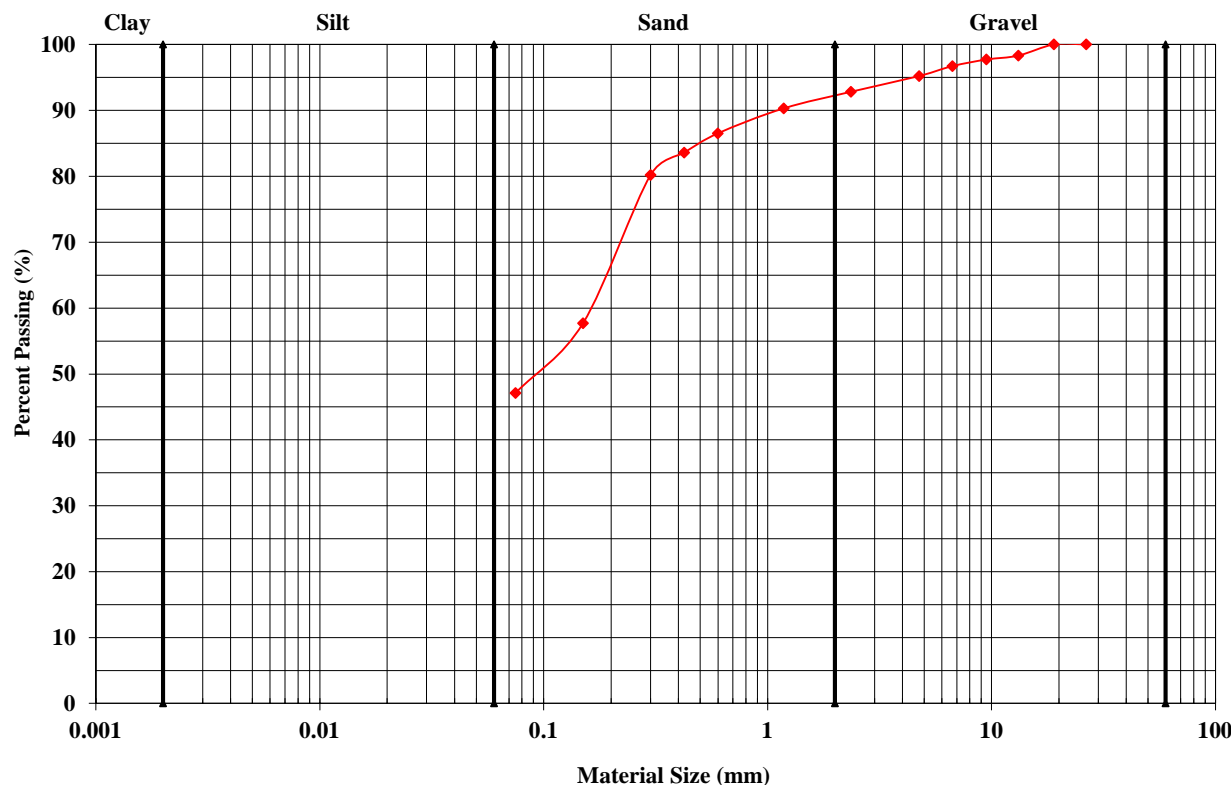
Sieve Size (mm)	Percent Passing (%)
26.5	100.0
19.0	100.0
13.2	98.3
9.5	97.7
6.7	96.7
4.75	95.2
2.36	92.8
1.18	90.3
0.60	86.5
0.425	83.6
0.30	80.2
0.15	57.7
0.075	47.1
