Report on
Geotechnical Investigation

The Gables New Primary School
Fontana Drive, Gables

Prepared for
School Infrastructure NSW

Project 216255.00
November 2024

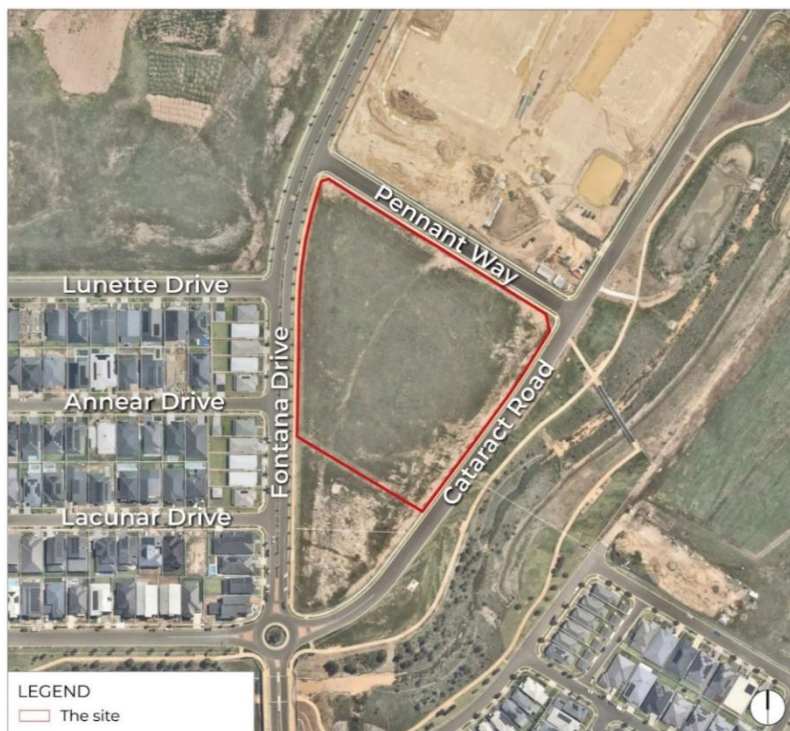
Figure 1: Site aerial imagery (Source: Nearmap, edits by Ethos Urban)

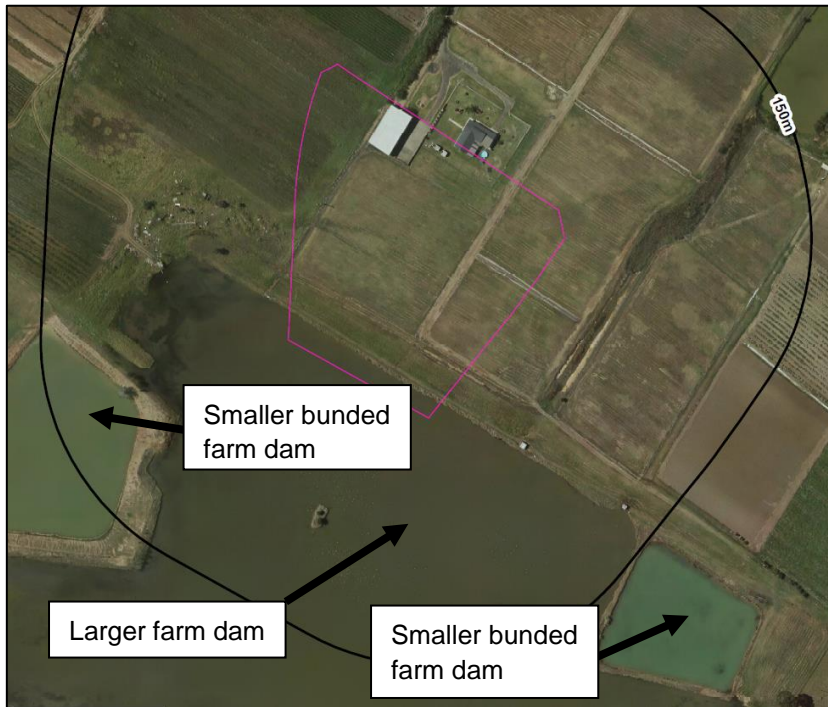
Figure 2: 2011 Lotsearch Imagery (NSW Government) showing approximate site location (pink), smaller bunded farm dams and larger dam water body.

Prior to 2016, several large farm dams were present within the southern border of the site. Government archive aerial imagery (NSW Department of Customer Service) indicates the presence of a dam within the vicinity of the proposed school site after 1956, which is visible up until the 2011 aerial imagery (Figure 2).

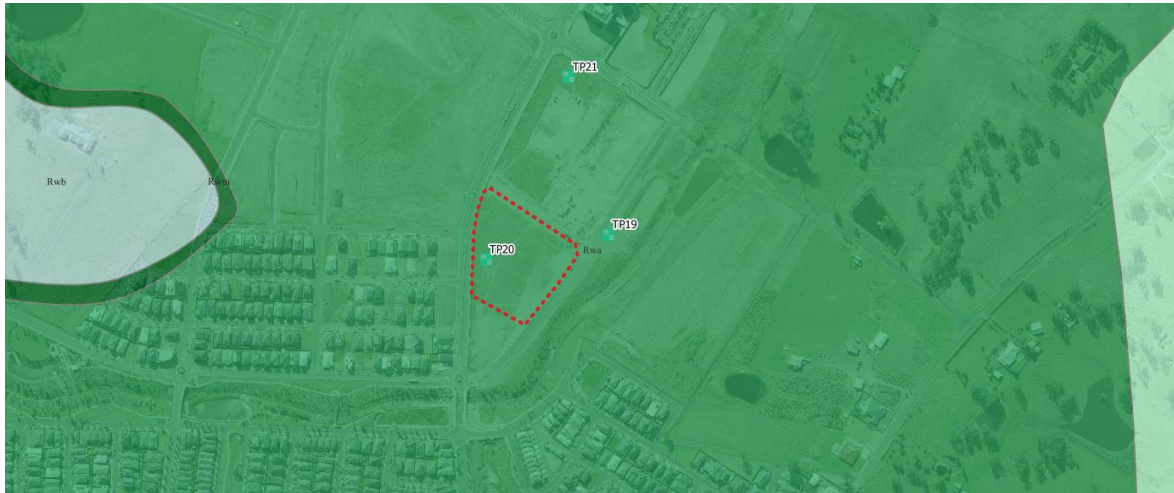
Figure 3: 1:100 000 Penrith Geology Map, showing location of proposed primary school (red). Rwb = Bringelly Shale, Rwa = Ashfield Shale, Rh = Hawkesbury Sandstone.

Reference to the Sydney 1:100 000 Geological Series map indicates that the site is underlain by Ashfield Shale, which typically comprises black to dark grey shale and laminite (finely interbedded sandstones and siltstones) and is part of the Wianamatta Group. Ashfield Shale overlies Hawkesbury Sandstone which is mapped approximately 800 m to the east of the site. An extract of the geological map is shown in Figure 3.

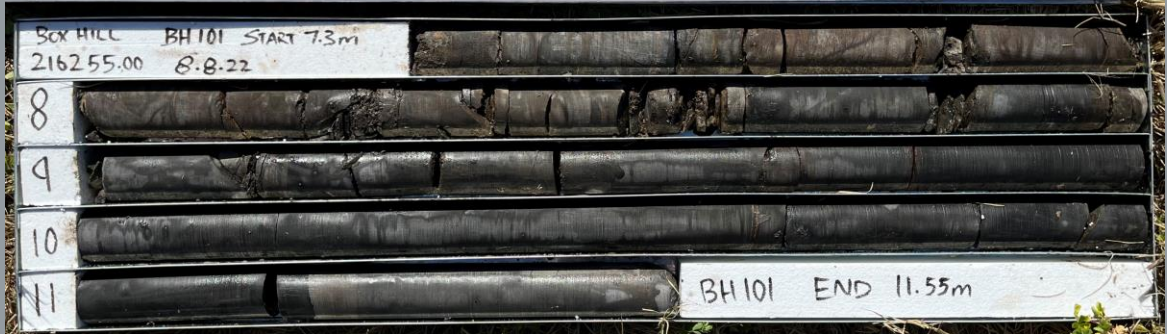
7.30 – 11.55m

Project No: 216255.00
BH ID: BH101
Depth: 7.30 – 11.55 m
Core Box No.: 1/1

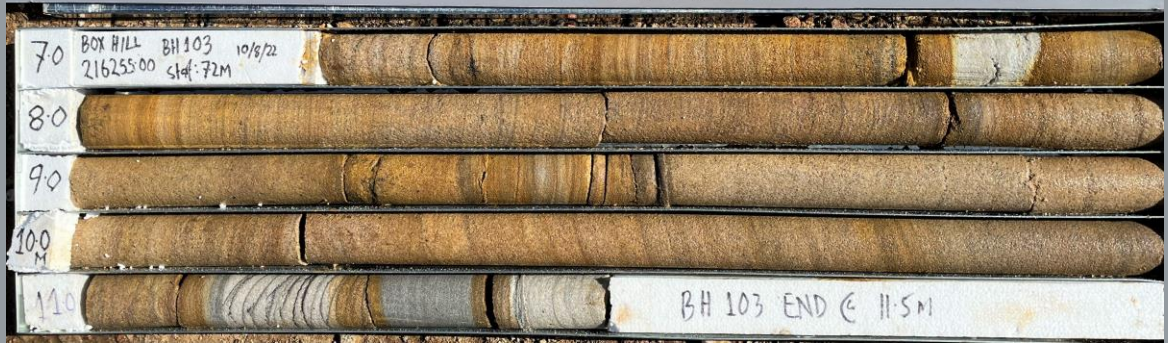
7.20 - 11.50m

Project No: 216255.00
BH ID: BH 103
Depth: 7.20 - 11.50 m
Core Box No.: 1/1

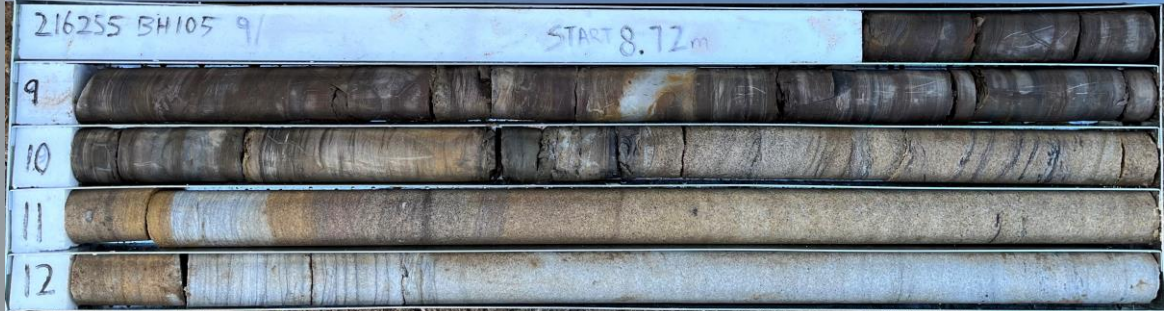
8.72 - 13.00m

Project No: 216255.00
BH ID: BH 105
Depth: 8.72 - 13.00 m
Core Box No.: 1/1
