**REPORT TO  
NSW DEPARTMENT OF EDUCATION**

**ON  
GEOTECHNICAL INVESTIGATION**

**FOR  
NEW HIGH SCHOOL FOR LEPPINGTON AND  
DENHAM COURT**

**AT  
128-134 RICKARD ROAD, LEPPINGTON, NSW**

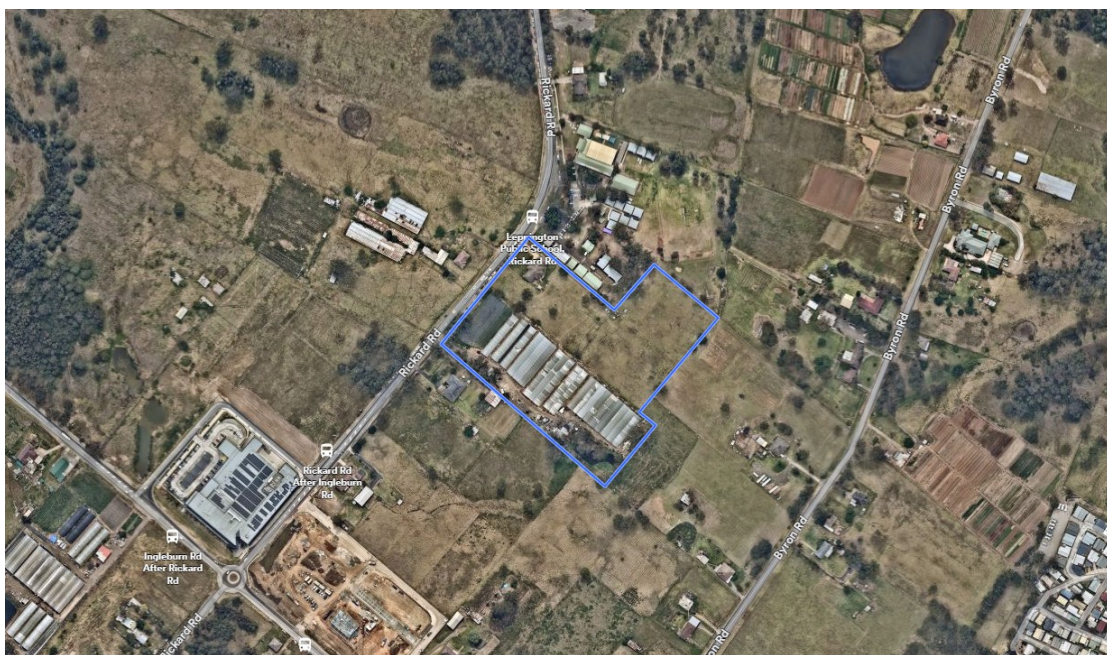
Figure A: Aerial image of site (Source: NearMap)
