**REPORT TO  
NSW DEPARTMENT OF EDUCATION**

**ON  
GEOTECHNICAL INVESTIGATION**

**FOR  
NEW HIGH SCHOOL FOR LEPPINGTON AND  
DENHAM COURT**

**AT  
128-134 RICKARD ROAD, LEPPINGTON, NSW**

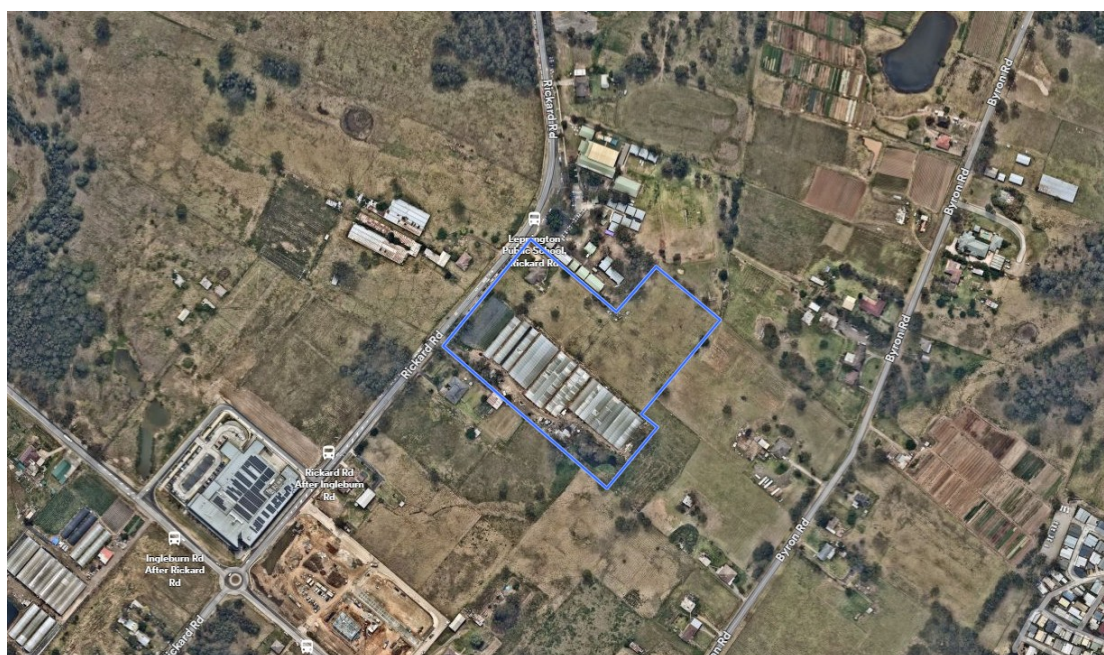
Figure A: Aerial image of site (Source: NearMap)

The northern portion of the site is currently used for residential purposes while the southern portion is used for agricultural purposes, with multiple greenhouses and an existing pond on the property.

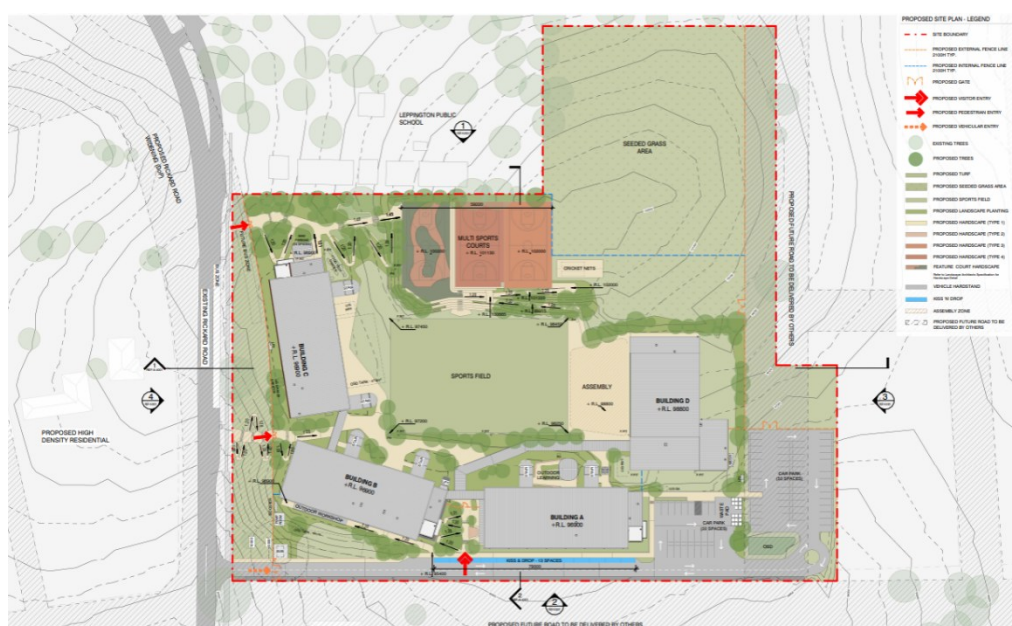
Figure B: New High School for Leppington and Denham Court (source: djrd architects)

The proposed activity is for a new high school that will service Leppington and Denham Court. The new high school will accommodate up to 1,000 students across 3 new buildings and will comprise 48 permanent teaching spaces (PTS), 3 support teaching spaces (STS), 9 specialist labs/workshops/kitchens and a hall. Buildings A, B and C will wrap the western and southern boundaries of the site, with the hall being located in the south-east corner. The activity also includes the construction of a sports field in the centre of the site and 3 multipurpose courts along the northern boundary. The proposed scope of works is illustrated in Figure B below.

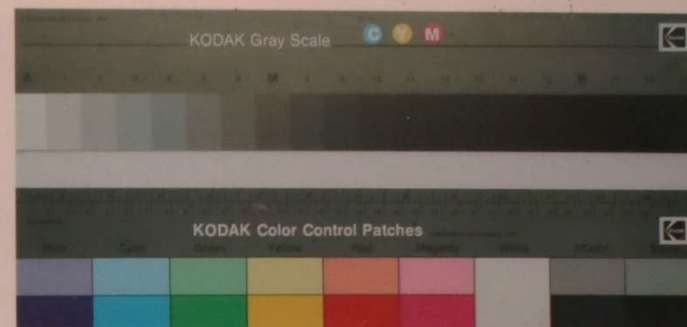
Job No: 35910BT  
Borehole No: BH102  
Depth: 12.00m to 12.17m

END OF BOREHOLE AT 12.17 m

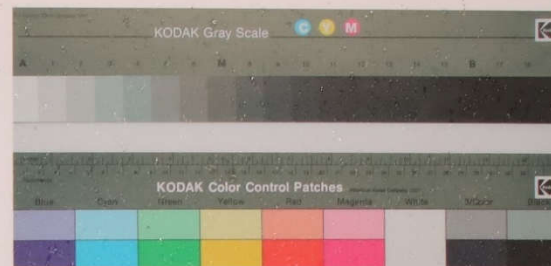
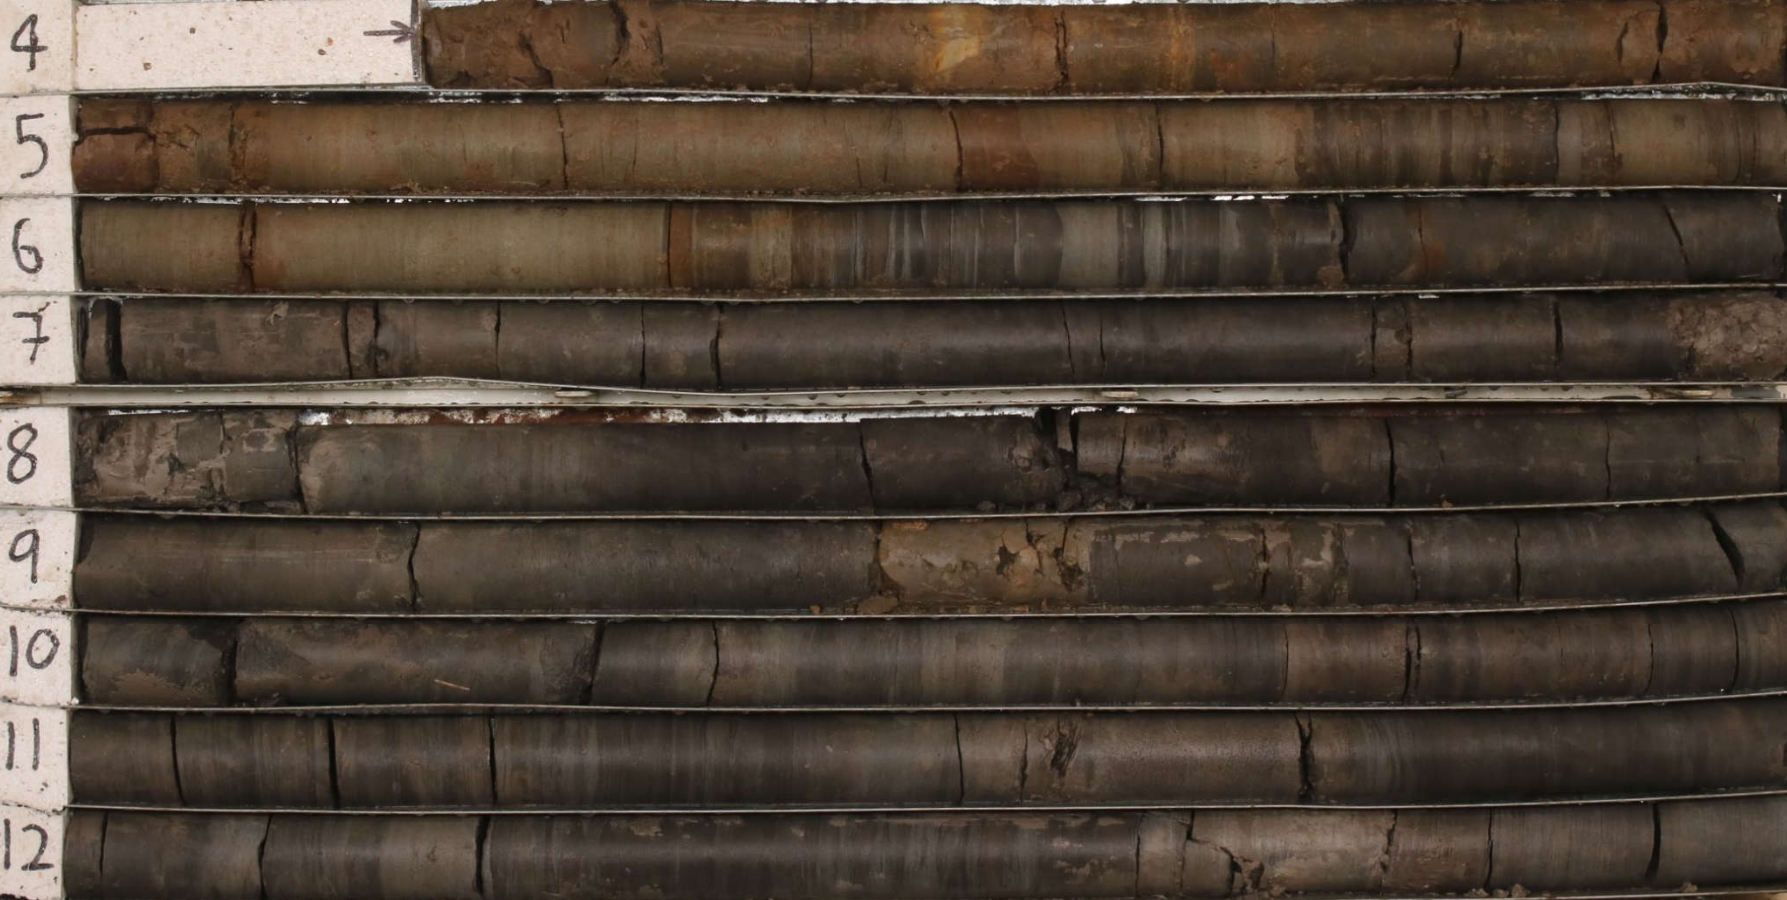
Job No: 35910LT  
Borehole No: BH104  
Depth: 4.20m to 13.00m

35910LT BH104 START CORING AT 4.20m
