Our Ref: PSM4693-012L REV5

**RE: NEW HIGH SCHOOL FOR SCHOFIELDS AND TALLAWONG  
GEOTECHNICAL INVESTIGATION**

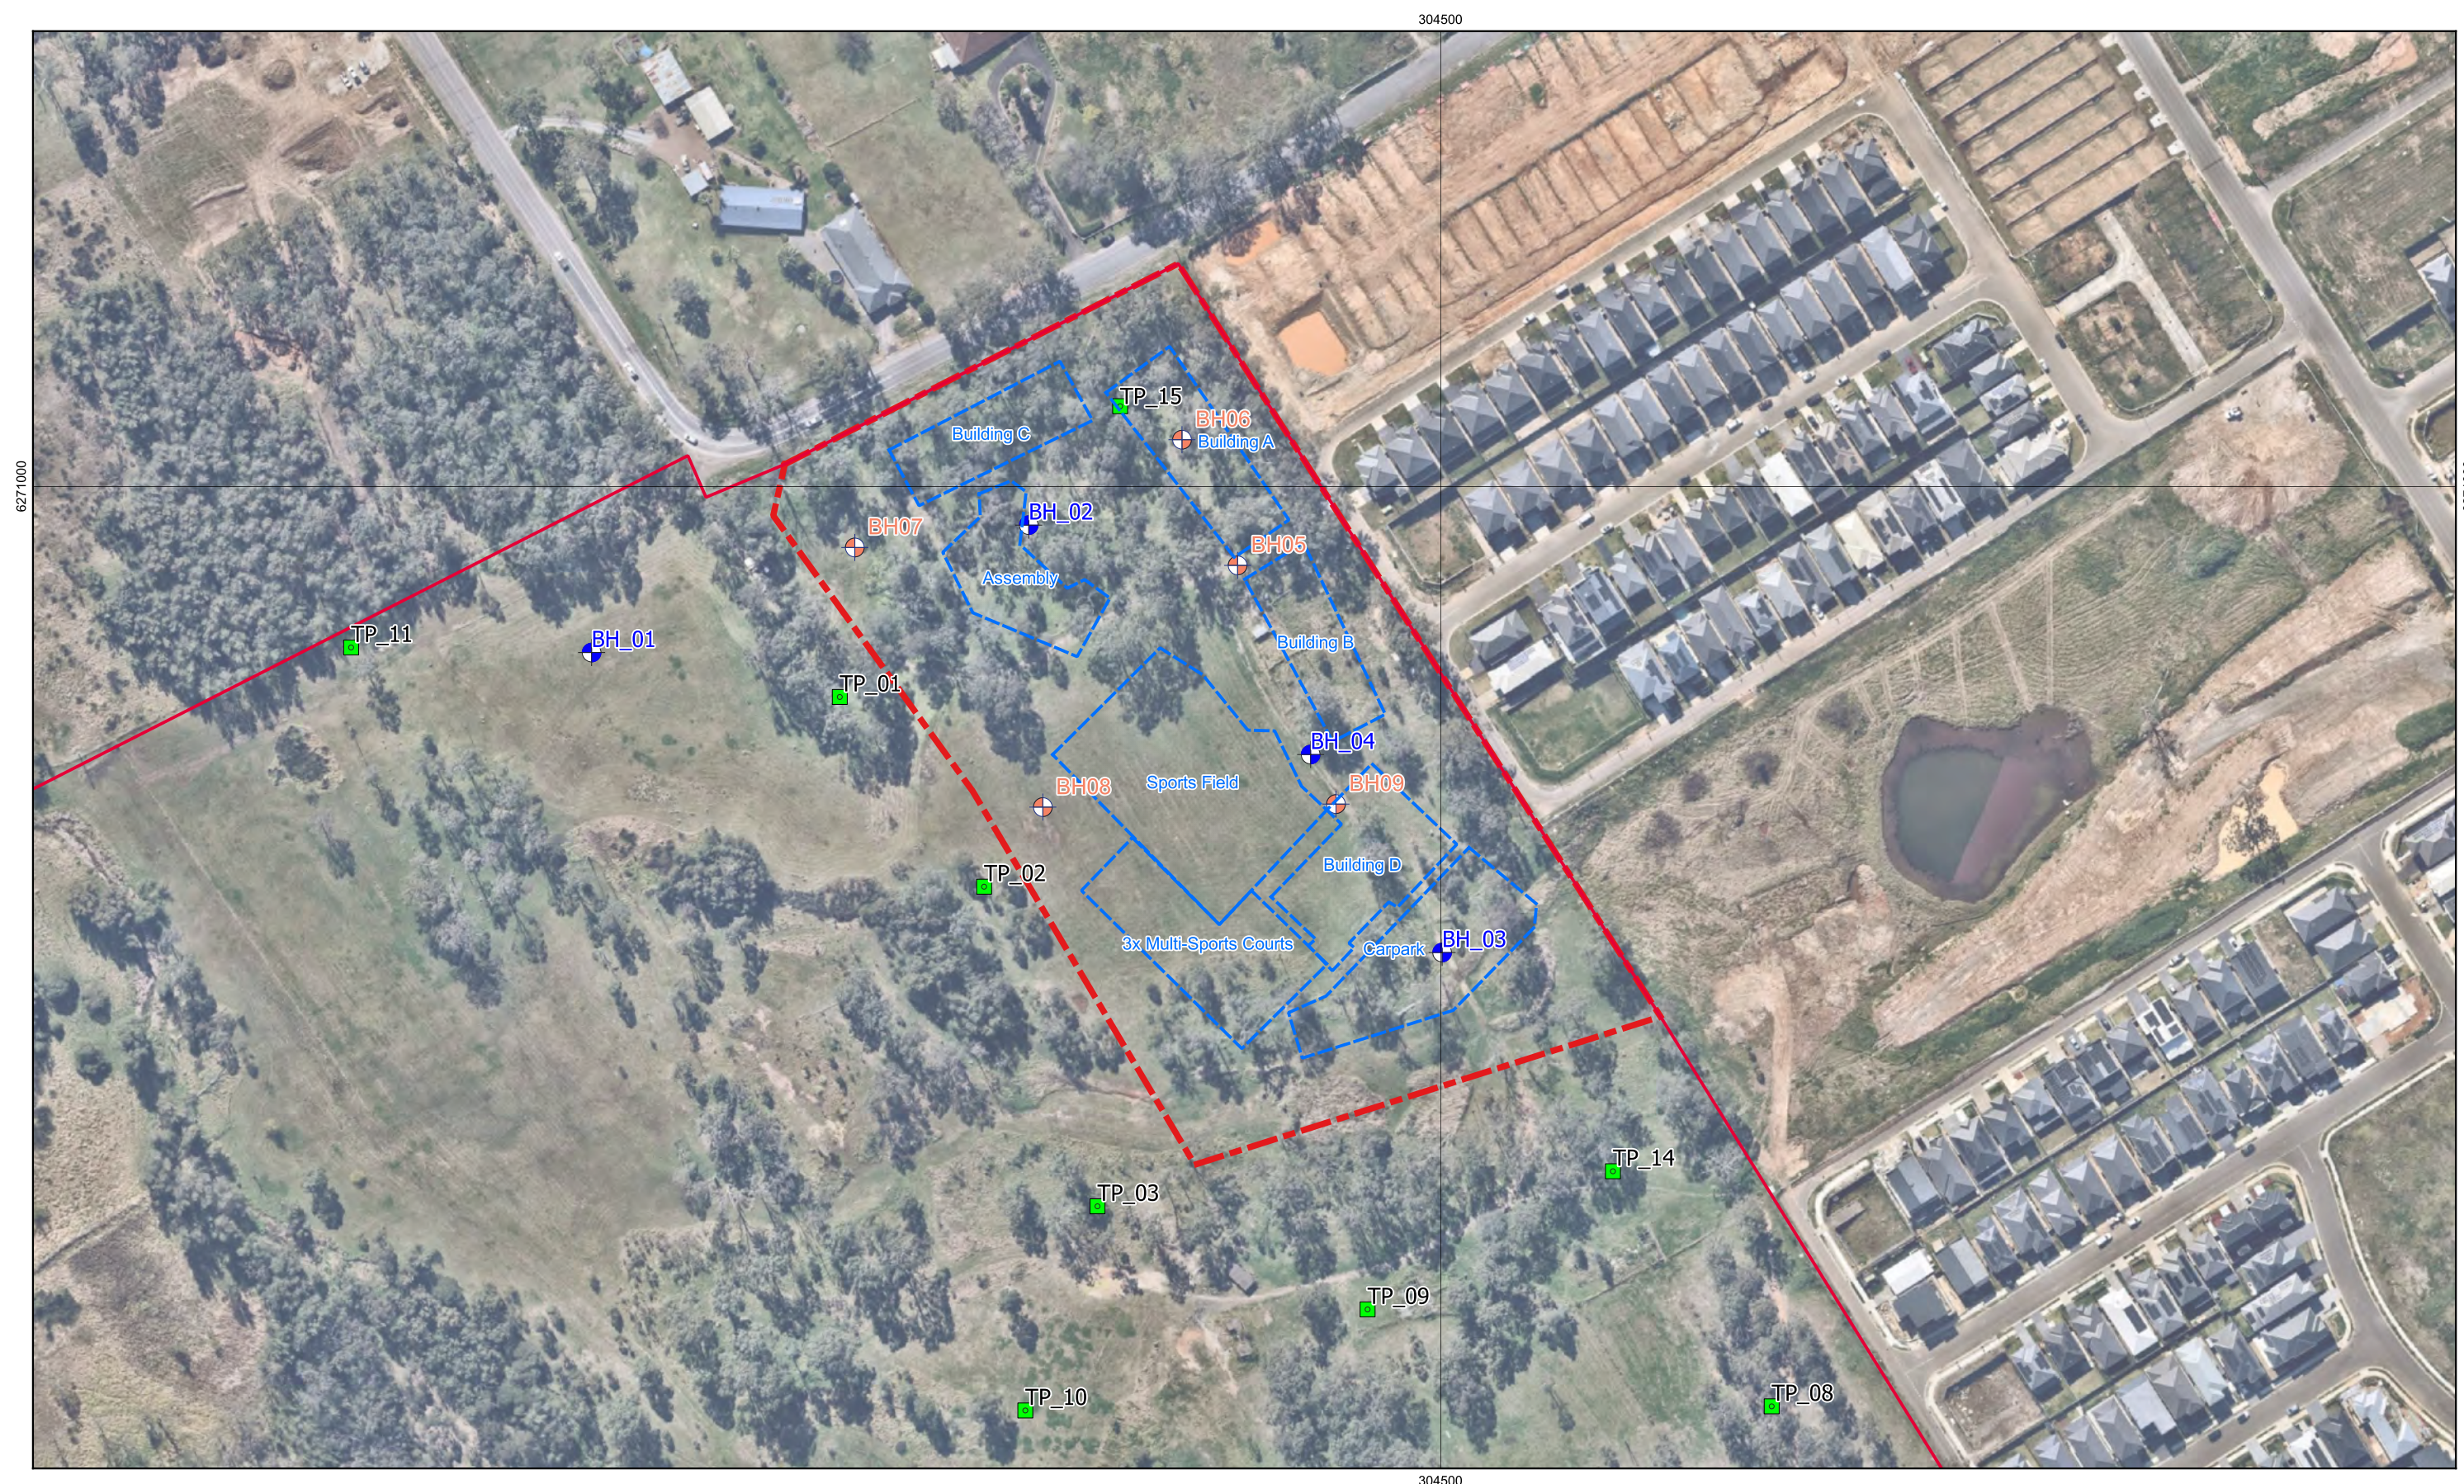
| PSM4693-012L | Figure 2 |

- Approximate Site Extents - Schofields - Tallawong High School
- 2022 Landcom Site Investigation - Project Boundary
- Proposed Site Plan
- Approximate Borehole Locations (2024 Oct)
- Approximate Test Pits Undertaken (2022 Landcom Site Investigation)
- Approximate Boreholes Undertaken (2022 Landcom Site Investigation)

Figure 2 presents the site locality plan of the Schofields - Tallawong High School.

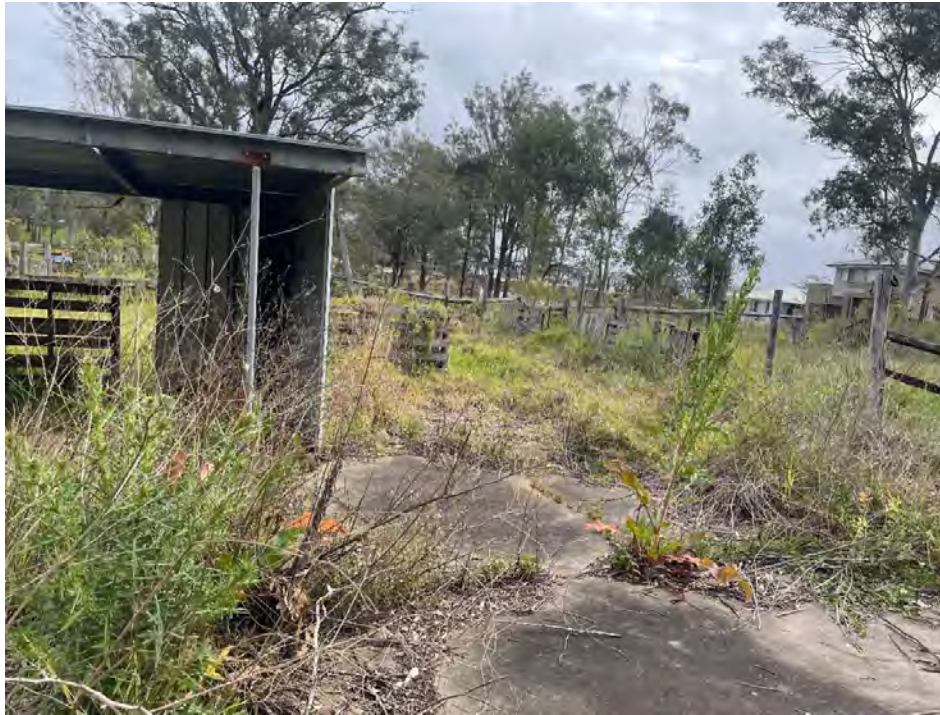
Photo 3 - Previous agricultural infrastructure near BH05 (2 October 2024)

- Previous agricultural infrastructure was still present on site consisting of sheds, metal and wooden fences and gates, timber utility poles and localised areas with concrete pavements and bricks (Photos 3 and 4 of Figure 4).
- Stockpile observed near BH05 (Photo 4 of Figure 4).
- Mature sparse trees of approximately up to 15 to 20 m throughout Site, mainly towards the north-western portion (Photo 4 of Figure 4).

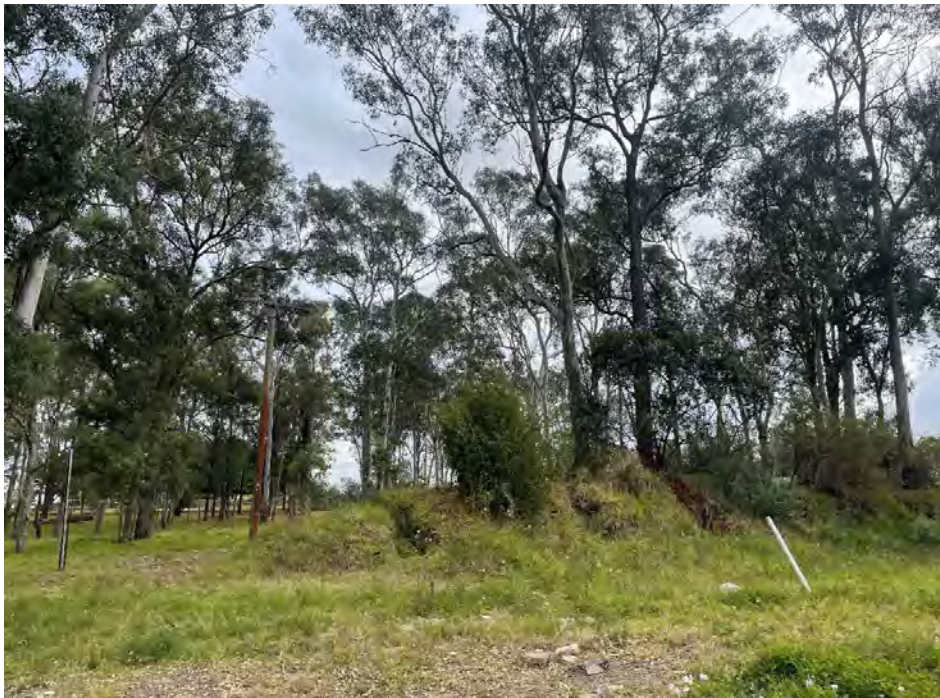
Photo 4 - Mature sparse trees up to 15-20 m height, a stockpile and timber power poles located immediately north of BH05 (2 October 2024)

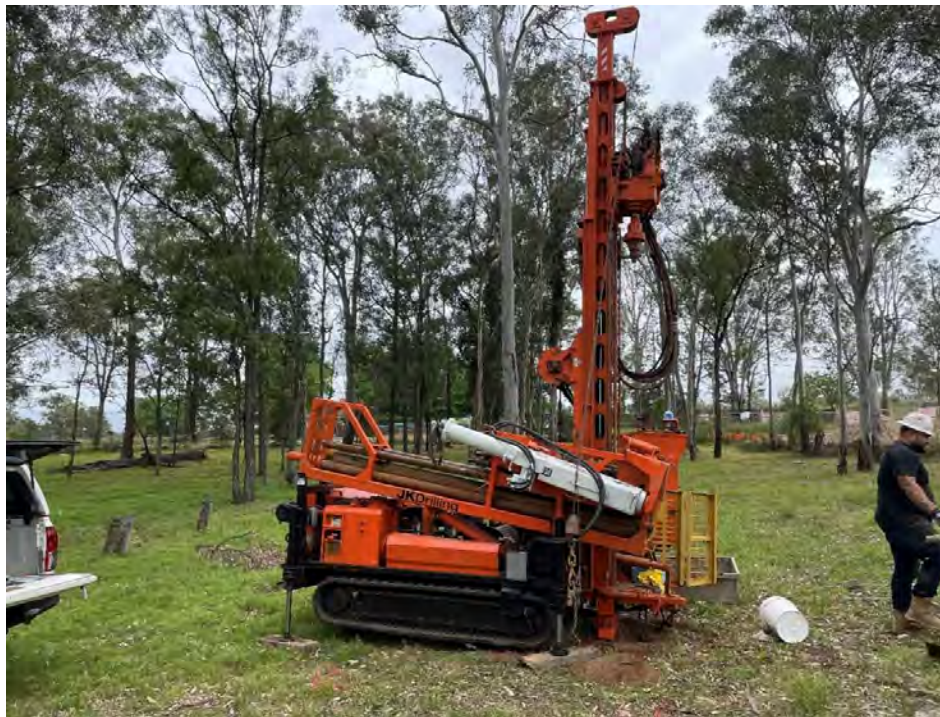
Photo 5 - 6-tonne track mounted drill rig used for BH05, BH06 & BH09 (photo taken at BH06)

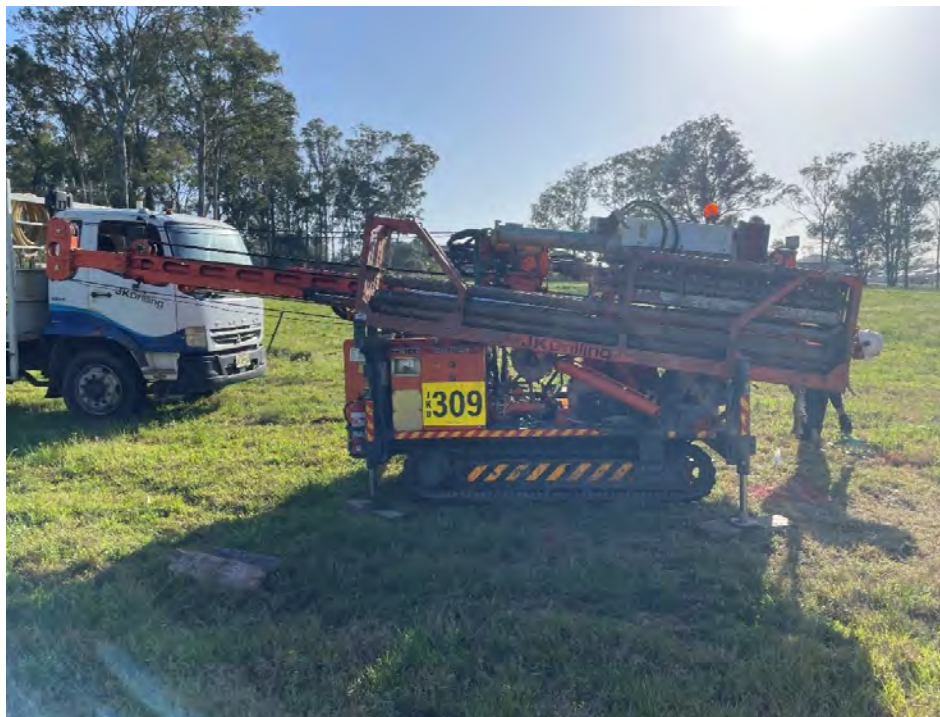
Photo 6 - 6-tonne track mounted drill rig used for BH07 & BH08 (photo taken at BH08)

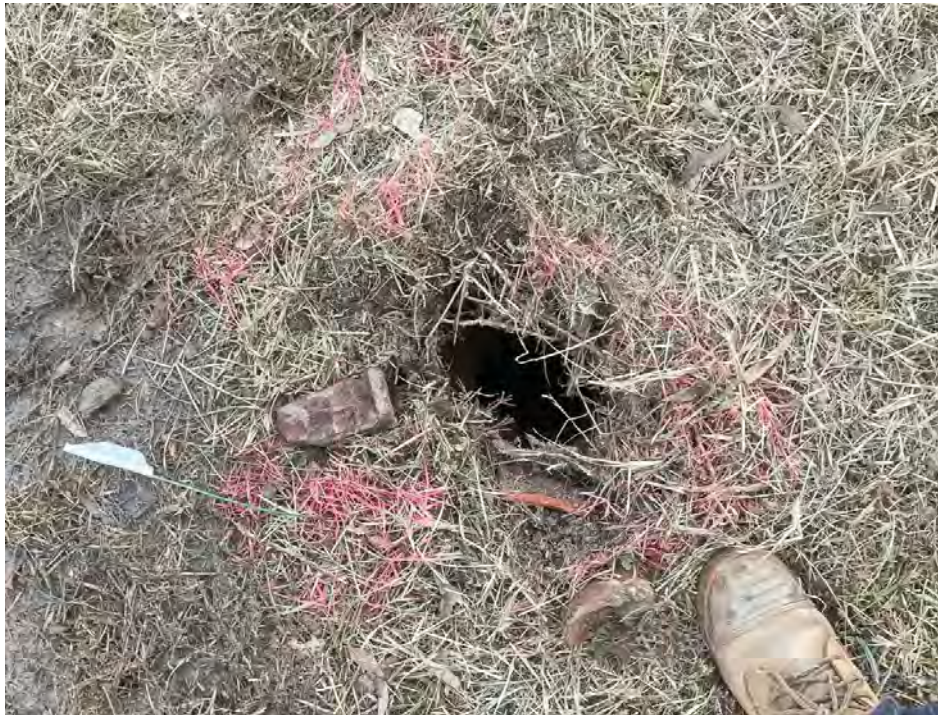
Photo 7 - Brick structure and void encountered whilst drilling BH05

| Inferred Unit | Depth to Top of Inferred Unit (m) | Material Description |
|---|---|---|
| EXISTING FILL | 0.1 to 0.2 | <p>SAND with clay and gravel, fine grained, brown and grey; low plasticity; clay low plasticity; gravel fine to medium grained, sub-angular, up to 10 mm; moist, inferred loose density; brick fragments up to 50 mm observed.</p> <p>CLAY trace gravel to Sandy Gravelly CLAY: medium plasticity, red brown to brown; sand fine to coarse grained, gravel fine to coarse grained, sub-rounded to sub-angular, up to 20 mm; moist (&lt;PL), stiff consistency.</p> <p><u>Along/near the existing access track areas:</u></p> <p>Silty Gravelly CLAY; medium plasticity, dark brown; gravel fine to coarse grained, sub-angular, up to 10 mm; moist, stiff consistency, some rootlets.</p> <p>Gravelly SAND trace silt: fine grained, dark brown; gravel fine to coarse grained, sub-angular, up to 30 mm; moist, inferred loose to medium dense.</p> <p><u>In some localised areas (near BH05):</u> Concrete slabs up to 200 mm thick and brick structures up to 1.2 m.</p> <p>COBBLES comprising of BRICK fragment and VOID, brick structure observed, void existed within the brick structure.</p> |

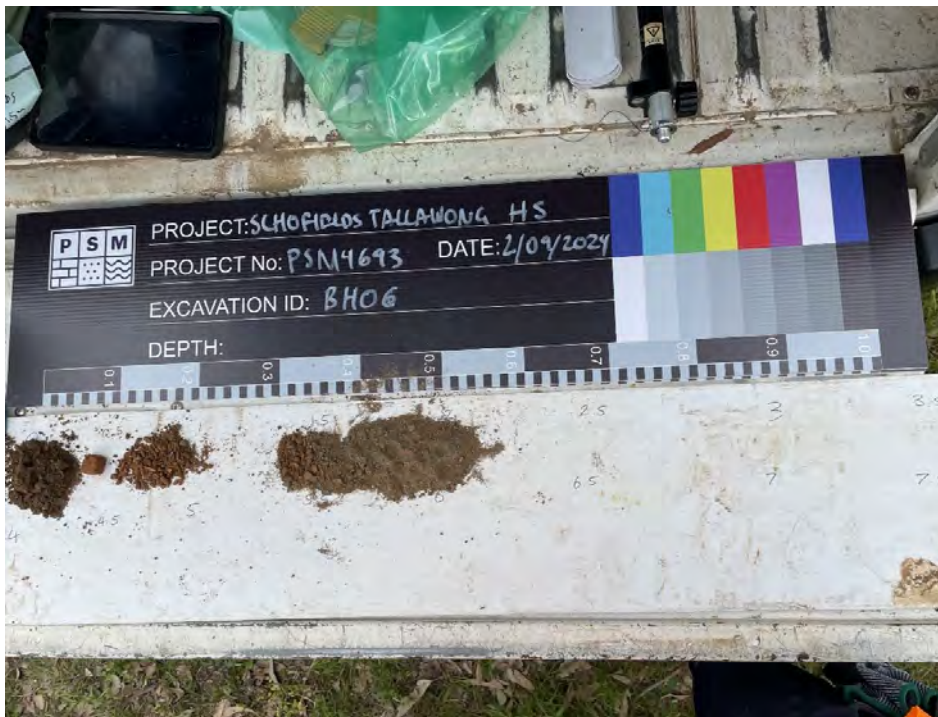
Photo 8 - Typical soil photo board - BH06 from 0 to 2.1 m

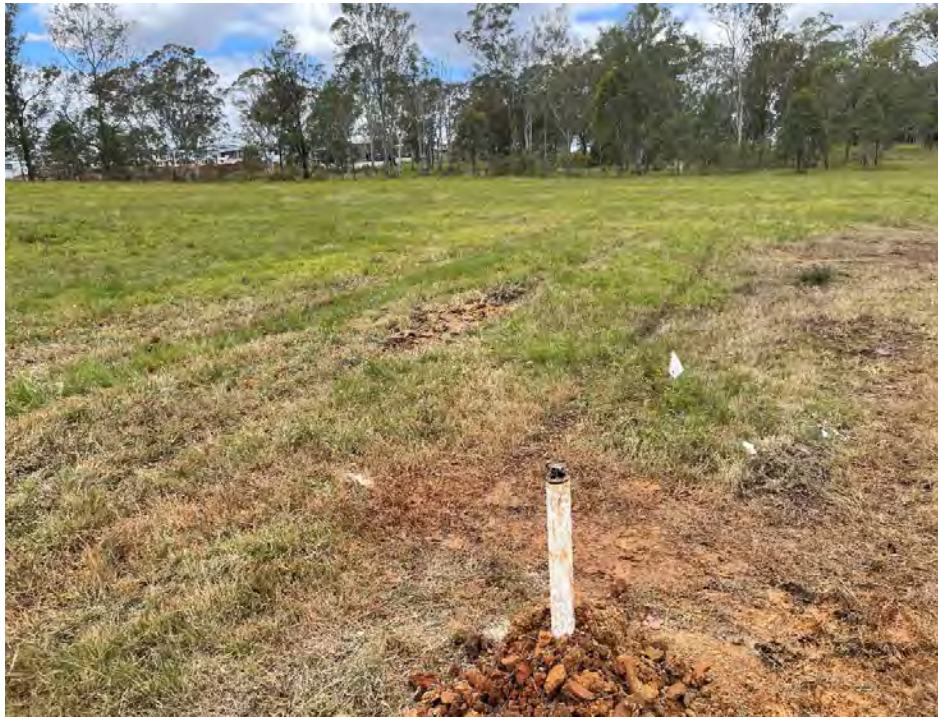
Photo 9 - Completed standpipe piezometer (BH09)

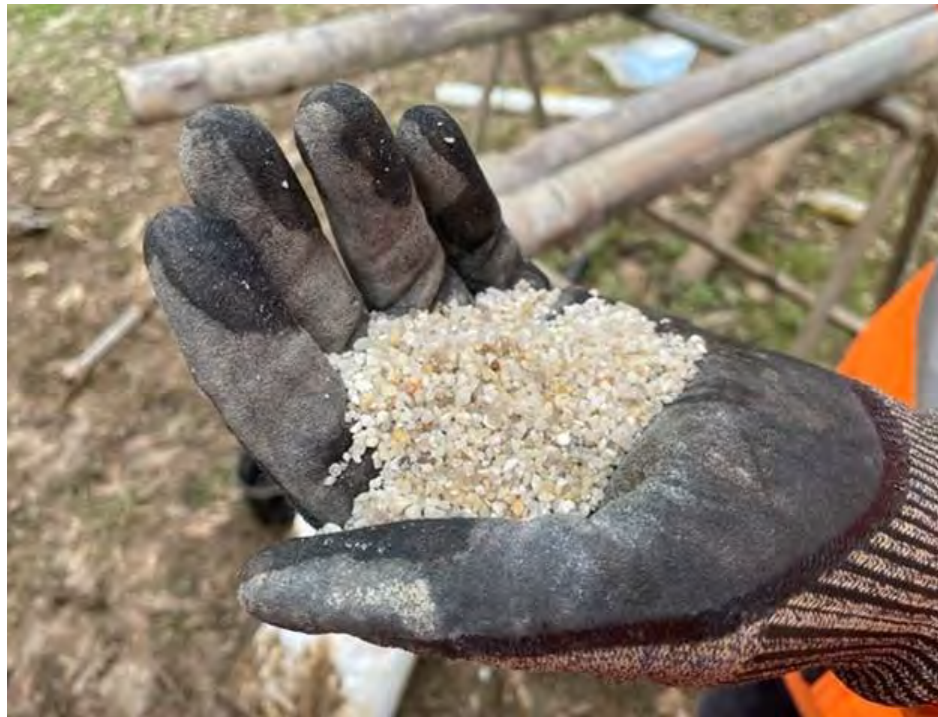
Photo 10 - Specialised Sand' material used for gravel pack/filter pack in piezometers

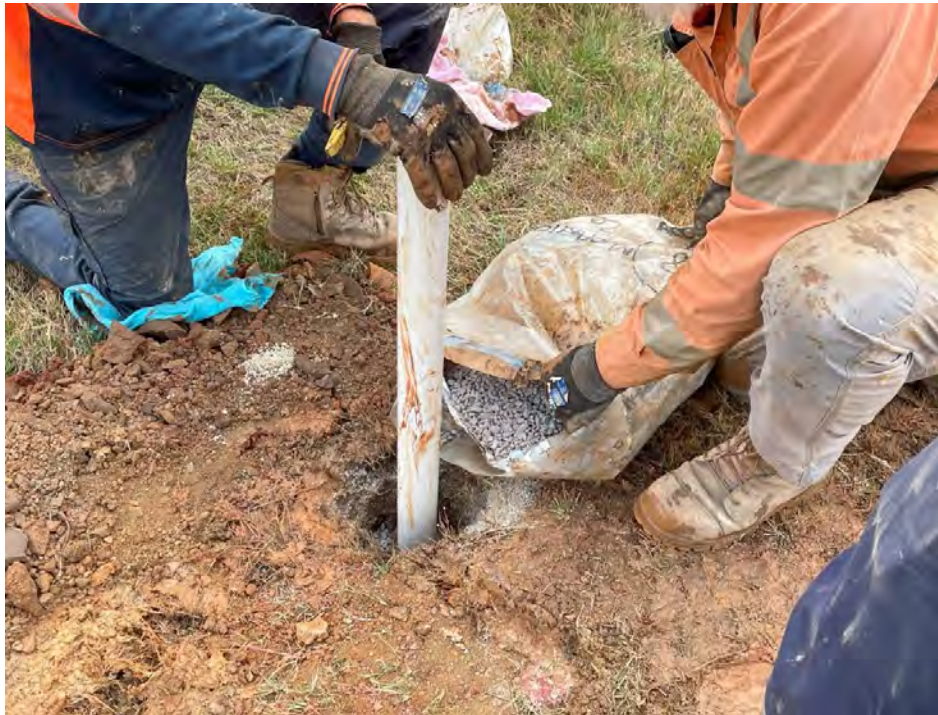
Photo 11 - Bentonite pellets used as an annular seal & backfill for piezometers (BH09)

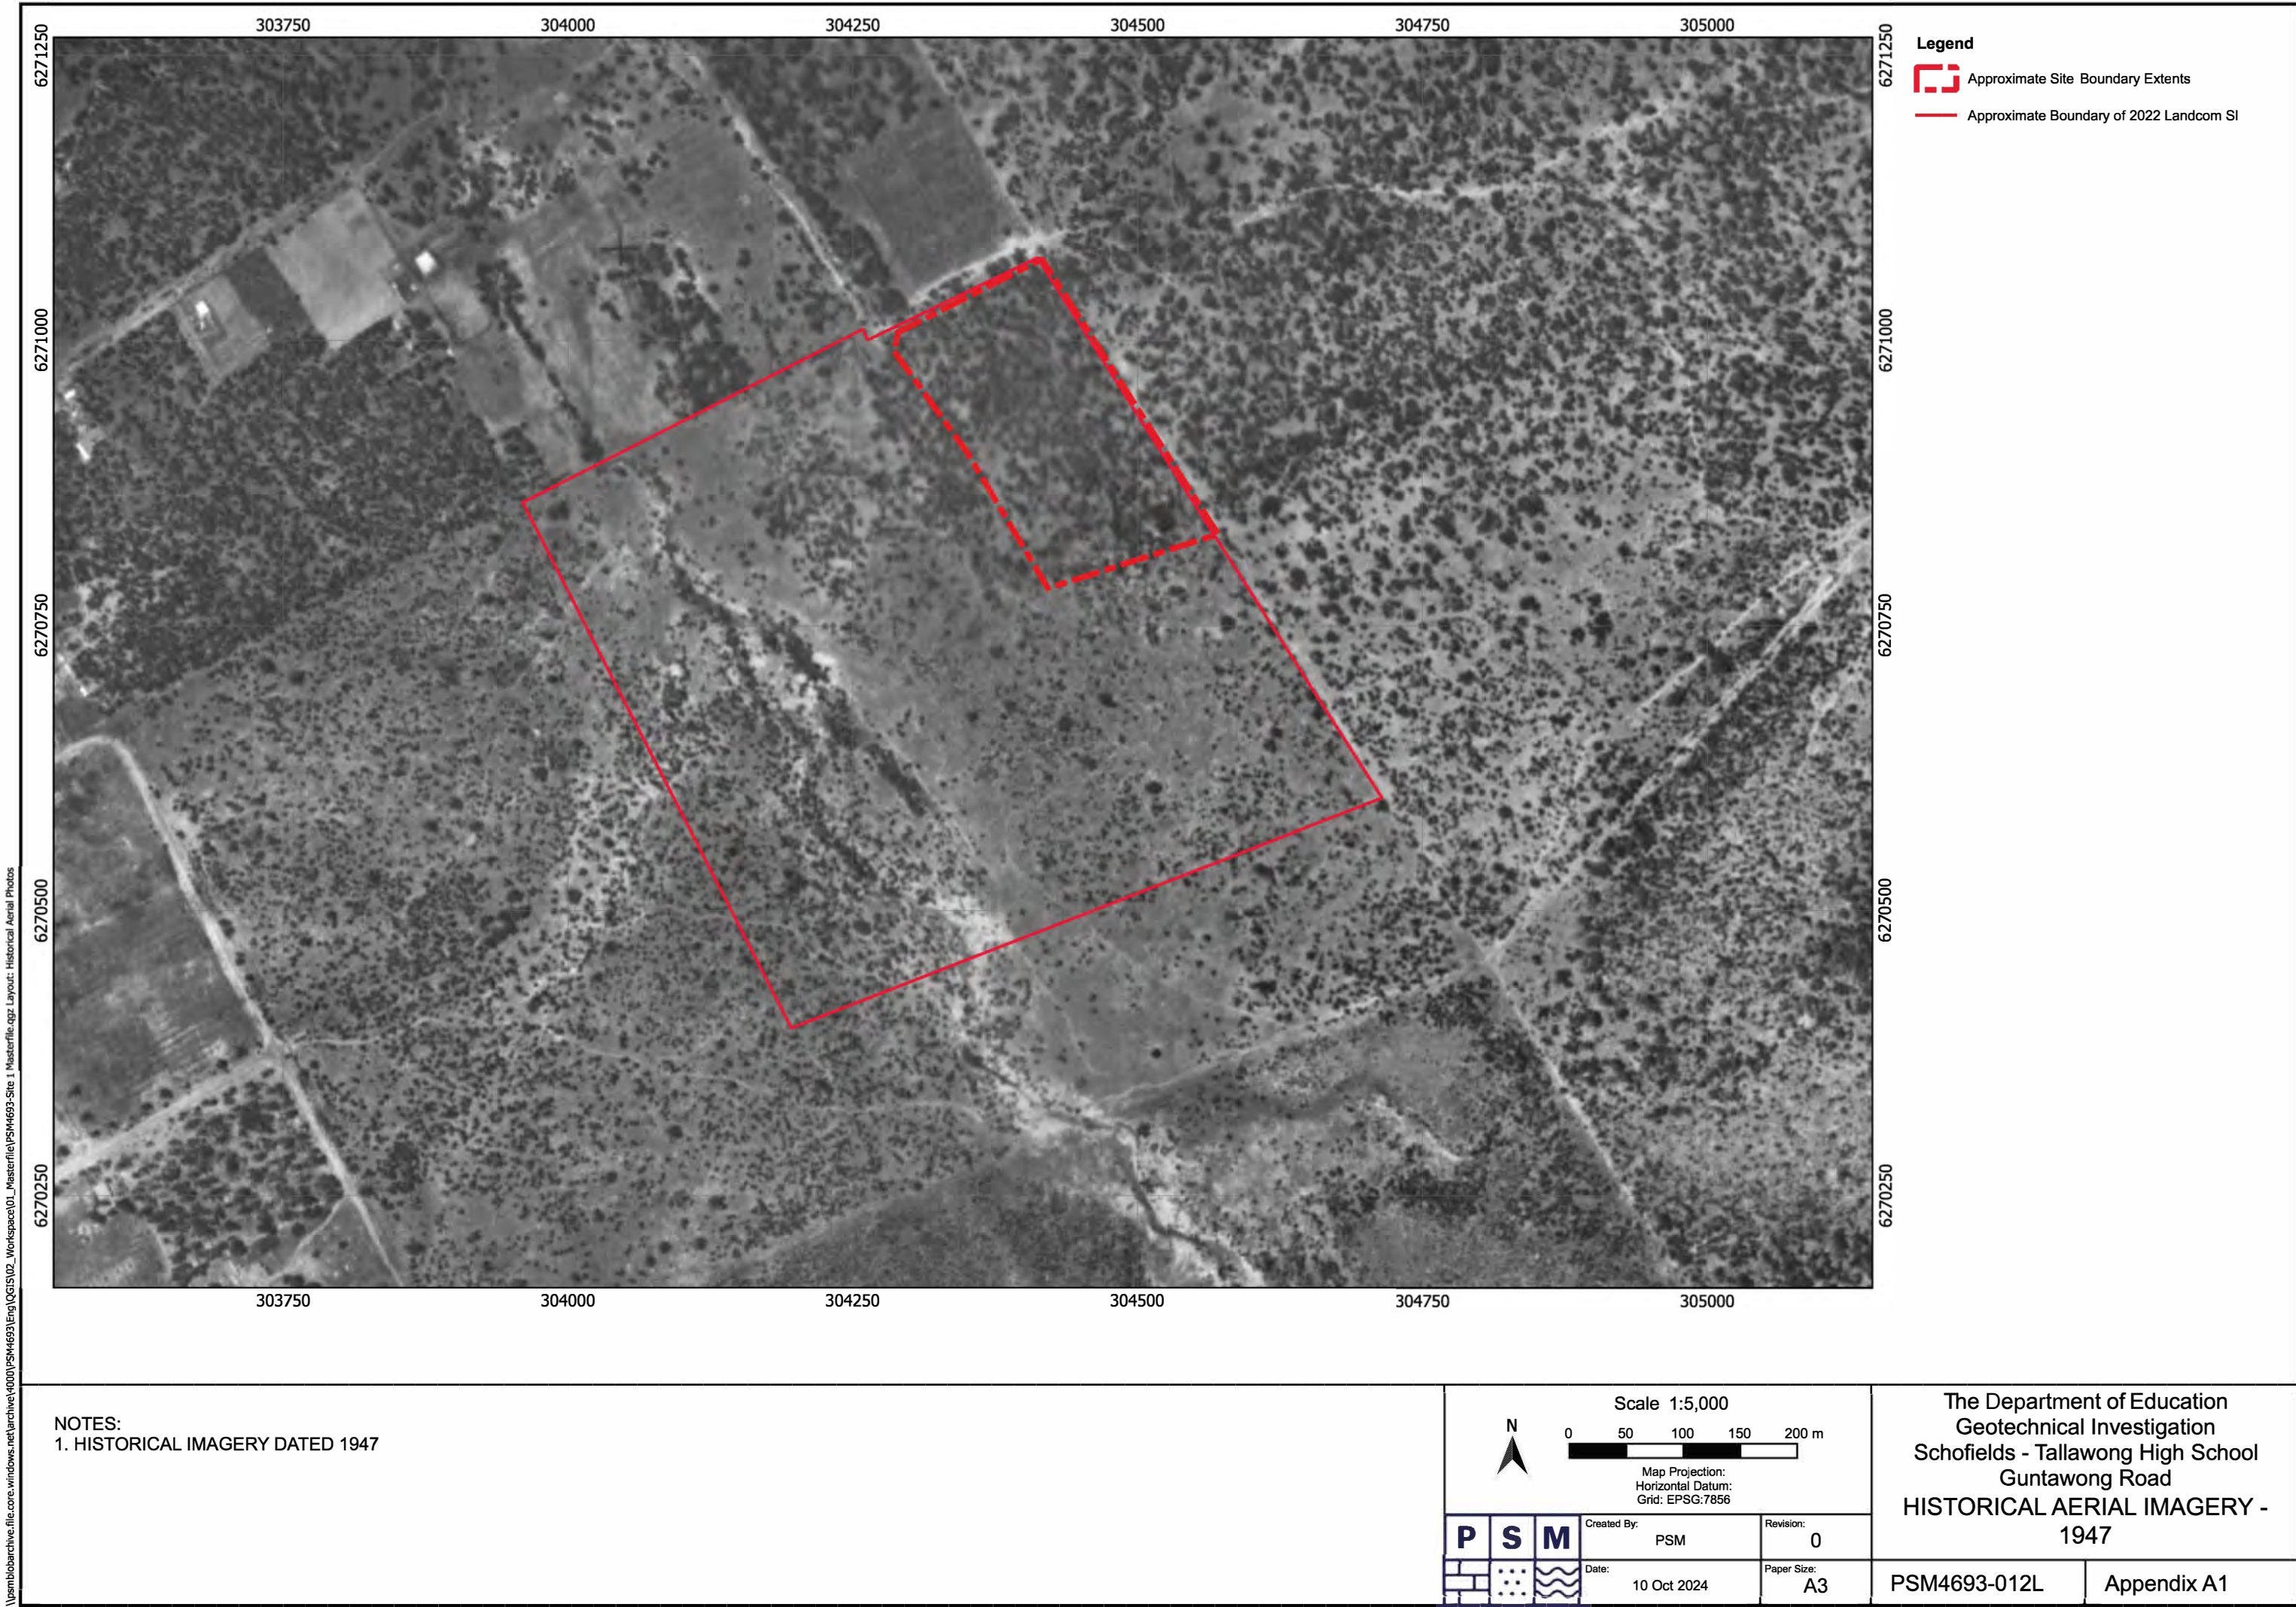
Appendix A1

NOTES:  
1. HISTORICAL IMAGERY DATED 1947

- 1947: Undeveloped vacant land. Scattered trees and heavy vegetation coverage across site with the outlines of Frist Pounds Creek observed south of The Site.
- 1975: Partial land clearance observed for the site area since 1947 photograph. Small buildings and structures for agricultural use have been constructed in the centre and northeast portions of The Site.

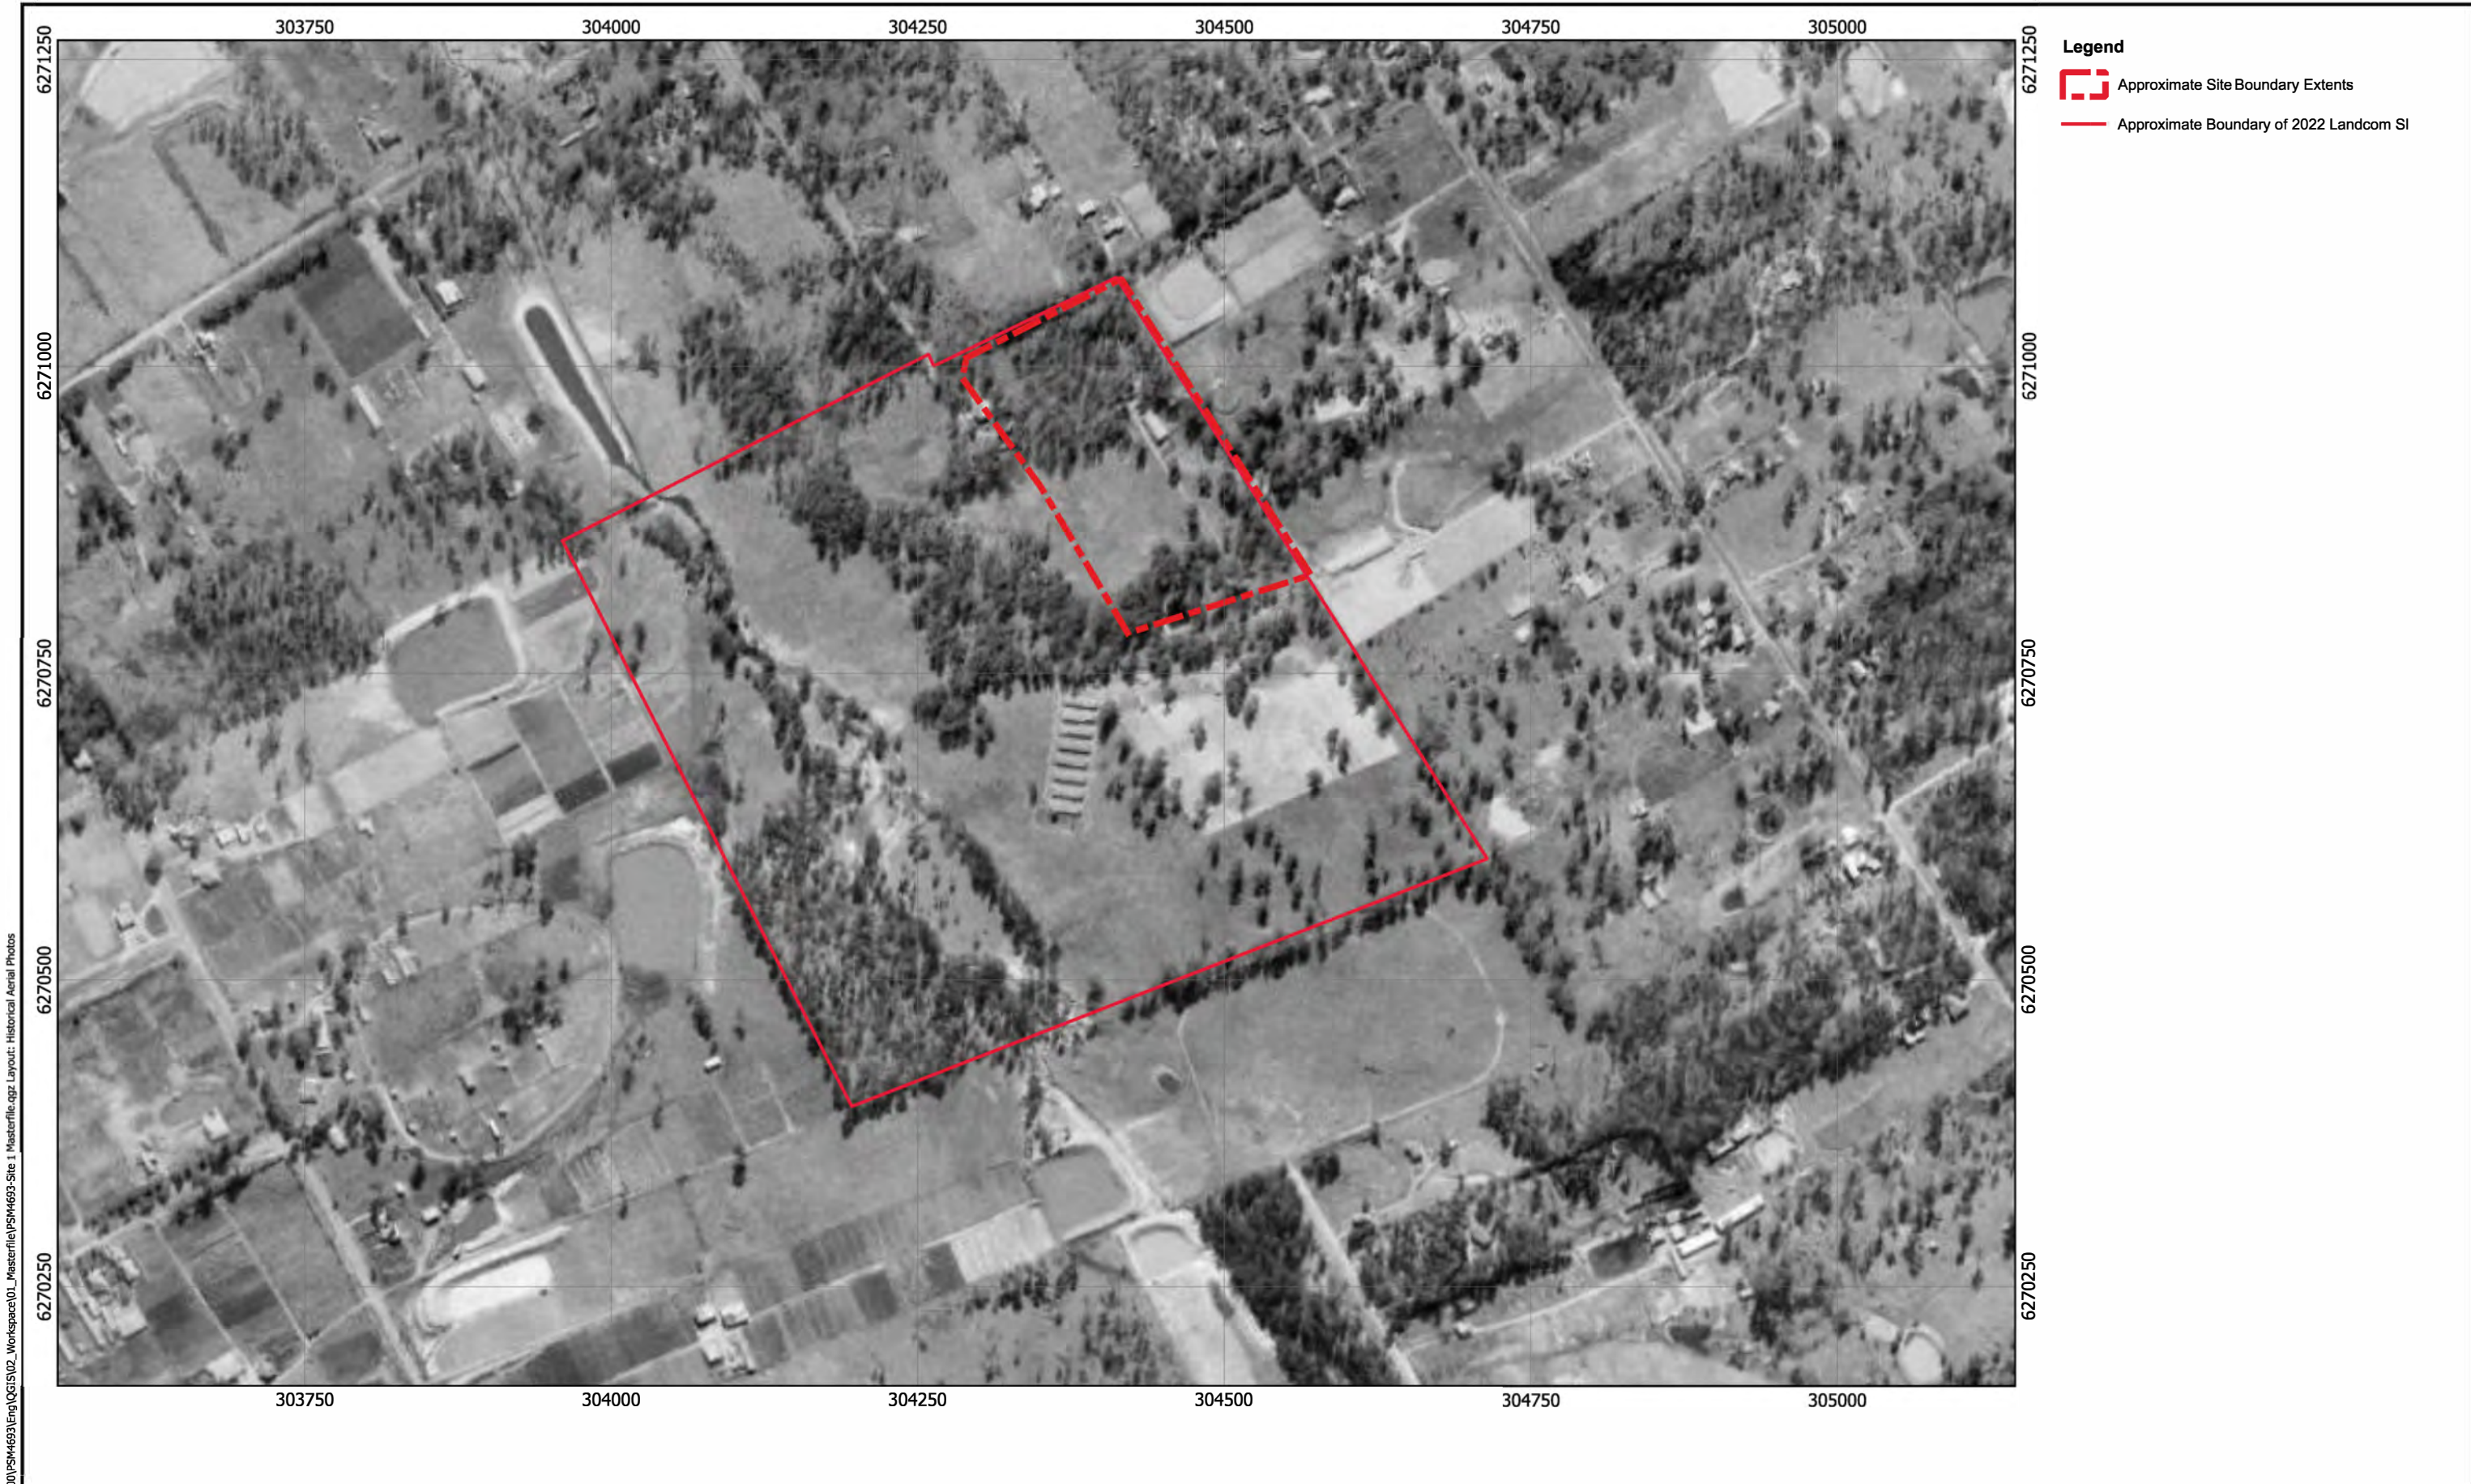
| PSM4693-012L | Appendix A2 |

NOTES:  
1. HISTORICAL IMAGERY DATED 1975

The Department of Education  
Geotechnical Investigation  
Schofields - Tallawong High School  
Guntawong Road  
**HISTORICAL AERIAL IMAGERY - 1975**

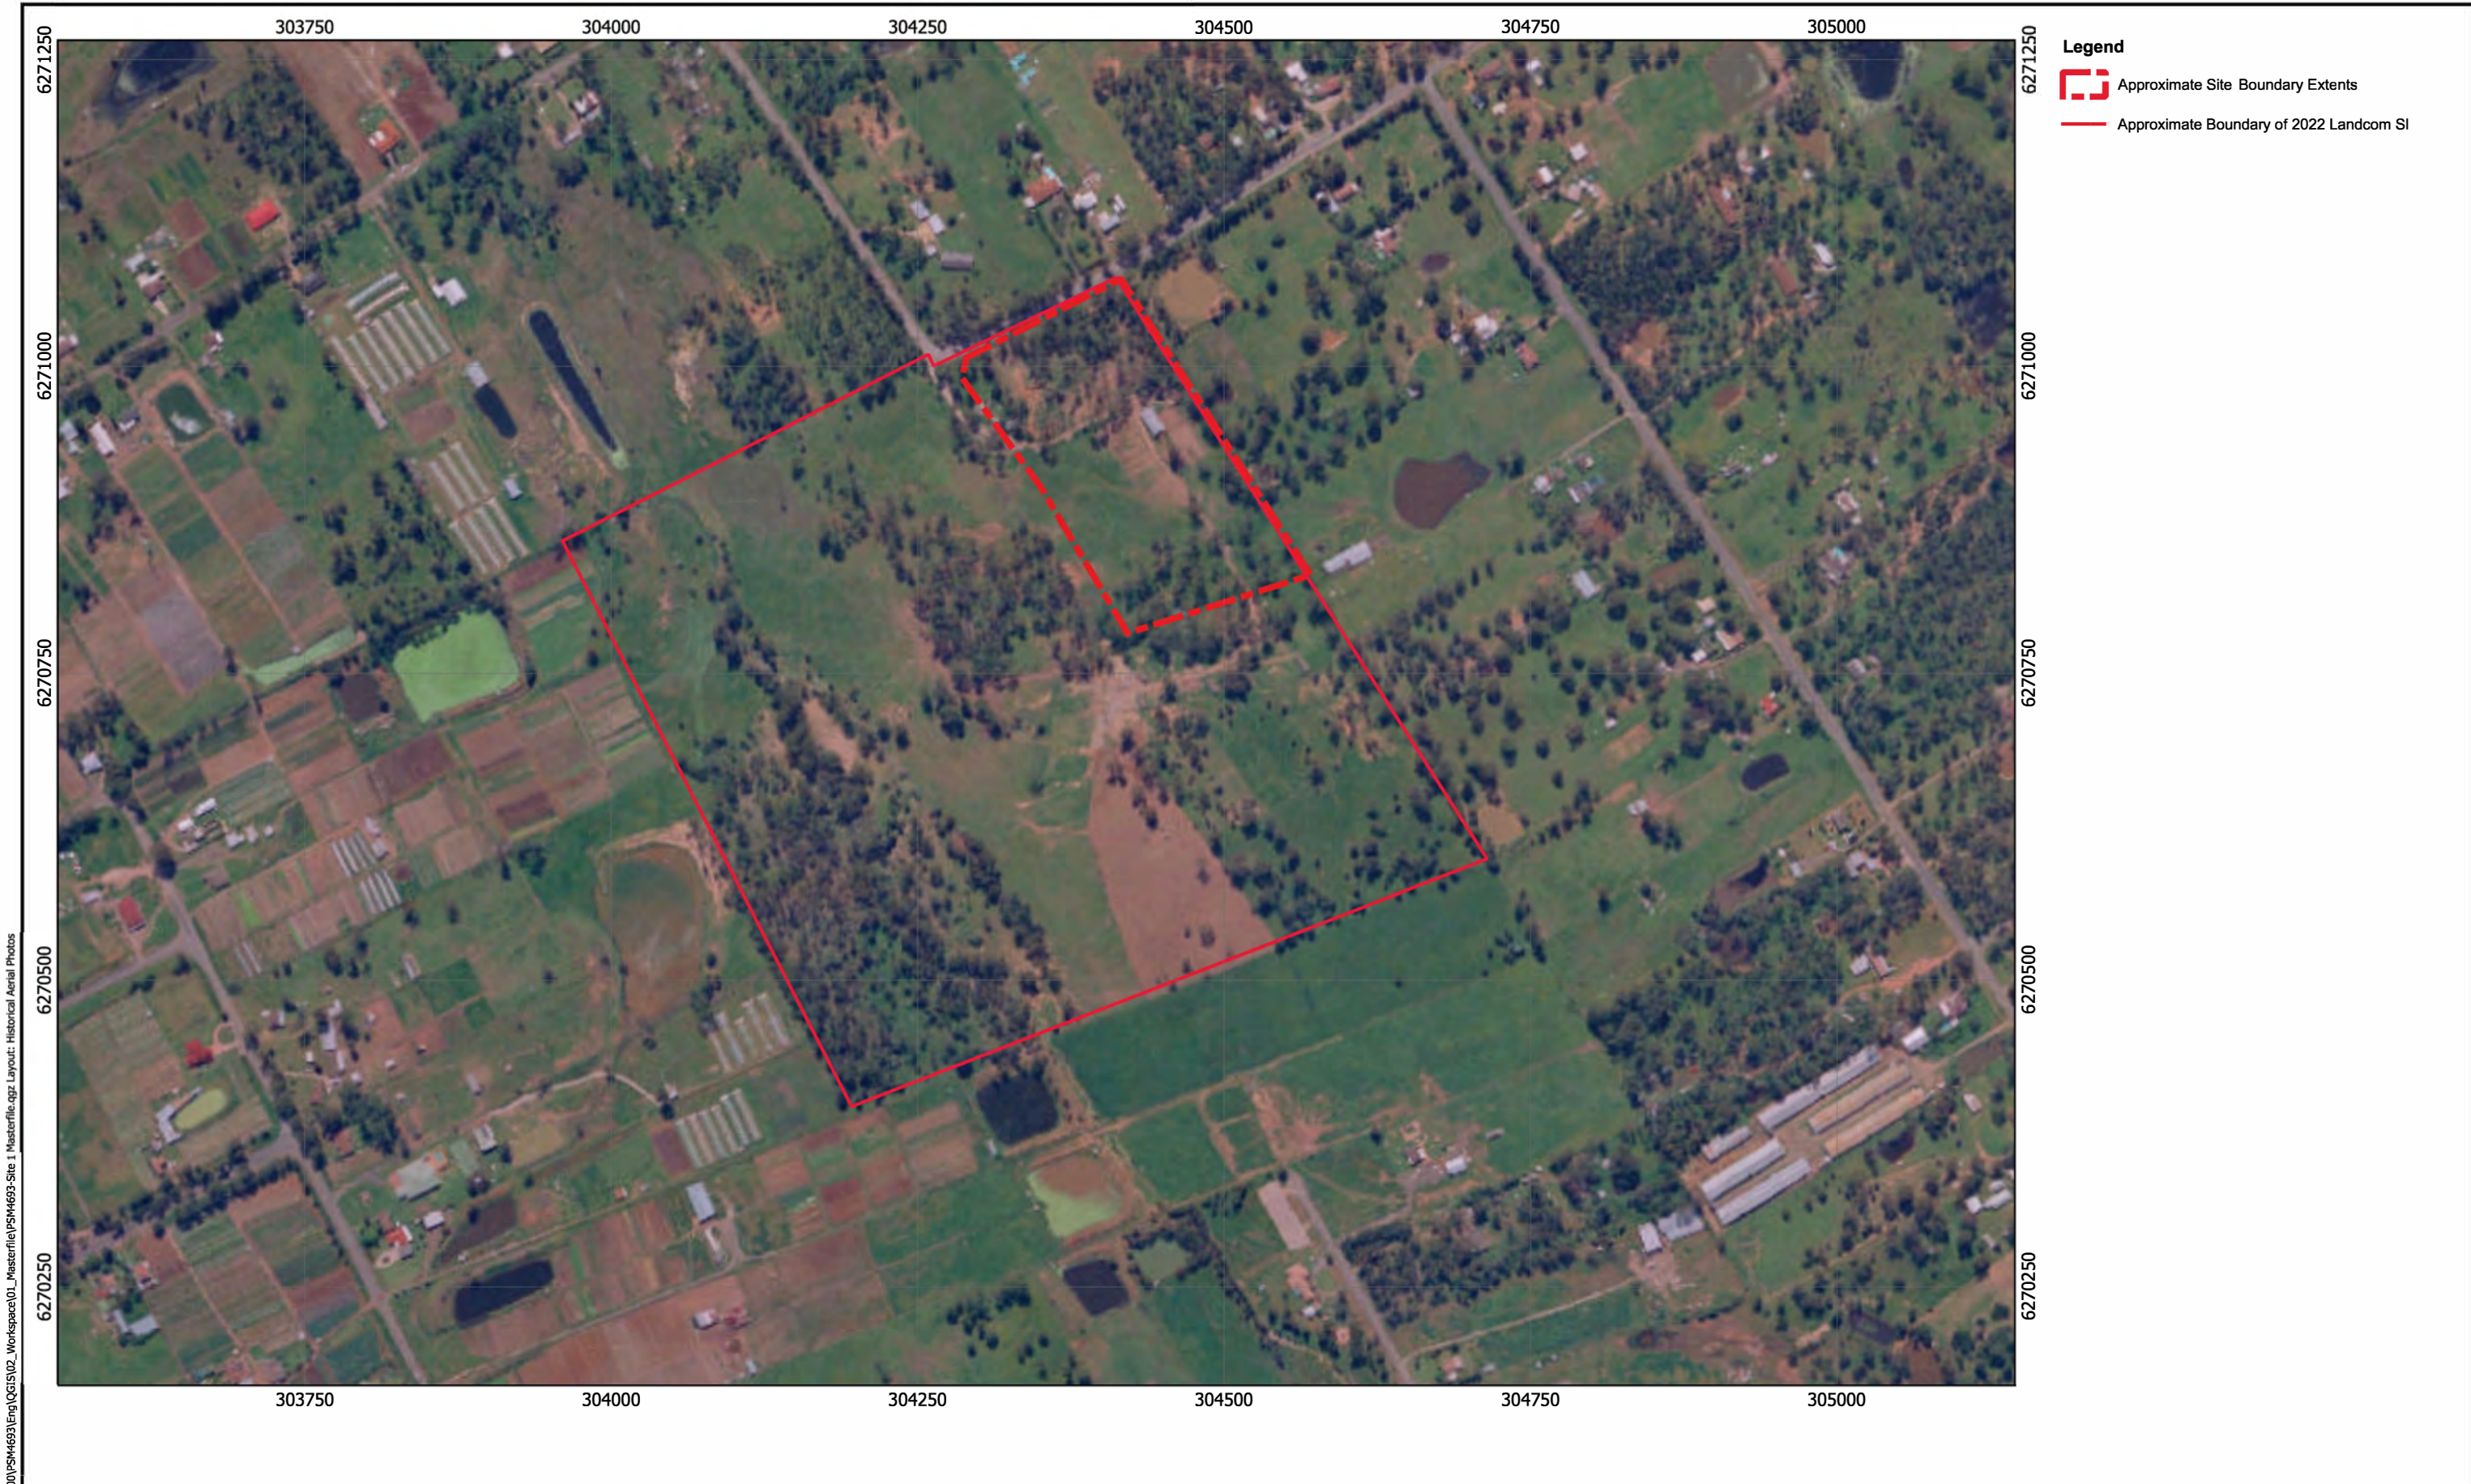
| PSM4693-012L | Appendix A3 |

NOTES:  
1. HISTORICAL IMAGERY DATED 1998

The Department of Education  
Geotechnical Investigation  
Schofields - Tallawong High School  
Guntawong Road  
**HISTORICAL AERIAL IMAGERY - 1998**
