# Remedial Action Plan, Proposed Tallawong High School

NSW Department of Education

JBS&G 67774 | 162922 (Rev 3)

21 January 2025

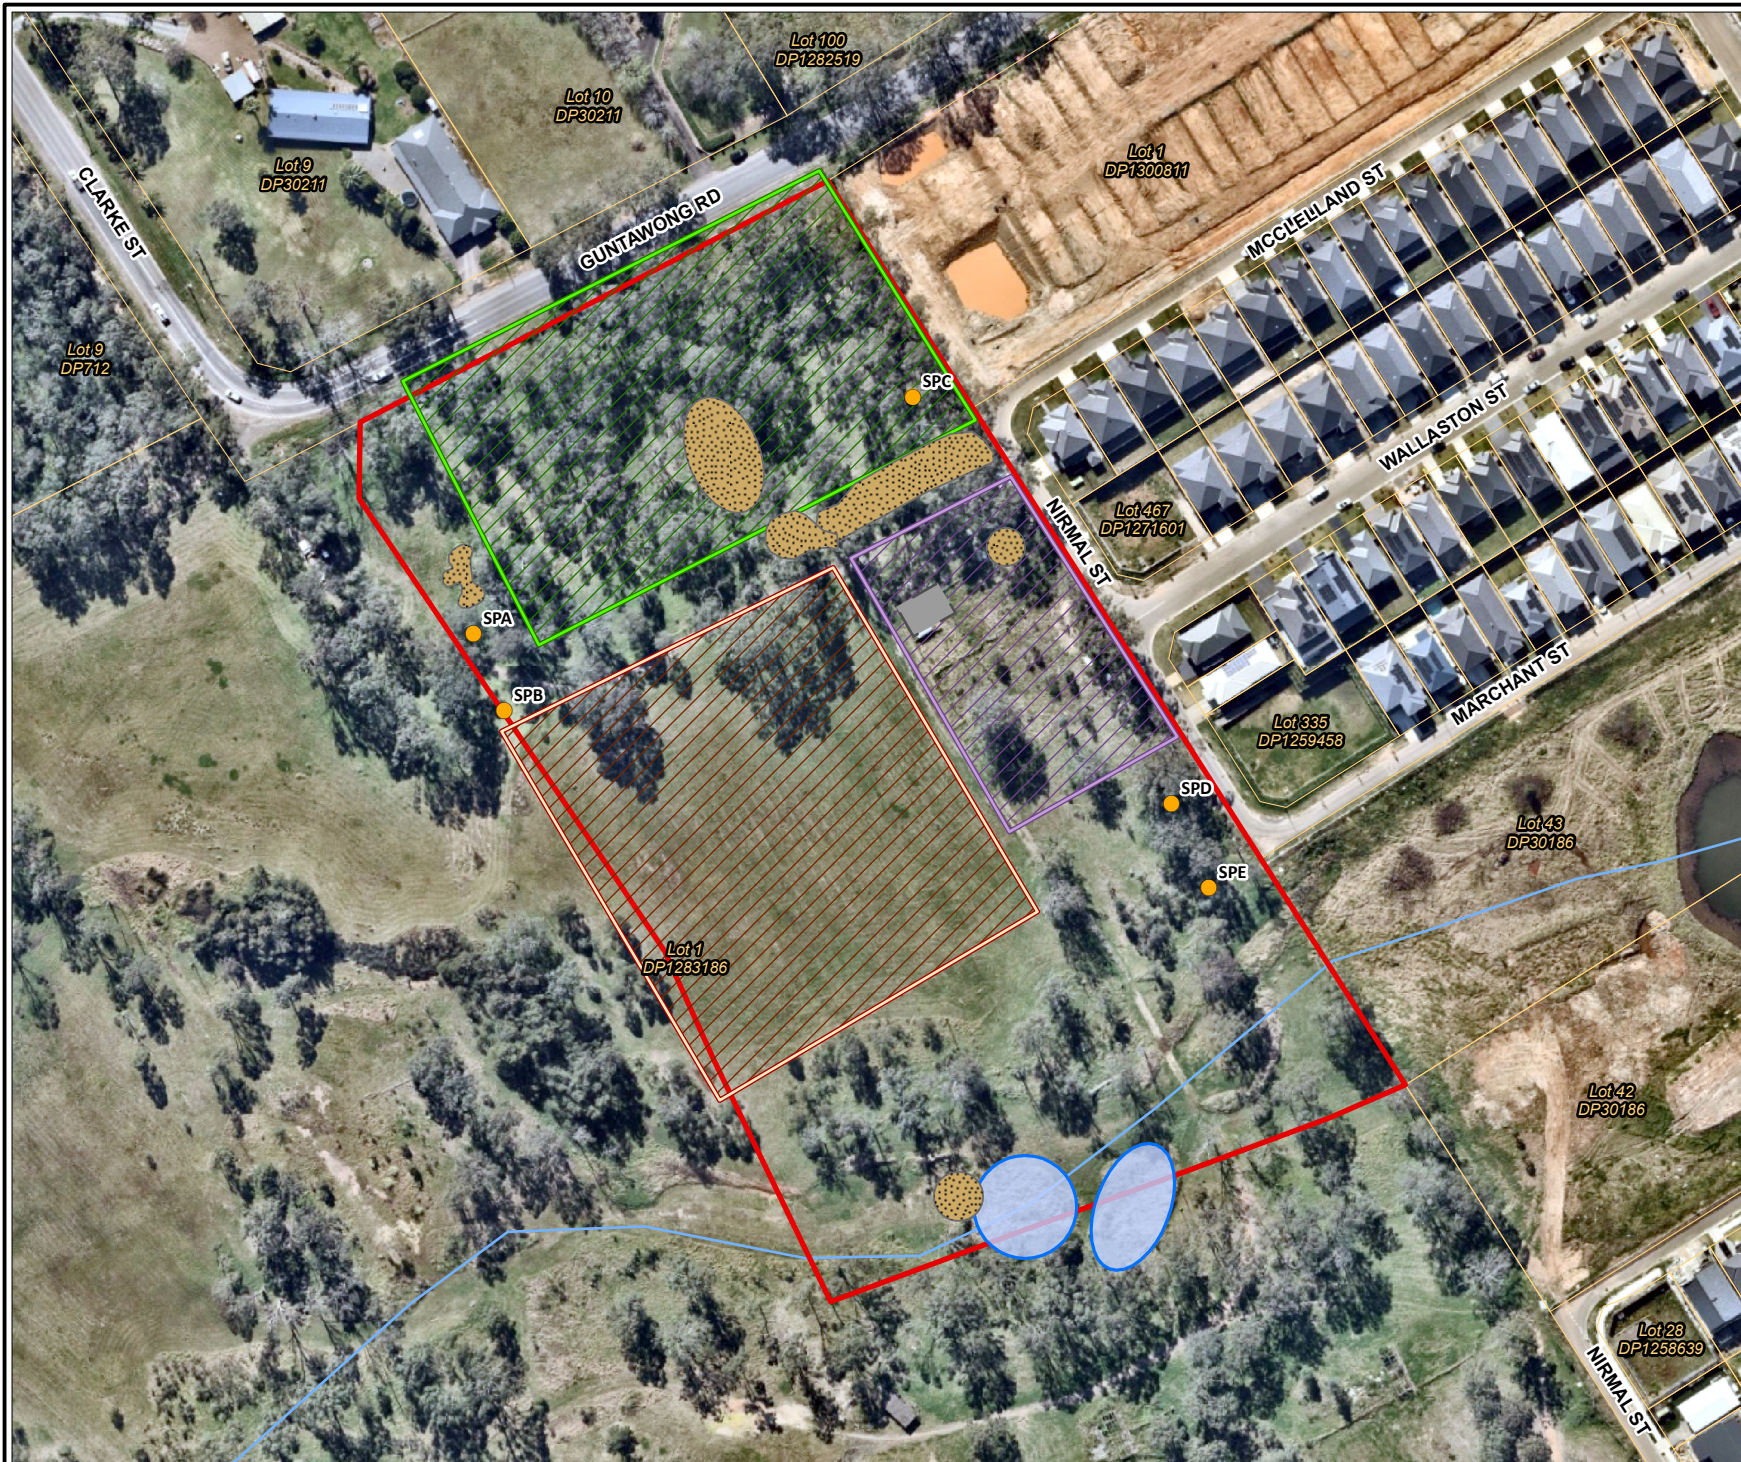
**FIGURE 2**

**SITE LAYOUT**

The site was accessed via a secured gate off Guntawong Road, however, there was limited sections of fencing adjacent the eastern side gate allowing access to site on foot. The eastern boundary of the site was not fenced with vehicle access possible from Nirmal Street. Five stockpiles of what appeared to be fly tipped materials were observed in the eastern portion of the site during the inspection on 19 September 2024. Fly tipped stockpiles included discarded asbestos containing material (ACM) sheeting and fragments of ACM sheeting, discarded tyres, a stockpile of silty topsoil (~5 m<sup>3</sup>), a stockpile of gravel/pebbles (~2 m<sup>3</sup>) and a stockpile of soil with building and demolition waste inclusions (~5 m<sup>3</sup>). The sheeting/fragments of ACM sheeting had been delineated with asbestos hazard warning tape. Stockpile locations are shown on **Figure 2**.

A former residence existed within the northeastern portion of the site (former Lot F) (**Figure 2**). During the inspection, the former building footprints and comprising concrete slabs, were observed to remain *in-situ*. The area was occupied by a shed and paddock, which did not contain any liquid chemicals, hazardous building materials or otherwise environmentally hazardous contents.

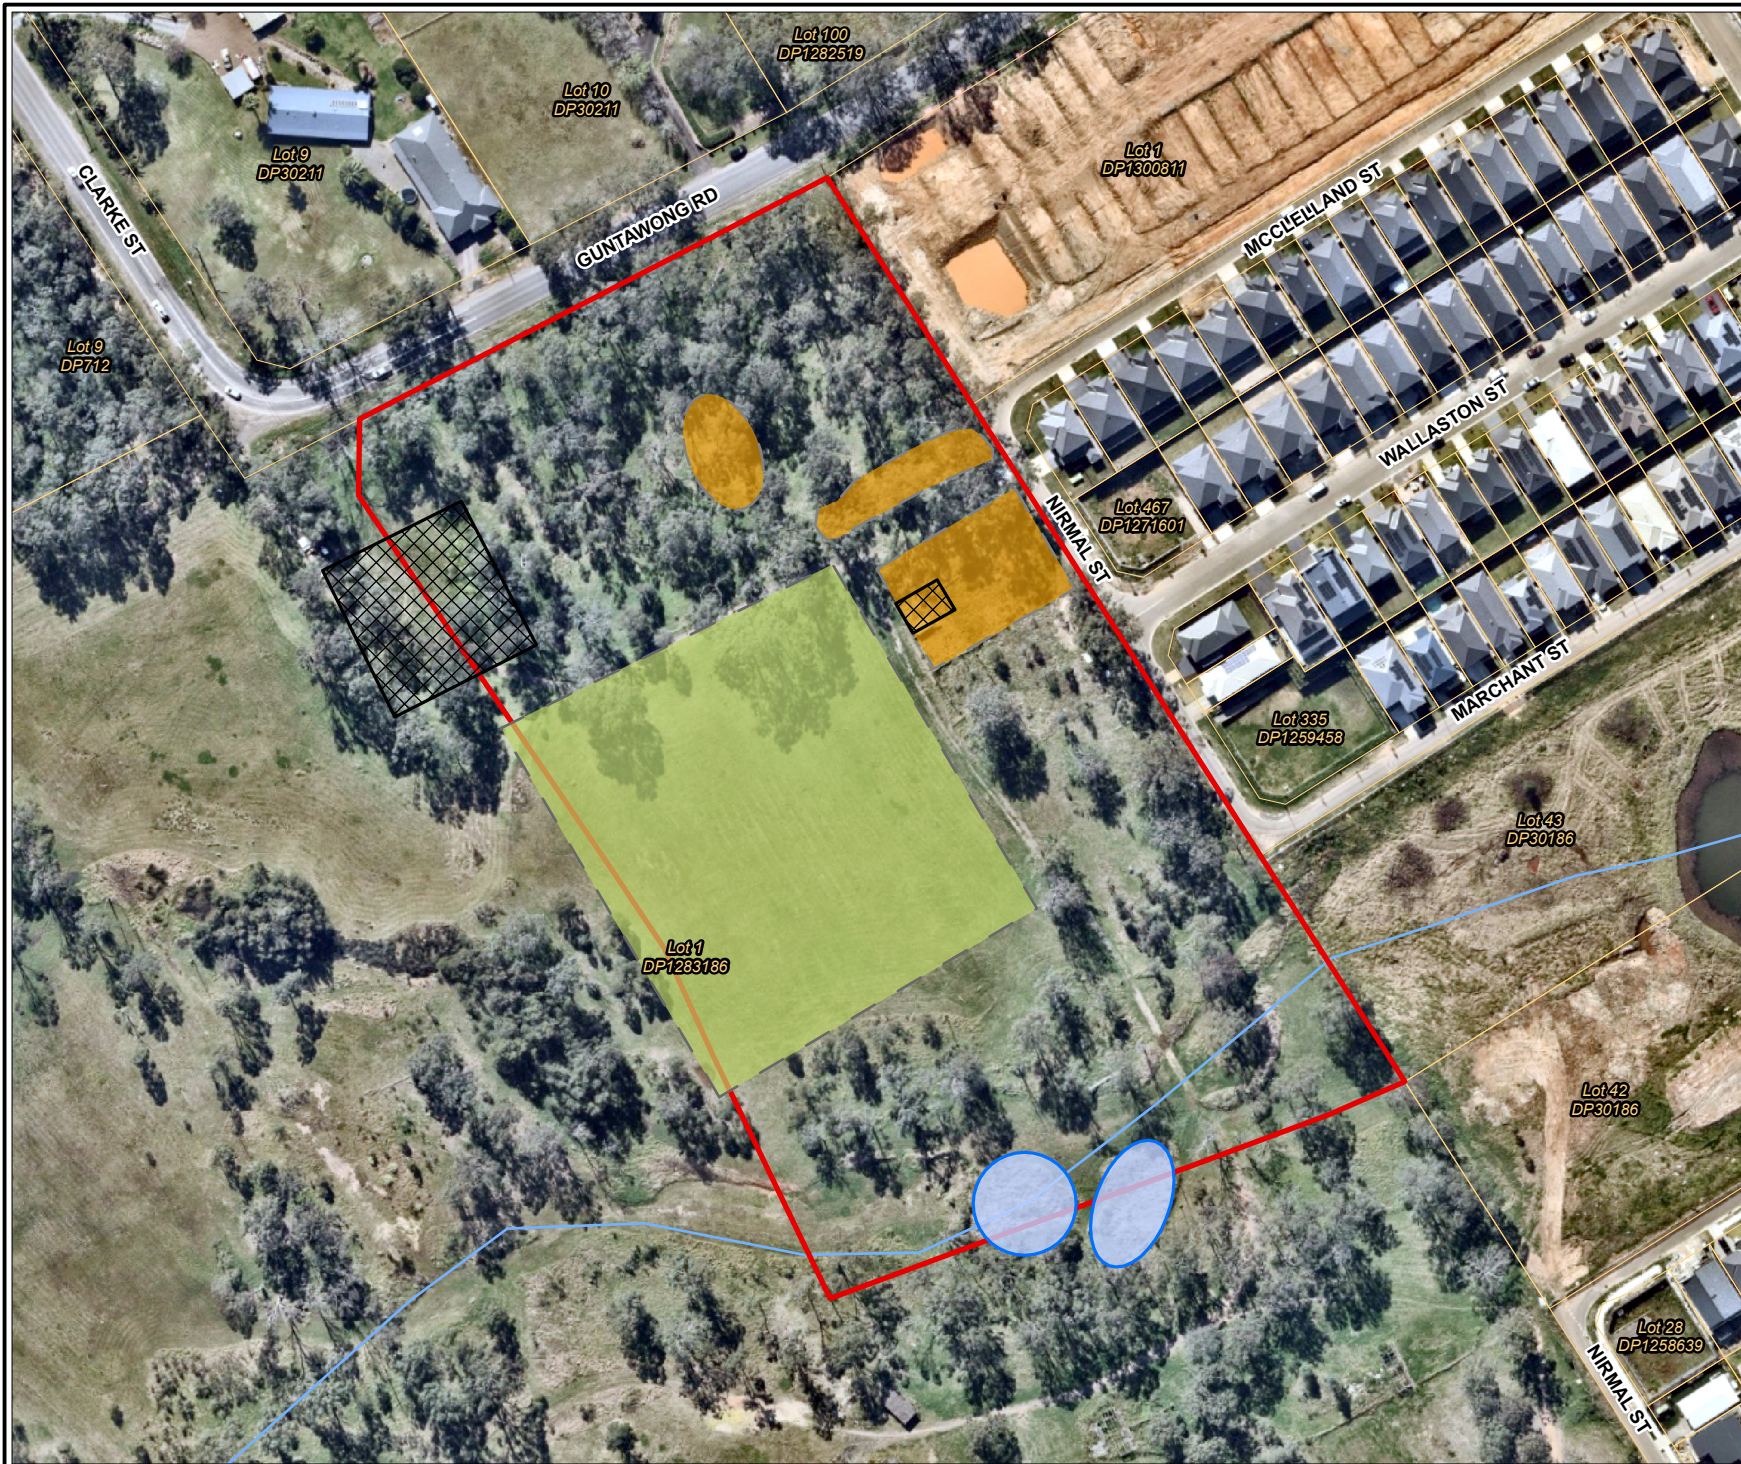
FIGURE 3

AREA OF ENVIRONMENTAL CONCERN

Local alterations to the ground surfaces were observed in the alignment of former structures. Evidence of cutting and filling comprised observation of anthropogenic building materials within surficial soils at numerous locations (**Figure 3**). Several stockpiles were observed at the site, south of the former structures. Asbestos containing material (ACM) was not observed within the stockpiles, although a detailed inspection of their contents was not undertaken as part of this inspection.
