## **Austral Public School Upgrade**

Geotechnical Interpretive  
Report

February 2025

Department of Education

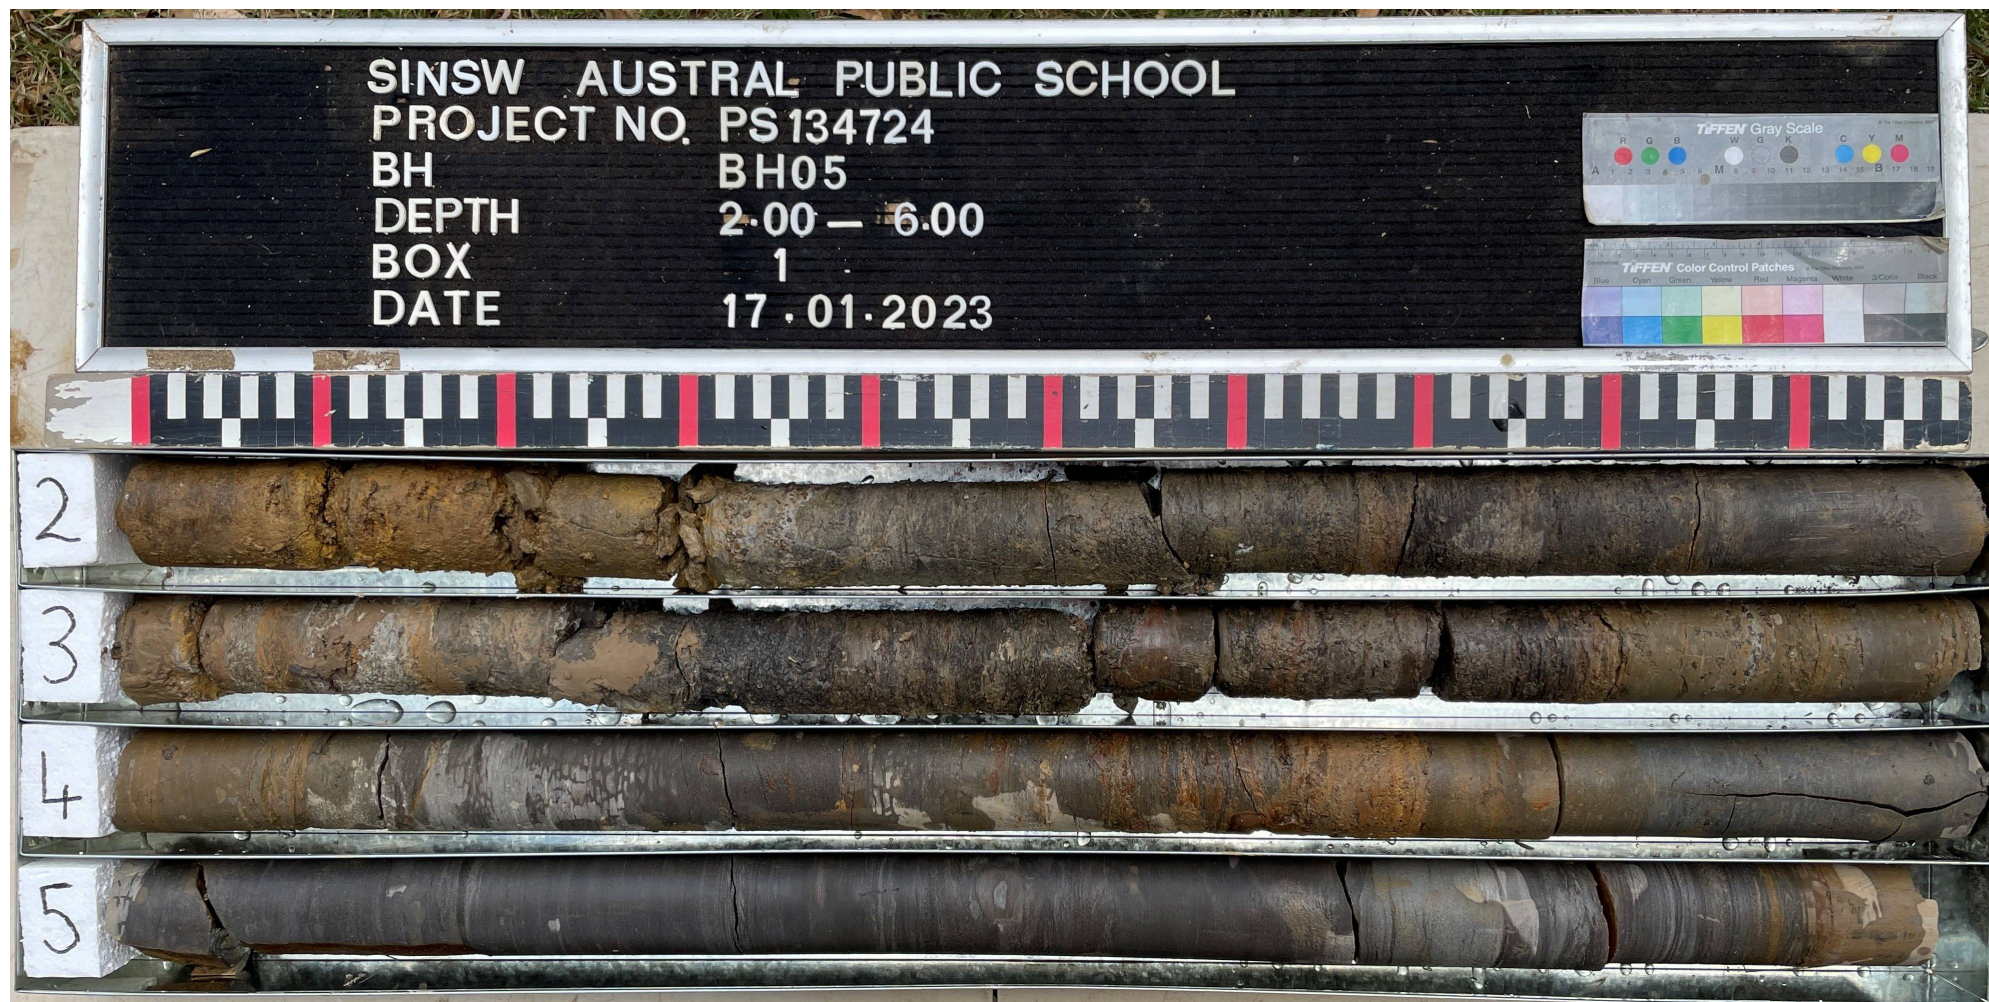
## REPORT OF CORE PHOTOGRAPHS: BH05

PointID : BH05 Depth Range: 2.00 - 6.00 m

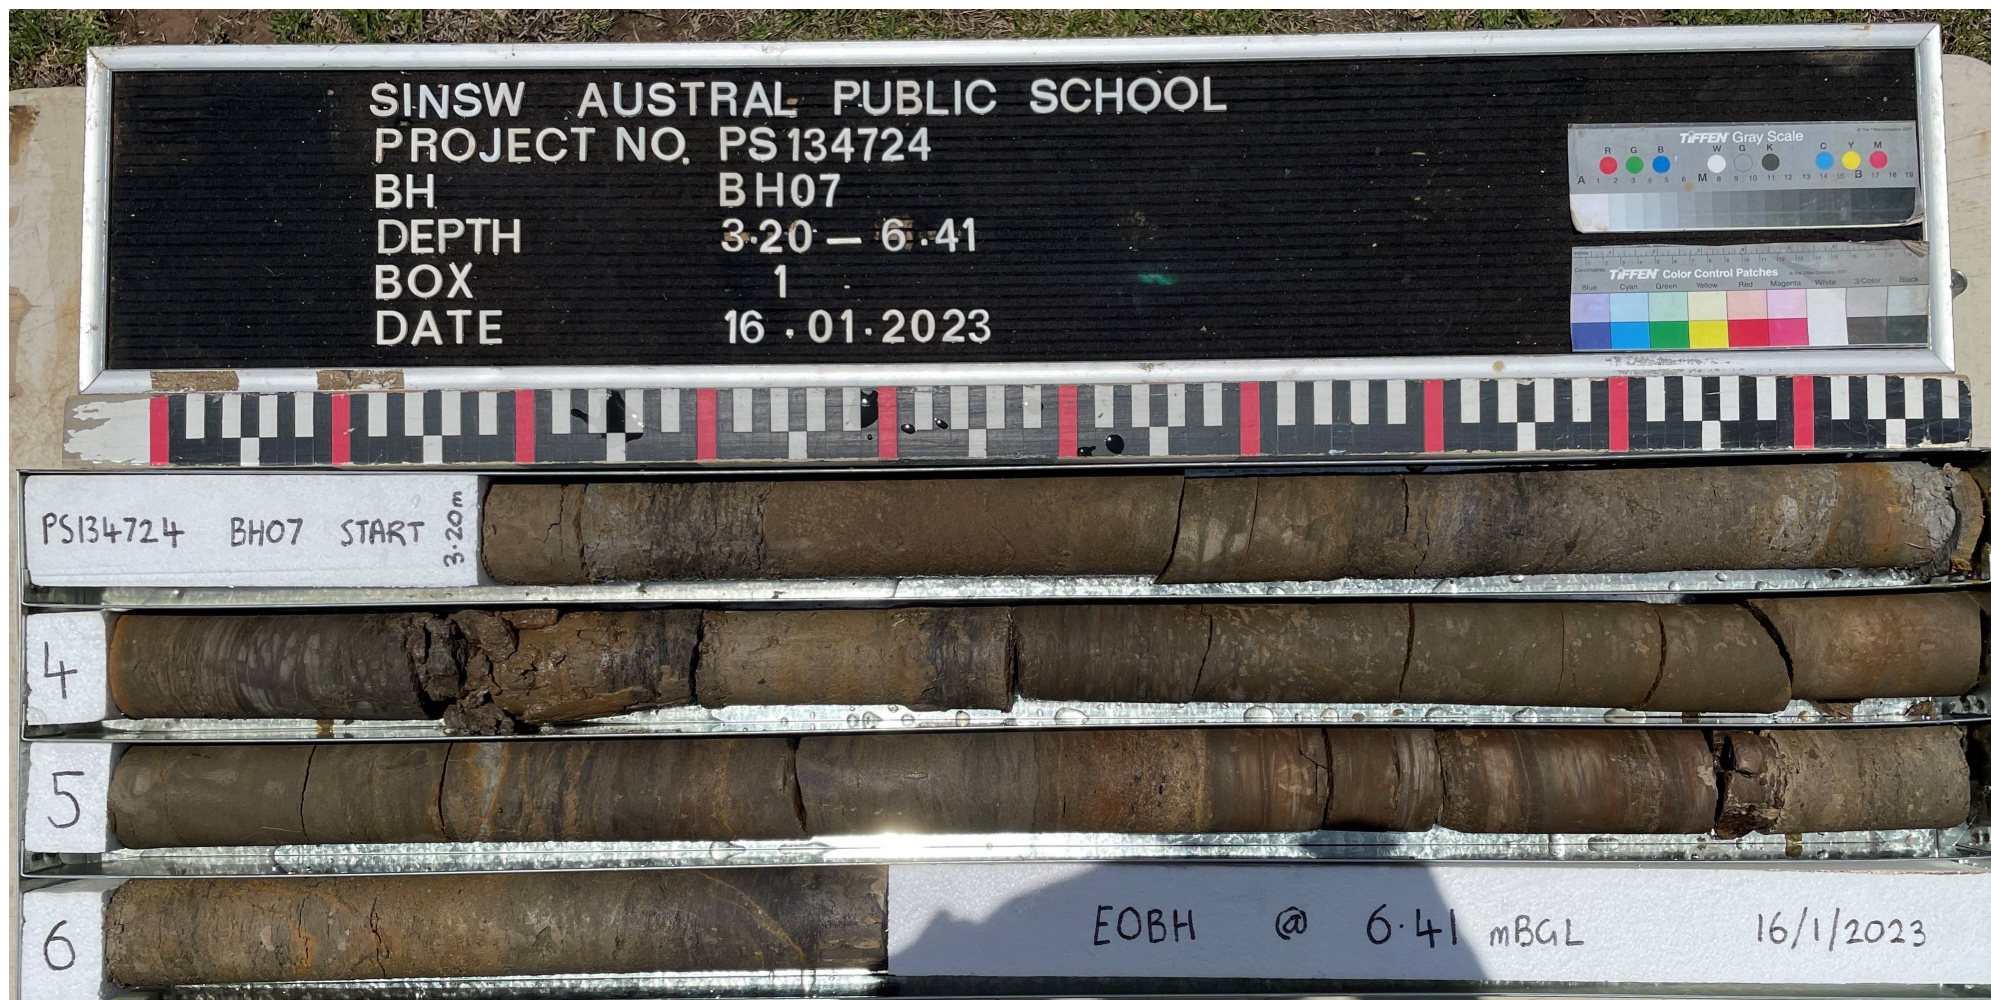
## REPORT OF CORE PHOTOGRAPHS: BH07

PointID : BH07 Depth Range: 3.20 - 6.41 m
