# **Remedial Action Plan**

Austral Public School Upgrade

Department of Education

Reference: 754-SYDEN366683-R01-Rev1

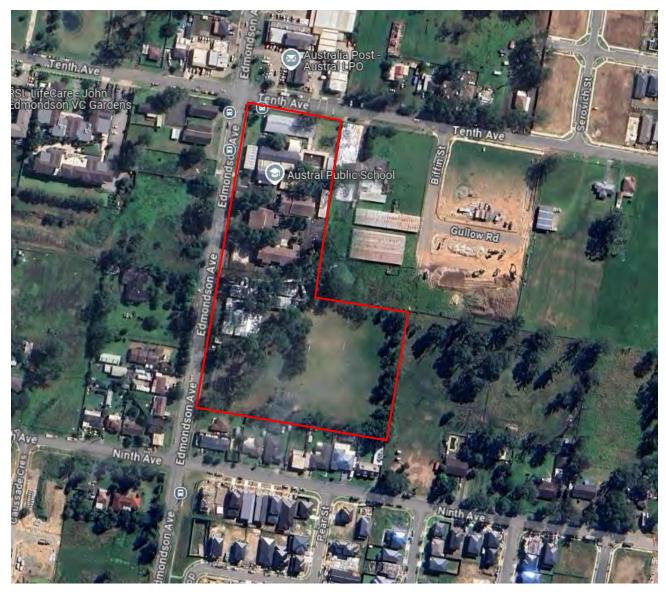
#### Figure A: Site layout and boundary (Source: GoogleMaps, accessed 1 November 2024)

The proposed activity is for the upgrades to the existing APS at 205 Edmondson Avenue, Austral, NSW, 2179 (the site) shown in Figure A below.

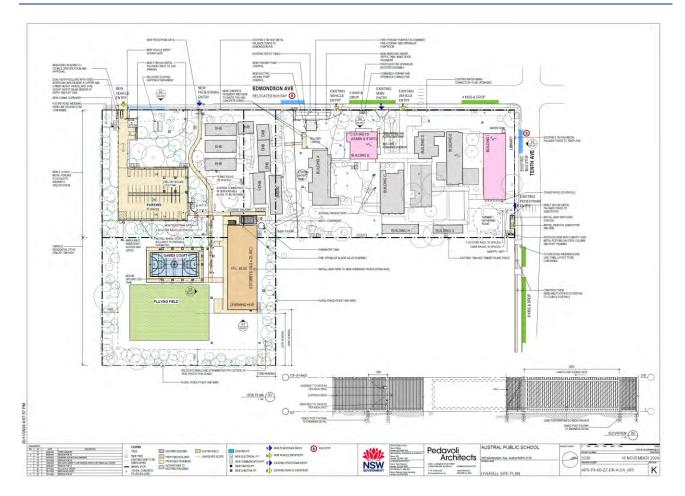
Figure B: Proposed site plan (source: Pedavoli Architects, Overall Site Plan (Rev K)

Figure B shows the scope of works for the proposed activity.

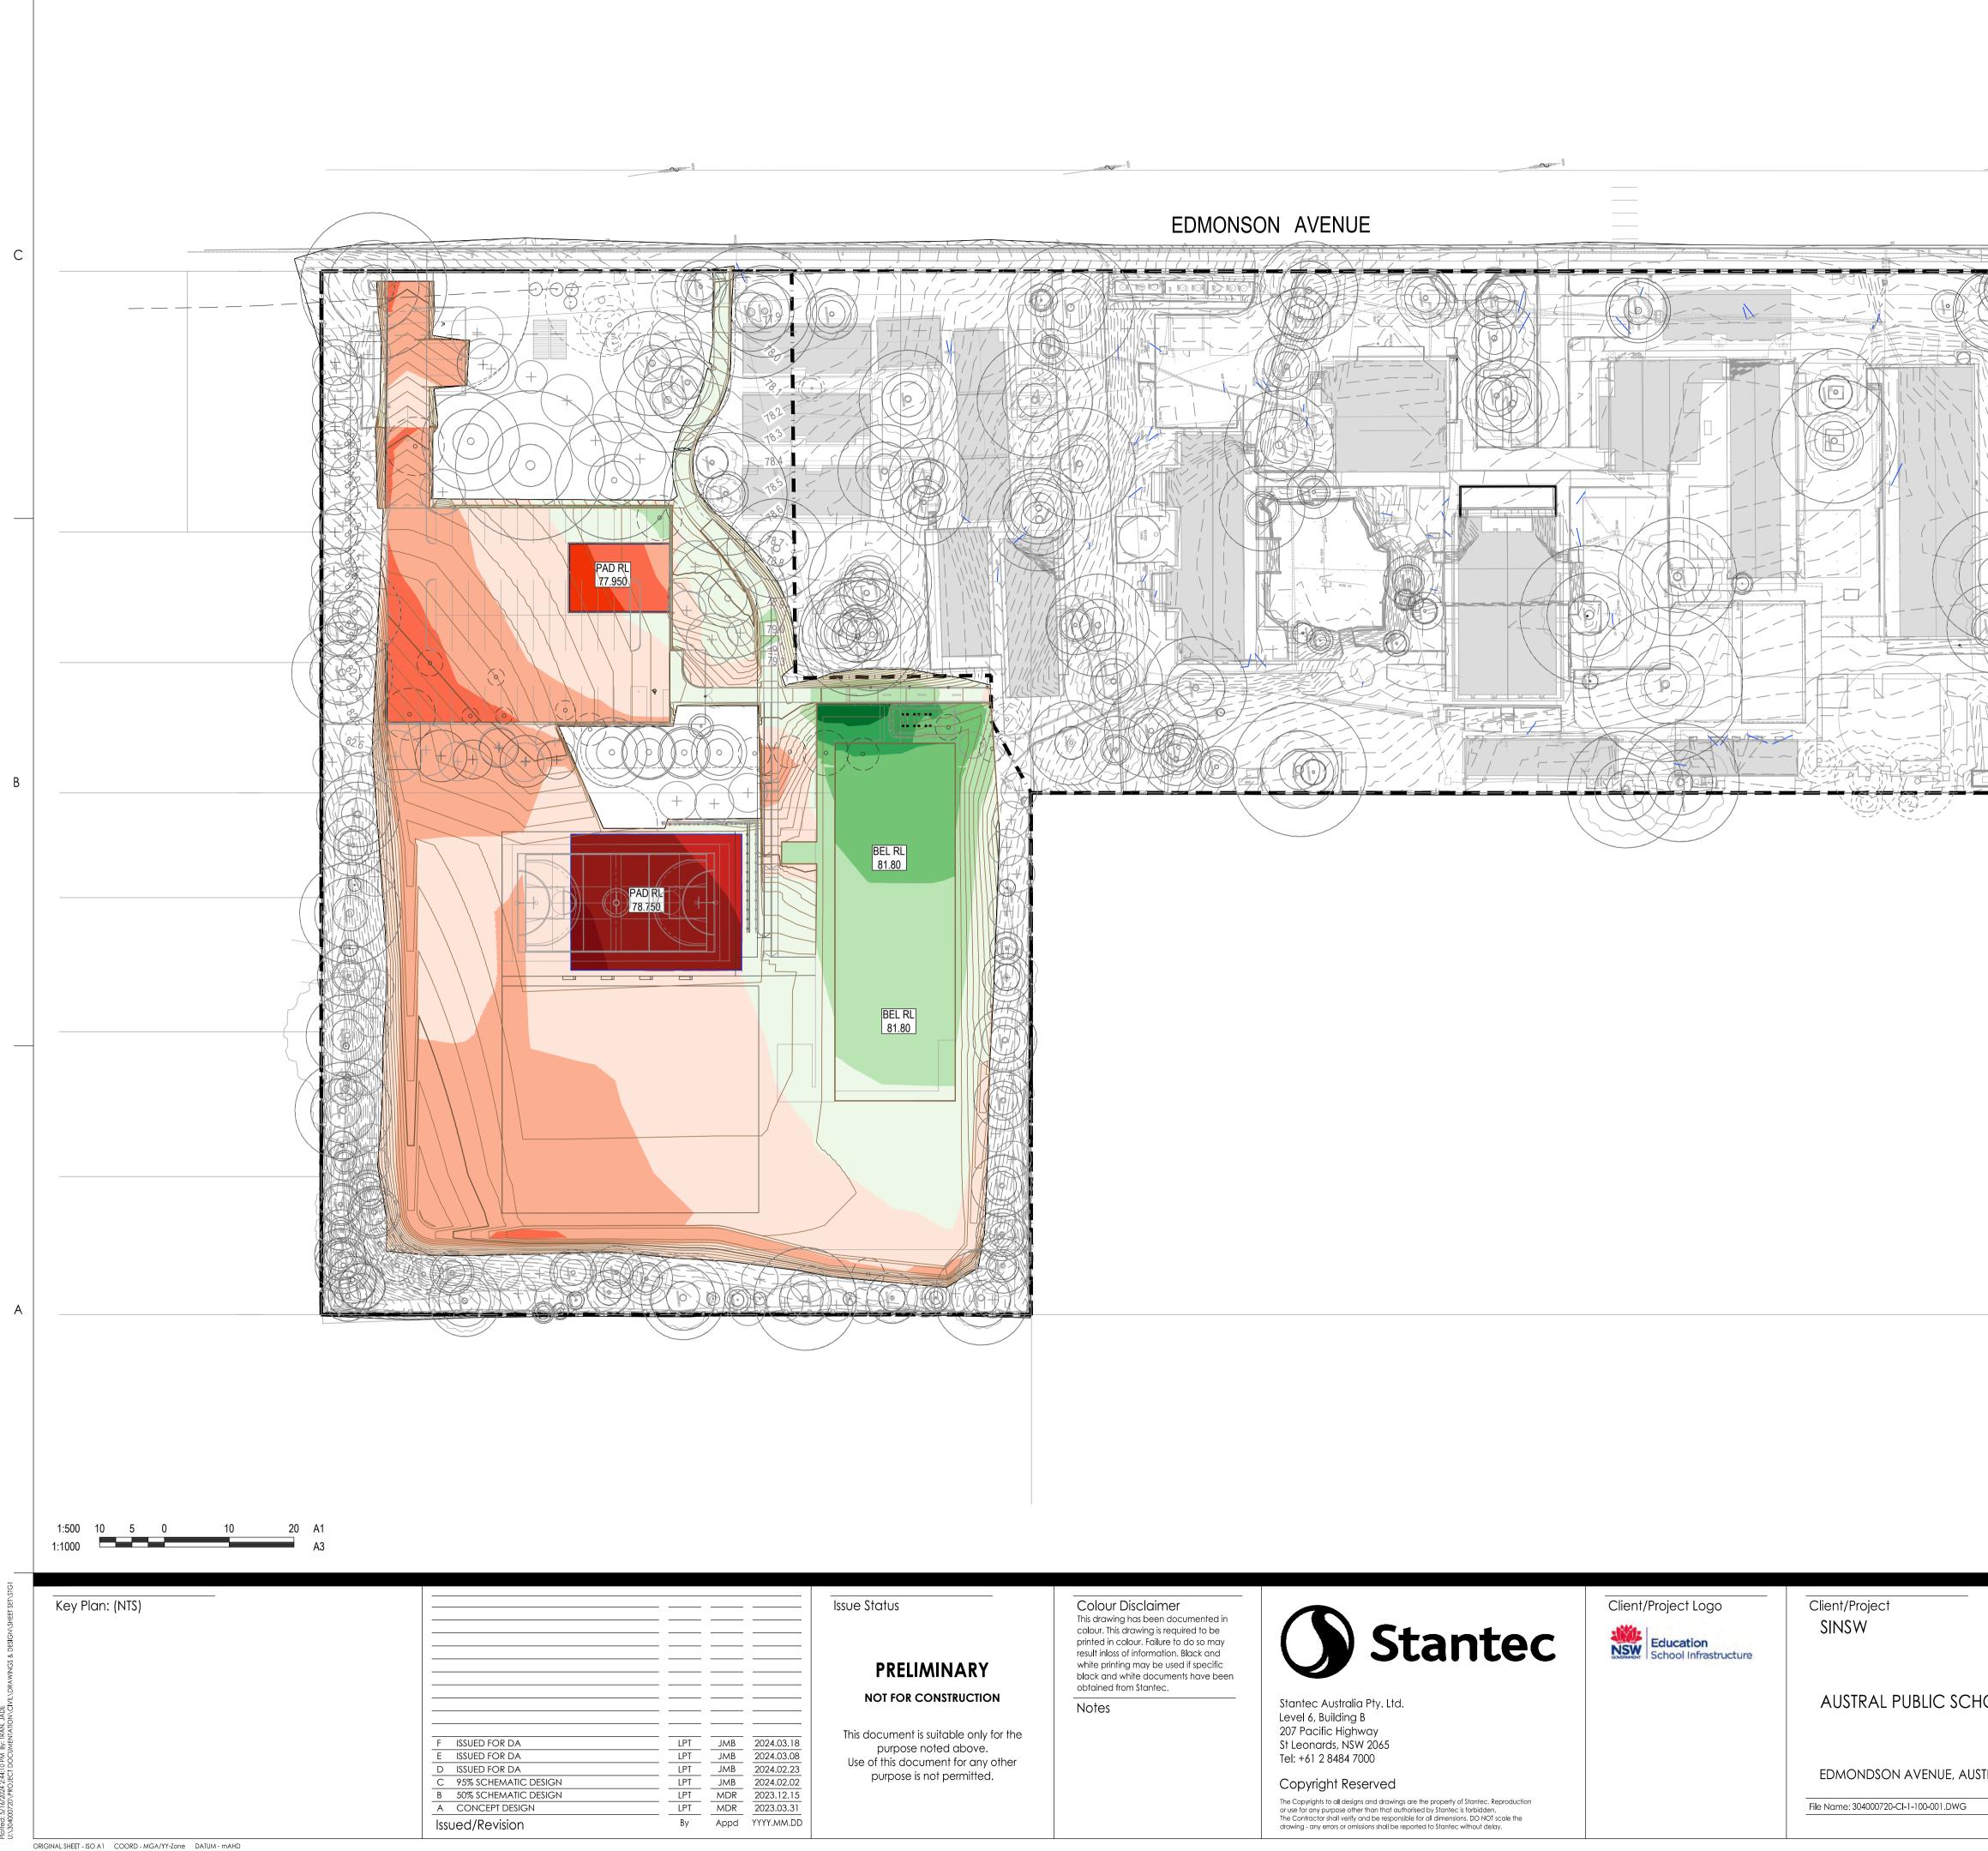
Title BULK EARTHWORKS PLAN	
OOL		
TRAL, NSW 2179	Project No. 304000720	Scale 1:500
	Revision Drawing No. <b>F</b>	CI-1-100-001

LEGEND	
	SITE BOUNDARY
	EXTENT OF WORKS
	BULK EARTHWORKS CONTOURS
— — — 18.0 — — —	EXISTING CONTOURS
BEL	BULK EARTHWORKS LEVEL
NOTES	
1. VOLUMES ARE INDICATIV	E ONLY AND ARE BASED ON A THE DESIGN SURFACE AND THE

2. NOTE THAT ALL VOLUMES AND MAY NOT REFLECT D	DEPICTED ARE SOLID VOLUMES ONLY TAILED EARTHWORKS.
3. NO ALLOWANCE HAS BEE	N MADE FOR BULKING FACTORS.
ON SITE DETENTION TANH TRENCHING, DETAILED EX	N MADE FOR DETAILED EARTHWORKS; i (S, RAINWATER TANK, SERVICE (CAVATION, FOOTINGS, RETAINING IG, BUILDING SLABS AND THE LIKE.
	USE FINAL SURFACE LEVELS AND AILS FOR ACTUAL EARTHWORKS LEVELS
	00mm HAS BEEN ASSUMED FOR THE ARTHWORKS. REFER GEOTECH REPOR ION.
<ul> <li>200mm TOPSOIL H,</li> <li>200mm STRUCTUR</li> </ul>	FILL VOLUME CONSIDERATIONS: AS BEEN CONSIDERED TO BE REMOVED AL SLAB UNDER BUILDING PADS. S FOR TRAFFICABLE PAVEMENT.

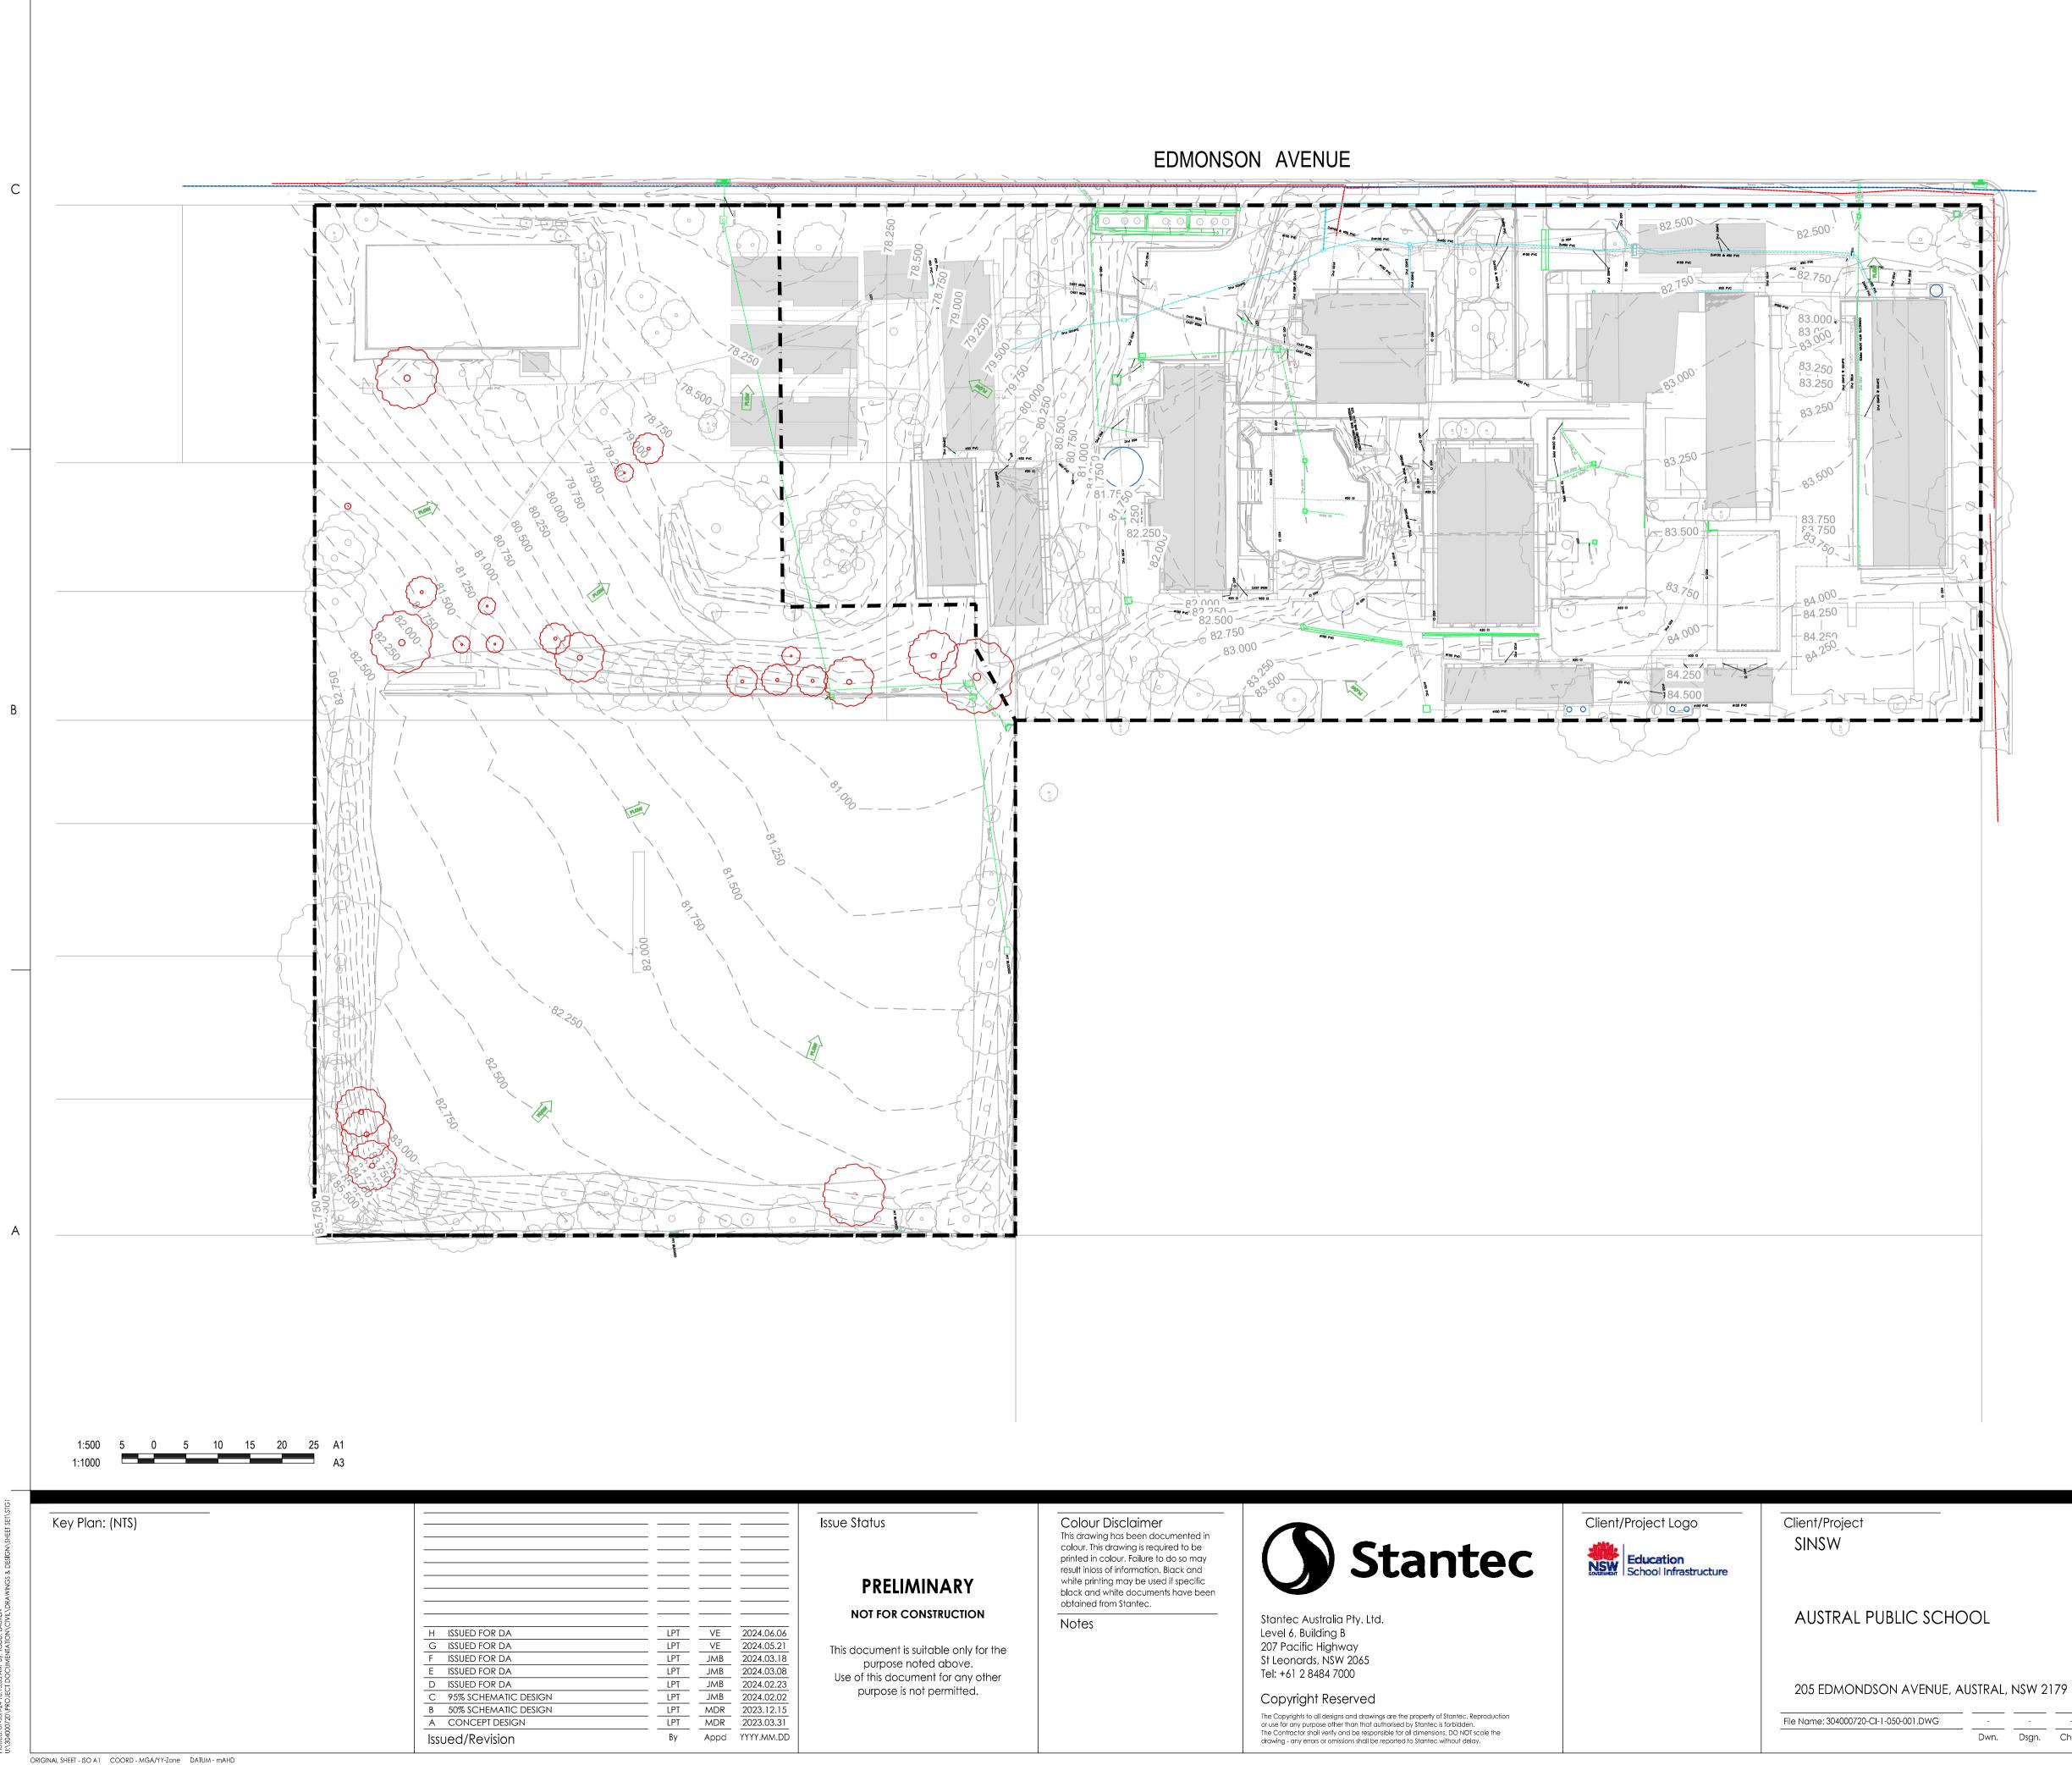
Title EXISTING CONDITIONS PLAN

- 1. EXISTING SERVICES SHOWN ON THE PLANS ARE LOCATED APPROXIMATELY BASED ON INFORMATION SUPPLIED BY THE RELEVANT AUTHORITIES. AND SURVEY RECEIVED ON 24/05/2024 PREPARED BY MONTEATH & POWYS PTY LTD. REFERENCE '220216C\_08', DATED 24/05/2024. STANTEC DOES NOT TAKE RESPONSIBILITY FOR THE SUITABILITY OR LOCATION/DEPTH OF THE EXISTING SERVICES.
- 2. THE INFORMATION IS SHOWN TO PROVIDE A BASIS FOR DESIGN. STANTEC DOES NOT GUARANTEE THE ACCURACY OR COMPLETENESS OF THE SURVEY BASE OR ITS SUITABILITY AS A BASIS FOR CONSTRUCTION DRAWINGS.
- 3. ALL AREAS WITHIN THE EXTENT OF WORKS TO BE SCANNED FOR EXISTING UTILITY SERVICES AND LOCATIONS PRIOR TO CONSTRUCTION.

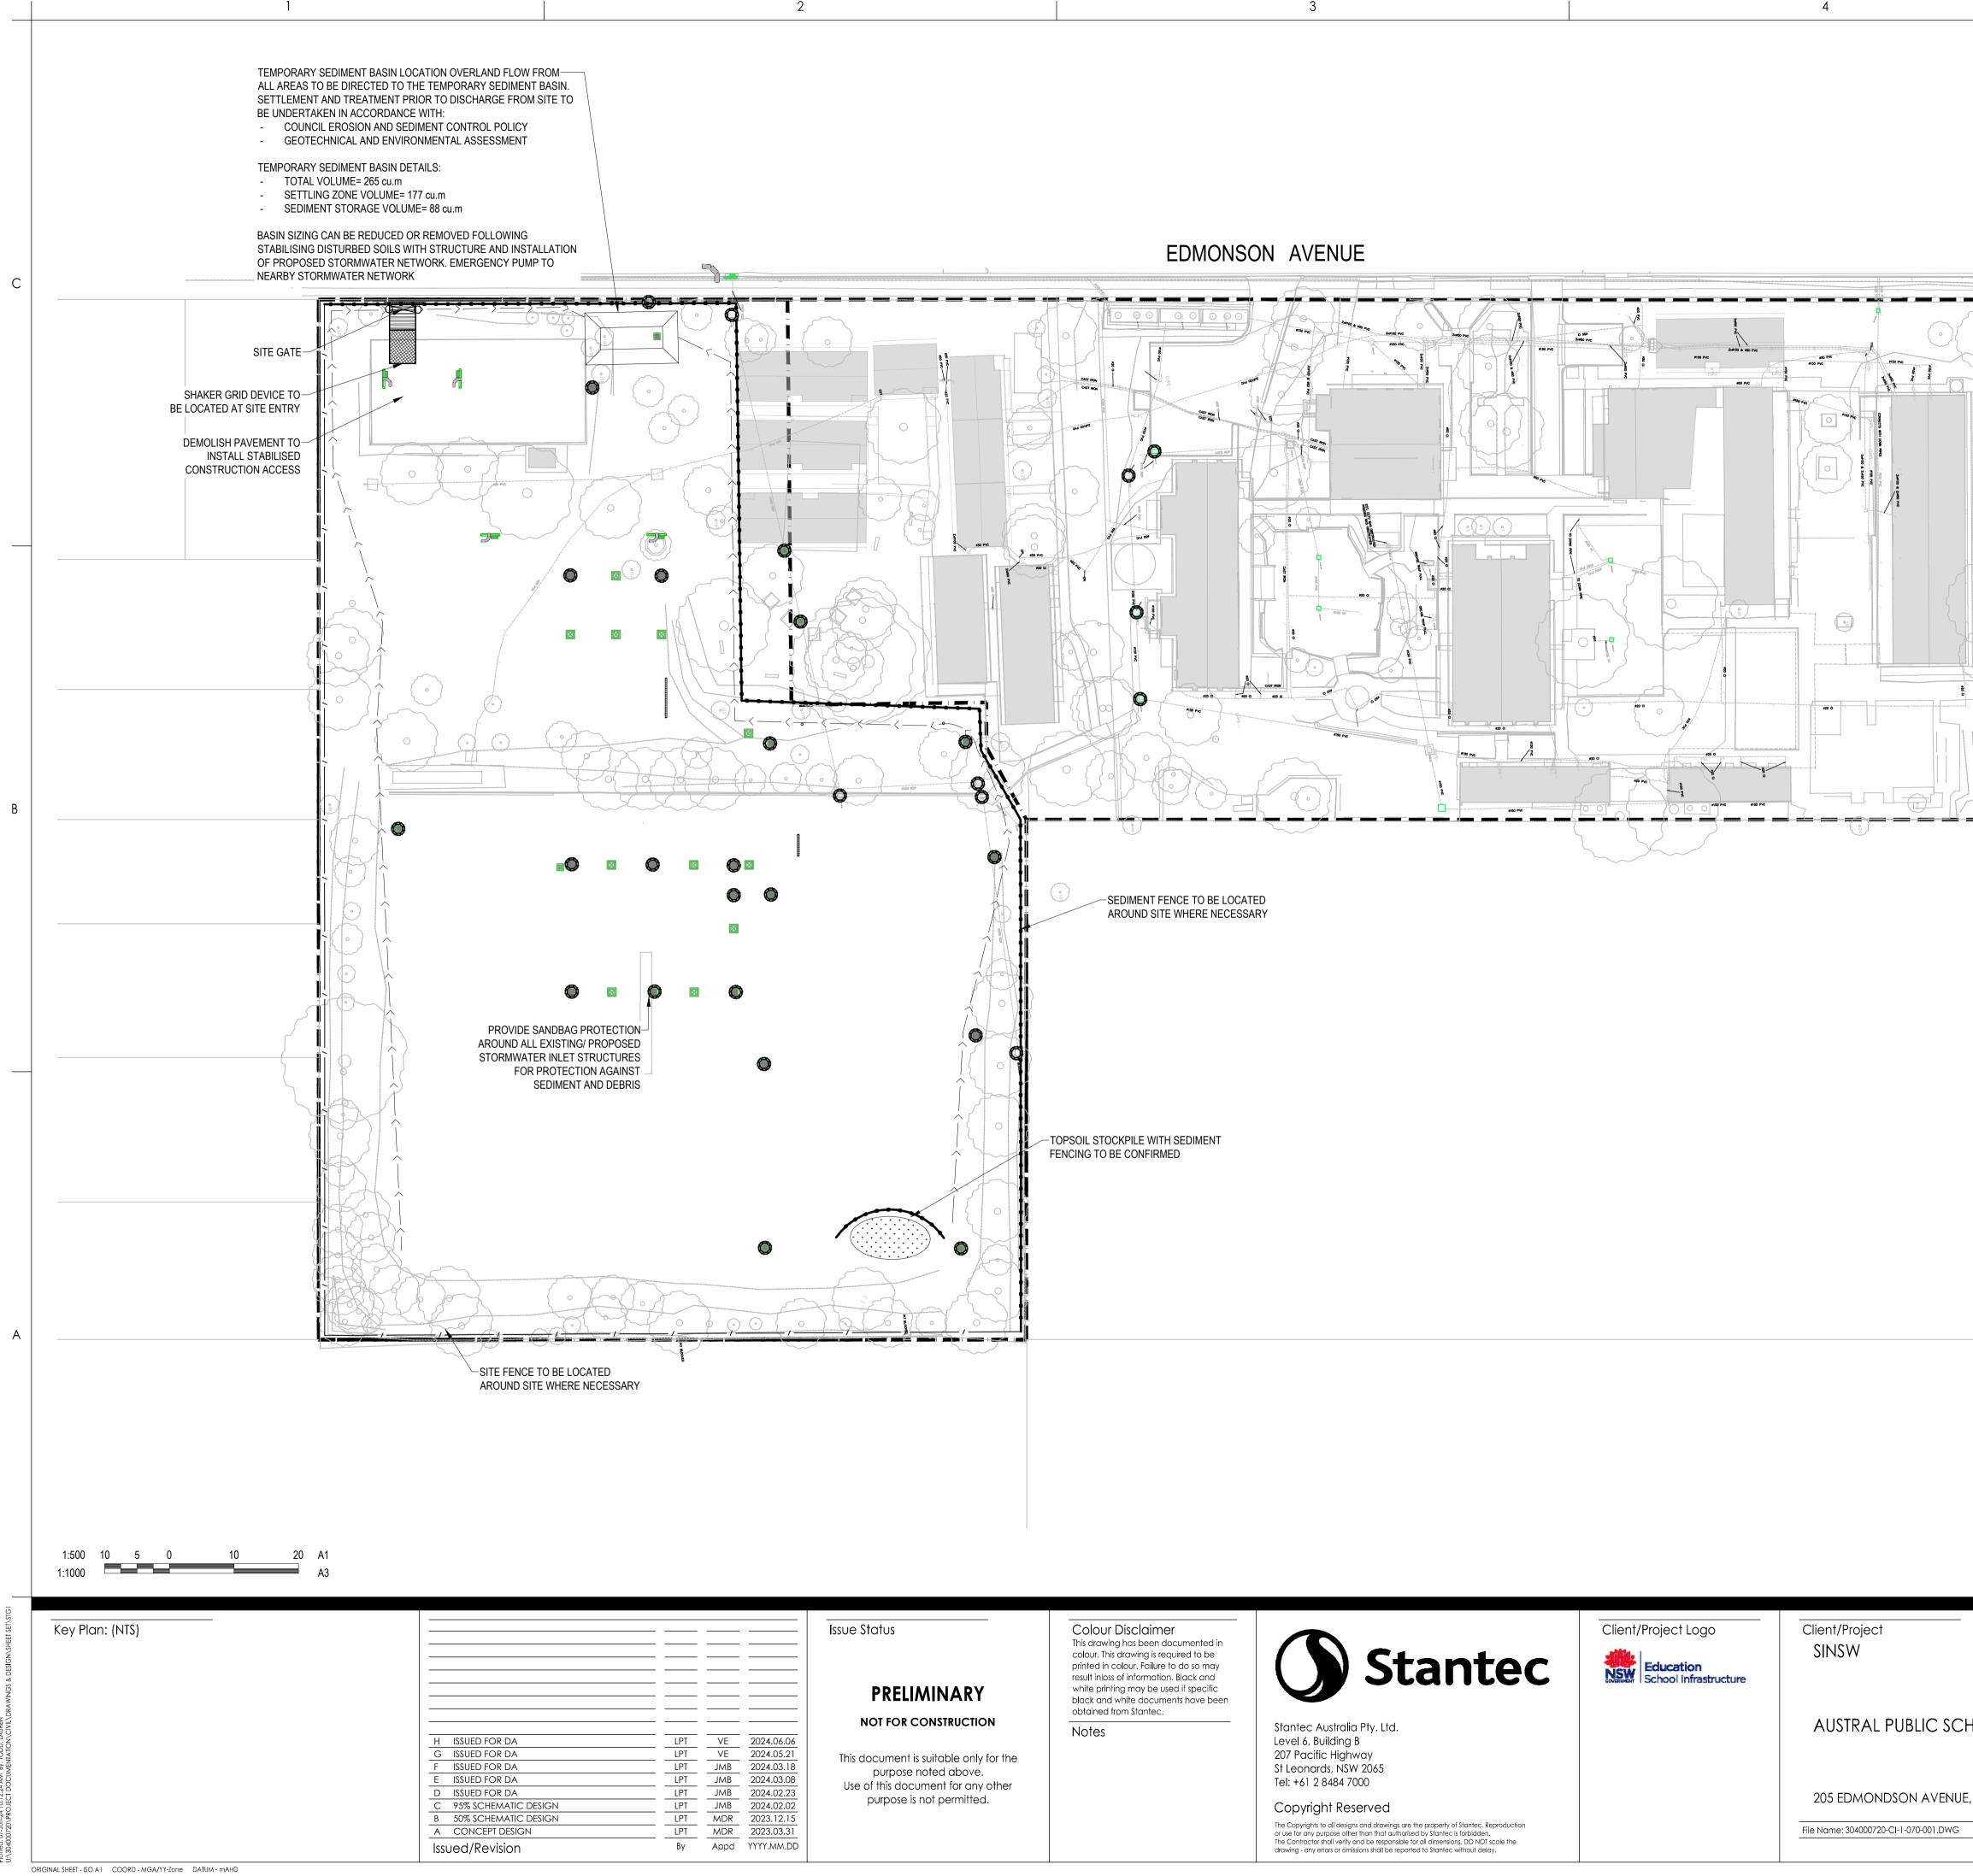
<sup>Title</sup> EROSIC PLAN	)n and sedimi	ENT CONTROL
HOOL			
, AUSTRAL, NSW 2179	Project No. 304000720		Scale 1:500
, AUSTRAL, INSVI 2177		Drawing No.

5	
LEGEND	
······································	SITE BOUNDARY
	EXTENT OF WORKS
	VEHICLE SHAKEDOWN DEVIC
oo	PROPOSED SILT FENCE
//	PROPOSED SITE FENCE
	SITE GATE
$\bigcirc$	SANDBAG PIT PROTECTION
	SEDIMENT TRAP FOR KERB INLET PITS
	PROPOSED GRATED DRAIN
	PROPOSED GRATED PIT
$\square$	PROPOSED JUNCTION PIT
	EXISTING STORMWATER PIT
	EXISTING KERB INLET PIT
<<	PROPOSED CATCH DRAIN
	PROPOSED SEDIMENT BASIN
	PROPOSED STOCKPILE

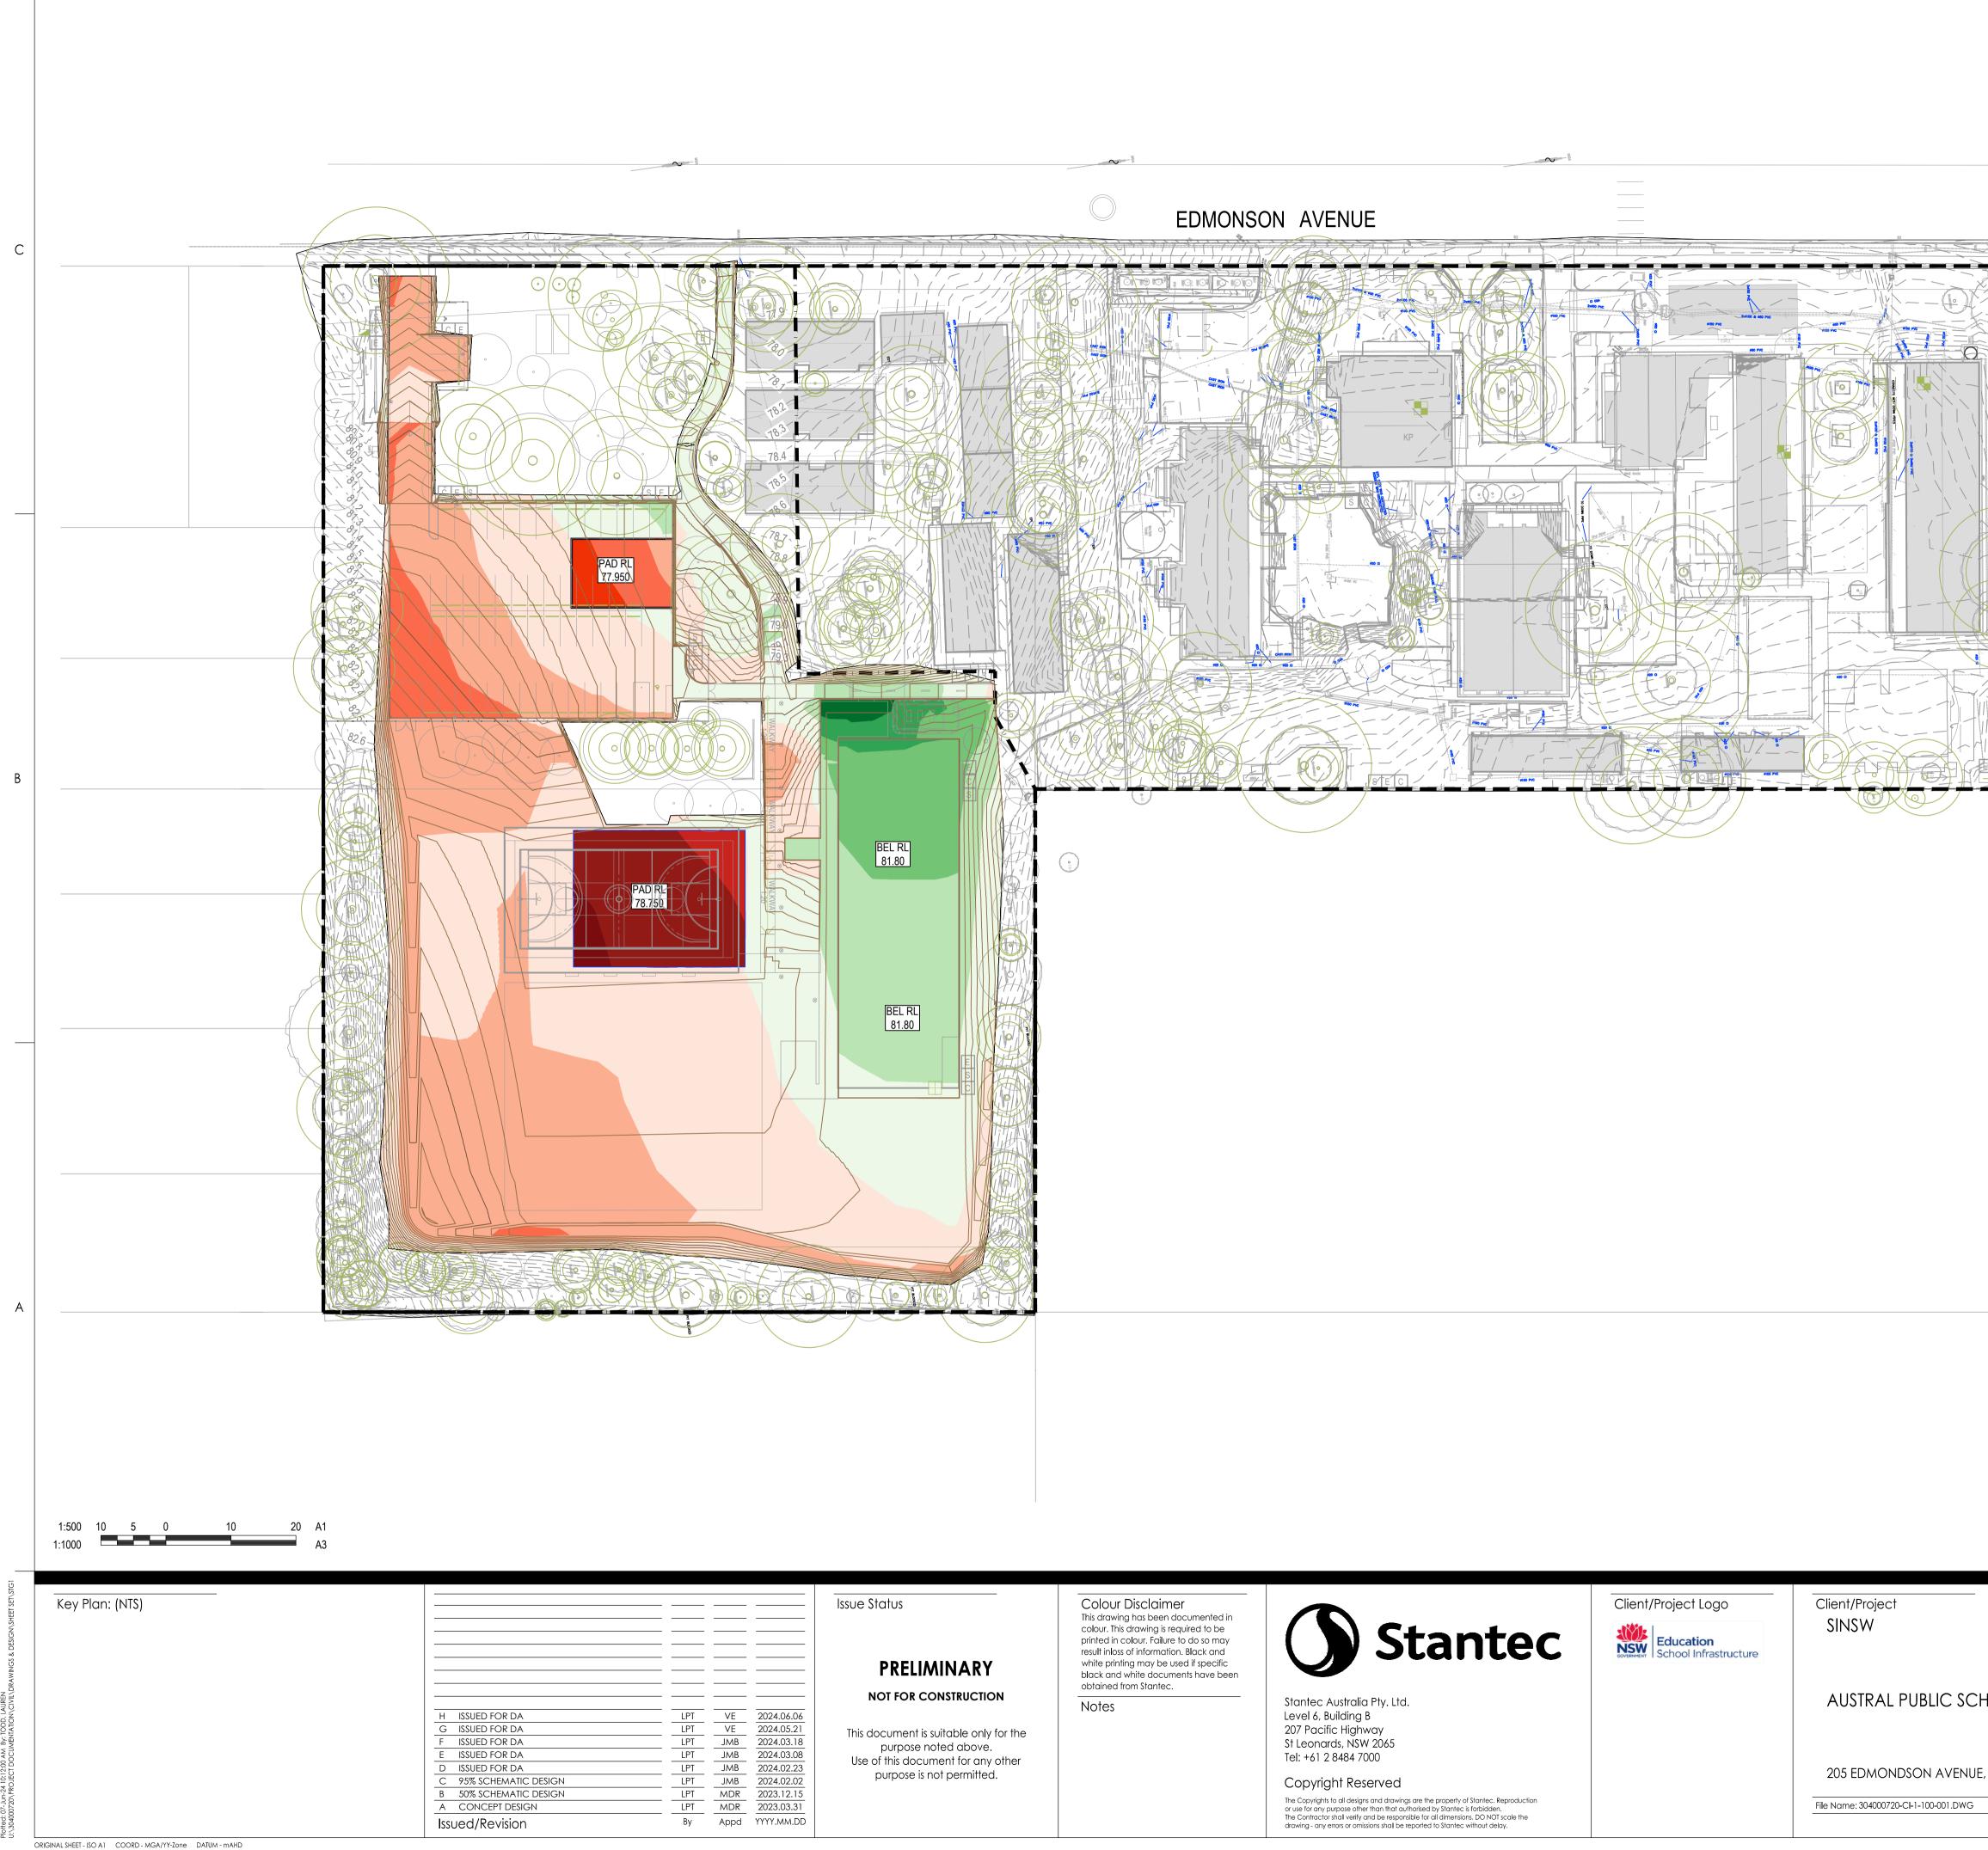
Title BULK E PLAN	ARTHWORKS	
OOL						
austral,	NSW 2 <sup>°</sup>	179		Project No. 30400072		Scale 1:500
			2023.03.31	Revision	Drawing No.	CI-1-100-001

<u>L</u>	EGEND	
		SITE BOUNDARY
-		EXTENT OF WORKS
-		- BULK EARTHWORKS CONTOURS
	— — 18.0 — — -	EXISTING CONTOURS
	BEL	BULK EARTHWORKS LEVEL
	OTES	
	UTES	
1.		TIVE ONLY AND ARE BASED ON A
	SURVEYED SURFACE.	IN THE DECICIN CONTACE AND THE

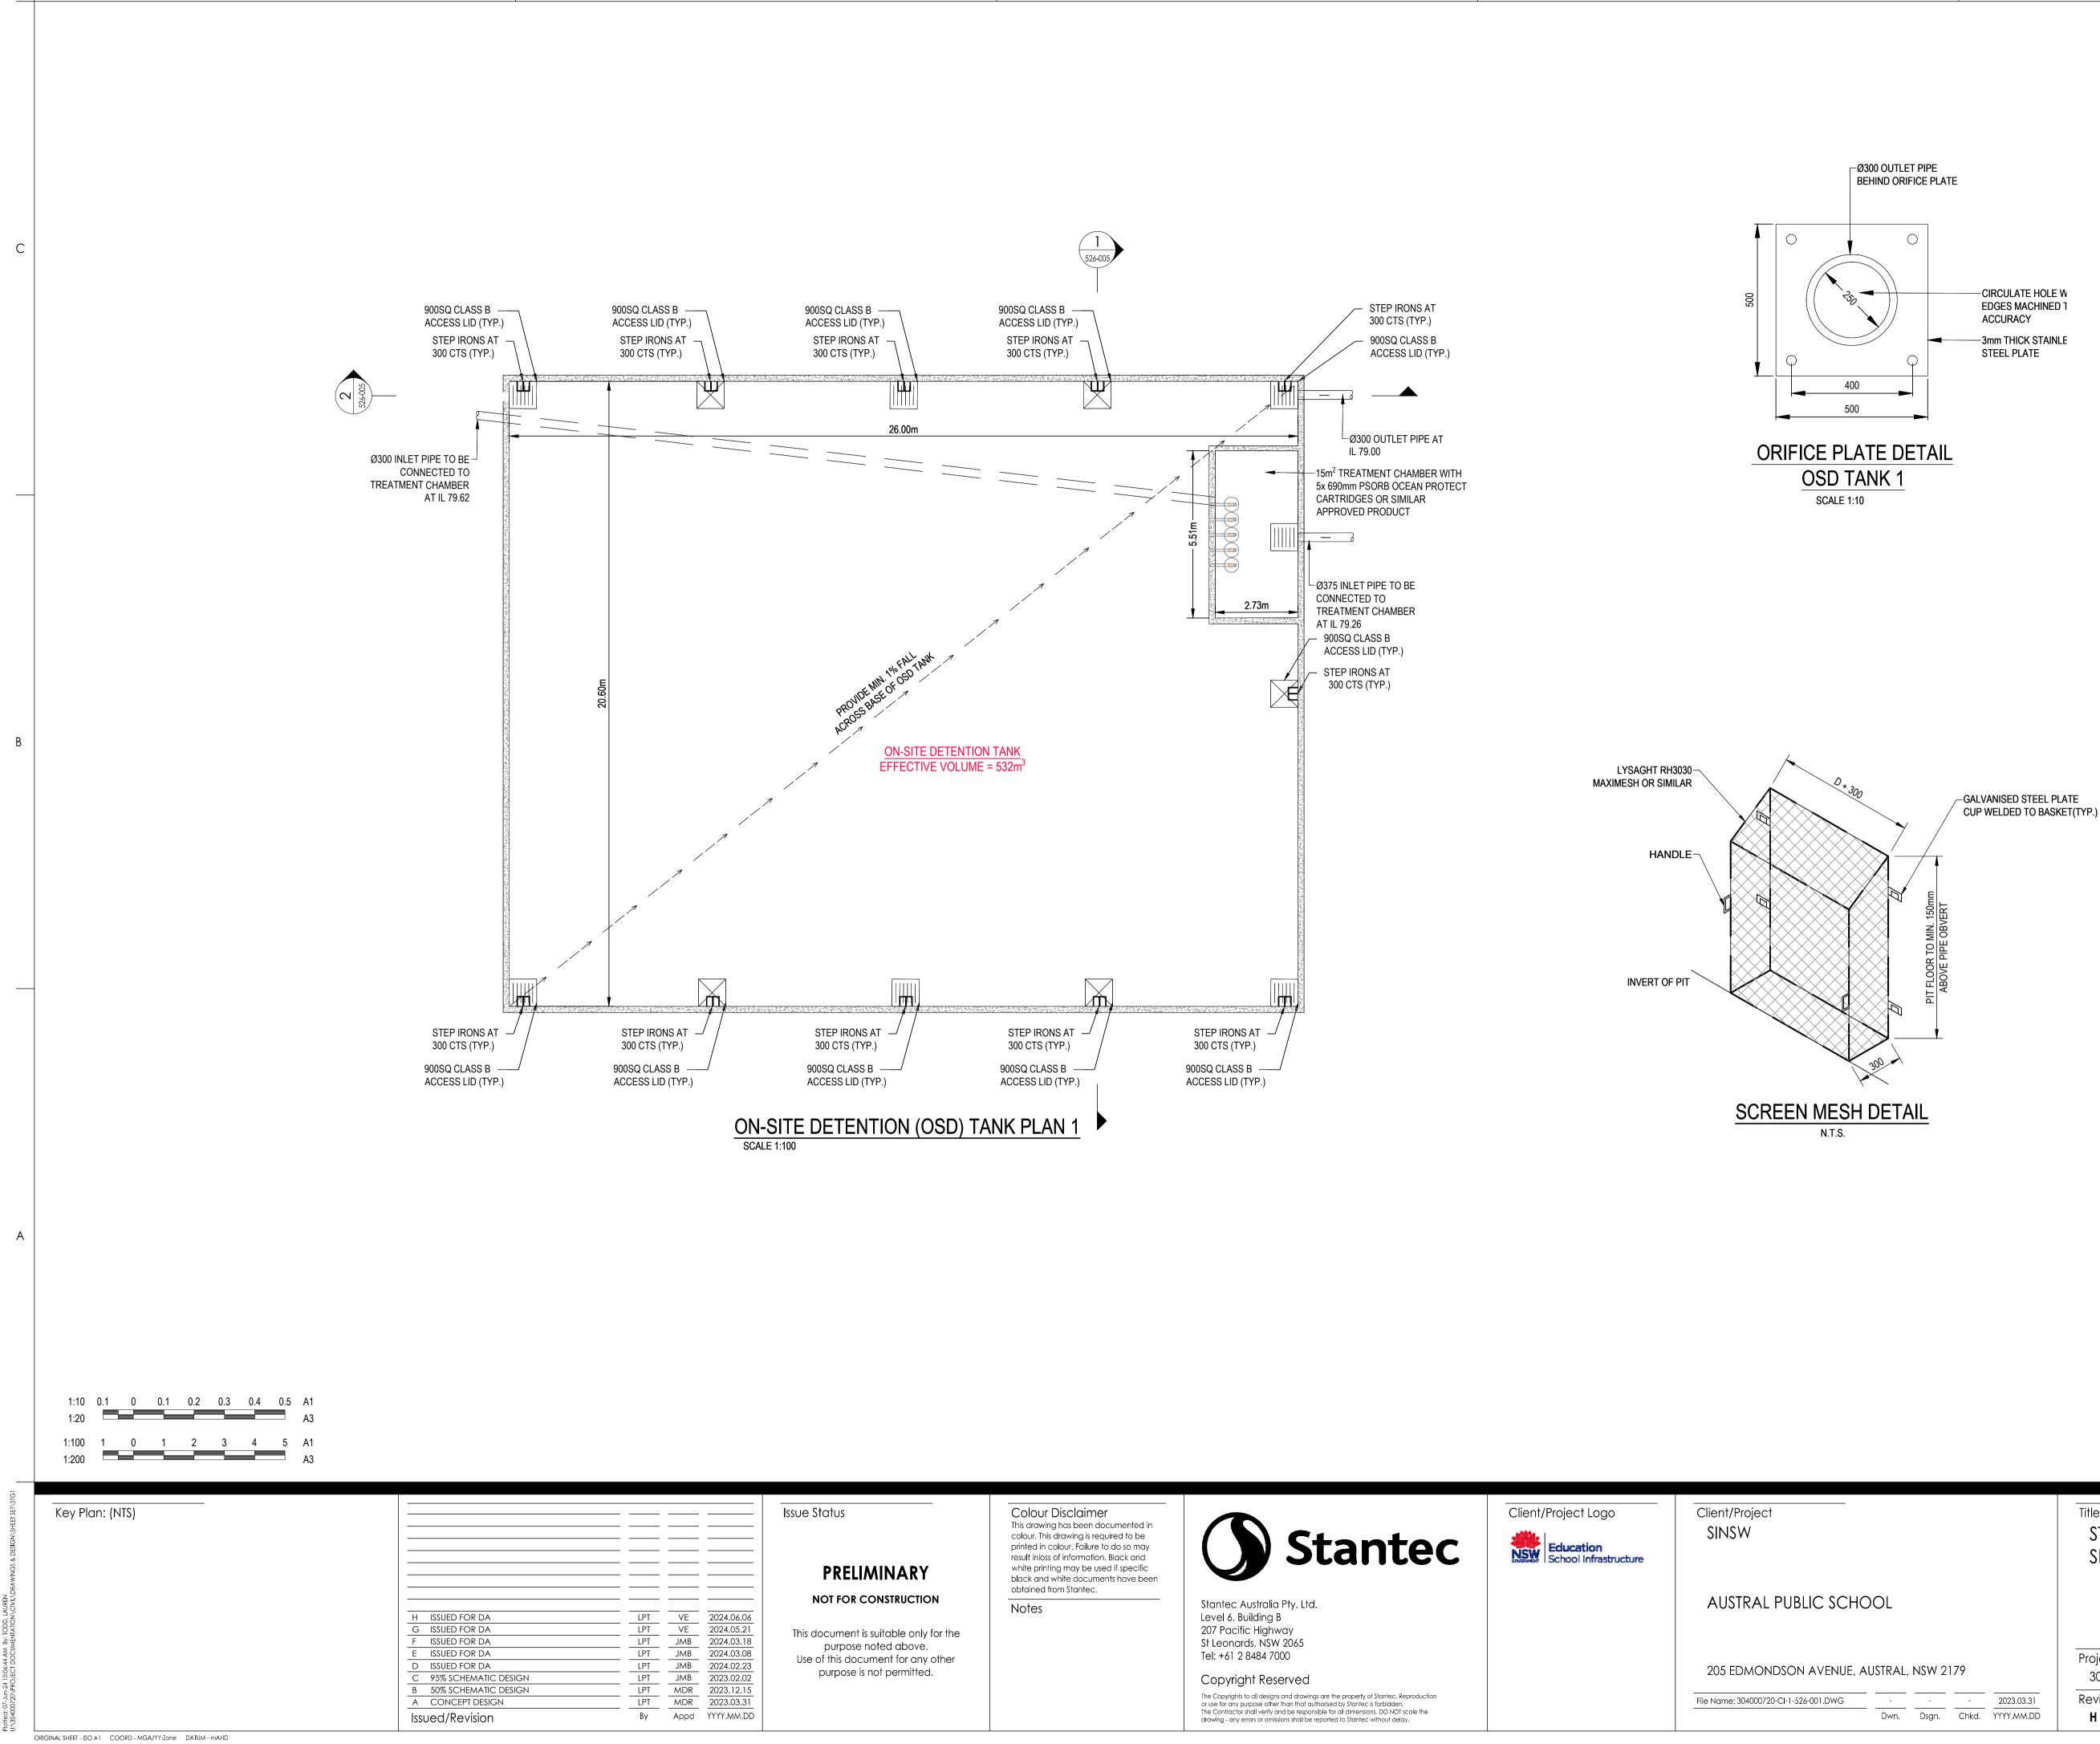
Title STORMWATER DRAINAGE DETAILS Sheet 4 of 7 Project No. Scale 304000720 1:100 - - <u>-</u> 2023.03.31 Dwn. Dsgn. Chkd. YYYY.MM.DD Revision Drawing No. CI-1-526-004 н

-CIRCULATE HOLE W EDGES MACHINED 1 ACCURACY -3mm THICK STAINLE STEEL PLATE
