# **Remedial Action Plan**

Austral Public School Upgrade

Department of Education

Reference: 754-SYDEN366683-R01-Rev1

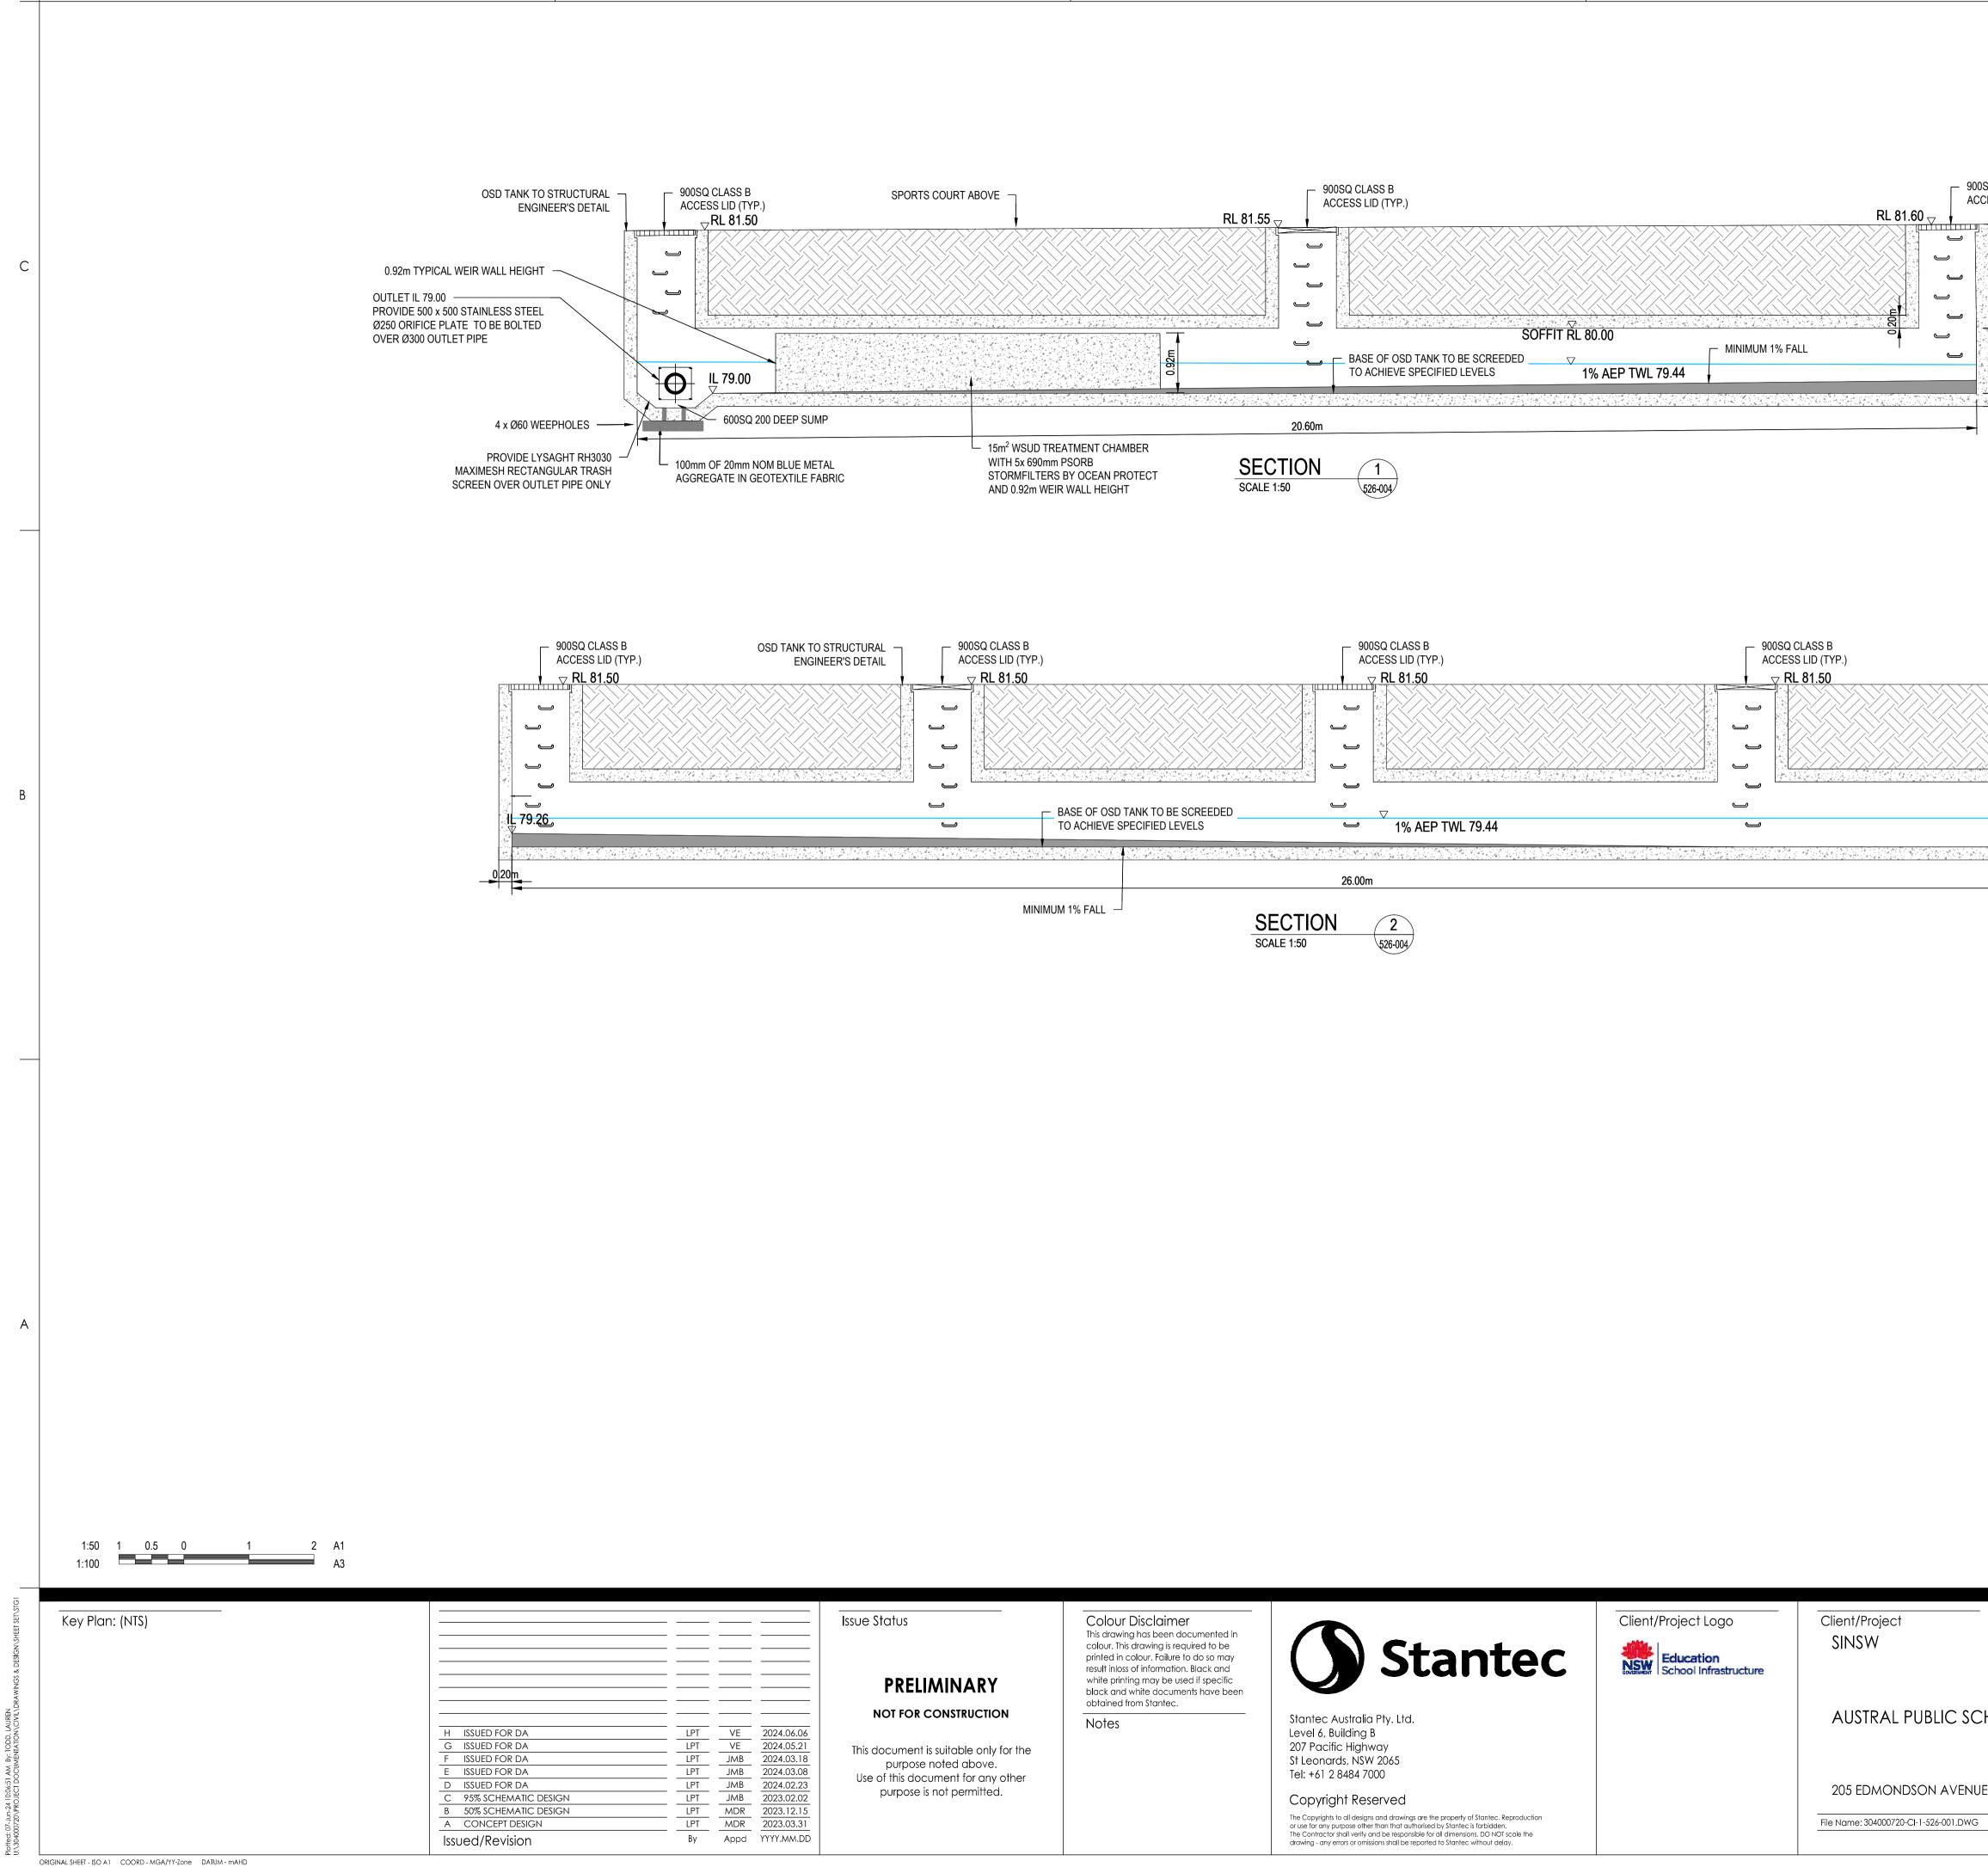
RL 81.50	<u> </u>	RL 81.50		RL 81.50
		<b></b>			SOFFIT RL 80.00	1.50m woo
	SPECIFIED LEVELS	See 1% AEP TW			IL 79.00	
<u>an an shinak ng Tagana sa kang maga</u>		26.00m				4 x Ø60 WEEPHOLES
MINIMUM 1% FALL -	SEC	2 1:50 2 526-004			PROVIDE LYSAGHT RH3030 MAXIMESH RECTANGULAR TRASH SCREEN OVER OUTLET PIPE ONLY OUTLET IL 79.00 PROVIDE 500 x 500 STAINLESS STEEL Ø250 ORIFICE PLATE TO BE BOLTED OVER Ø300 OUTLET PIPE	<ul> <li>600SQ 200 DEEP SUMP</li> <li>100mm OF 20mm NOM BLUE METAL AGGREGATE IN GEOTEXTILE FABRIC</li> </ul>
This dra colour. printed result in white p black a	Ur Disclaimer wing has been documented in This drawing is required to be in colour. Failure to do so may loss of information. Black and rinting may be used if specific nd white documents have been	Sta	Client/Project	SINSW		Title STORMWATER DRAINAGE DETAILS SHEET 5 OF 7
This dra colour. printed result in white p black a obtaine	wing has been documented in This drawing is required to be in colour. Failure to do so may loss of information. Black and rinting may be used if specific nd white documents have been ad from Stantec.	Stantec Australia Pty. Ltd. Level 6, Building B 207 Pacific Highway		SINSW	SCHOOL	STORMWATER DRAINAGE DETAILS
