REPORT TO HEALTH INFRASTRUCTURE

PRELIMINARY (STAGE 1) SITE INVESTIGATION

PROPOSED ALTERATIONS AND ADDITIONS

FINLEY HOSPITAL, 24 DAWE AVENUE, FINLEY, NSW

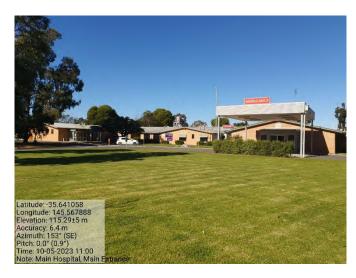
Photograph 1: Main hospital building

Several single-storey buildings of brick and fibre cement construction with metal roofing were observed across the site. The main hospital building occupied the central portion of the site, with a maintenance building to the south-east, and the staff accommodation building to the south-west. A small mortuary building was located in the southern portion of the site, with a metal carport structure attached to the west of the mortuary building. A stand-alone garage/shed structure of metal sheet construction was located to the east of the community health building. The buildings appeared to generally be in good condition based on a cursory inspection.

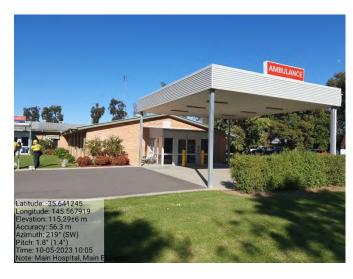
Photograph 2: Ambulance entrance

Two stand-alone metal carport structures were located to the north of the main hospital building. The western carport was associated with ambulance parking and entrance, and the eastern carport was reserved for evening shift staff parking. A metal awning structure was also observed to the east of the plant room area of the main hospital building. This structure was constructed over the self-contained back-up generator, which was located on a concrete pad. The carports and awning structure appeared to be in good condition based on a cursory inspection.

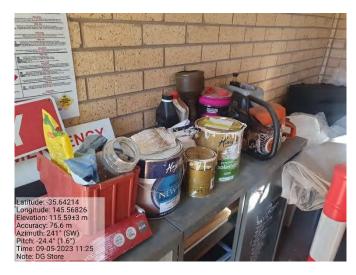
Photograph 7: Stored paints and fuel

Minor quantities of paints, fuel, solvents (mineral turpentine), lubricants and grease stored in 5-20L containers and pressurised cannisters were observed within the maintenance areas. Several oxygen (O_2) cylinders were stored in cages within the storage/plant areas in the south of the main building. Large dumpster-style bins for general waste were observed to the south of the maintenance building and several 240L bins were observed across the site.

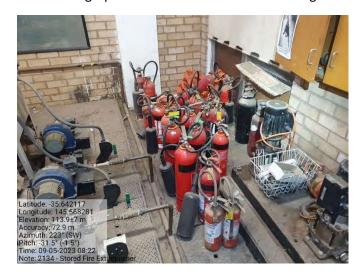
Photograph 8: Fire extinguishers in boiler room

Several carbon dioxide (CO₂) and dry powder type fire extinguishers were observed within the boiler room (part of the main hospital building). Fire extinguishers were also observed throughout the buildings and in external storage boxes across the hospital grounds, though the external boxes were not inspected. No visible evidence or available records of discharge/use of the fire extinguishers at the site was observed.

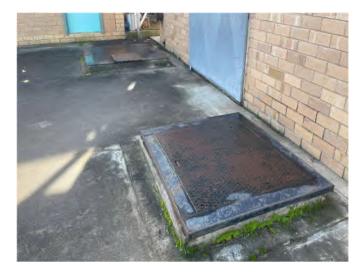
Photograph 12: USTs

Two underground storage tanks (USTs) were observed to the west of the maintenance shed. The USTs appeared to be concrete lined pits with metal-plate lids. JKE were informed by the maintenance manager (David McIlwain) that the tanks were no longer in use, though were previously used to store fuel oil for the boilers. No information on whether the tanks were drained and/or decommissioned was available. JKE consider the USTs represent a potential point-source of contamination.
