**REPORT TO  
HEALTH INFRASTRUCTURE**

**ON  
DETAILED (STAGE 2) SITE INVESTIGATION**

**FOR  
PROPOSED HOSPITAL DEVELOPMENT**

**AT  
FINLEY HOSPITAL, 24 DAWE AVENUE, FINLEY,  
NSW**

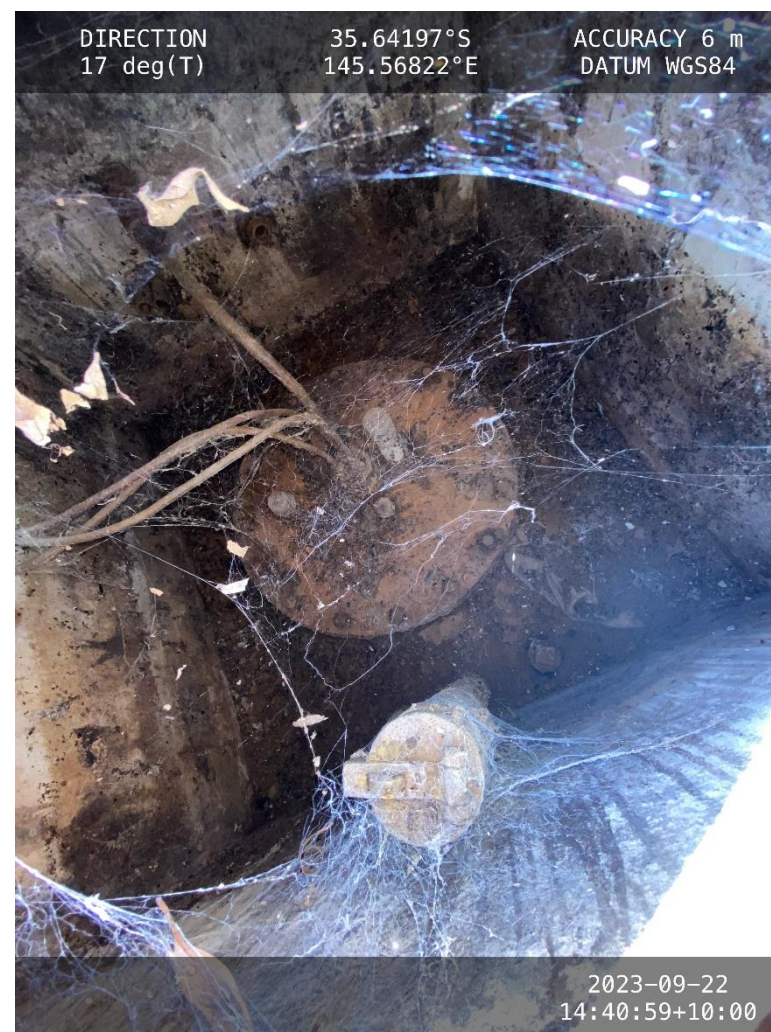
- Two USTs were observed to the west of the maintenance shed and there was a generator to the north-east of the USTs (see Figure 2). JKE was advised by hospital staff that the USTs were no longer in use, though previously contained fuel oil for the on-site boilers;

Photograph 2: UST access point

Data Gap	Assessment
	<p>On this basis, the RAP is to include provisions for the removal and validation of the USTs, and any associated infrastructure and stained and/or odorous soils.</p>
<p>Building footprints not assessed.</p>	<p>The sampling locations were positioned outside of the building footprints. The fill and soil conditions beneath the building footprints are currently unknown, though JKE is of the opinion that the soil contaminant conditions would likely be similar to the available data. However, asbestos impacts may be encountered and there is a potential that pesticide applications occurred beneath the buildings, given the detectable concentration of dieldrin in TP114.</p> <p>JKE understand that the existing buildings will likely be retained in the proposed development. In the event that the existing buildings are not retained, further investigation beneath the building footprints is recommended following demolition. Hence, provisions for additional testing are to be included in the RAP.</p>

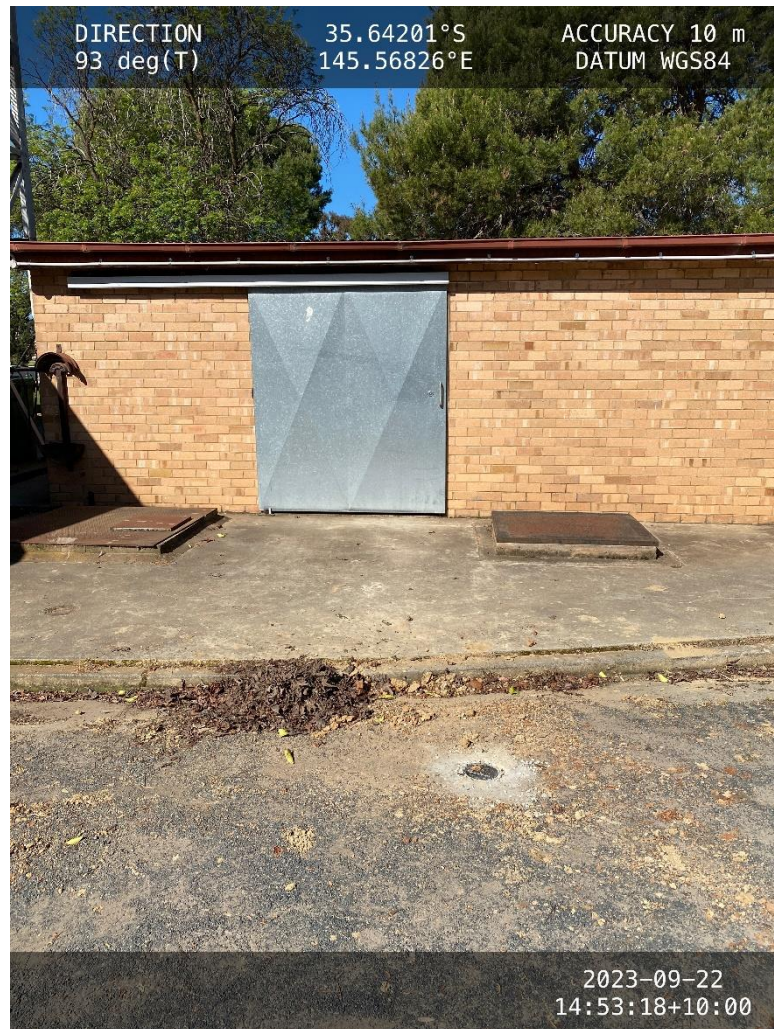
JKE note that a hydrocarbon odour was encountered in the shallow fill soils in BH103, along with an elevated PID reading of greater than 25ppm. BH103 was targeted to the vicinity of the disused USTs. The odorous fill may be indicative of a historical leak/spill in this vicinity. Though the TRH and PAH results were below the PQL, given the proximity to the USTs, consideration should be given to localised remediation in this area. There is a potential for impacts to occur within the tank pit backfill sands.

Photograph 3: MW103 and USTs

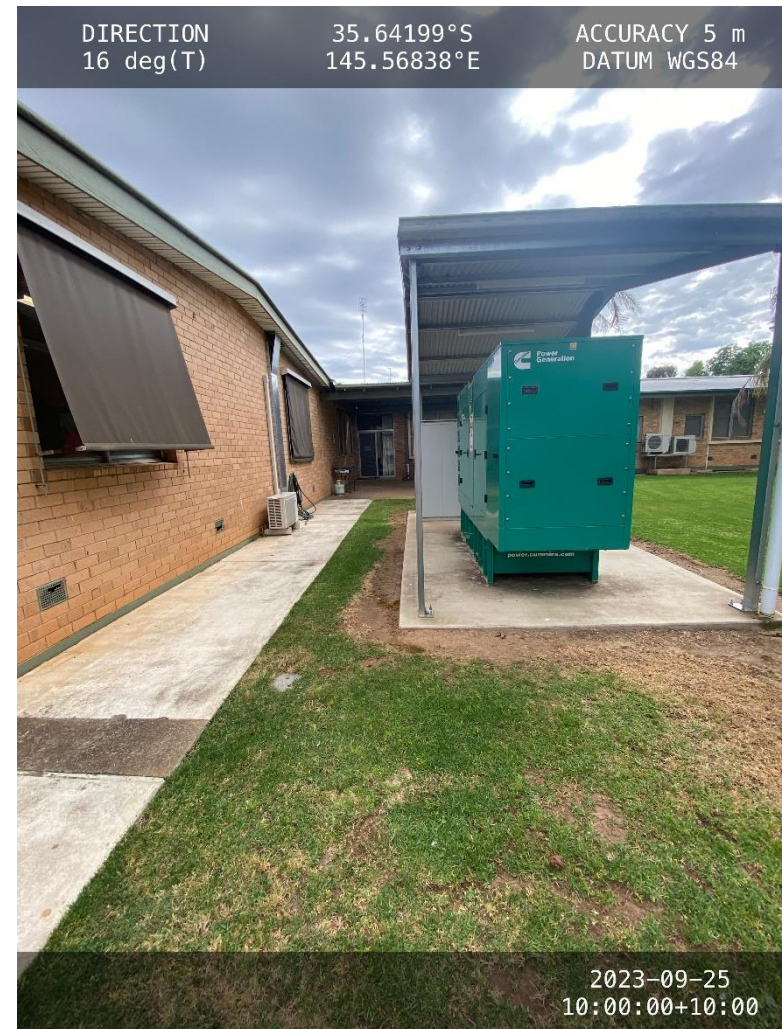
Photograph 4: Current back-up generator

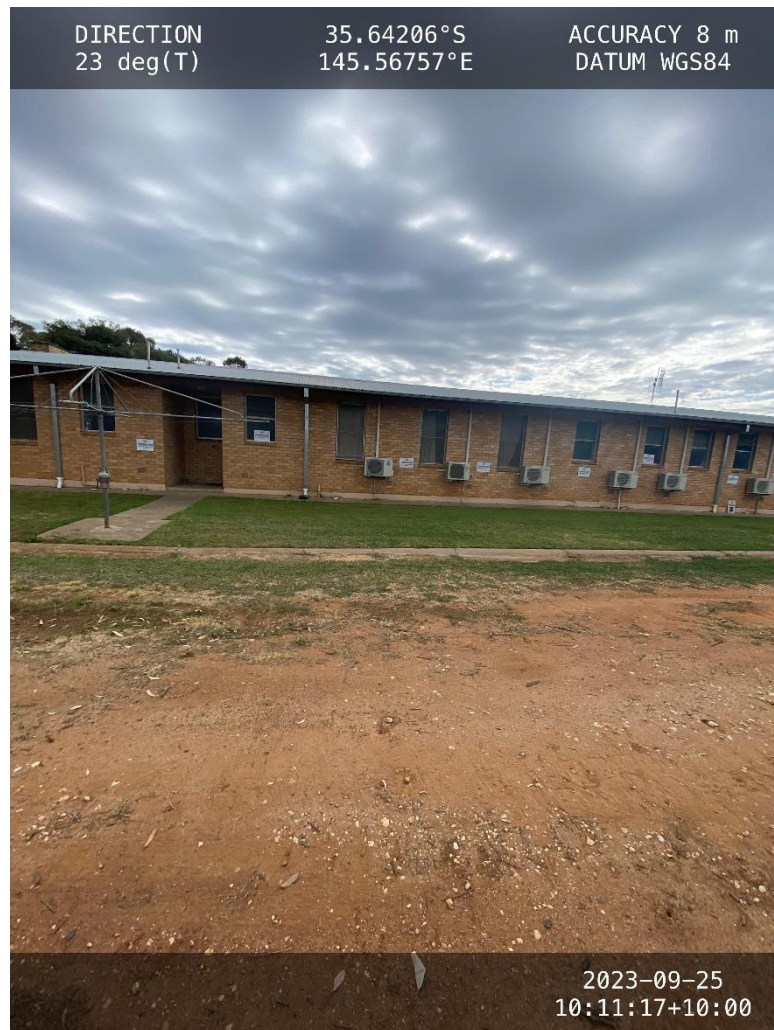
Photograph 5: Staff accommodation building and access track

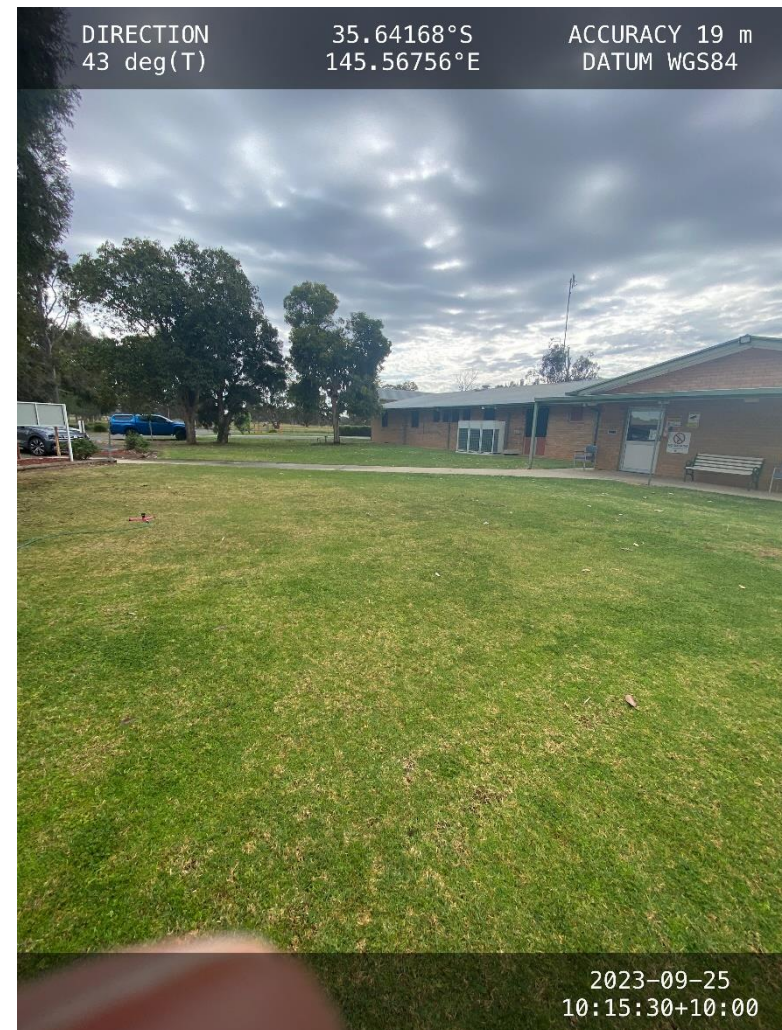
Photograph 6: General site condition
