Leppington Public School Upgrade

Statement of Heritage Impact

Prepared for NSW Department of Education

E240165 RP#1

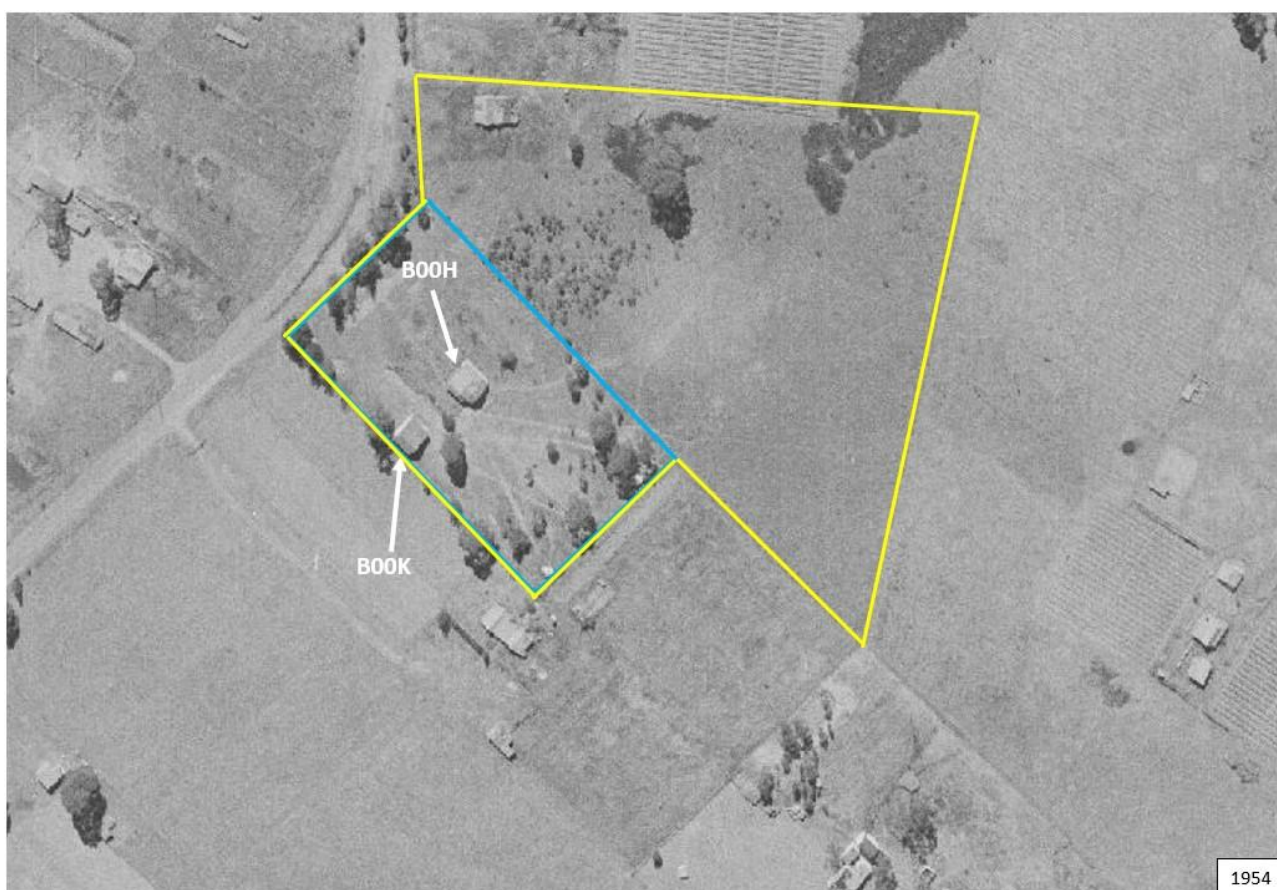
Plate 1.1 LPS 1954 (rough outline in blue)

The earliest historical aerial photography accessed for this report dates to 1954 (Plate 1.1) and captures the first (B00H - 1922) and second (B00K - 1950) school buildings on the site. A building, possibly a farm shed, is visible along the inside of the northern perimeter of the current boundary (yellow). The unidentified building is in the vicinity of what is now Building B, or directly to the east of it.

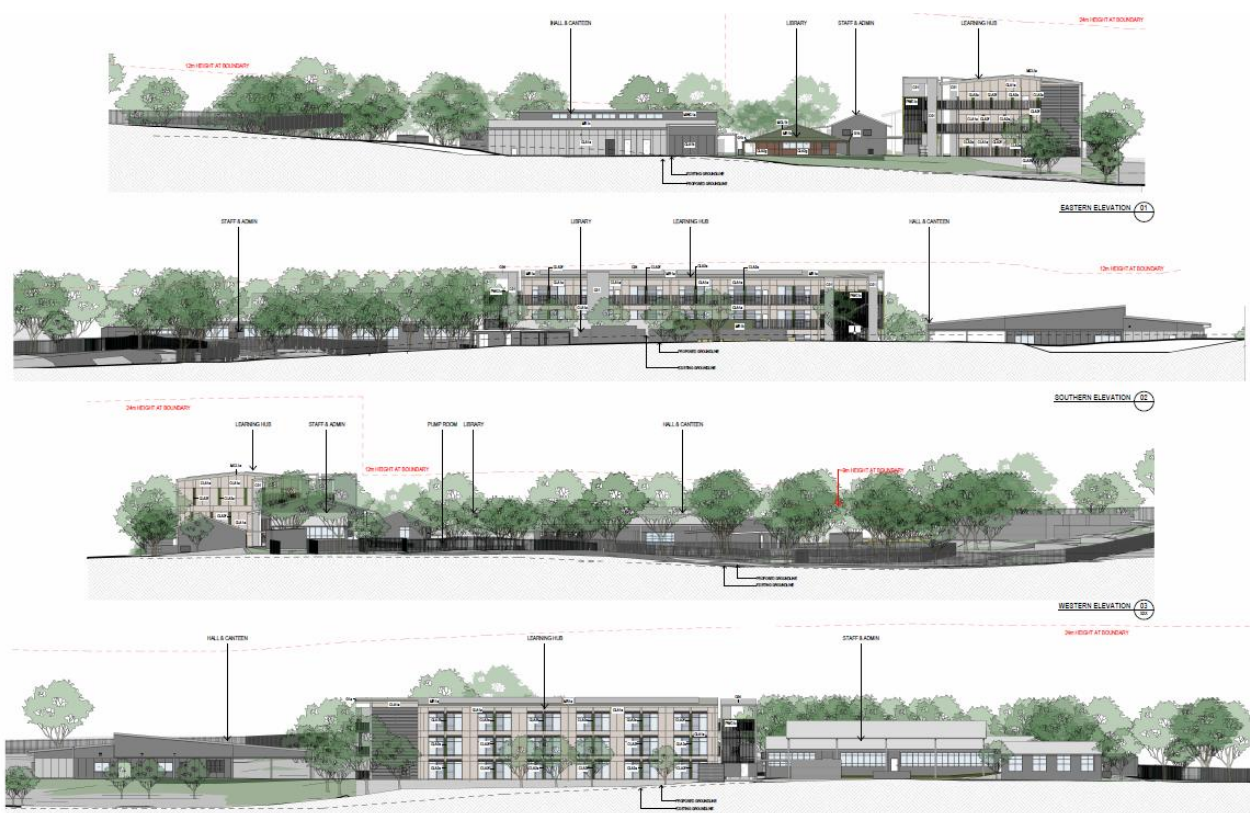
Elevations of the proposed new buildings are shown in Plate 2.3 and Plate 2.4. The drawings are of buildings of standard school design that is functional and blends in well with the surrounding environment.

Source: Pedavoli Architects 04 December 2024, LPS-PA-00-ZZ-DR-A-REF_111 Revision A G

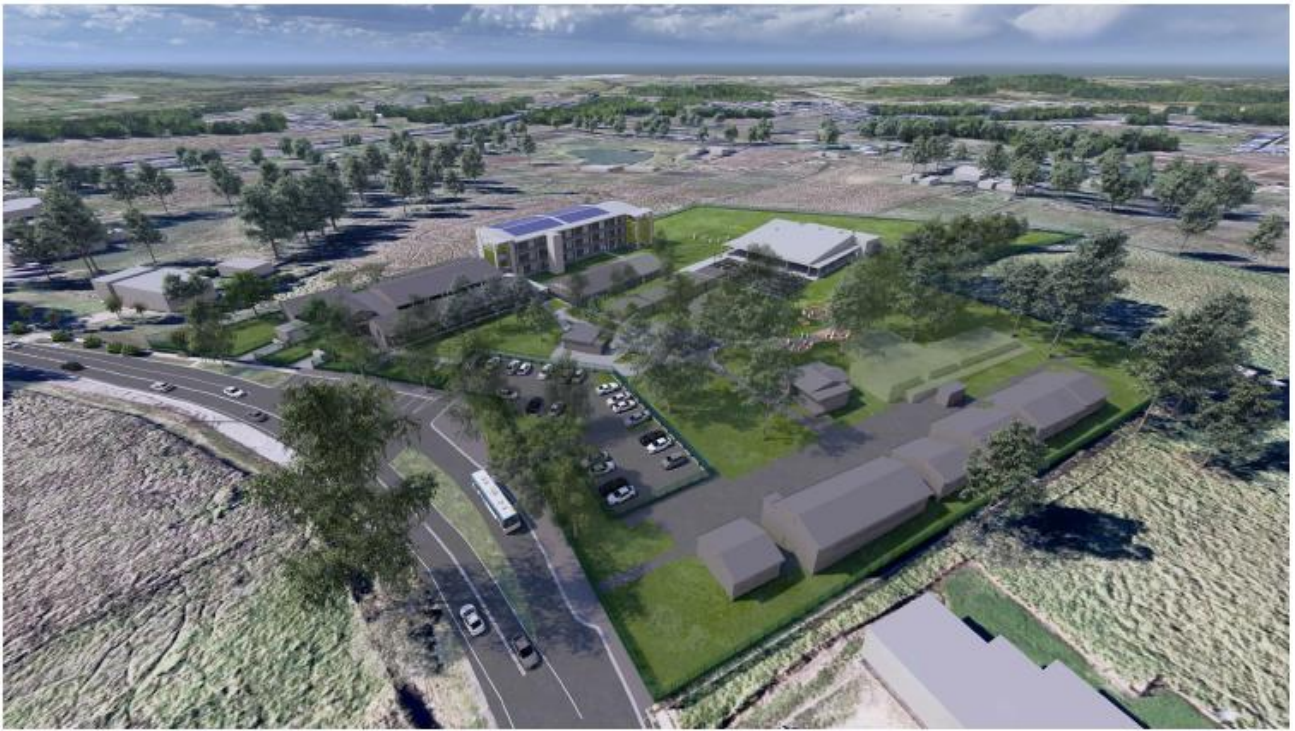
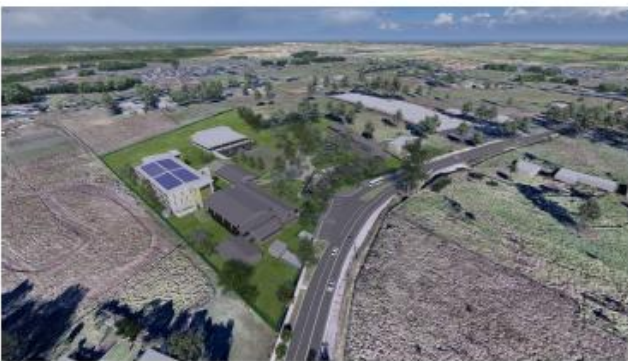
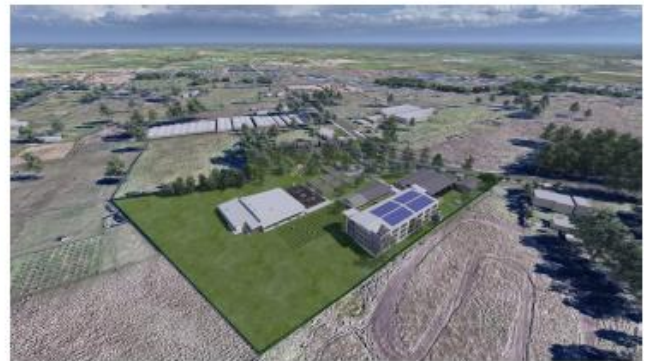
Plate 2.4 Massing of the design proposal

The design is represented schematically in the massing diagram that demonstrates that of the new buildings and landscaping will be located on the northern boundary of the school property. The green in the centre of the school provides a space that allows for the differentiation of old and new, as well as creating an expanse that impedes the overshadowing of the buildings with historical significance.

This spatial arrangement will also hold the open, green character of the school as urban development encroaches.

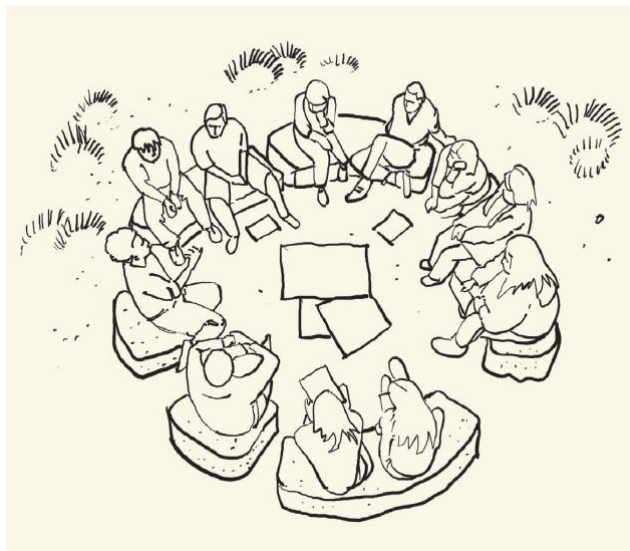
Plate 3.1 Illustration of a yarning circle

A yarning circle is a harmonious, creative and collaborative way of communicating to: encourage responsible, respectful and honest interactions between participants, building trusting relationships foster accountability and provide a safe place to be heard and to respond promote student–student interactions and student–school–community connectedness enrich learning experiences for students (Pedavoli Architects 2023, p.14),

It is a school cultural activity shared from Aboriginal and Torres Strait Islander culture (Pedavoli Architects 2023, p.15).¹

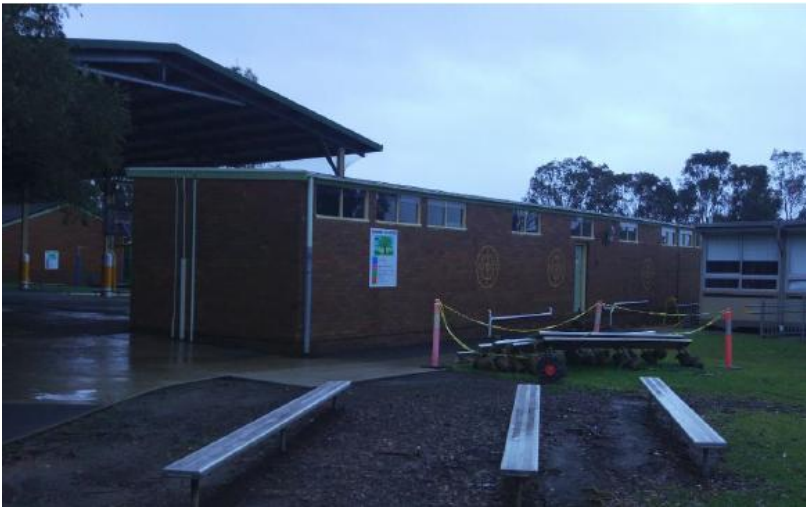
Plate 3.3 Building C view, facing north

Additionally, the building cannot continue its original use. Coupled with the projected growth and development in the surrounding area, its removal is necessary to accommodate proposed expansion plans, ensuring better positioning of facilities for school functionality and future developments.

Building C is a mid-century facilities-building situated perpendicular to the northern boundary of the school (Plate 1.2), which was identified as one to consider retaining (EMM 2023). This building is part of a group, also comprising Building A, Building B, Building D, Building F and Building G, and its significance is founded in its ability to contribute to an understanding of the mid-century growth of the school.

Building C, located north of the site and outside the locally listed curtilage, will also be demolished, resulting in a total loss of heritage significance. Despite its contributory aesthetic significance as part of a mid-century development group, Building C fails to meet modern standards and does not provide adequate passive surveillance for the safety of children. Its removal is necessary to accommodate expansion plans, resulting in the total loss of its historical and aesthetic significance.

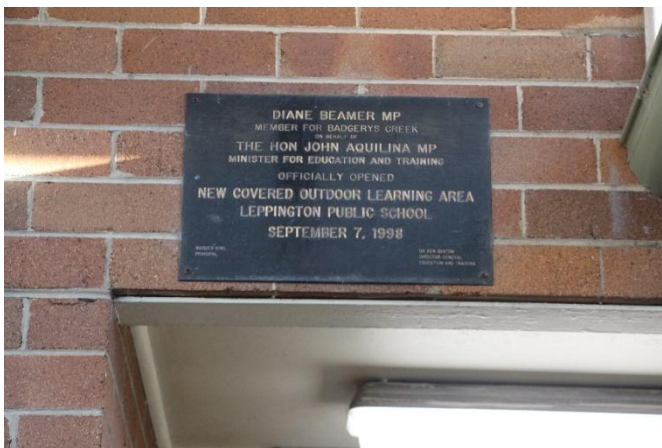
Plate 3.5 Building A, plaque commemorating the opening of the COLA by Hon. John Aquilina Minister for Education and Training. 1998.

The plaques should be recorded and removed before the commencement of construction to prevent damage or loss. The plaques should be safely stored off-site. After construction is completed, the plaques should be reinstated in a suitable location at eye level, ensuring their contribution to the historical context of the site's development is preserved and accessible.

The movable items impacted by the proposed work at Building E and Building A include the 1981 plaque commemorating the opening of the new accommodation by Hon. Paul Landa, and the 1998 plaque commemorating the opening of the COLA by Hon. John Aquilina. These plaques contribute to understanding the mid-century growth of the school. To prevent damage during construction, it is recommended to record and remove the plaques, store them off-site, and reinstate them at eye level after construction.

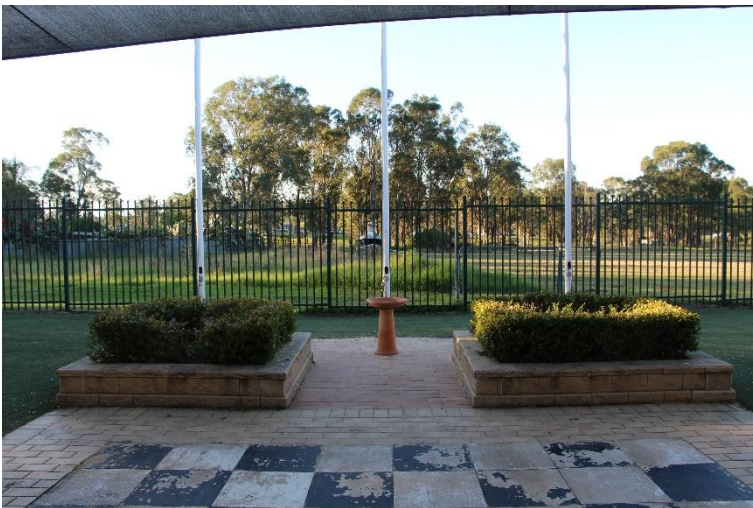
Plate 3.7 **2016 ANZAC memorial for ANZAC Day commemoration activities**

The demolition of the 2016 ANZAC memorial and the 2014 paving will have no impact on the site's historical heritage, as they are located away from the listed heritage buildings. Their contemporary nature and lack of historical significance further support this assessment Plate 3.7. It is recommended to consider integrating a new commemorative feature in the new construction to continue honouring the ANZAC Day activities and the contributions of the students and school community.

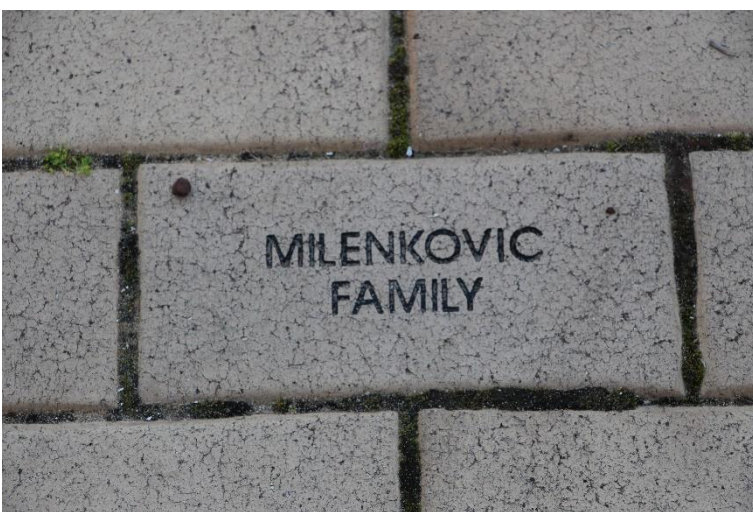
Plate 3.8 **2014 paving of 26 family names commemorating the 'Year 4/5/6 Runners up of the Department of Veteran Affairs ANZAC Competition'**

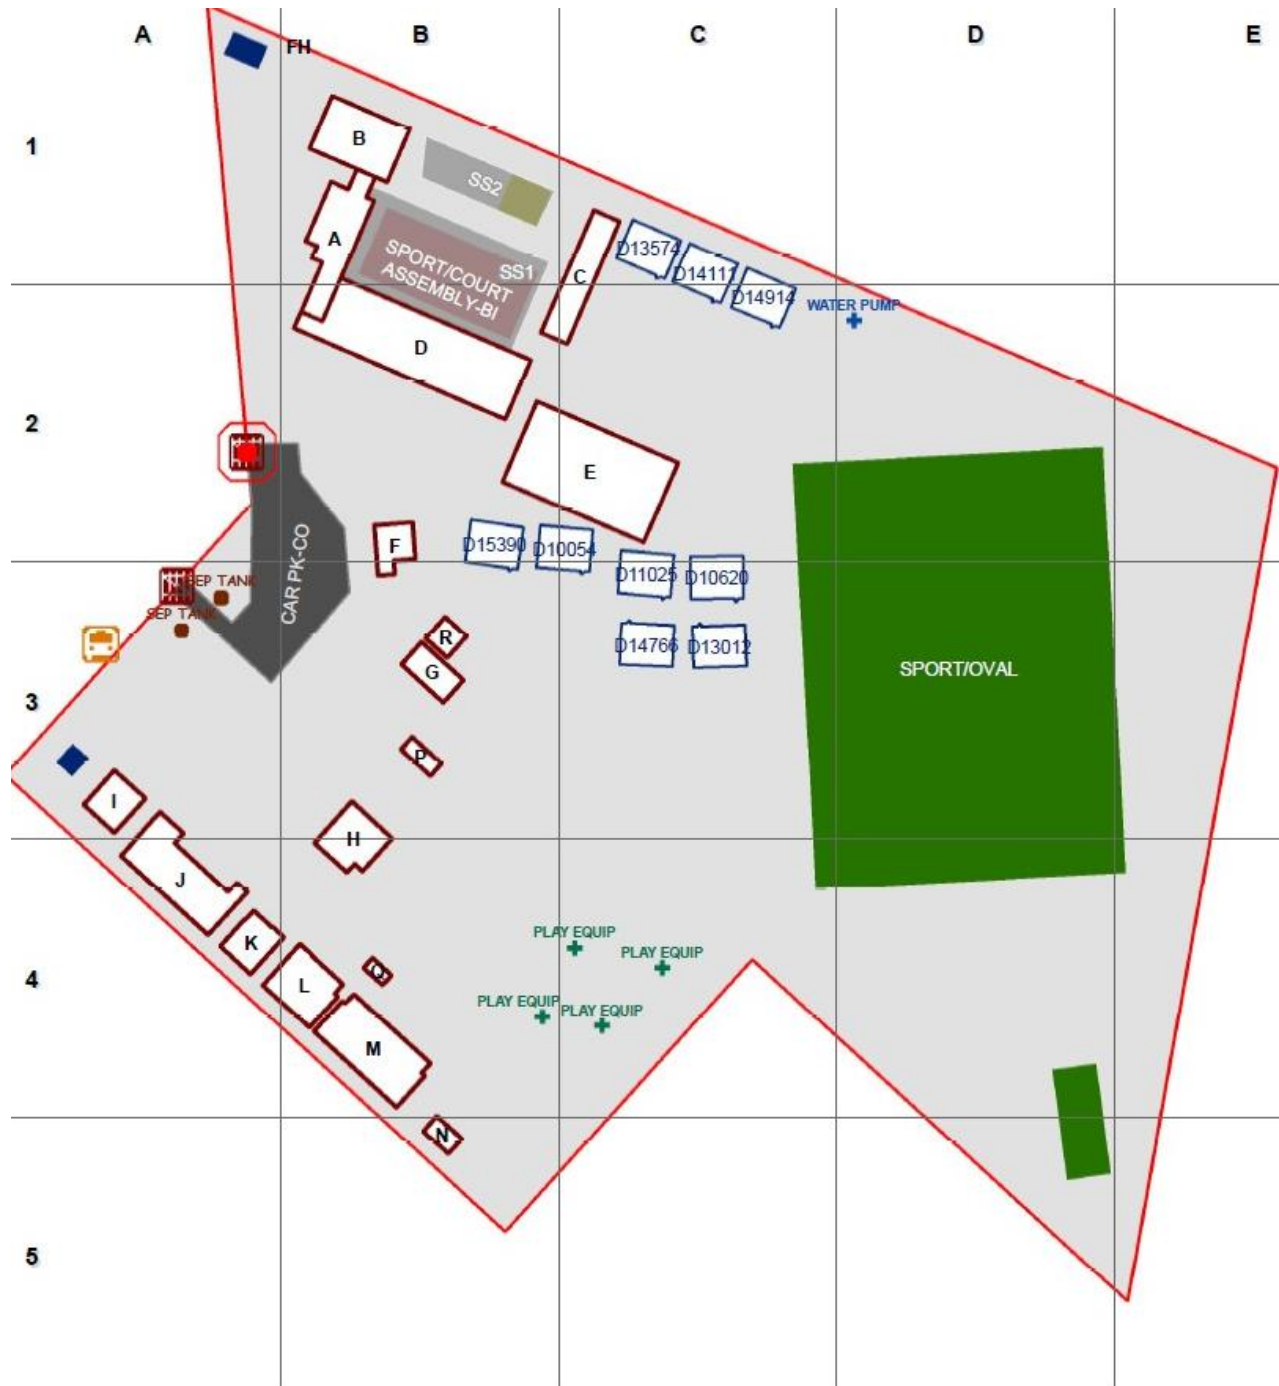
Plate 1.1 Diagrammatic map of the Leppington Public School site, associated school buildings and functions

Plate 1.1 provides a diagrammatic map of the project area and individual buildings that make up the school campus. The map provides an alphabetic identification or a description to the built elements in the project area that have been used in this report when referring to specific buildings or locations.

Table 1.1 identifies the seventeen school buildings, their current function and location within the project area based on three groupings (north, centre or south of the project area). A physical description of these buildings has been provided in Section 4 of this report.

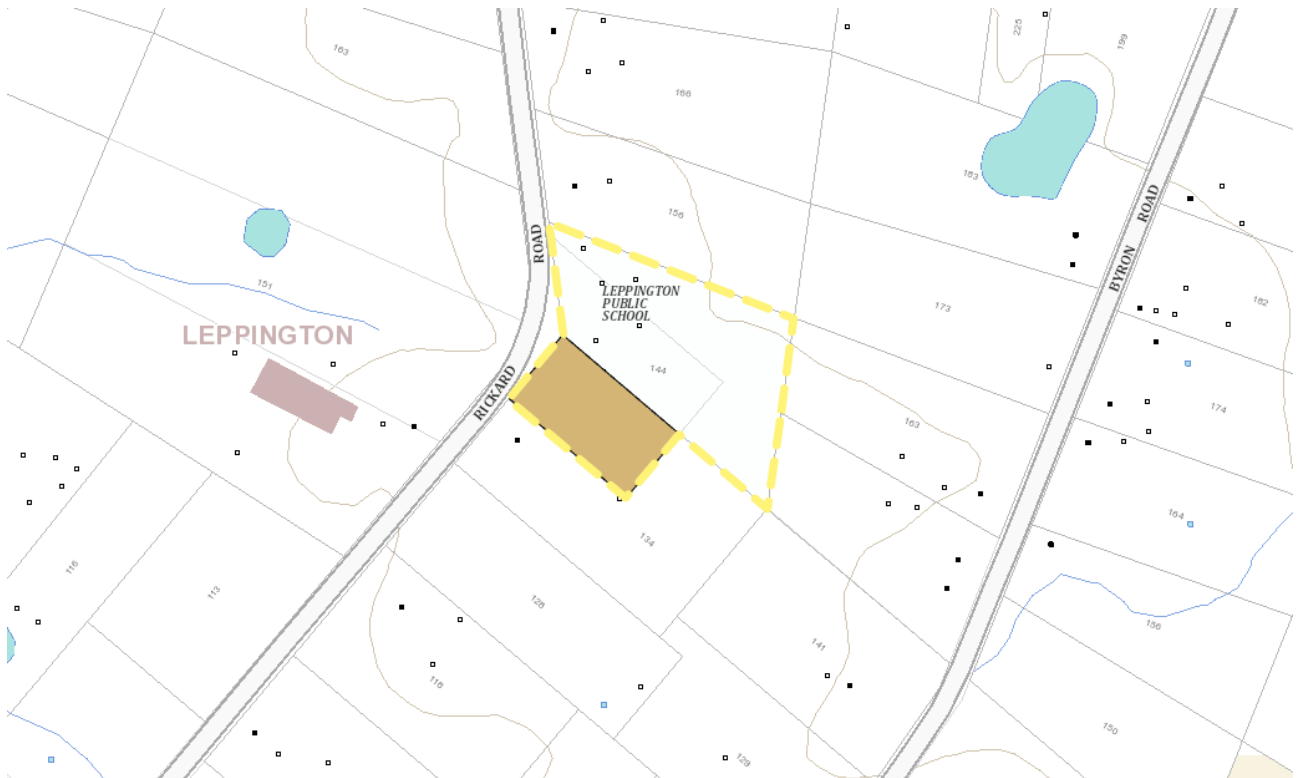
Plate 2.1 Map showing the extent of Leppington Public School/project area (yellow dashed) and the southwestern section identified as the heritage item in the S170 register (gold)

A portion of the project area comprising two lots (Lot 39C, DP 8979 and Lot 38E, DP 8979) is also identified as Item 131 '*Leppington Public School - Buildings B00H-B00M*' of heritage significance in the NSW Department of Education S170 heritage and conservation register (refer to Plate 2.1 and Plate 2.2).

The S170 listing for the item (Heritage Item ID: 5065988) notes that the listing relates specifically to buildings H, I, J, K, L and M, being the earliest buildings constructed in the project area. In conjunction the curtilage defined in the S170 listing illustrated the boundaries of the original school site.

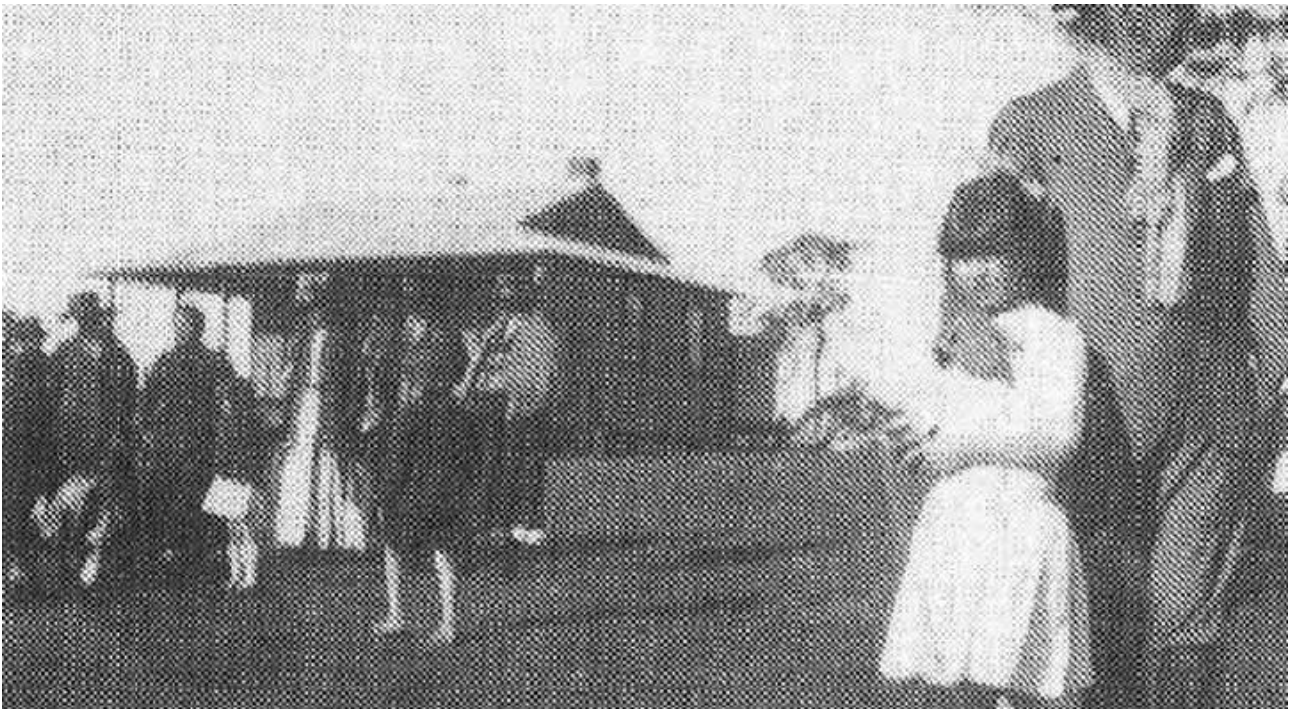
Plate 3.6 **Photograph of the original Raby Public School building (B00H) c. 1923, looking eastward**

The construction of the first school building took place in 1922, and it served the initial 28 enrolled students when the school officially opened in January 1923 under the name 'Raby Public School'. This building, which still stands within the project area (B00H), was originally a weatherboard single-story structure. It featured a single internal classroom space, a wrapping verandah, and an open fireplace (Plate 3.6). In 1942, an extension was added to the eastern side of the building to accommodate a larger number of students, necessitating the partial enclosure of the verandah (Australian Museum Business Services 2012: 138).

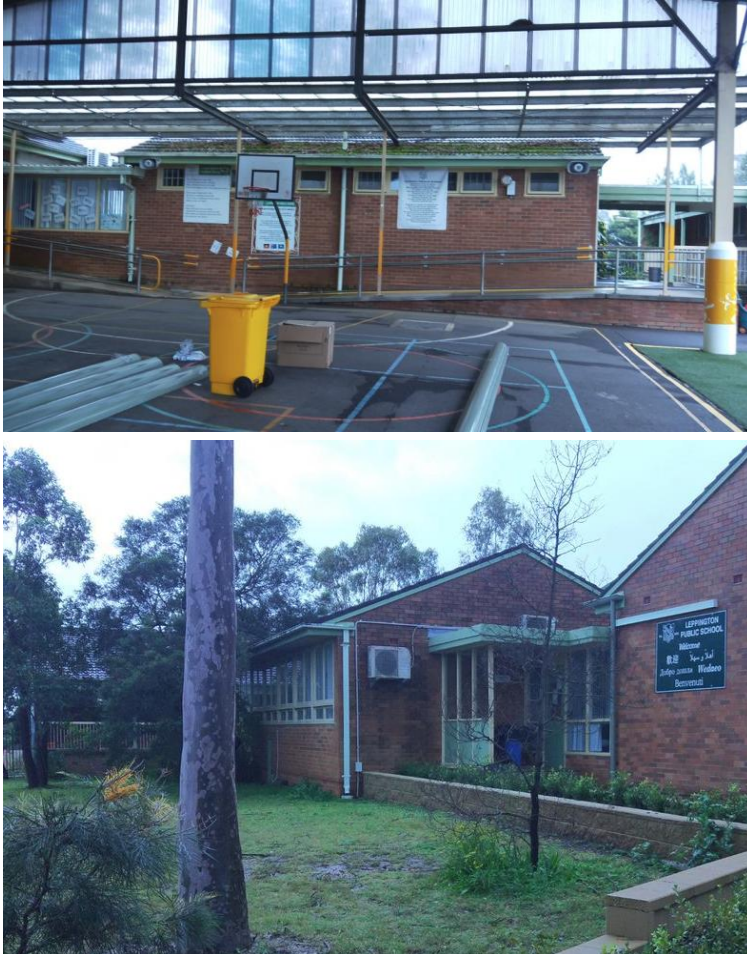
Building	Current function	Location	Date	Physical/ architectural description	Condition	Image
B00A	Administration	North of project area	1967	<p>A single storey building characterised by:</p> <ul style="list-style-type: none"> • a red brick structure • open gable roof structure that extends into an awning to the west elevation • timber bargeboards and fascias • metal gutters and downpipes • terracotta, Marseilles roof tiles • tall, two panel timber framed awning and sliding windows to west elevation • small, upper level, timber framed awning windows to the east elevation. <p>The building is a general example of mid-twentieth century school building architecture and does not include any notable built elements or detailing.</p>	<ul style="list-style-type: none"> • The building is stable and in generally good condition both externally and internally. • Largely intact externally with various internal modifications. • Later additions including accessibility ramps, air conditioning units, awnings and connective structures have been introduced externally. • Downpipes and gutters appear to be original with sections recently replaced.

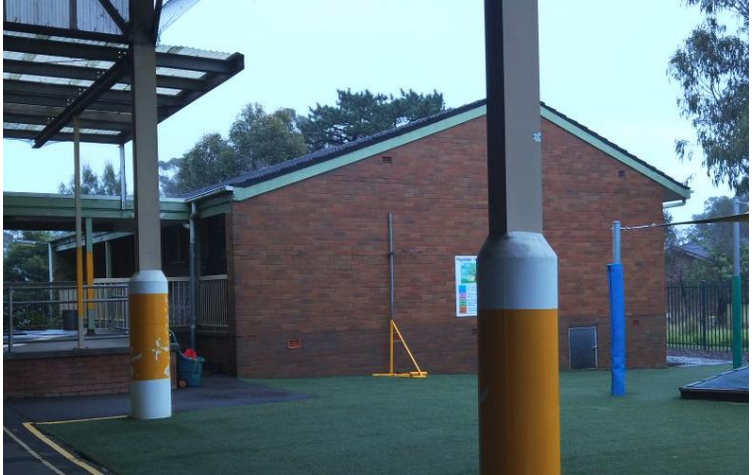
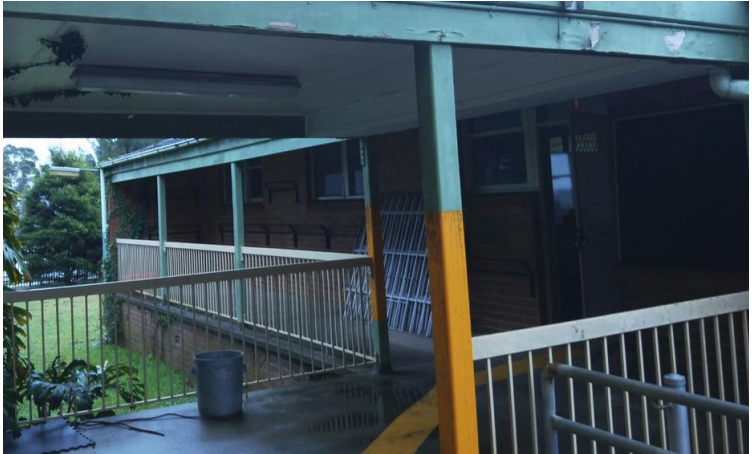
Building	Current function	Location	Date	Physical/ architectural description	Condition	Image
B00B	General Learning	North of project area	1968	<p>A single storey building characterised by:</p> <ul style="list-style-type: none"> • a red brick structure with an enclosed and covered verandah to the extent of the south elevation • an asymmetric, open gable roof structure that extends into a small awning to the north elevation and into the verandah roof structure to the south elevation • the enclosed verandah includes a timber balustrade and posts supporting the verandah roof structure • timber bargeboards and fascias • metal gutters and downpipes • terracotta, Marseilles roof tiles • timber framed, double hung windows and timber framed doors. <p>The building is a general example of mid-twentieth century school building architecture and does not include any notable built elements or detailing.</p>	<ul style="list-style-type: none"> • The building is stable and in generally good condition both externally and internally. • Largely intact externally with various internal modifications. • Downpipes and gutters appear to be original with sections recently replaced.

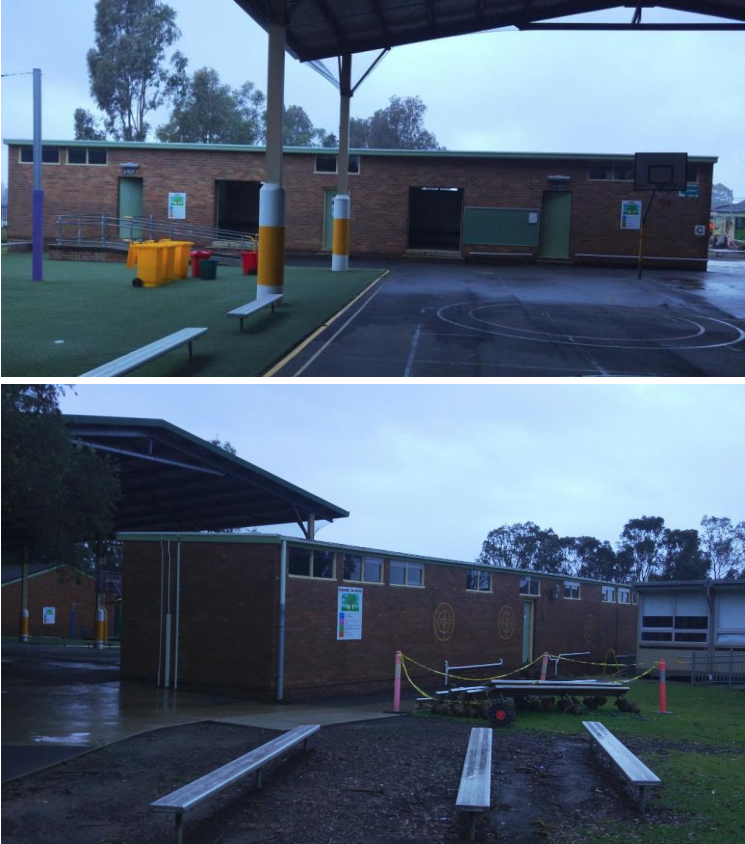
Building	Current function	Location	Date	Physical/ architectural description	Condition	Image
B00C	Pupil Facilities	North of project area	1966	<p>A single storey building characterised by:</p> <ul style="list-style-type: none"> • a simple, long, red brick structure extending north to south • a simple skillion roof with corrugated sheeting • only high level, small, timber framed windows to the east and west elevations • frameless standard doors with timber door panels • larger timber panel double doors to the west elevation. <p>The building is a general example of mid-twentieth century school building architecture and does not include any notable built elements or detailing.</p>	<ul style="list-style-type: none"> • The building is stable and in generally good condition both externally and internally. • Largely intact externally with various internal modifications. • Later additions including accessibility ramps, guttering and downpipes.

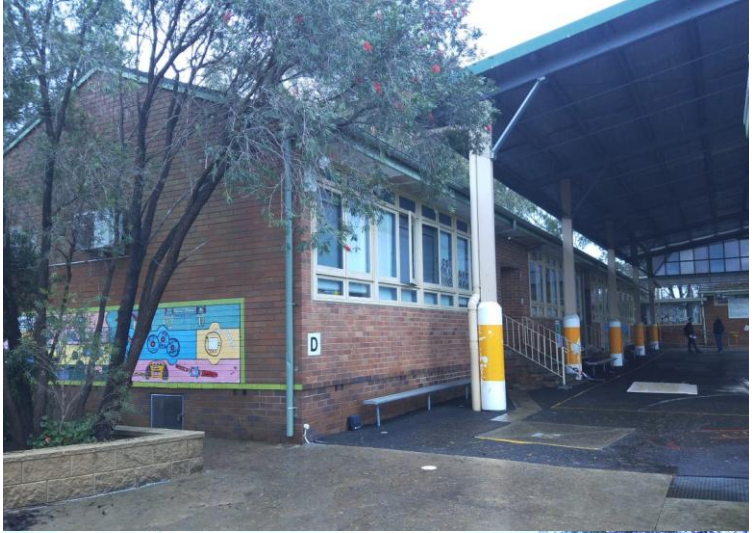
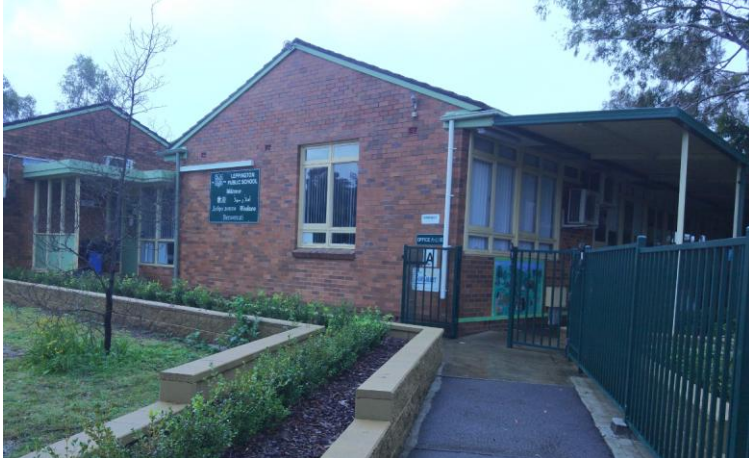
Building	Current function	Location	Date	Physical/ architectural description	Condition	Image
B00D	General Learning	North of project area	1966	<p>A single storey building characterised by:</p> <ul style="list-style-type: none"> • a long building form with an east to west orientation; • red brick structure onto brick foundations with access via two sets of concrete and brick stairs with metal handrails to the north elevation • open gable roof structure; terracotta, Marseilles roof tiles • timber bargeboards and fascias • metal gutters and downpipes • tall, three panel timber framed awning and sliding windows to the south, west and north elevations. <p>The building is a general example of mid-twentieth century school building architecture. The three panel timber windows are distinctive architectural features, also present to B00J.</p>	<ul style="list-style-type: none"> • the building is stable and in generally good condition both externally and internally. • Largely intact externally with various internal modifications. • Later additions including accessibility ramps, air conditioning units, awnings and connective structures have been introduced externally. • The awning to the southern elevation is a later addition that is applied to a smaller, original awning that extends from the roof structure. • Downpipes and gutters appear to be original with sections recently replaced.

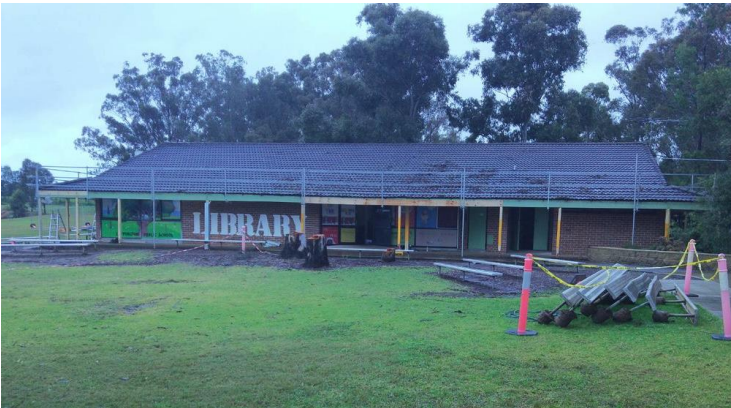
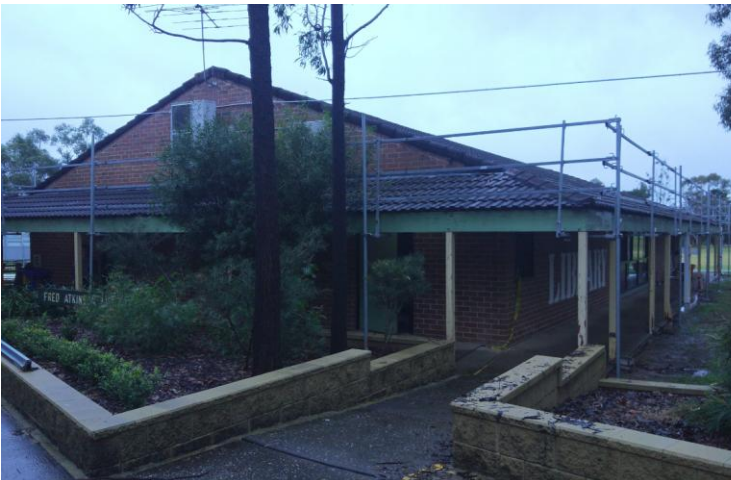
Building	Current function	Location	Date	Physical/ architectural description	Condition	Image
B00E	Library/ Tiered Learning	North of project area	1981	<p>A single storey brick building with a Dutch gable roof structure and terracotta, Marseilles roof tiles. The roof structure extends into a wraparound awning to all elevations, supported by timber posts.</p> <p>The building is a general example of a late twentieth century school building.</p>	<p>The building is stable and in generally good condition internally with some dilapidation noted externally to the main roof structure and awning roof structure. During the inspection, roof works were being conducted to the building to rectify damaged roof tiles and awning plates.</p>

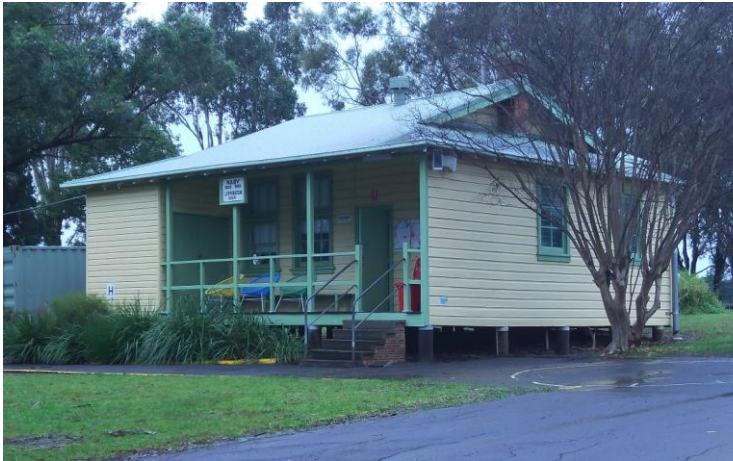
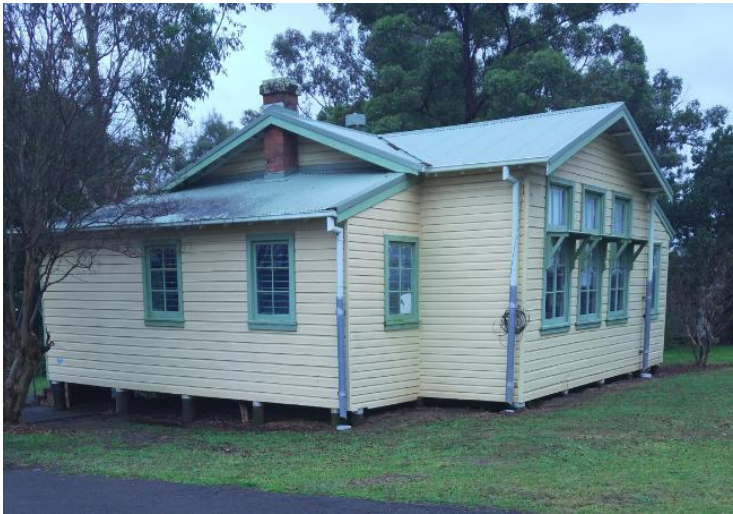
Building	Current function	Location	Date	Physical/ architectural description	Condition	Image
B00H	Staff Facilities	South of project area	1922, 1942 (ext.)	<p>A single storey building characterised by:</p> <ul style="list-style-type: none"> • a timber structure elevated onto recent piers • horizontal weatherboard cladding • a transverse Dutch gable roof structure with corrugated roof sheeting. A section of the roof structure transitions into the verandah awning supported by timber posts • a fireplace and chimney stack • double hung, timber sash windows • a verandah that includes timber floorboards and a timber balustrade • concrete and brick stairs lead to the verandah area where main access to the building is achieved • windows to the rear of the building include decorative timber awnings supported by timber brackets to shade lower sashes. <p>The building is unique in its architectural expression within the project area and includes detailing that is indicative of the period of its construction (1922).</p>	<p>The building is stable and in generally good condition both externally and internally.</p> <p>The building has experienced modifications and alterations since its construction including:</p> <ul style="list-style-type: none"> • an extension of the structure to the east in 1942 that resulted in the modification of the roof structure and wall structure of the building, both internally and externally • the extension of the building resulted in the enclosure of south-west and north-east aspects, and partial closure to the façade of the building. The original verandah that would have warped around the structure • the original timber steps to the building have been replaced with the current concrete and brick stairs • original piers have been replaced with cylindrical concrete piers • the fireplace is extant but has been made inoperable.

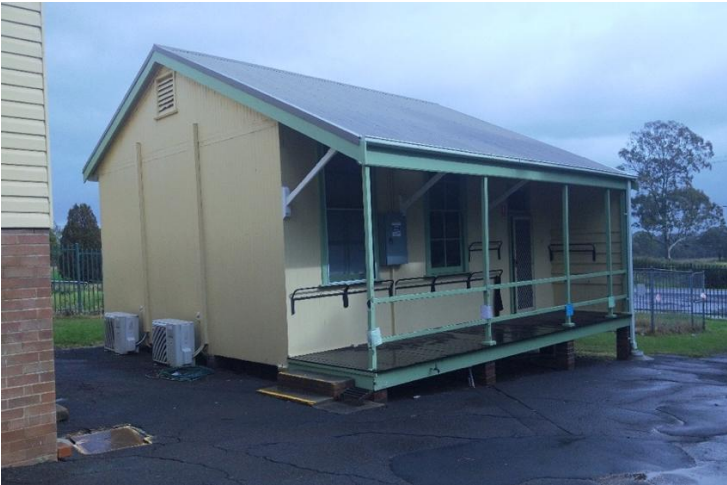
Building	Current function	Location	Date	Physical/ architectural description	Condition	Image
B001	General Learning	South of project area	Intro. 1960–1970	<p>A single storey timber structure with vertical weatherboard cladding, an open gable roof structure with corrugated sheeting and a front verandah. The roof structure extends above the verandah space and is supported by timber posts. The verandah includes timber floor boards and a simple timber balustrade consisting of two rows of timber rails.</p> <p>The building includes detailing of an earlier period than that when it was introduced (1960s). The building is noted as being a portable timber classroom that is easily disassembled and transported and of a style that was first introduced in 1912. Features of the building that suggest it may date from the early twentieth century rather than the mid-twentieth century include vertical weatherboard cladding, double hung, timber sash windows and the overall external and internal form. This may suggest that the building was introduced to the project area as an existing structure from another site, rather than a newly constructed building.</p>	<p>The building is stable and in generally good condition both externally and internally.</p> <p>The building interior and exterior has experienced some additions and modifications. including the addition of railing, air conditioning units and metal bracing to the front verandah roof structure. The later modification would indicate that the building may be experiencing some structural issues that require rectification.</p>

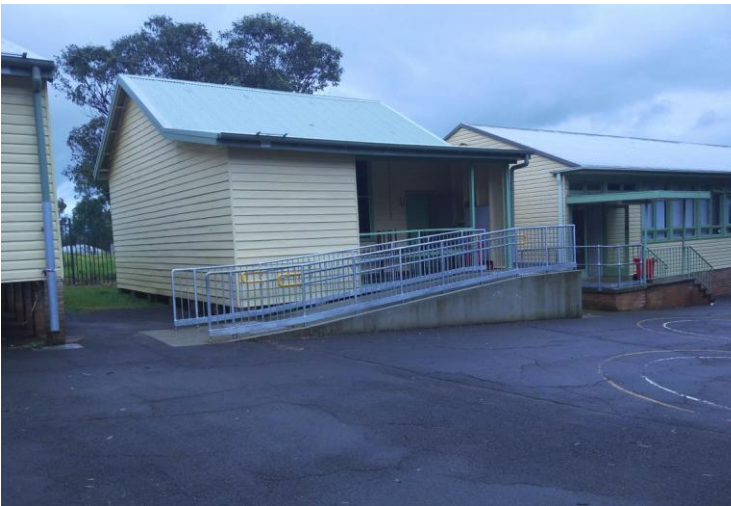
Building	Current function	Location	Date	Physical/ architectural description	Condition	Image
B00J	General Learning	South of project area	1961–1970	<p>A single storey timber structure constructed onto a brick foundation, characterised by:</p> <ul style="list-style-type: none"> horizontal weatherboard cladding an open gable roof structure with corrugated metal sheeting tall, three panel timber framed awning and sliding windows to the south and north elevations two entry points to the east and west ends of the building, onto the north elevation, accessed via two brick stairs with concrete floor tiles and metal handrails Stair platforms include flat roof awning structures supported by metal posts small, louvered ventilation openings. <p>The building is distinct in the southern cluster of school buildings for its brick foundations, and shares a distinctly similar style of window, stairs and balustrades to B00D. These buildings may share a common date of construction based on both the design and substantiated by</p>	<p>The building is stable and in generally good condition both externally and internally.</p> <p>Roof sheeting, downpipes and gutters appear to be original largely replaced.</p> <p>North elevation entry awnings appear to be recent additions to the building.</p>

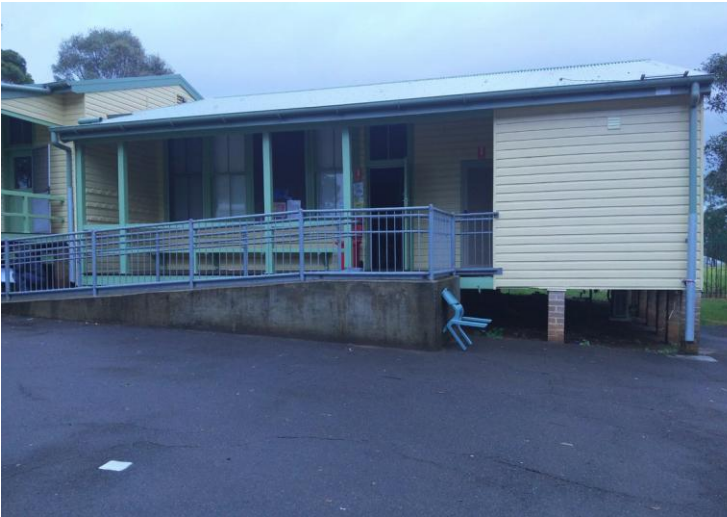
Building	Current function	Location	Date	Physical/ architectural description	Condition	Image
B00L	General Learning	South of project area	1950-1961	<p>A single storey timber structure with weatherboard cladding and an open gable roof structure clad in corrugated sheeting. The building is constructed onto brick piers.</p> <p>The building includes a partially enclosed front verandah with timber floor panels. The roof structure transitions into a verandah awning supported by timber posts.</p> <p>Windows are timber framed and double hung and doors include timber panels and framing.</p> <p>This building shares a similar structure and design to B00K however the building occupies a large footprint and physically abuts the nearby B00M.</p>	<p>The building is stable and in generally good condition both externally and internally.</p> <p>A recent accessibility ramp has been introduced to the north (main) elevation.</p> <p>Roof sheeting, downpipes and gutters appear to be original largely replaced.</p>

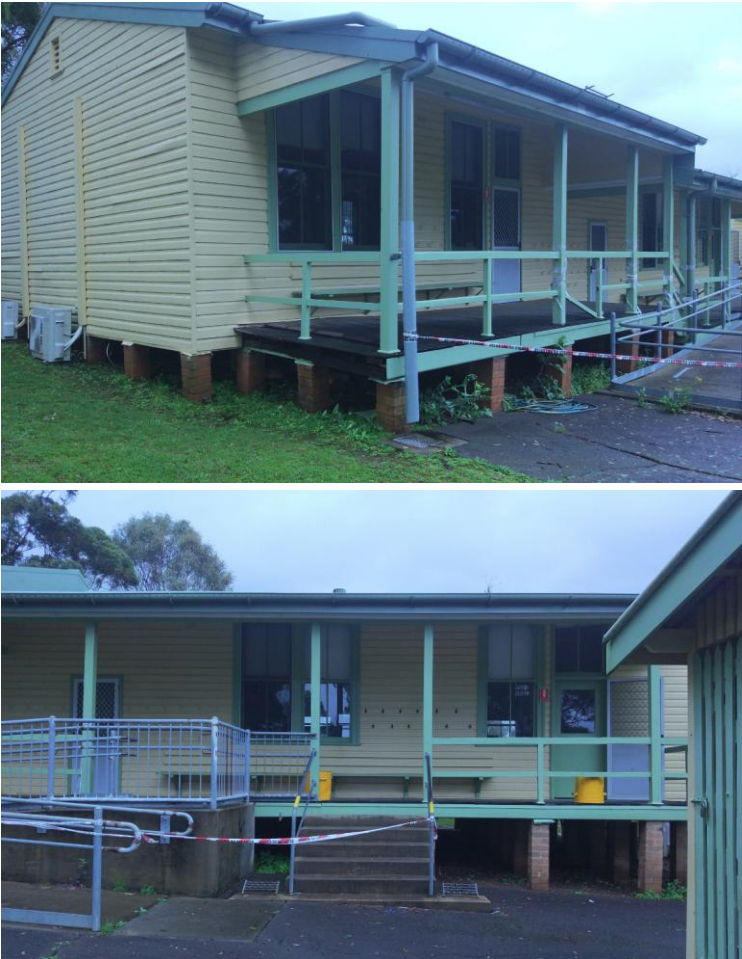
Building	Current function	Location	Date	Physical/ architectural description	Condition	Image
B00M	General Learning	South of project area	1950–1961	<p>A single storey timber structure with weatherboard cladding and an open gable roof structure clad in corrugated sheeting. The building is constructed onto brick piers.</p> <p>The north elevation includes the main entry doorway accessed via concrete stairs to a verandah with timber floor panels, timber balustrade and awning structure supported by timber posts.</p> <p>Windows are timber framed and double hung and doors include timber panels and framing.</p> <p>This building shares a similar structure and design to B00K and B00L. The building occupies the largest footprint of these three buildings and the verandah is not partially enclosed.</p>	<p>The building is stable and however appeared to be in poor condition externally. As such access into the building was not possible during the inspection.</p> <p>The verandah structure exhibited the highest levels of dilapidation including damaged floor structures and broken balustrade segments.</p> <p>A recent accessibility ramp and concrete stairs have been introduced to the north (main) elevation and air conditioning units have been introduced to the east elevation.</p> <p>Roof sheeting, downpipes and gutters appear to be original largely replaced.</p>

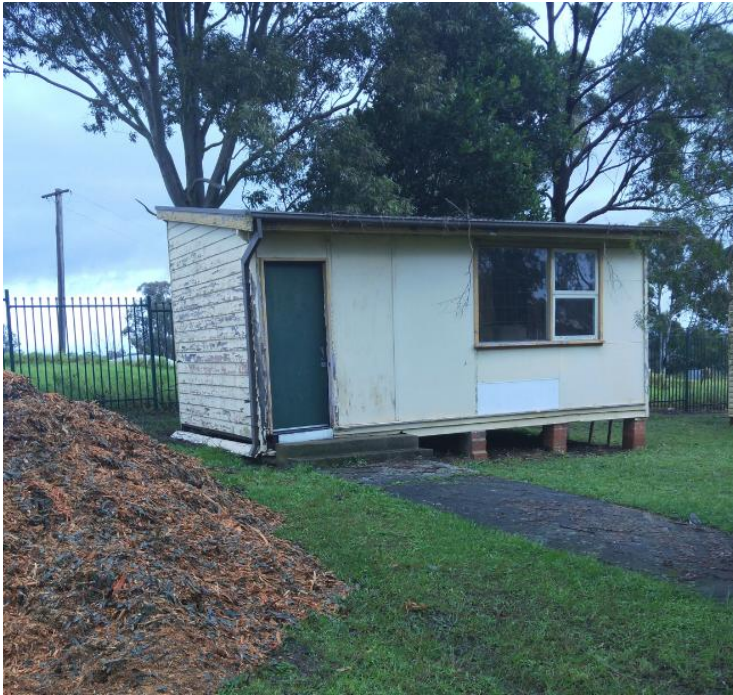
Building	Current function	Location	Date	Physical/ architectural description	Condition	Image
B00N	Admin	South of project area	1950–1961	<p>A single storey weatherboard and fibro sherd structure with a skillion roof. The shed is constructed onto brick piers and includes concrete steps to the main entry at a single point to the north elevation. A large window of varied make is present to the north elevation.</p> <p>The building is a general weatherboard shed with no distinct or notable architectural features or built elements.</p>	<p>The building was noted as being in generally poor condition and was inaccessible during the site inspection. It has been noted that the building has experienced severe termite damage and cannot be occupied or utilised.</p> <p>The building appears to have been significantly modified including the replacement of the original weatherboard north elevation with fibro sheeting, modifications to the window and changes to the roofing and roof structure.</p> <p>The significance B00N has been impacted by the above noted dilapidation and modification. of the building.</p>

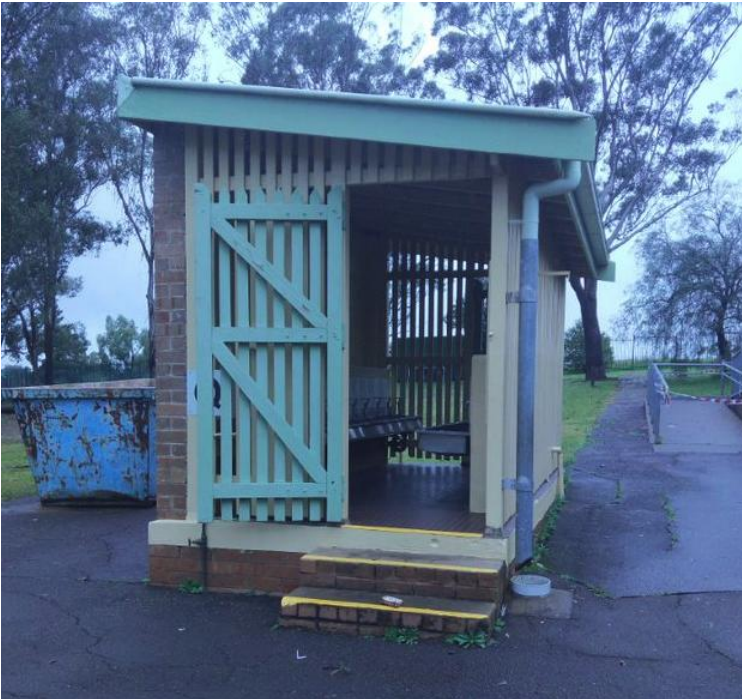
Building	Current function	Location	Date	Physical/ architectural description	Condition	Image
B00Q	Pupil Facilities	South of project area	1950–1961	<p>A small ablutions shed characterised by a semi-enclosed structure consisting of a single brick wall and three wall sections constructed of timber panelling, onto brick foundations. The roof structure is skillion with corrugated metal sheeting and includes timber facias and a metal gutter and downpipe.</p> <p>Square tiles are applied to the flooring and the interior of the structure includes metal bubblers and sinks.</p> <p>Access to the structure is via two brick stairs to the west and east elevations that lead to a timber door panels that includes timber panels fixed to a braced door frame.</p> <p>The shed is unique within the project area in terms of its design, form and function and is the only semi-enclosed structure.</p>	<p>The building is stable and in generally good condition both externally and internally.</p> <p>Roofing, gutters and downpipes appear to be recent changes to the structure however many of the built elements and fixtures appear to be both original and intact.</p>
