Leppington Public School Upgrade

Statement of Heritage Impact

Prepared for NSW Department of Education

E240165 RP#1

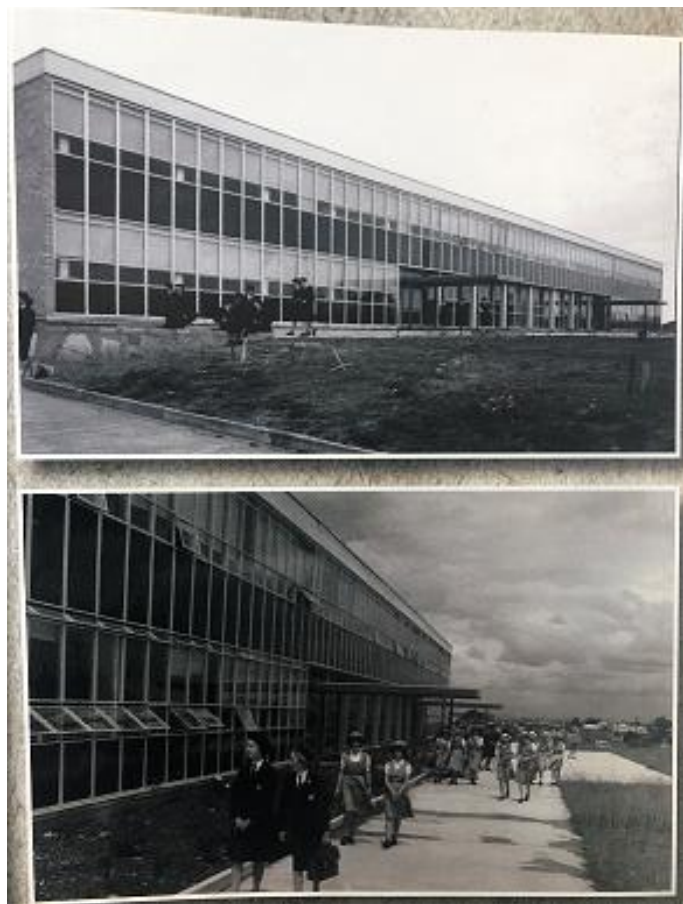
Plate 5.1 Early photograph of the first school building at Beverly Hills Girls High School (1957)

- small awning windows seamlessly integrated into the curtain wall structure
- the lower sections of the building are characterised by evenly spaced concrete columns supporting a covered area and the extensive use of large, glazed panels for walls and doors
- simple flat roofed awnings, integrated into the mains structure and supported by concrete posts.

In summary, the building is an example of the application of modernist architectural principles, differing considerably from the context and design of B00J and B00D, which are more reflective of the architectural styles of the early to mid-twentieth century. Although brickwork is present in the Beverly Hills Girls High School building, it is exclusively utilised externally for minor elevations rather than the main building materiality. The building does not include any weatherboard. In conjunction, the first Beverly Hills Girls High School building was constructed between five and ten years before B00J and B00D, is in a similar (then) non-city context yet exhibits a modernist design, style, and construction that was more reflective of the popularised "new trends in the design of state schools" dating from the late 1950s to the late 1960s (Plate 5.3).

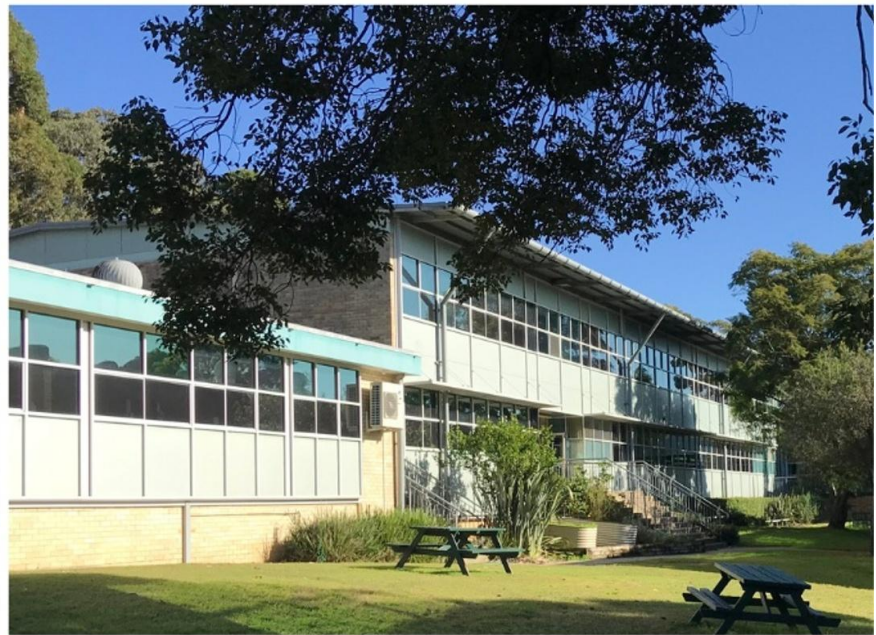
- the building includes an open gable roof structure that extends into an awning constructed using metal joists, beams and bracing
- blonde brickwork utilised exclusively for minor external elevations, base coursing and small sections to external walls.

Plate 5.4 The Manly Girls High School building (1958)

One photo has been sourced of the school building (Plate 5.4) that illustrates the following:

The building shares some minor similarities with B00J and B00D, including an open gabled roof and the use of brickwork. However, the building primarily exemplifies the modernist design, style, and construction. Nevertheless, due to a substantial dearth of visual or written evidence, it is challenging to thoroughly analyse this building.

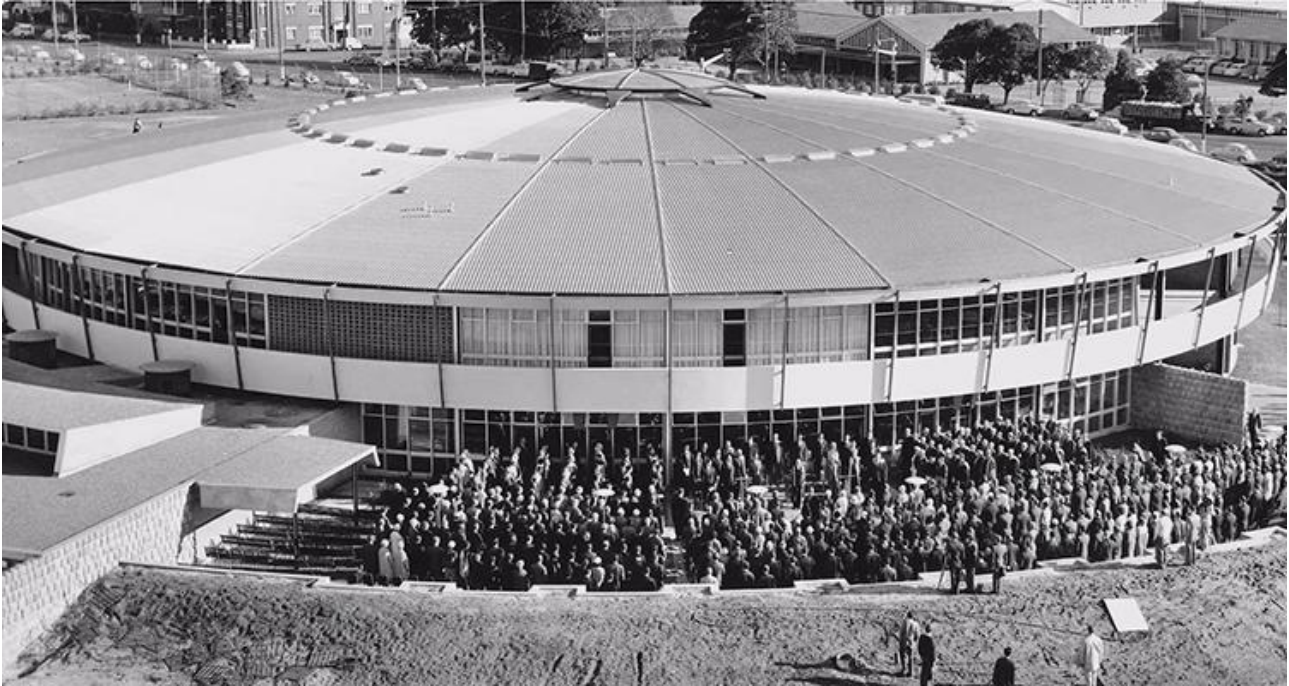
Plate 5.5 Photograph of the UNSW Roundhouse building dating from the 1960s

The UNSW Roundhouse building is the most prolific and notable building attributed to J. Van der Steen. The building was constructed in 1959 and opened in 1961 with J. Van der Steen as the project architect representing the GAO, in collaboration with the architecture practice Edwards, Madigan, Torzillo, Briggs Architects. The building was considered at the time a cutting-edge architectural statement as Sydney's first-ever circular educational building, and one of the only buildings solely dedicated to student recreation on a university campus in NSW (refer to Plate 5.5 and Plate 5.6).

- a two storey, circular form and floor plan and skillion roof structure that follows this form
- thin, metal-framed curtain wall that fully wraps around the building to the ground floor and upper level. Curtain walls include in-fills of glass to all segments in a three panel, repeated grid
- a unique balcony that wraps around the entire semi-enclosed walkway to the upper level of the building that includes angled, metal balustrades, angled metal bracing at regular intervals and thin metal handrails. The balcony can be accessed via external stairs to the ground floor.

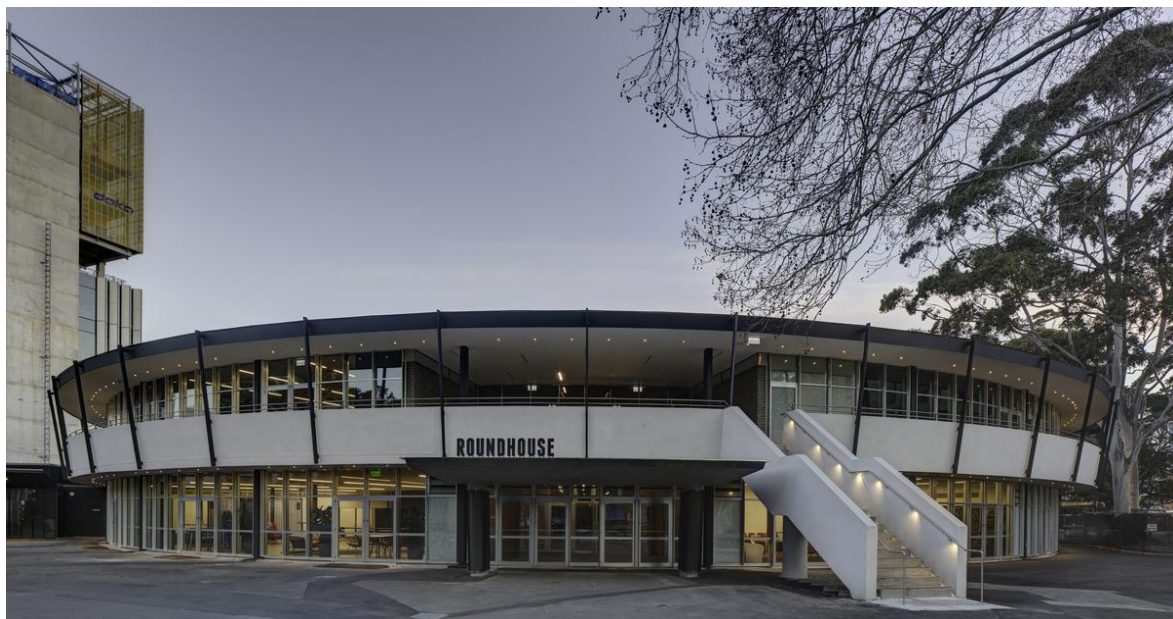
Plate 5.6 A recent photograph of the UNSW Roundhouse building.

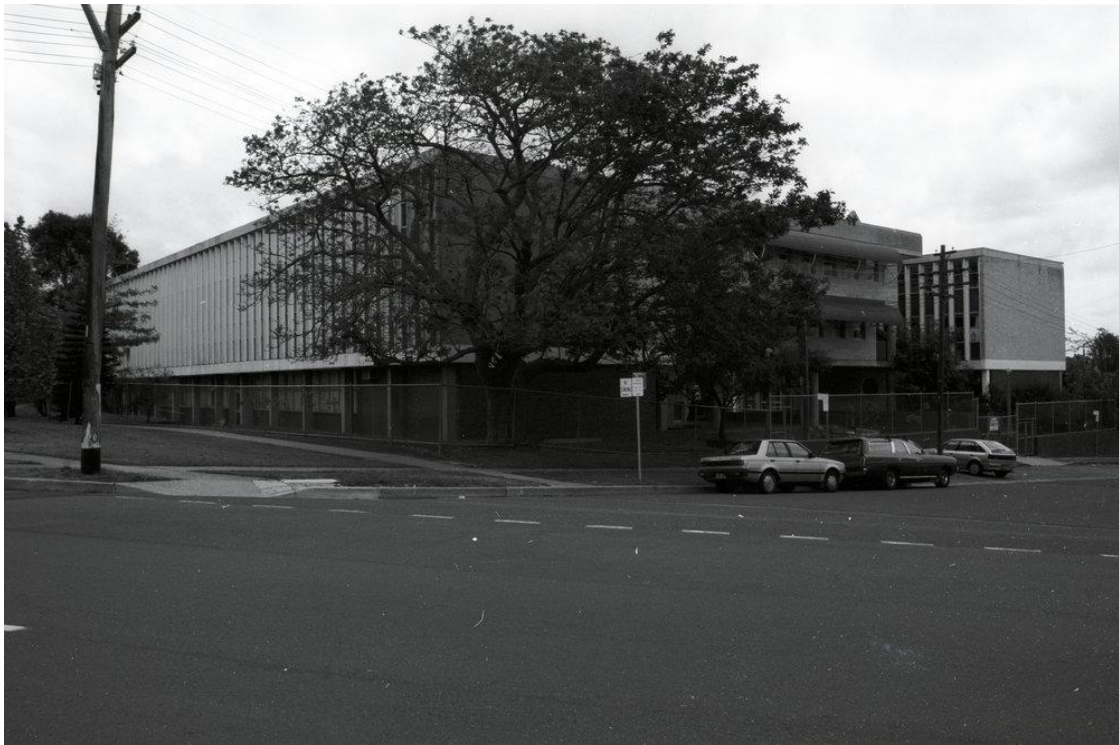
Plate 5.7 **View of Seaforth Technical College in 1991 at the south-east corner along Sydney Road**

There is very little information relating to the buildings' design and construction in available historical resources. The three images below dating from 1991 (Plate 5.7, Plate 5.8 and Plate 5.9) were the only images of the buildings able to be sourced, prior to their modification. Note that a central building is present in these photographs that is later addition. Based on its design and architectural style, it was likely introduced in the latter half of the twentieth century (1980-1990).

- the ground floor also predominately includes curtain walls with some wall sections constructed with brickwork
- both buildings include flat roof structures.

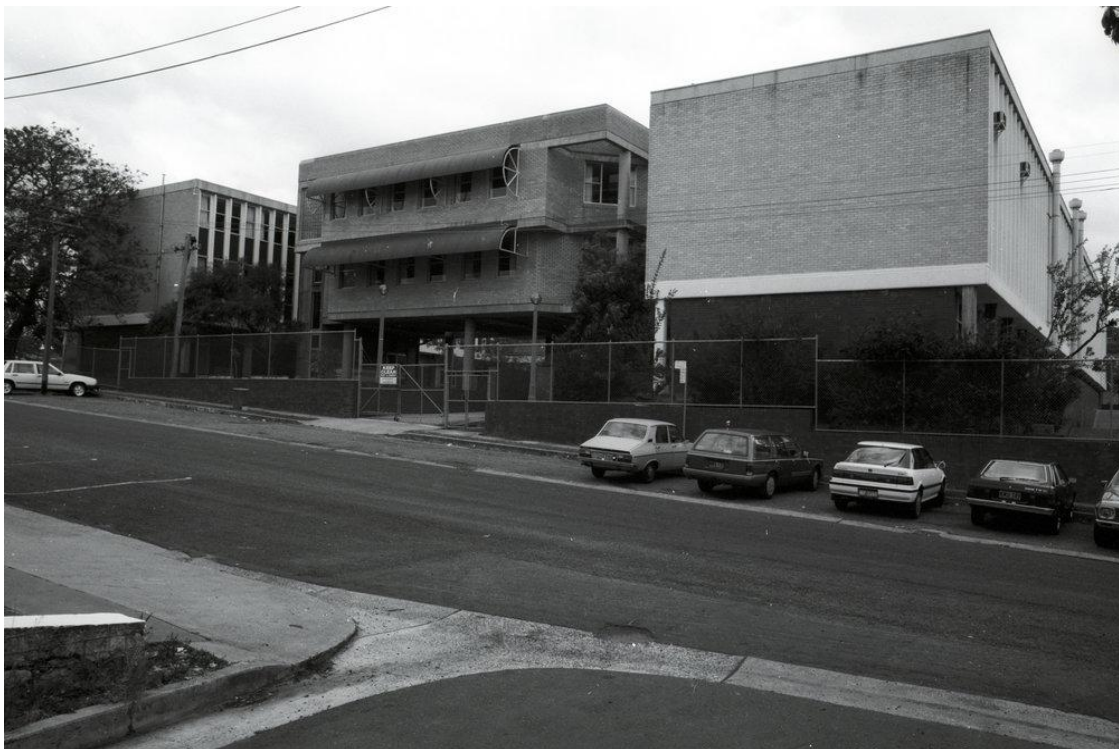
Plate 5.8 **View of Seaforth Technical College in 1991 at the corner of Kempbridge Avenue and Sydney Road**

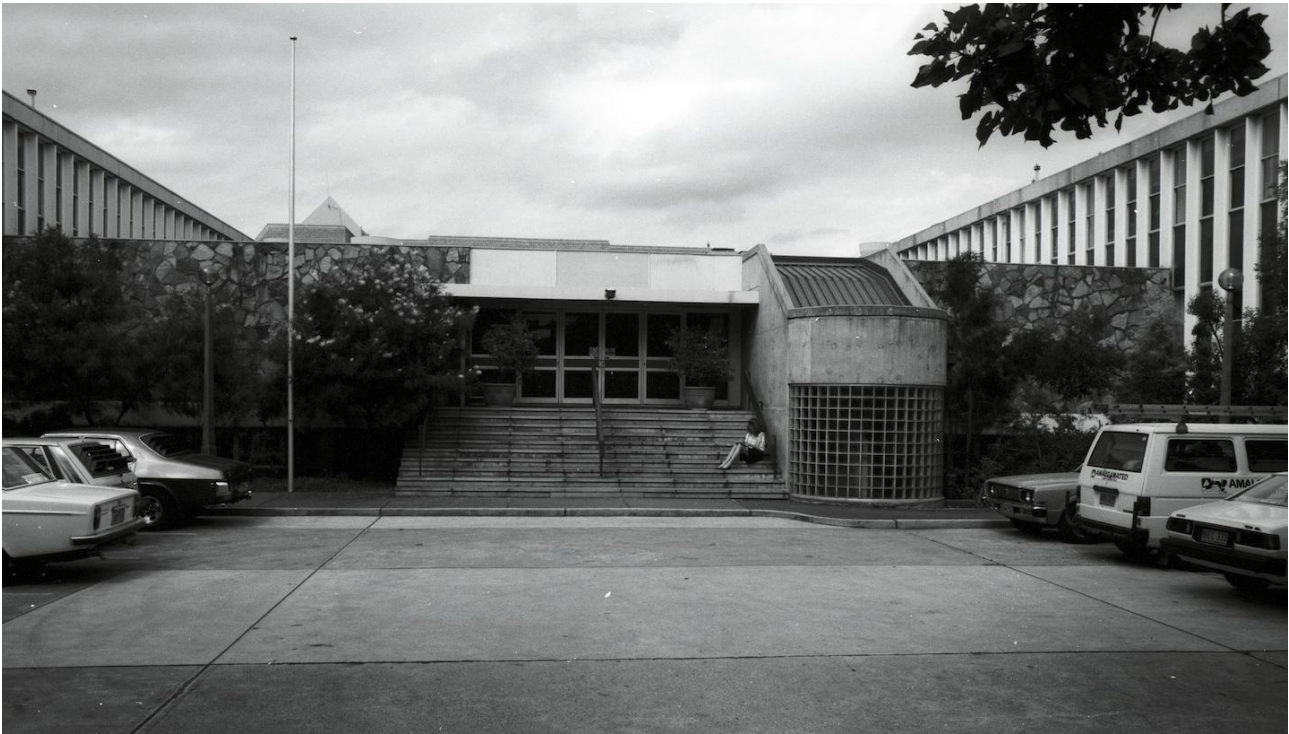
Plate 5.9 View of entry to intermediate building of the Seaforth Technical College in 1991

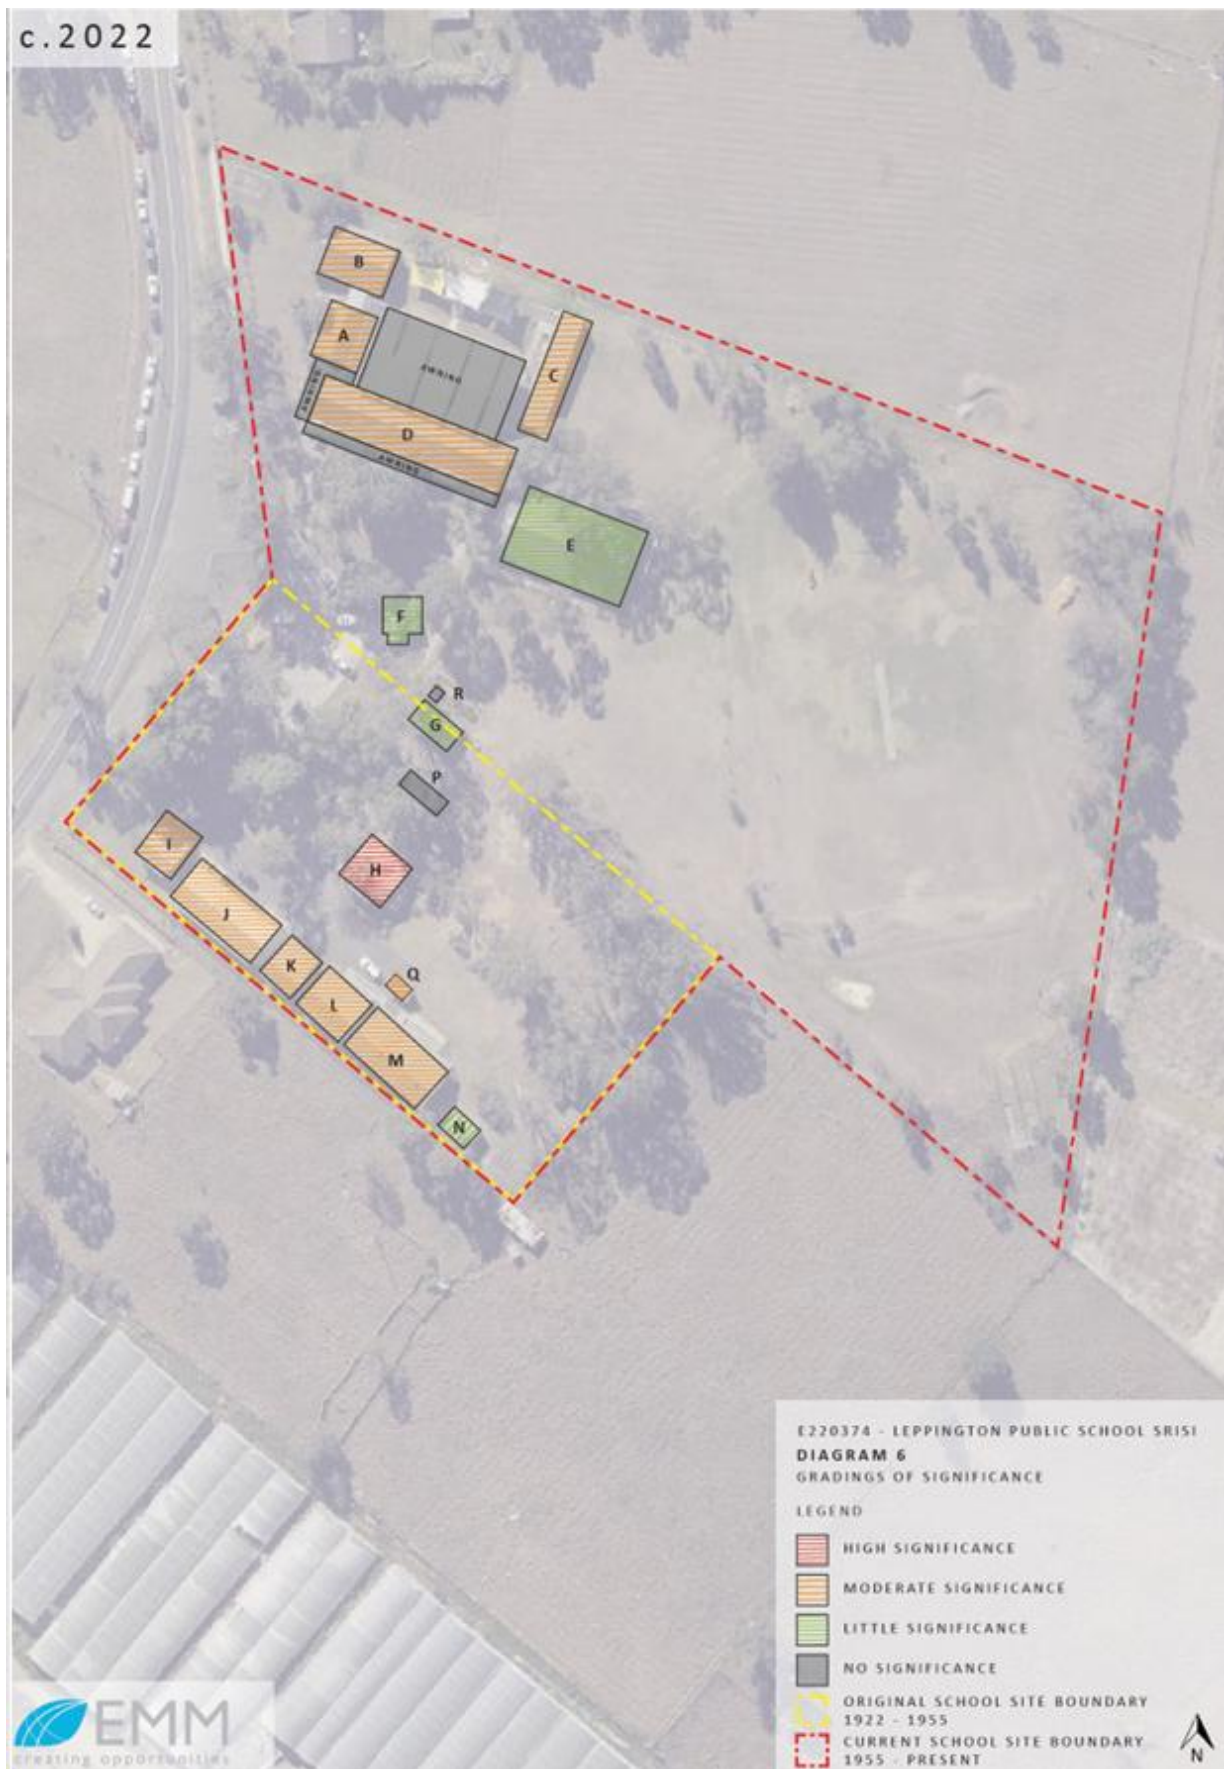
Plate 7.2 Indicative diagram illustrating the updated gradings of significance for built elements for Leppington Public School
