GEOTECHNICAL INVESTIGATION

PARRAMATTA EAST PUBLIC SCHOOL UPGRADE

PARRAMATTA EAST PUBLIC SCHOOL, 30-32 BRABYN STREET, NORTH PARRAMATTA, NSW

Date: 4 March 2025 Ref: 35073LTrptRev3

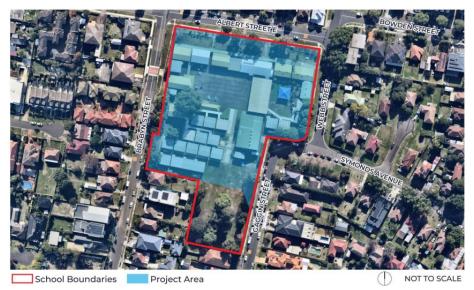
Plate 1. Site Aerial (Source: Nearmap, Ethos Urban)

An aerial image of the site and project area is shown at Plate 1 below.

The purpose of the site investigation was to obtain geotechnical information on the subsurface conditions within the Project Area as shown in Plate 1. Based on the information obtained from the subsurface investigation we have provided our comments and recommendations for the proposed development.

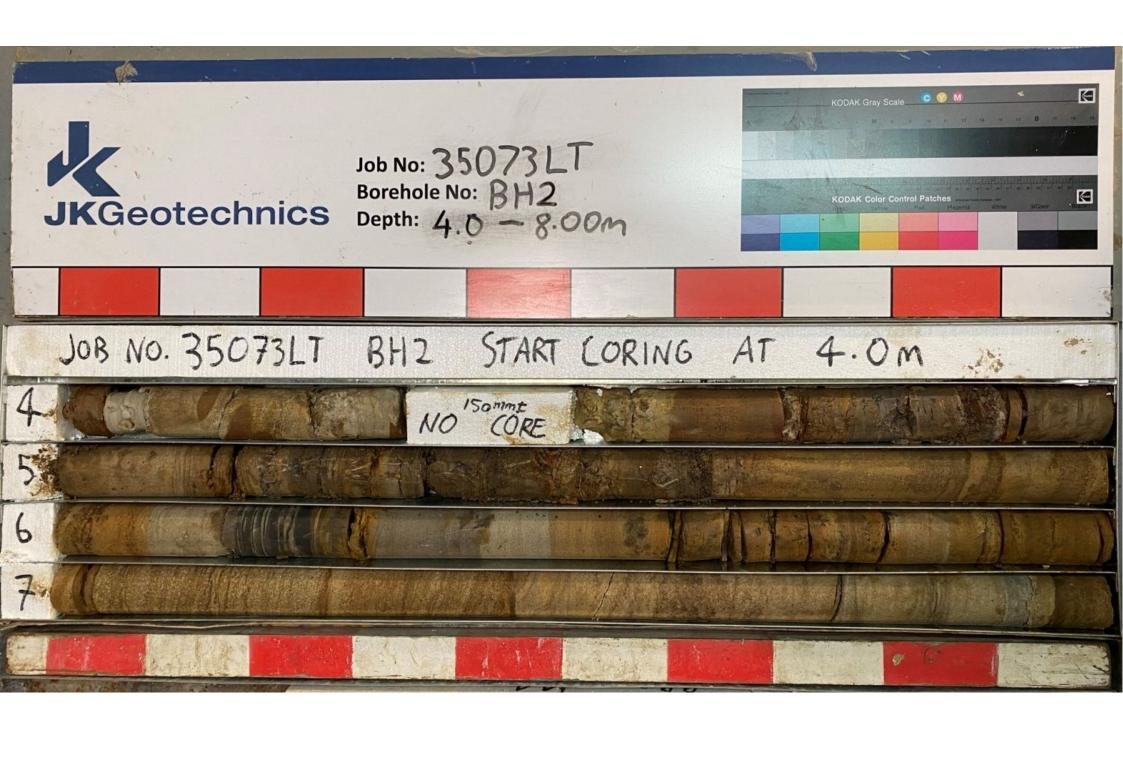
,	-	-										
					CORE DESCRIPTION			POINT STREM				DEFECT DETAILS	
<u>@</u>	ا ہے	(m AHD)	(ر	Graphic Log	Rock Type, grain characteristics, colour,	ing		IND	ΕX	SPACI (mm		DESCRIPTION	Ē
Water Loss\Level	Barrel Lift	4	Depth (m)	hic	texture and fabric, features, inclusions and minor components	Weathering	Strength	I _s (5		,	"	Type, orientation, defect shape and roughness, defect coatings and	leta Formation
/ate	arre	RL (n	eptł	rap	and minor components	/eat	tren	M -0.3	د- 1 -5			seams, openness and thickness	. E
		₾		g		>	Ø	≥ ¬ ∑ :	- > =	500	8 8	Specific Gen	eral <u></u>
ON COMPLETION OF CORING		21 –	_						ii		; <u> </u>	- -	
P.E.		21	_						Ϊİ	i i i	i	- -	
So		1	_								! [- -	
N O		-	-								; }	-	
		_	_					l i i i	ii	l i i i	i	- -	
					START CORING AT 4.00m				1 1		! -	-	
			4 -		SANDSTONE: fine to medium grained,	HW	M - H	883	88 88		-	(4.04m) CS, 0°, 40 mm.t	
		20 –	_	::::::::	light grey and orange brown, sub-horizontally bedded.				 1 2		it	—— (4.24m) CS, 0°, 50 mm.t

5.3					sub-horizontally.				60		;	-	
31.20.24		1	7-		as above,	1	Н	iii	Ĭ i	l i i i	i į	- -	
% Z		17 –	-	::::::::::	but medium grained and bedded at 5-10°.				# I		! -	-	
100% RETURN		_	_		5-10 .				1.4			- -	
iawing S			-						1.41		it	-	
7			_						 			(7.74m) Be, 10°, P, R, Fe Sn	
₹.G		1	-	::::::::::							! [
AMA	\vdash		8-		END OF BOREHOLE AT 8.00 m				1.9		$\dot{+}$	7.92m) Be, 5°, R, Clay Vn	
ARA		16-	_		END OF BOREHOLE AT 8.00 III			i i i	Ϊİ	l i i i	j	- -	
100			-								!	-	
		1	_									-	
AASTE		-	_					liii	iί	l i i i	i	- -	
ZE-1		-	-								ļ	-	
NET NET NET NET NET NET NET NET NET NET			9 —									- -	
ED BY		4-	_									-	
3		15 –	=						11		ļ	- -	
D 00-		-	-									-	
GLB		-	_									- -

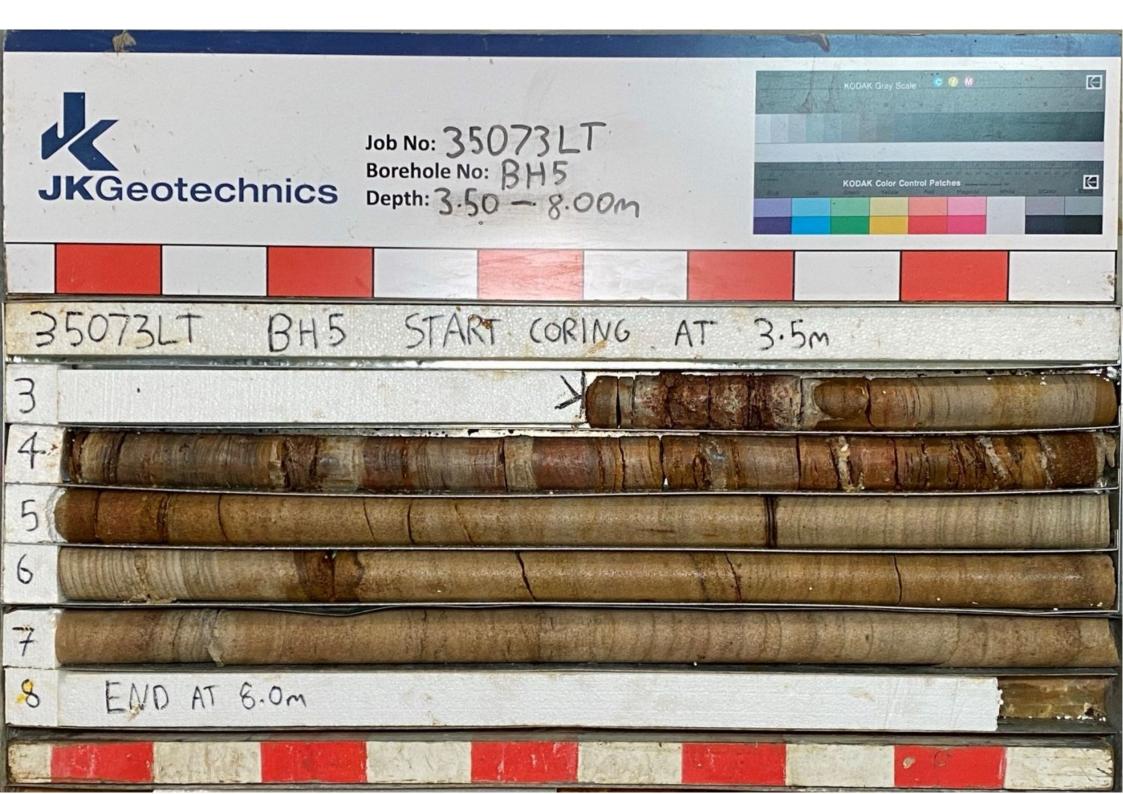
- 19 <i>-</i> -	-		START CORING AT 3.50m				
		-	- - - 4 —		SANDSTONE: fine to medium grained, red brown and light grey, bedded at 5-15°.	MW	L-M	1.1	(3.54m) CS, 30 mm.t - (3.57m) XWS, 10 mm.t (3.58m) CS, 70 mm.t (3.65m) XWS, 20 mm.t (3.67m) CS, 30 mm.t (3.80m) Be, 15°, P, R, Fe Sn (4.00m) XWS, 50 mm.t
					LAMINITE: SILTSTONE: dark grey, interbedded with SANDSTONE: fine	HW	VL - L	0.20	(4.55.11)
100% RETURN		18	- - - - - - 5		grained, grey and orange brown, bedded at 0-5°. SANDSTONE: fine to medium grained, light grey and red brown, bedded at 0-5°.	MW	М		(4.29m) CS, 10 mm.t (4.30m) XWS, 30 mm.t (4.35m) CS, 30 mm.t (4.45m) ES, 20 mm.t (4.45m) ES, 20 mm.t (4.65m) ES, 20 mm.t (4.65m) ES, 20 mm.t (4.65m) ES, 20 mm.t (4.67m) ES, 10 mm.t (4.67m) ES, 10 mm.t (4.72m) CS, 10 mm.t
£		17 —	6-		as above, but light grey, with occasional grey laminae.	SW	M - H	\$2.1 \$2.1 \$1.0 \$1	(4.92m) Be, 0°, P, R, Fe Sn (5.10m) Be, 5°, P, R, Fe Sn (5.10m) Be, 5°, P, R, Fe Sn (5.10m) Be, 5°, P, R, Fe Sn (6.26m) Be, 0°, P, R, P, P, R, P,

100% RETURN		- 15 — -	- 7 - - - - - - -			FR	Н	1.31 1.31 1.12 1.13 1.13 1.14 1.15 1.15 1.15 1.15 1.15 1.15 1.15	
		14 - - - 13	8 - - - - - - 9 - - - - - - - - - - - - -		END OF BOREHOLE AT 8.00 m
