Parramatta East Public School Upgrade
30-32 Brabyn Street, Parramatta,
City of Parramatta LGA, NSW

Preliminary Indigenous Heritage and Impact Assessment

Prepared for the NSW Department of Education

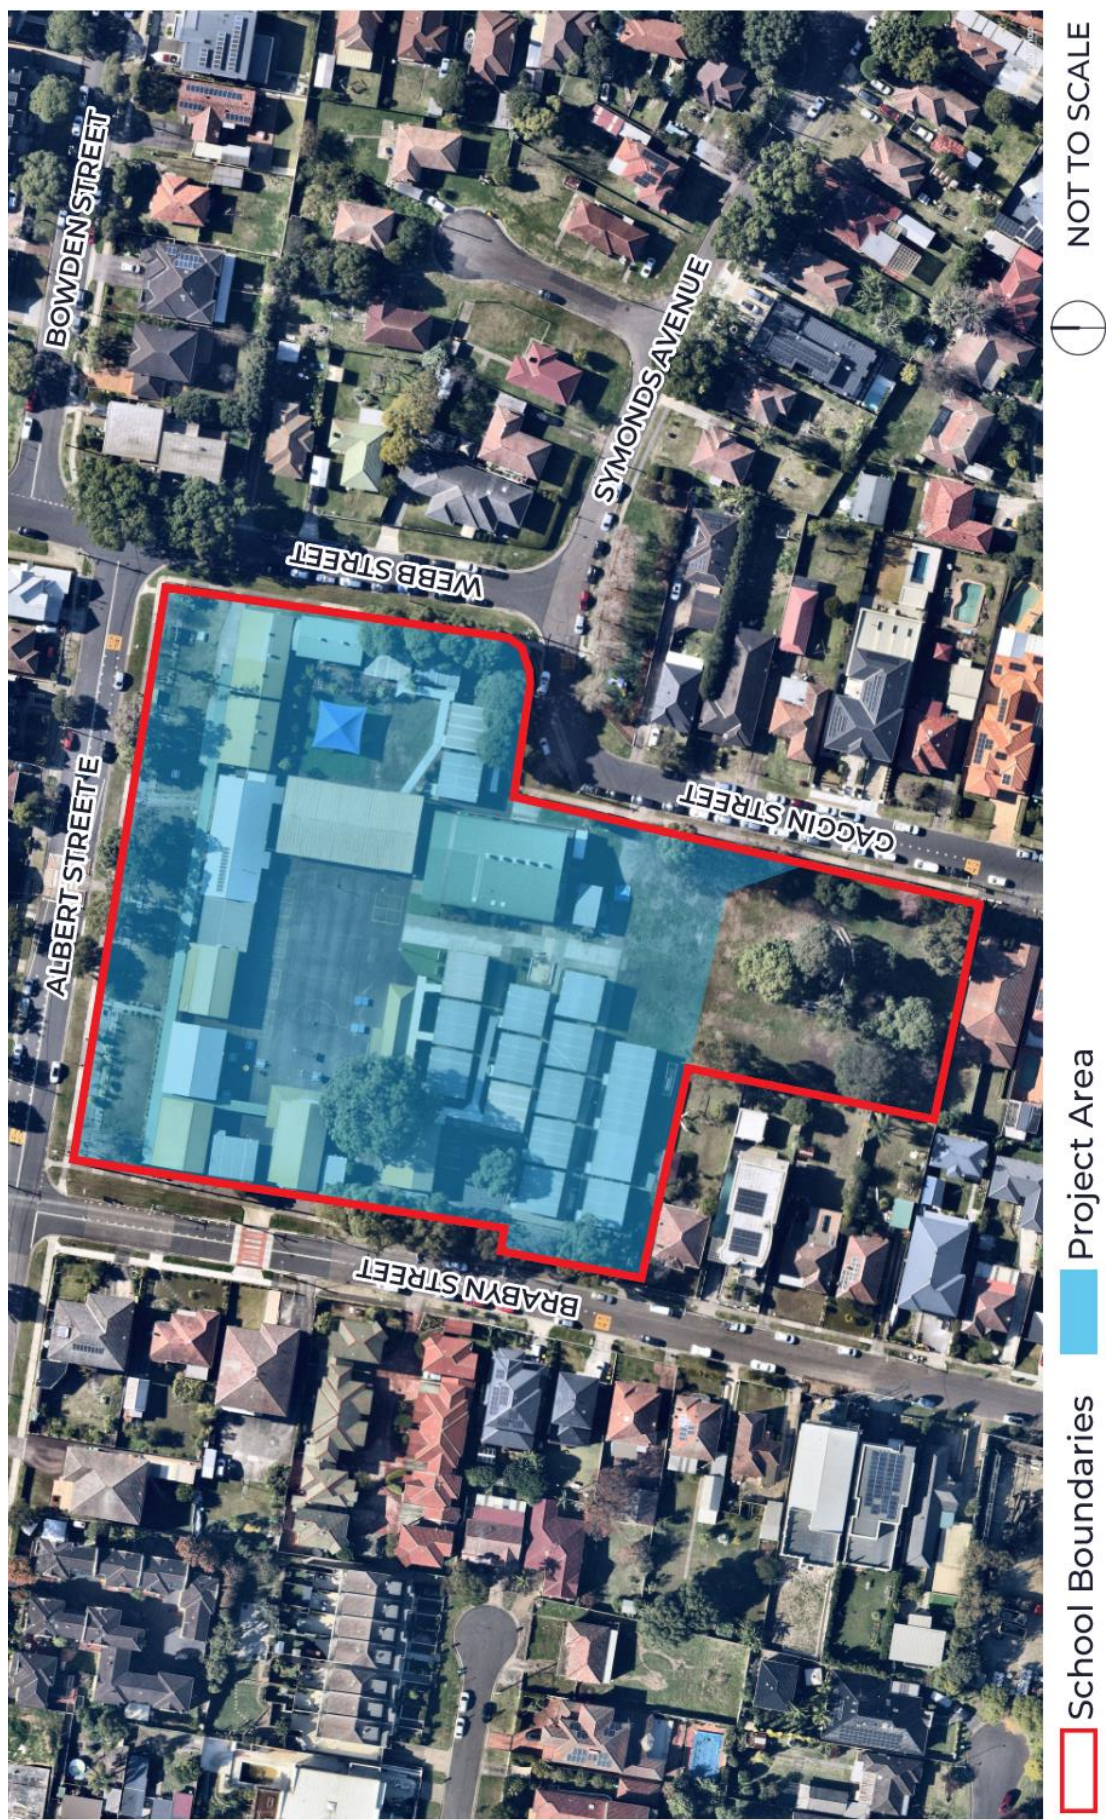
Figure 2: Site Aerial

The site has an area of approximately 16,250m², is of an irregular shape, and is bounded by Brabyn Street to the West, Albert Street East to the North, and Gaggin Street/Webb Street to the East.

An aerial image of the site is shown in Figure 2.

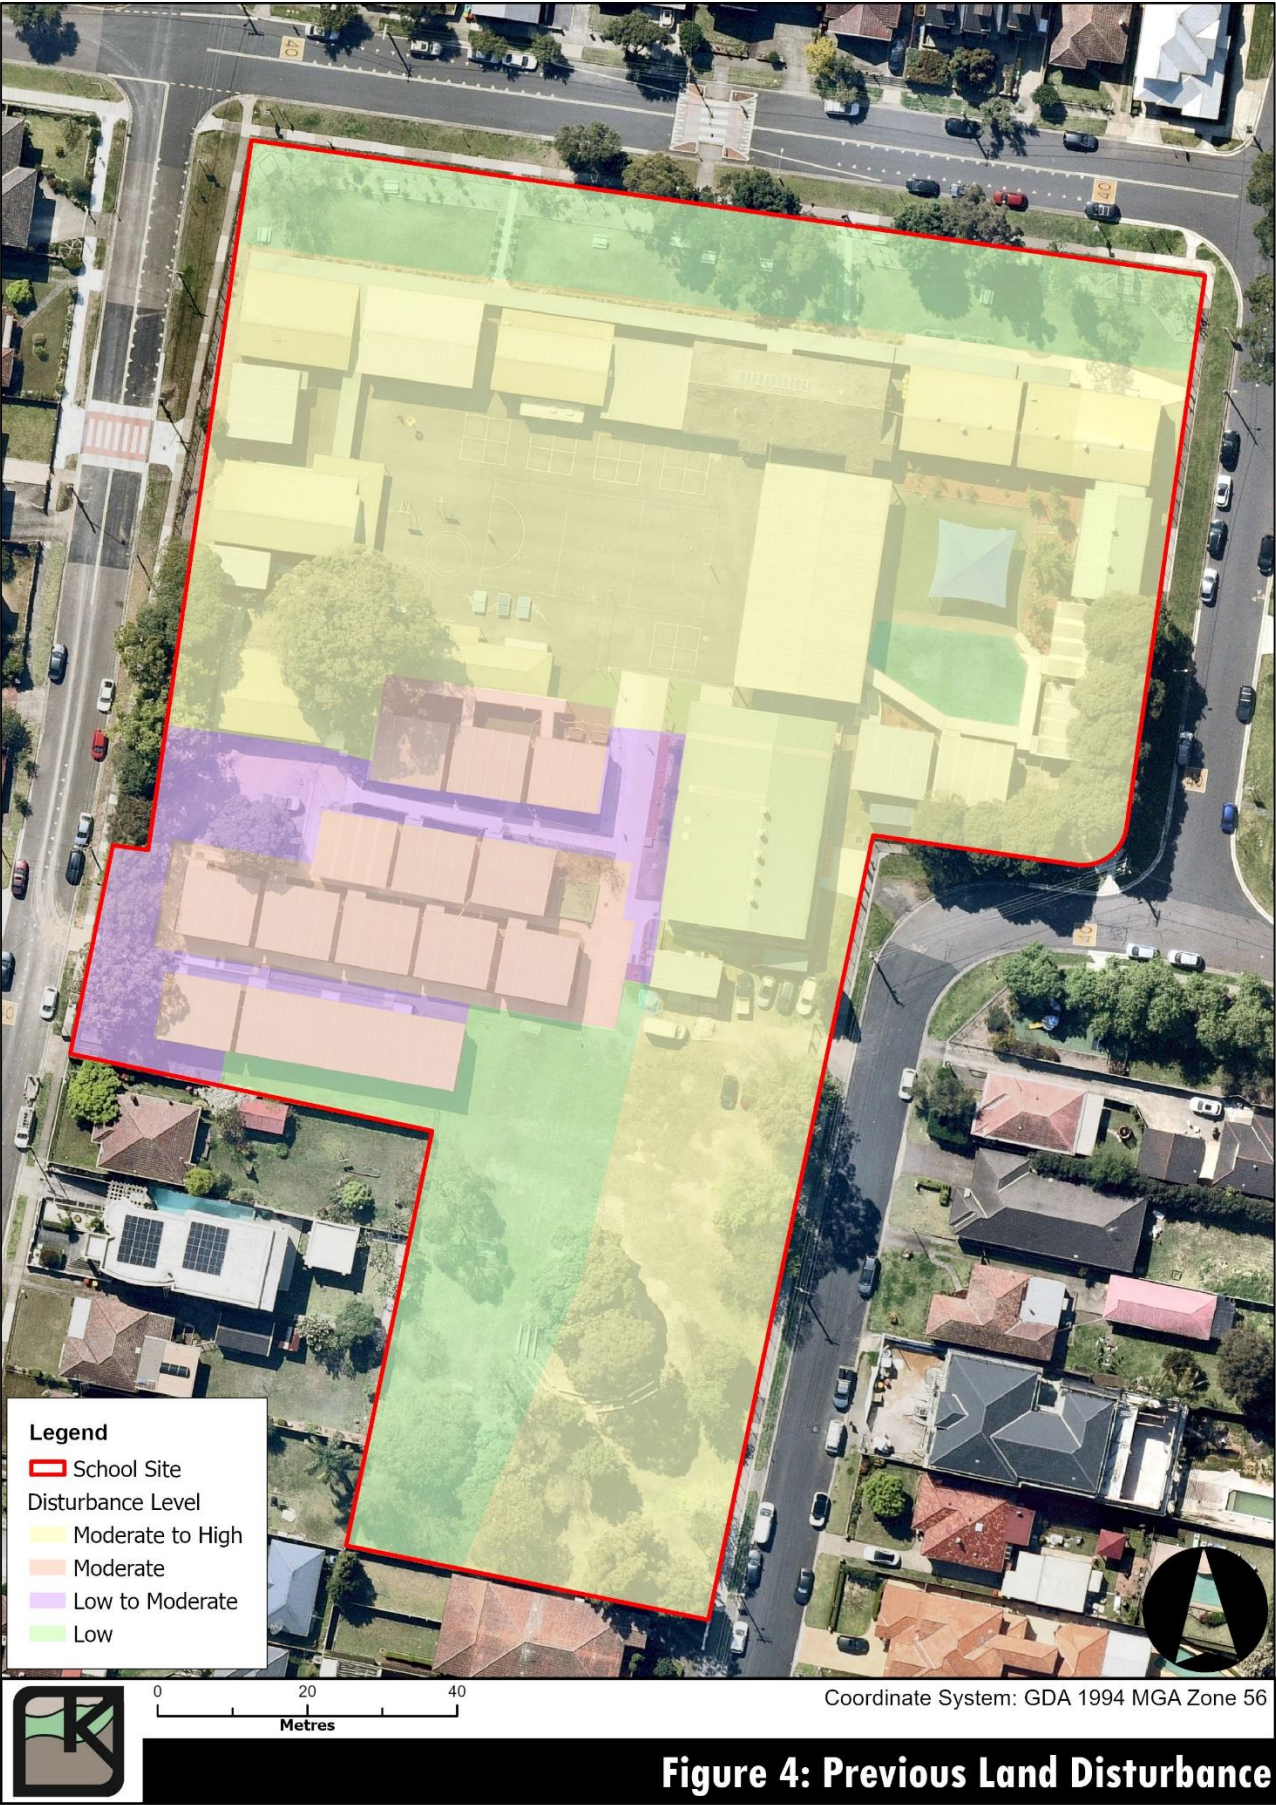
The northern portion of the site is considered to be heavily disturbed, due to the construction of classrooms and a concreted playground area.

The eastern section of the southern portion of the site is considered to be moderately-to-heavily disturbed. This determination has considered the residential dwellings that once stood on the now-cleared playground area in the southern portion of the site. While there may be discrete areas of low disturbance, the overall disturbance is considered moderate-to-high (refer to Figure 4).

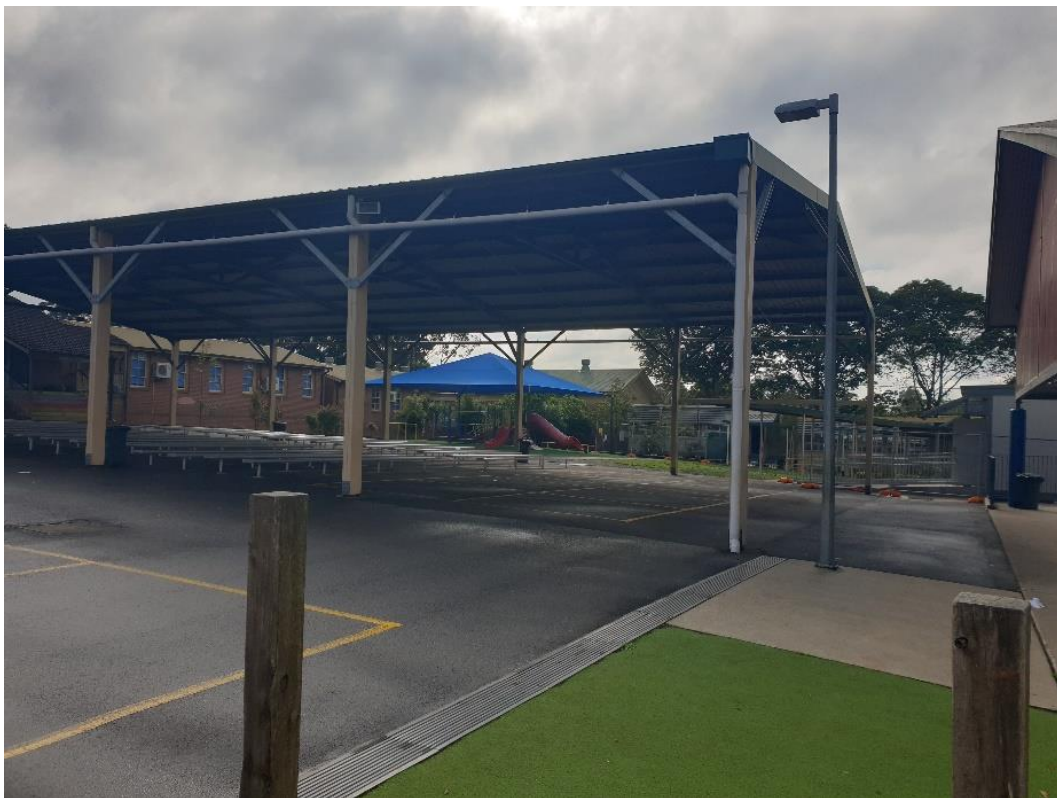
Plate 11: General view of the site, showing the concreted outdoor areas

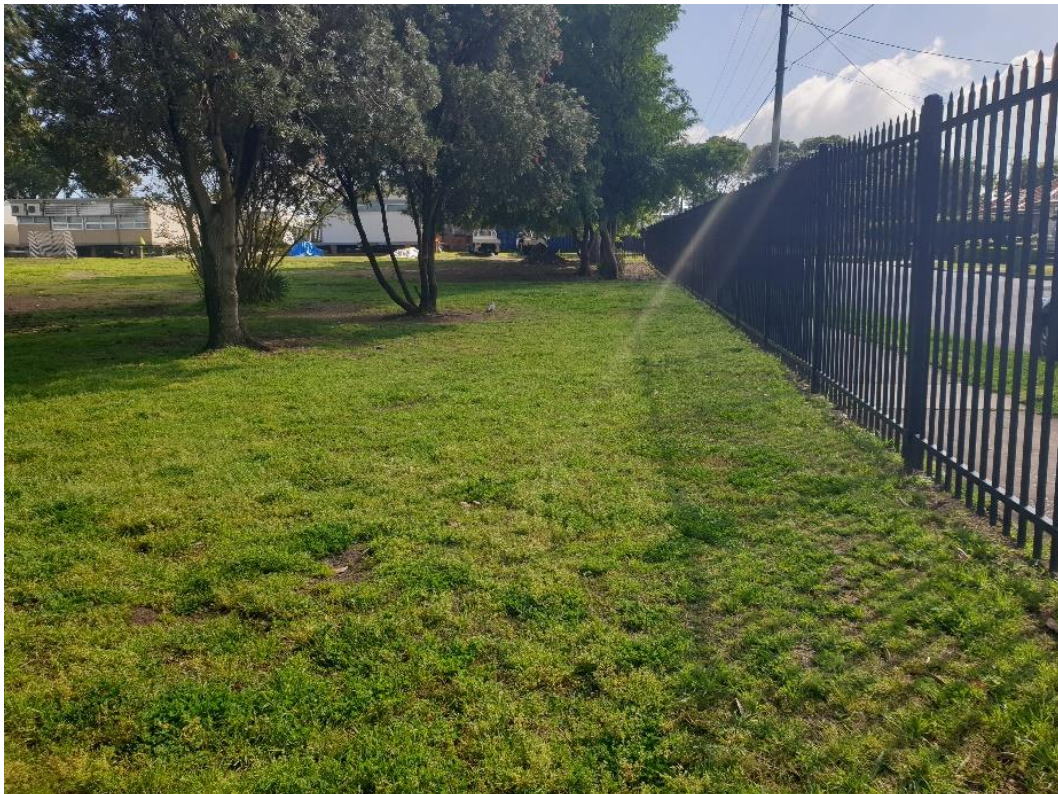
Plate 17: Example of GSV in the playground

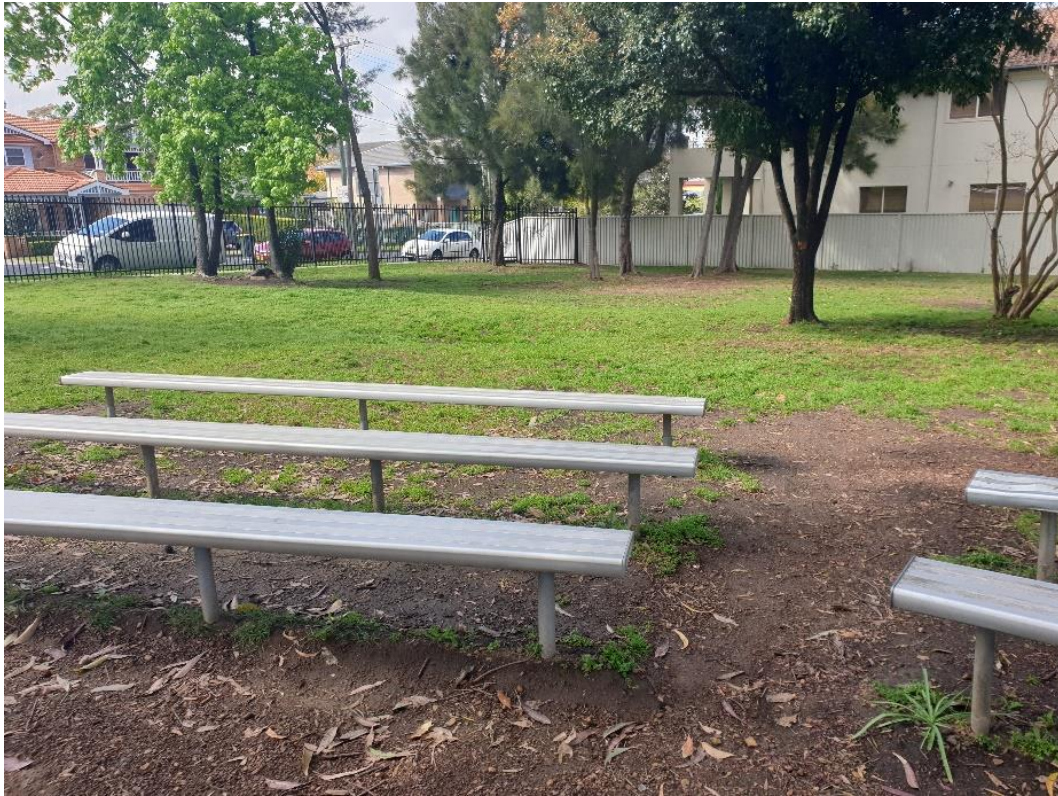
Plate 18: Example of the change in GSV between high traffic areas and the rest of the playground

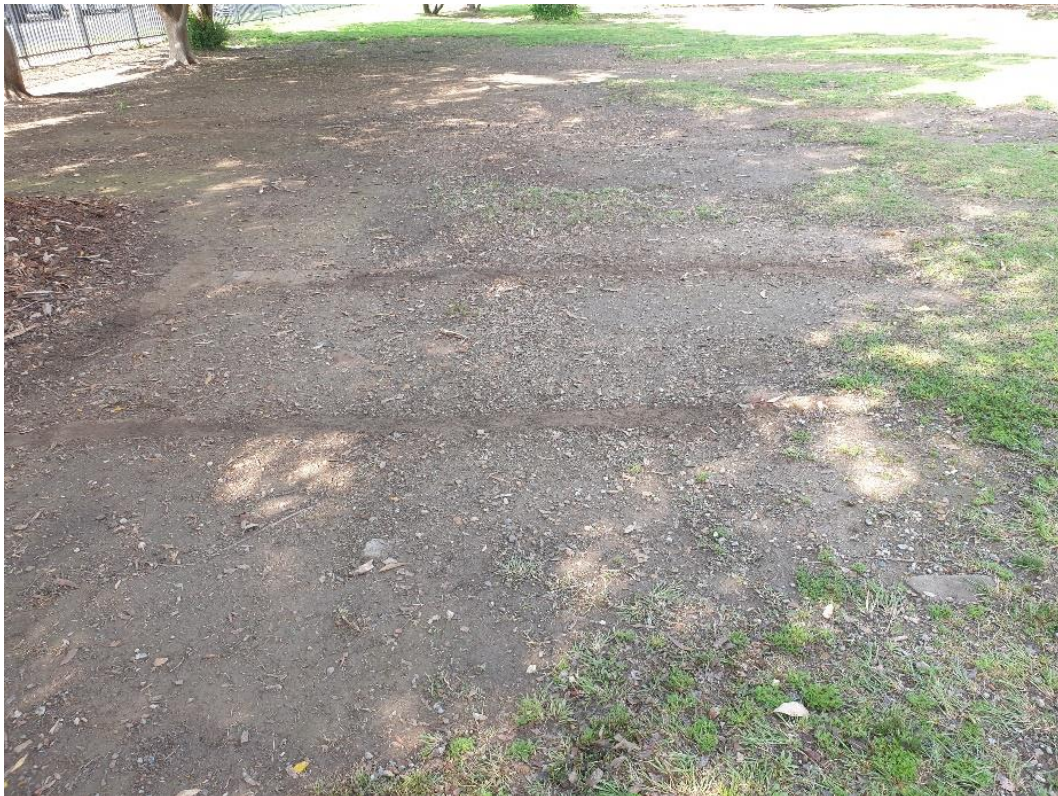
Within the site the areas of ground exposure were typically located under trees, in areas where the vegetation had died back, or in well-trodden areas of the playground. The areas of exposures were typically approximately 100-300cm in width and had a visibility of 90%.

Plate 19: General view of a large area of exposure in the playground
