**REPORT TO
NSW DEPARTMENT OF EDUCATION**

**ON
REMEDIATION ACTION PLAN**

**FOR
PARRAMATTA EAST PUBLIC SCHOOL (PEPS)
UPGRADE**

**AT
30-32 BRABYN STREET, NORTH PARRAMATTA,
NSW**

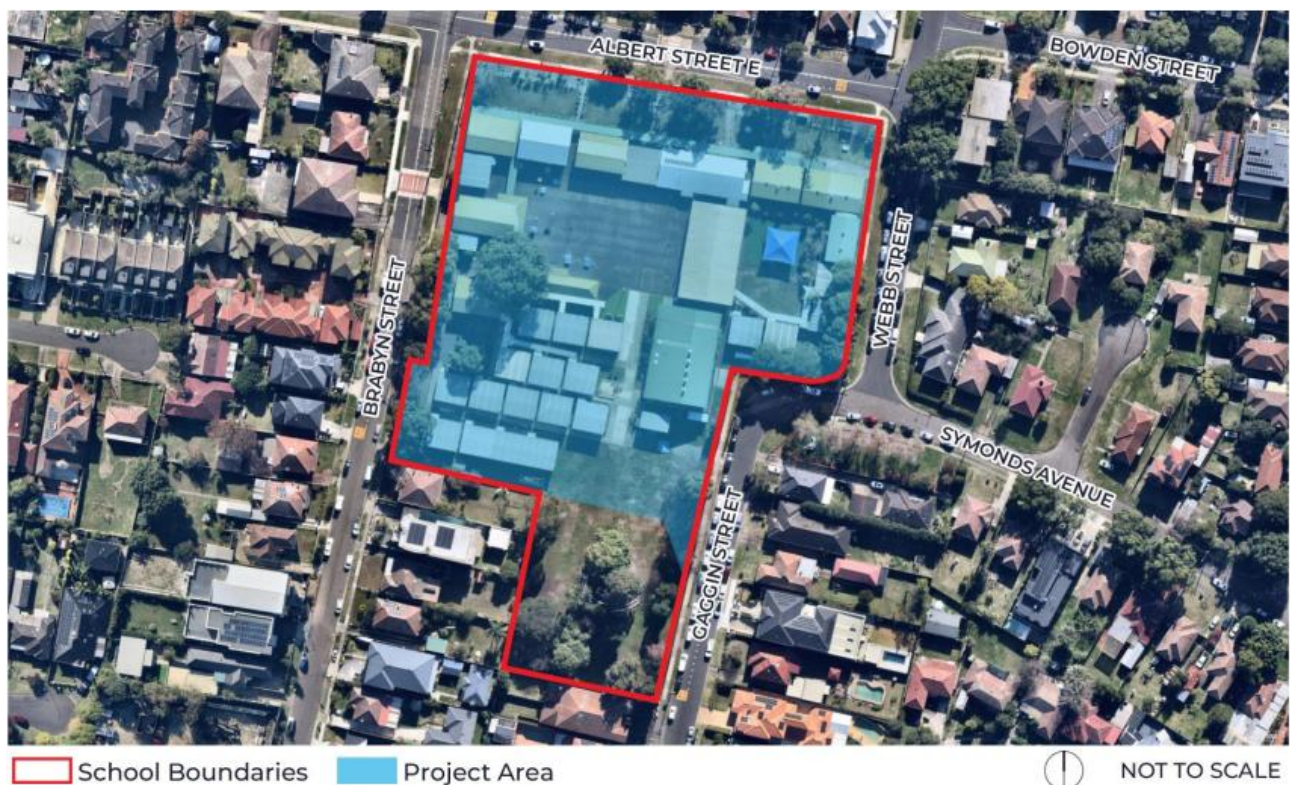
Figure 1-1: Site Aerial

The wider site has an area of approximately 1.782Ha, is of an irregular shape, and is bounded by Brabyn Street to the west, Albert Street East to the north, and Gaggin Street/Webb Street to the East. The project area is contained within the wider site and represents where the proposed works will be undertaken, with an area of approximately 1.492Ha. An aerial image of the site is shown at Figure 1-1 below.

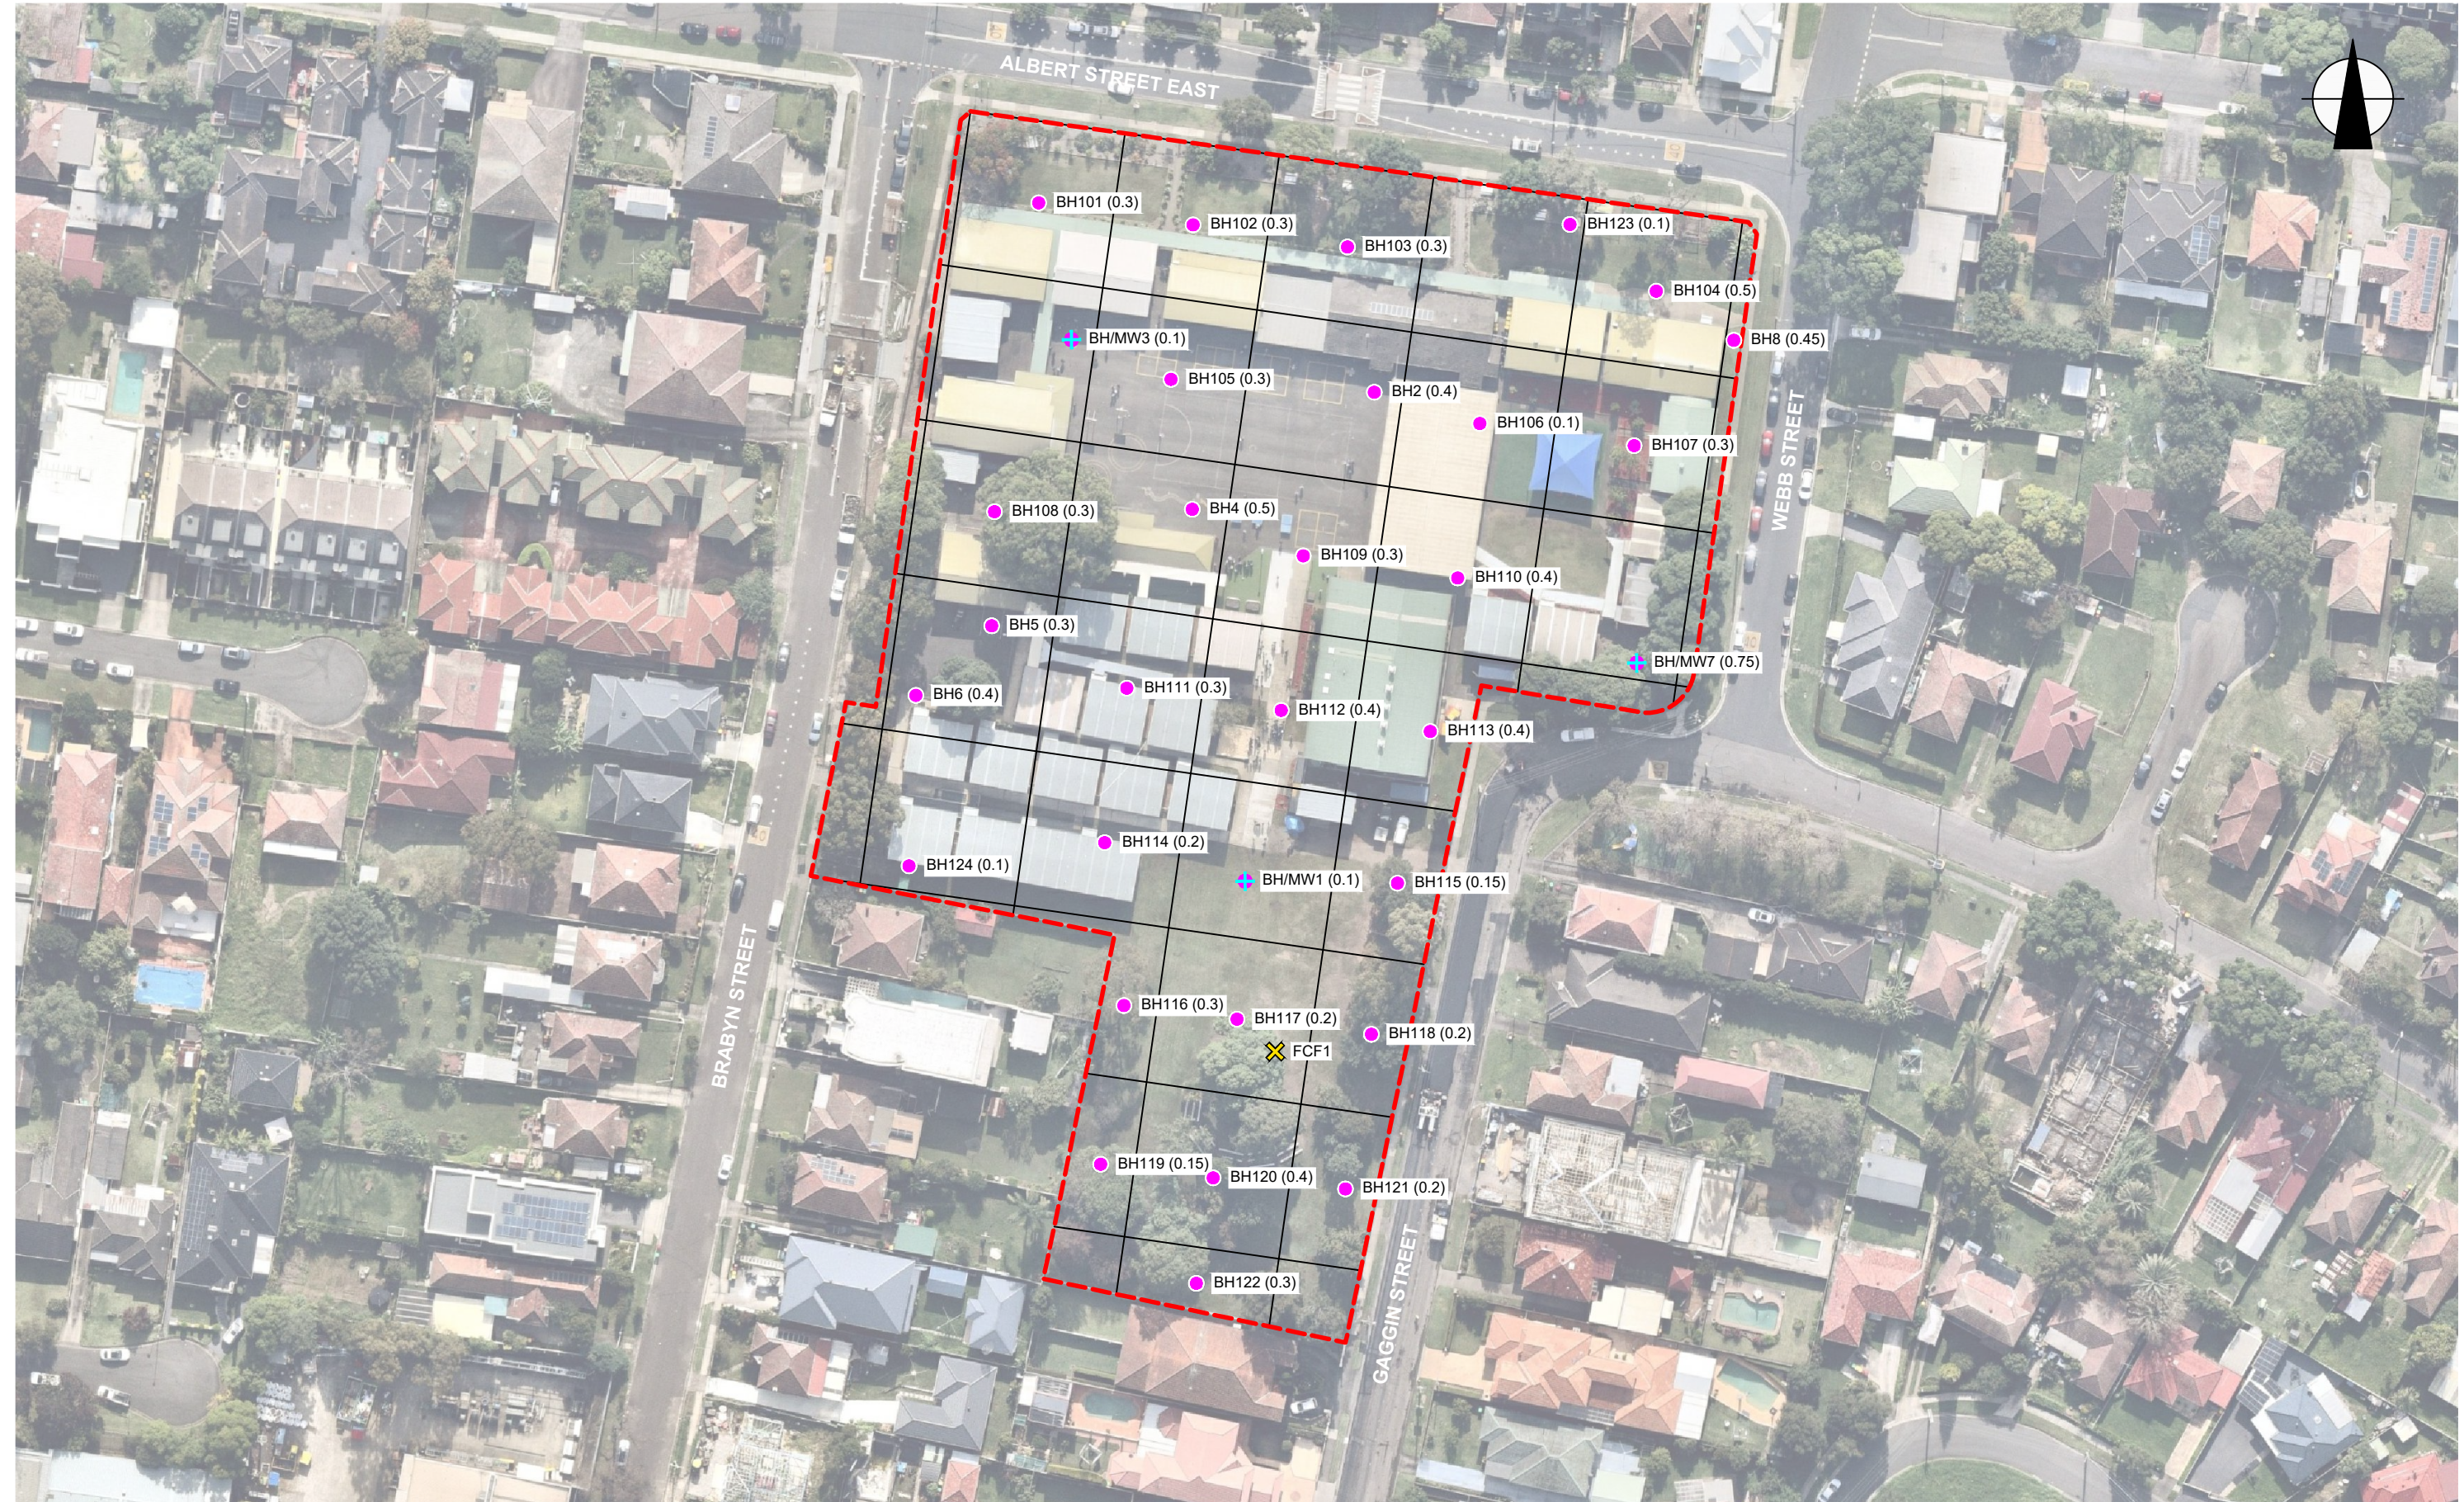
- APPROXIMATE SITE BOUNDARY
- X FCF(Surface) FIBRE CEMENT FRAGMENT LOCATION, NUMBER AND DEPTH (Surface/m)
- BH(Fill Depth) BOREHOLE LOCATION, NUMBER AND DEPTH OF FILL (m)
- + BH/MW(Fill Depth) BOREHOLE AND GROUNDWATER MONITORING WELL LOCATION, NUMBER AND DEPTH OF FILL (m)
