# Parramatta East Public School Upgrade, 30-32 Brabyn St, Parramatta, City of Parramatta, NSW

Statement of Heritage Impact

Prepared for Johnstaff on behalf of NSW Department of Education

March 2025

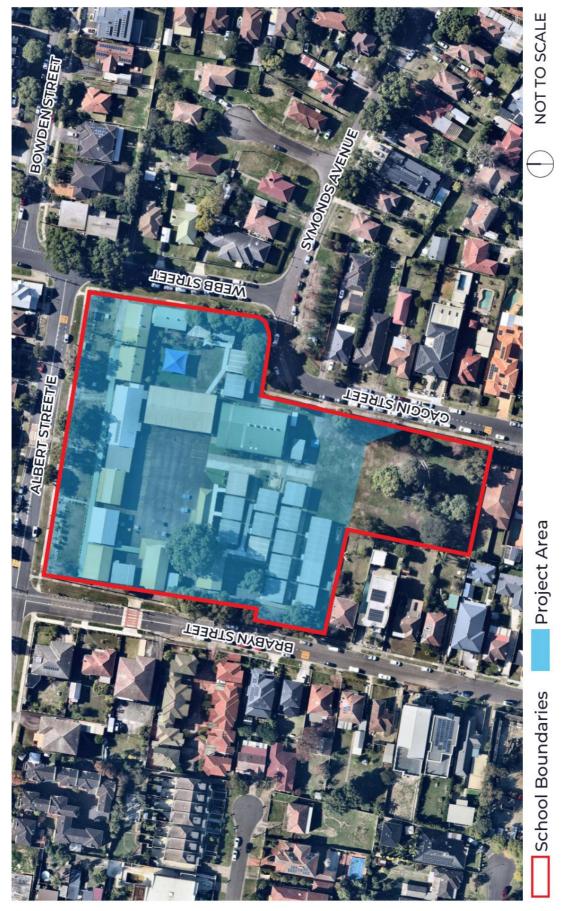
Figure 2: Site Aerial

An aerial image of the site is shown in and Figure 2.

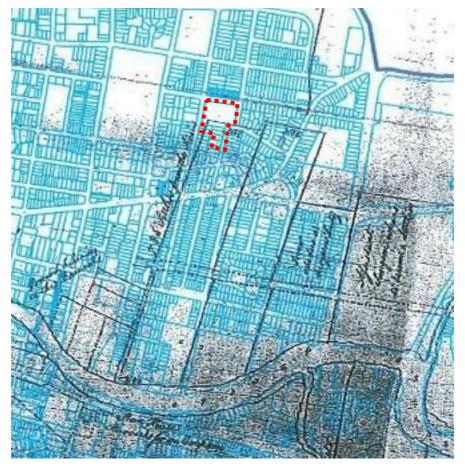
Figure 5: Detail of site (outlined) from c1791 map showing the towns of Parramatta and settlements of Rose Hill, Field of Mars and Toongabbie (source: Godden Mackay Logan (2000b))

Land on the northern bank of the Parramatta River (south of the site) was granted in two 60-acre farms by Governor Phillip to settlers "from the Sirius". According to the 1791 map of the settlement in Parramatta (at the time referred to as Rose Hill) (refer to Figure 5), the site is in the northwestern corner of Town Boundary Farm No. 7, a 60 acre grant to William Reid, with Town Boundary Farm No. 6 which was owned by Robert Webb to the east (GML, 2013, p. 13) (refer to Figure 6). Watkin Tench (1793) visited Robert Webb in 1790, and described his farm thus:

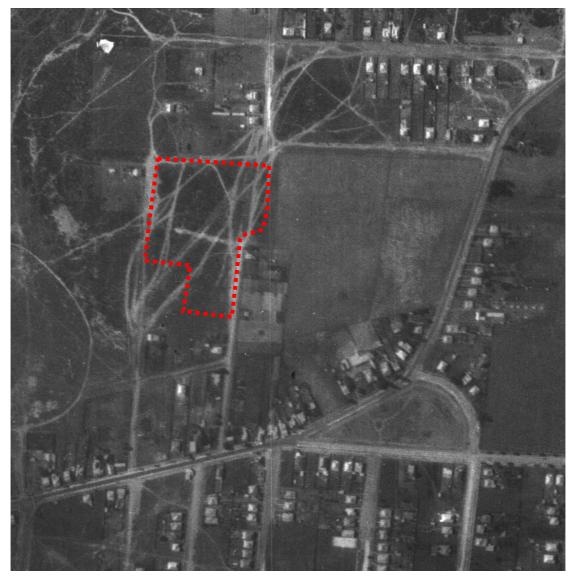
Figure 11: 1930 aerial photograph (source: Historical Aerial Photography – Foundation Spatial Data). Approximate location of the site is outlined in red

Historical aerials and satellite images of the site dating 1930-2017 were reviewed as part of preparing this PHA (see Figure 11 to Figure 21). These aerials provide a summary of development at the site and within the surrounding area (refer to Table 2).

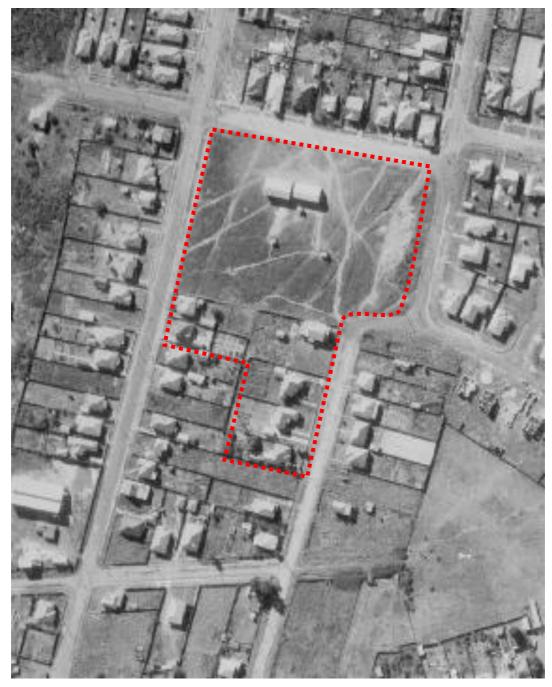
Figure 13: 1951 aerial photograph (source: Historical Imagery Viewer). The site is outlined in red

During the inspection of the southern playing field, remains of the former residential dwellings and associated gardens, established between the 1940s and the late 1970s (refer to Figure 12 to Figure 16), including brick foundations and sections of clay pipes were observed (refer to Plate 65 to Plate 70). This indicates that while the demolition has occurred as part of extending the school grounds to expand the playing field, there was likely to have been minimal ground disturbance as part of these works.

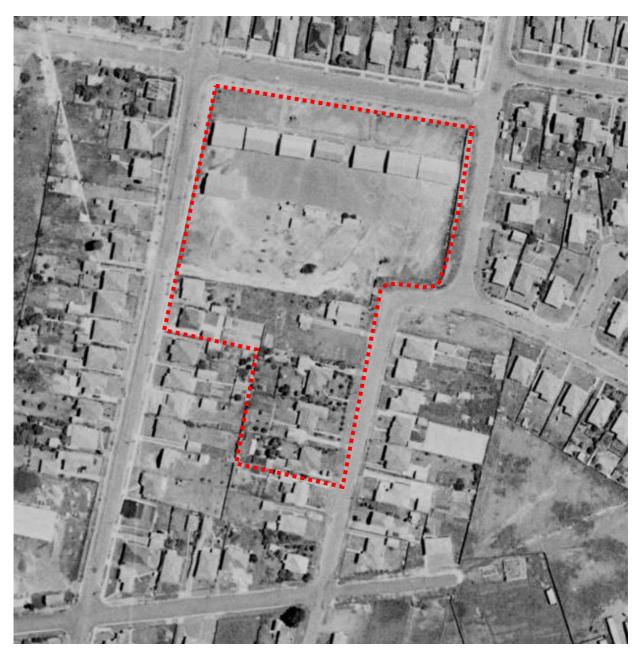
Figure 14: 1955 aerial photograph (source: Historical Imagery Viewer). The site is outlined in red

The topography of the site gently slopes to the south/southeast. Open grounds are immediately located at the northern and southern end of the school complex. The trees at the northern end of the campus were planted between 1955 and 1965 (see Figure 14 and Figure 15). The majority of the trees at the southern end of the campus were planted post 1951 (see Figure 12 and Figure 13). The tree at the northeastern corner of Block H appears to have been planted between 1965 and 1978 (see Figure 15 and Figure 16).

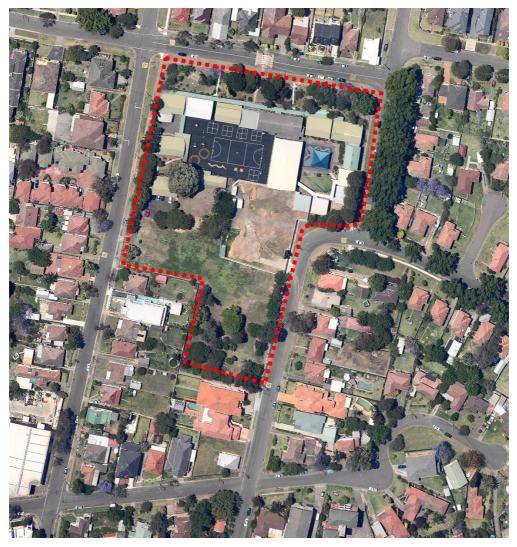
Figure 20: 2009 aerial photograph (source: Nearmap). The site is outlined in red

2009	In this aerial photograph, a landscaped play area has been established between the Block A extension and the sheltered play area. Two (2) buildings at the southern end of the Block A have been established. An additional, two (2) buildings have been established south of the landscaped play area. Block Q (Hall) is being constructed to south of the covered and uncovered play areas. The grassed playground at the southern end of the campus appears unchanged.
2017	In this aerial photograph, Block Q has been constructed. There are three (3) rows of demountable buildings (totalling 8) to the south of Block J, with an uncovered concrete path connecting the buildings. A demountable building has been established between Blocks F and G. The grassed playground at the southern end of the campus appears unchanged.

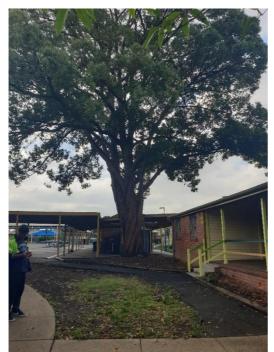
Plate 13: Mature planting at the northeastern corner of Block H

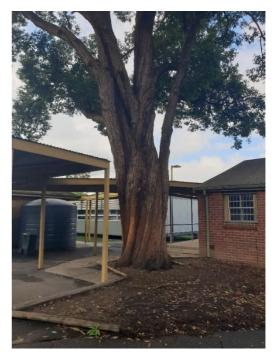
Plate 14: Closeup of mature planting at the northeastern corner of Block H

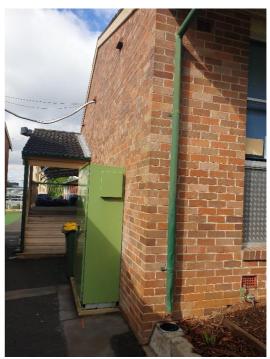
Block C is a brick construction. It has a south facing verandah (refer to Plate 31, Plate 35 and Plate 36).

All the buildings have a gable roofs. In most cases the roofs are clad with sheet metal, although Block C has a tiled roof (refer to Plate 31). Most of the buildings appear to have been built to the same standard design and feature pairs of double hung timber windows and boarded doors with highlight sashes above.

Plate 31: Northern elevation of Block C

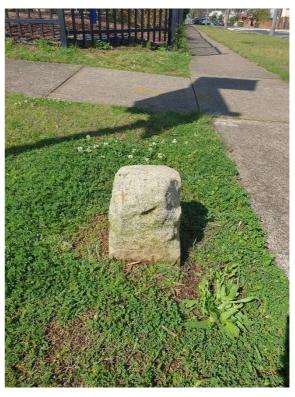
Outside of the Parramatta East Public School ground, at the corner of Brabyn St and Albert St E, a possible section of a sandstone marker was identified (refer to Plate 63 and Plate 64).

Plate 63: Remains of a possible sandstone marker at the corner of Brabyn St and Albert St E

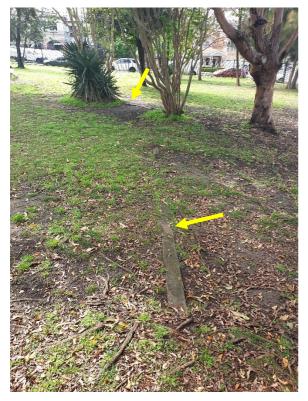
Plate 68: Remains of former residential structures
