Native Vegetation Management Plan

New High School for Medowie

Department of Education

31 January 2025

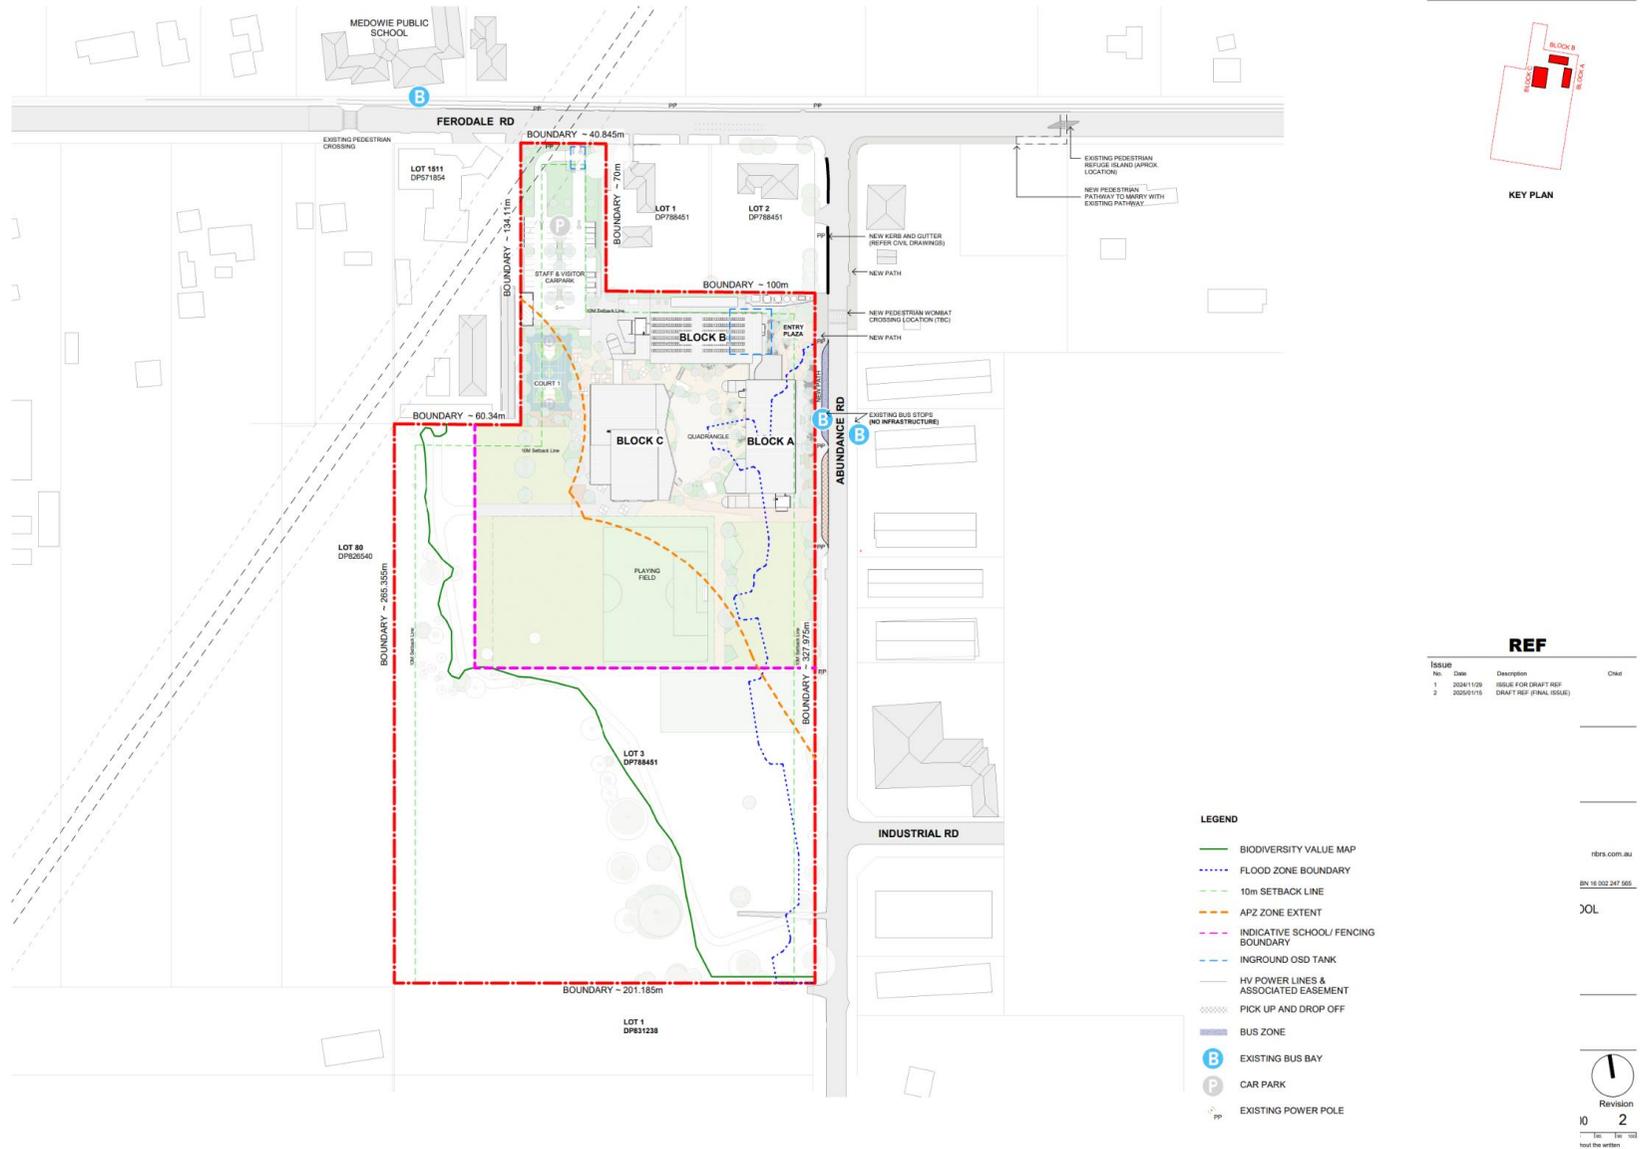
Figure 1-1 Site Plans

The proposed activity involves the construction of the New High School for Medowie (Figure 1-1).

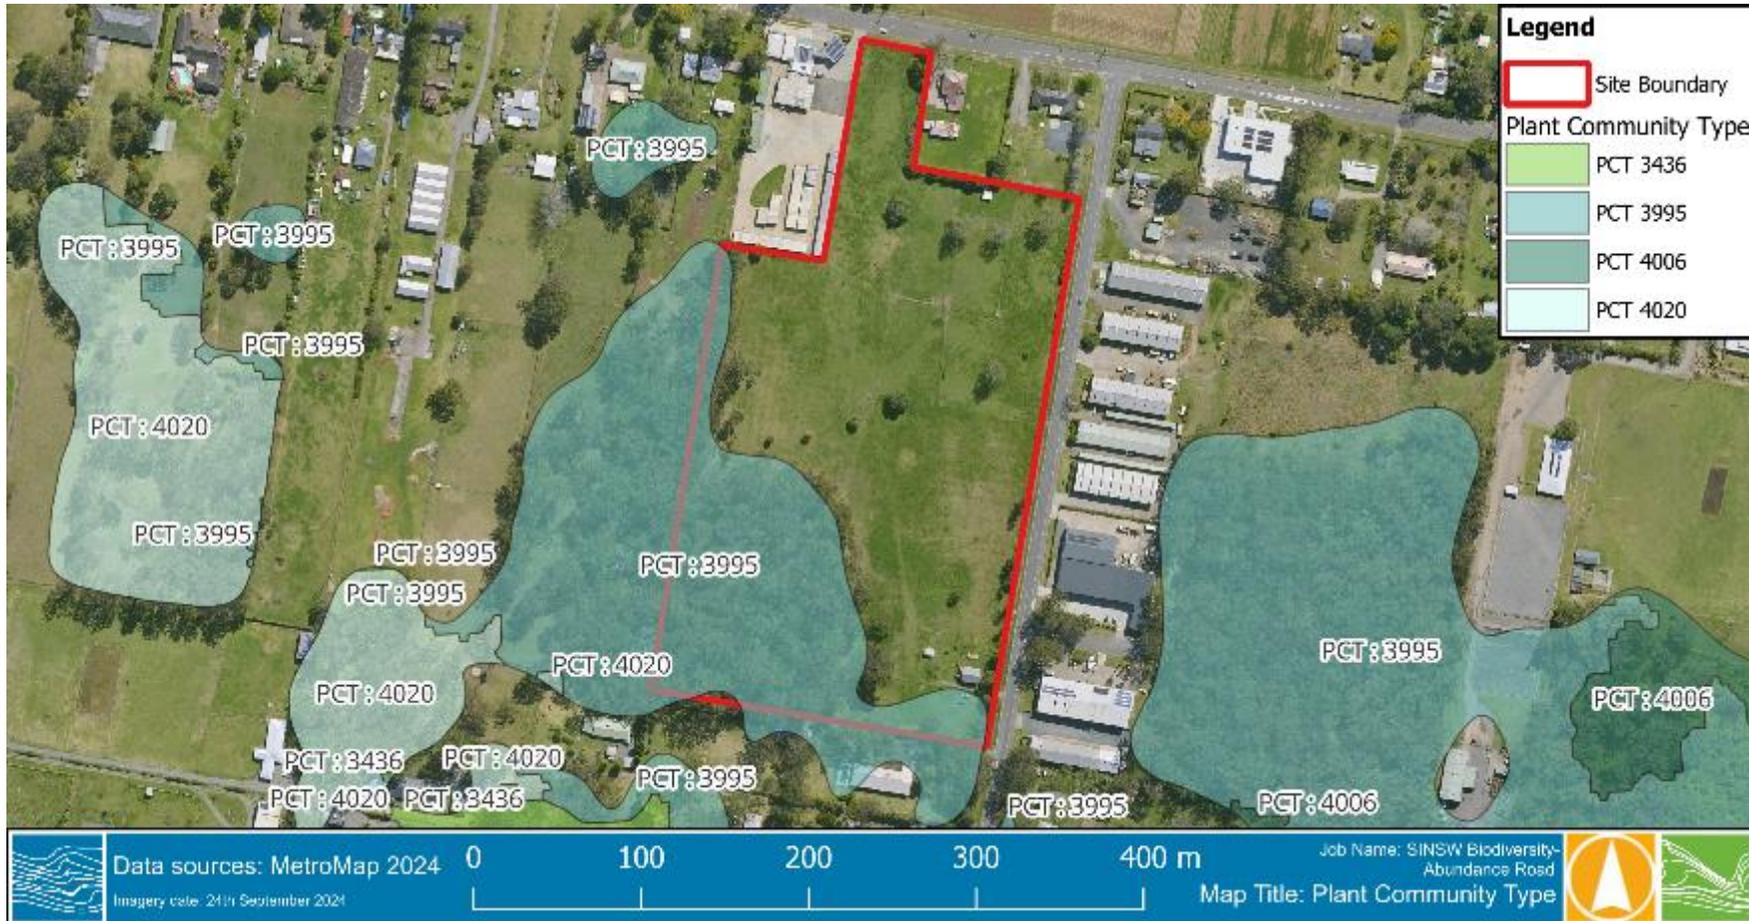
Figure 2-3 PCT mapping.

Desktop analysis of the site using recent high-resolution satellite imagery indicated that this PCT is likely present within the subject site (Figure 2-3). A qualified ecologist conducted an on-ground site assessment to determine the presence and condition of native vegetation on site and if it confirms to the listed associated TEC above.

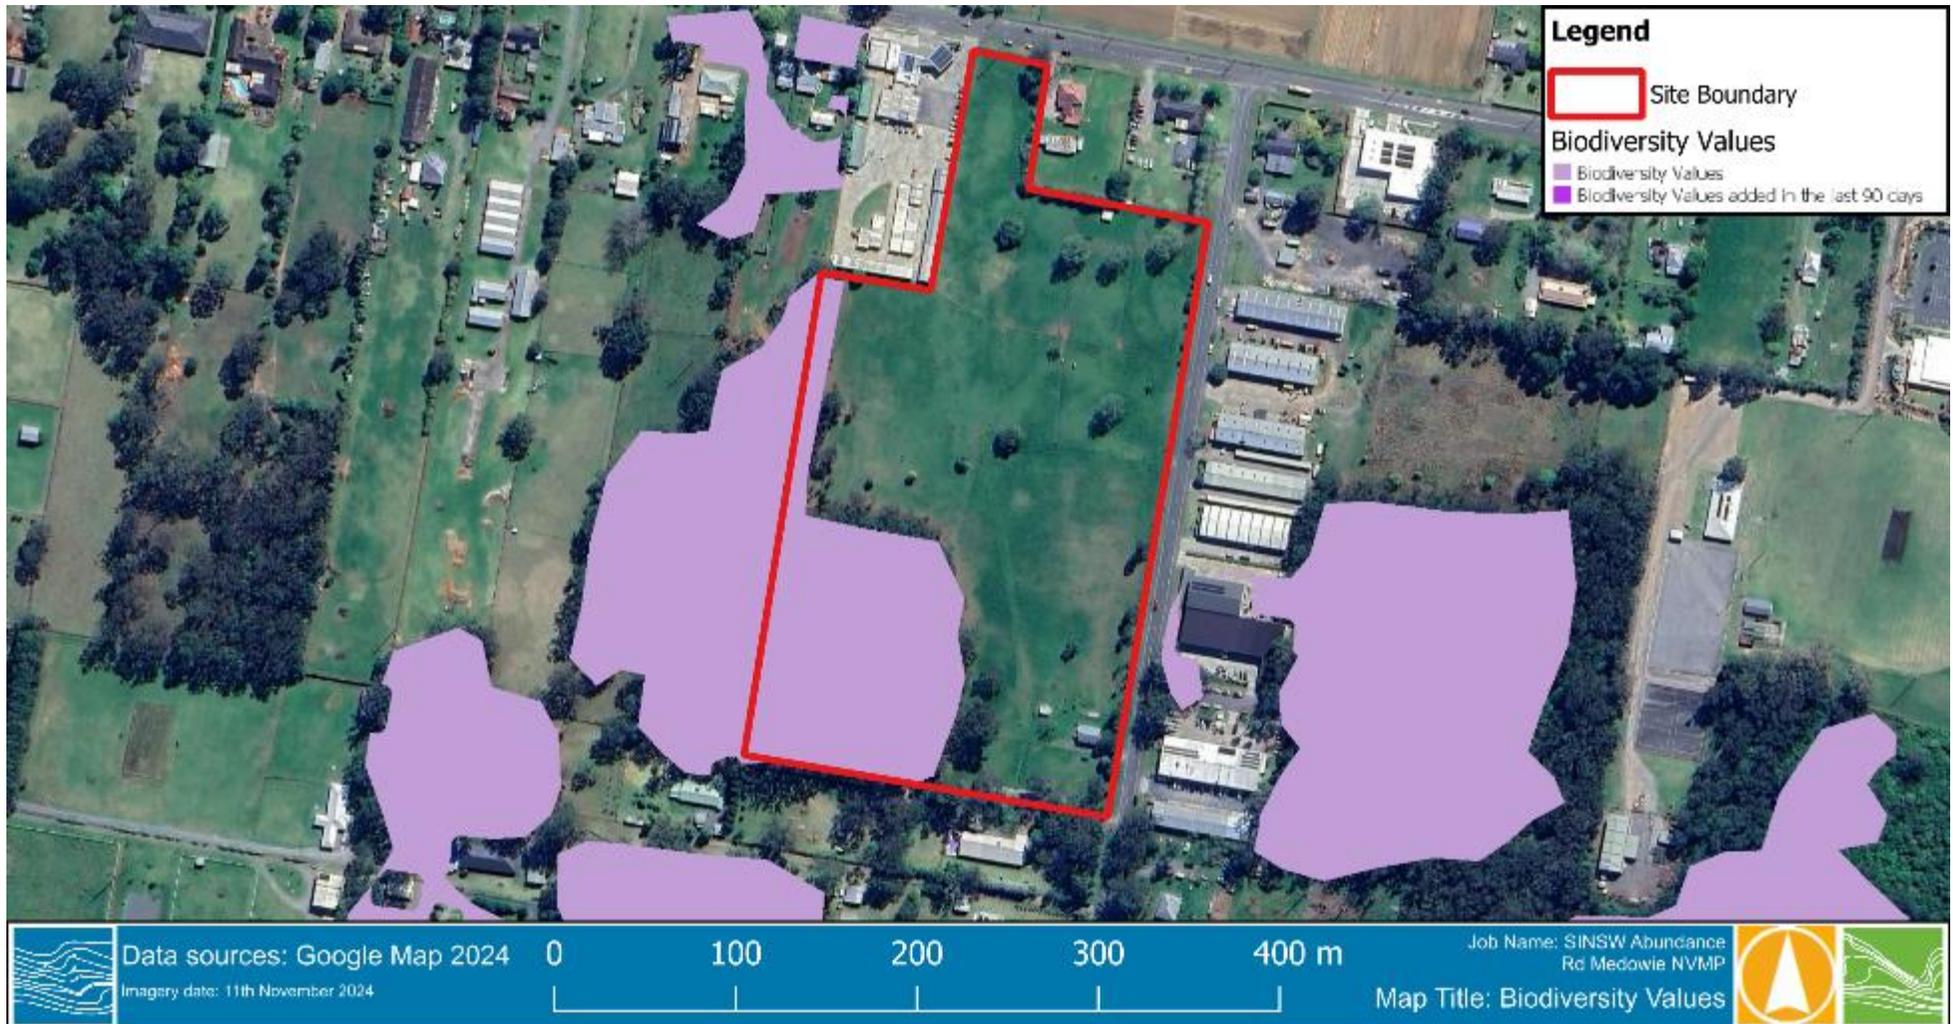
Figure 2-4 Biodiversity Values

The subject site contains areas mapped as possessing Biodiversity Values (BV) recorded as Core Habitat within an approved Comprehensive Koala Plan of Management (Koala SEPP). These coincide with the area of remnant native vegetation present in the south west corner of the site. The BV map can be seen in (Figure 2-4).

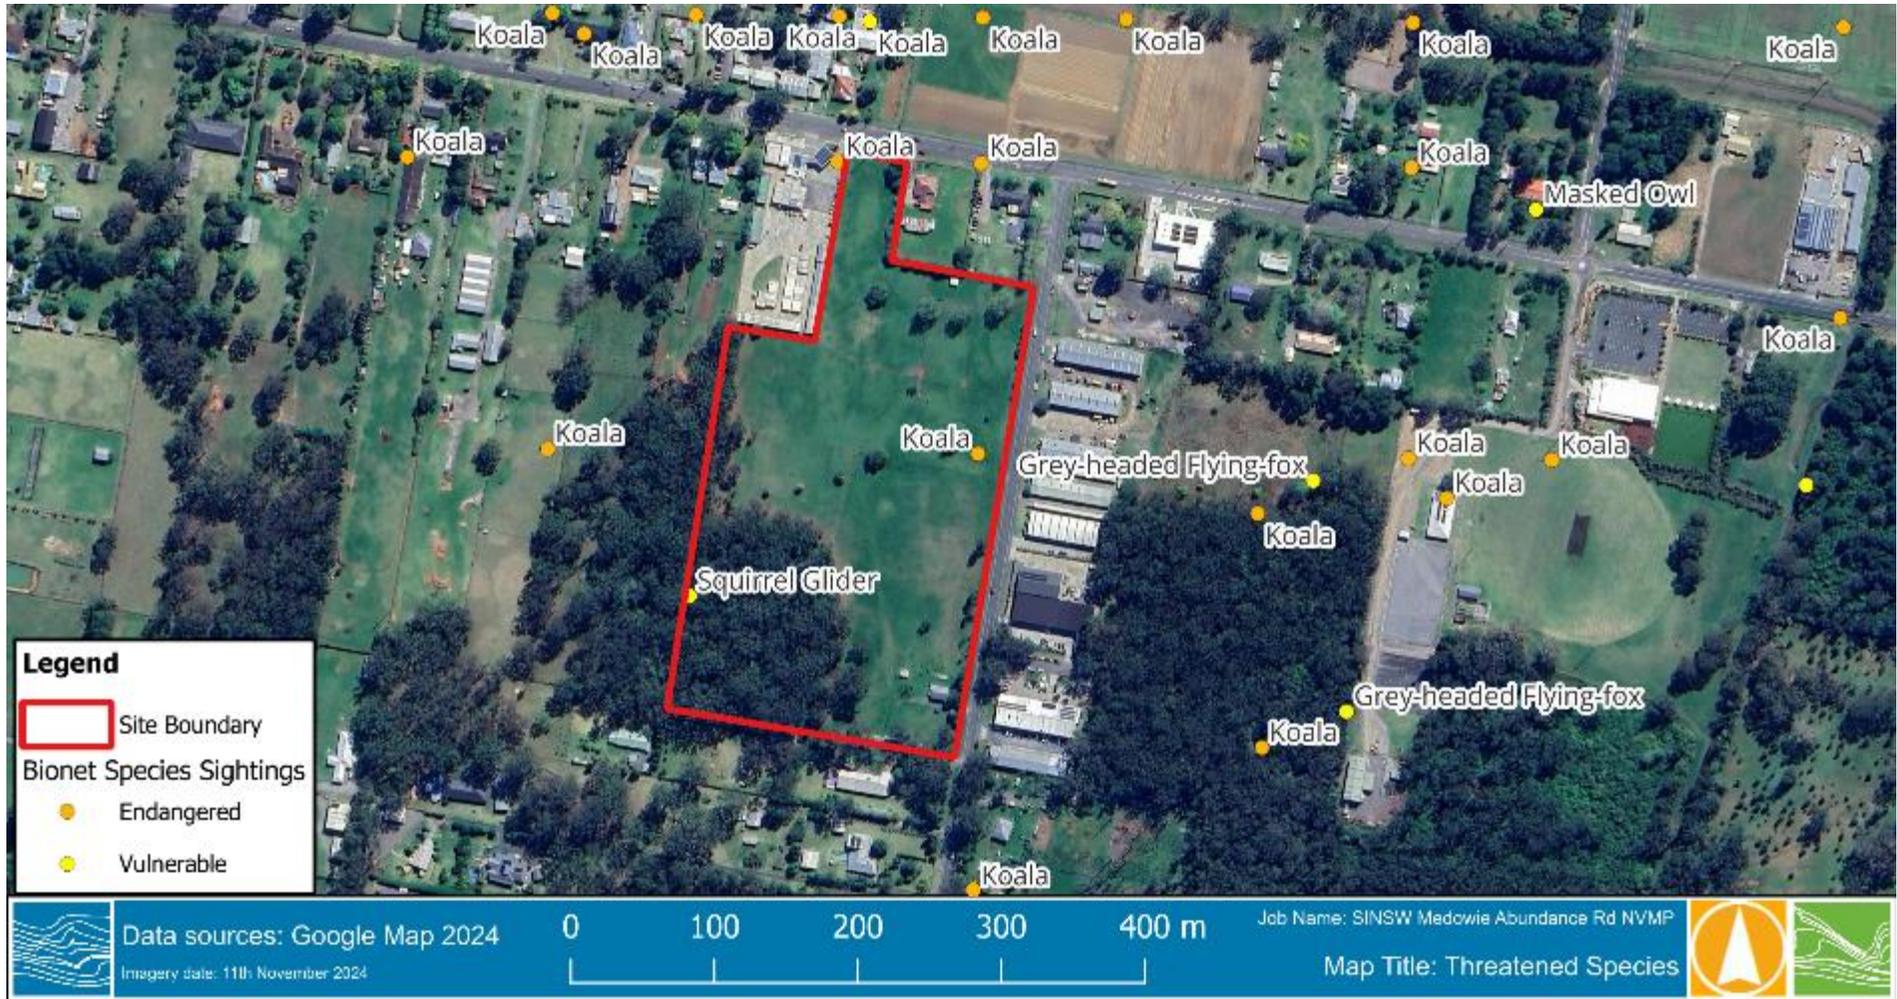
Figure 2-5 Threatened Species Map

- Koala (*Phascolarctos cinereus*) (Endangered - EPBC Act and BC Act);
- Grey-headed Flying Fox (*Pteropus poliocephalus*) (Vulnerable - EPBC Act and BC Act);
- Squirrel Glider (*Petaurus norfolcensis*) (Vulnerable – BC Act);
- Greater Broad-nosed Bat (*Scoteanax rueppellii*) (Vulnerable – BC Act); and
- Little Bent-winged Bat (*Miniopterus australis*) (Vulnerable – BC Act).

No threatened flora species have been recorded within or close to the site.

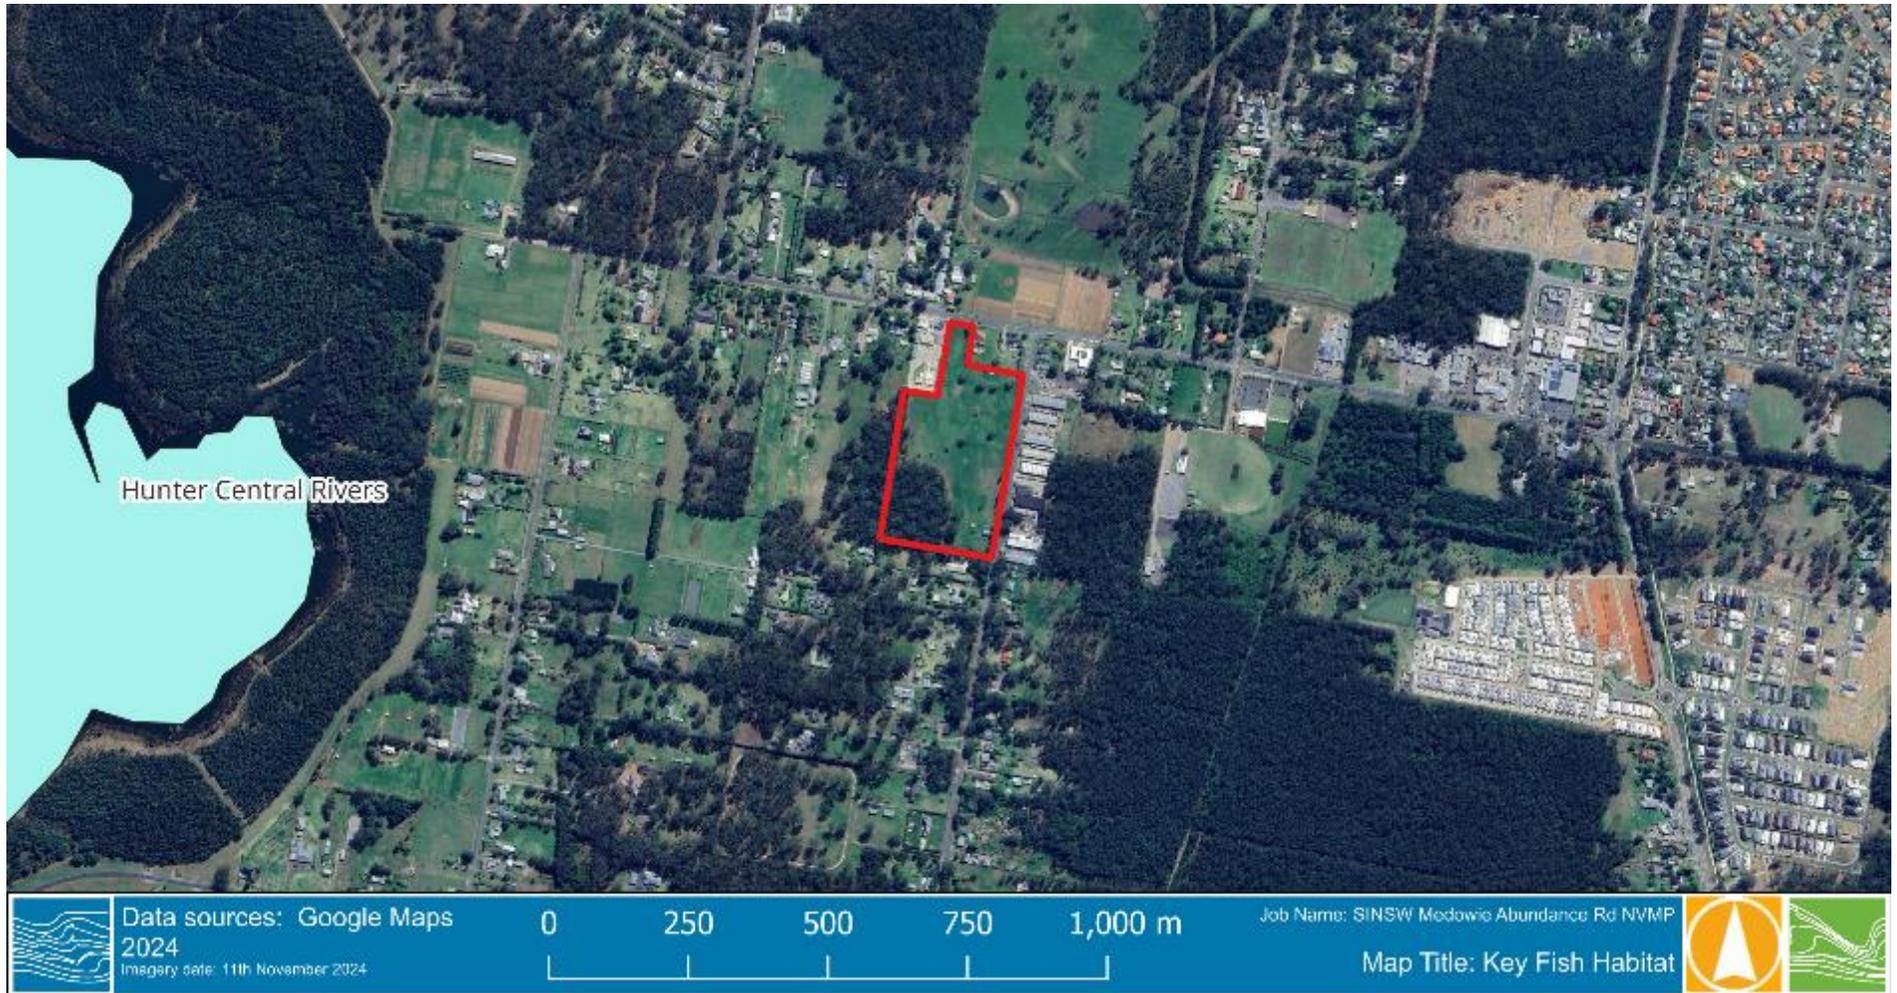
Figure 2-6 Key Fish Habitat

The subject site is not mapped as containing any Key Fish Habitat. Furthermore, the subject site is not in close proximity to any significant waterways or drainage areas or any waterfront land. The nearest waterbody is Grahamstown Lake, which is approximately 1 km west of the site (Figure 2-6). As such, there are no further provisions within the FM Act and WM Act that require consideration as part of the proposed activity.

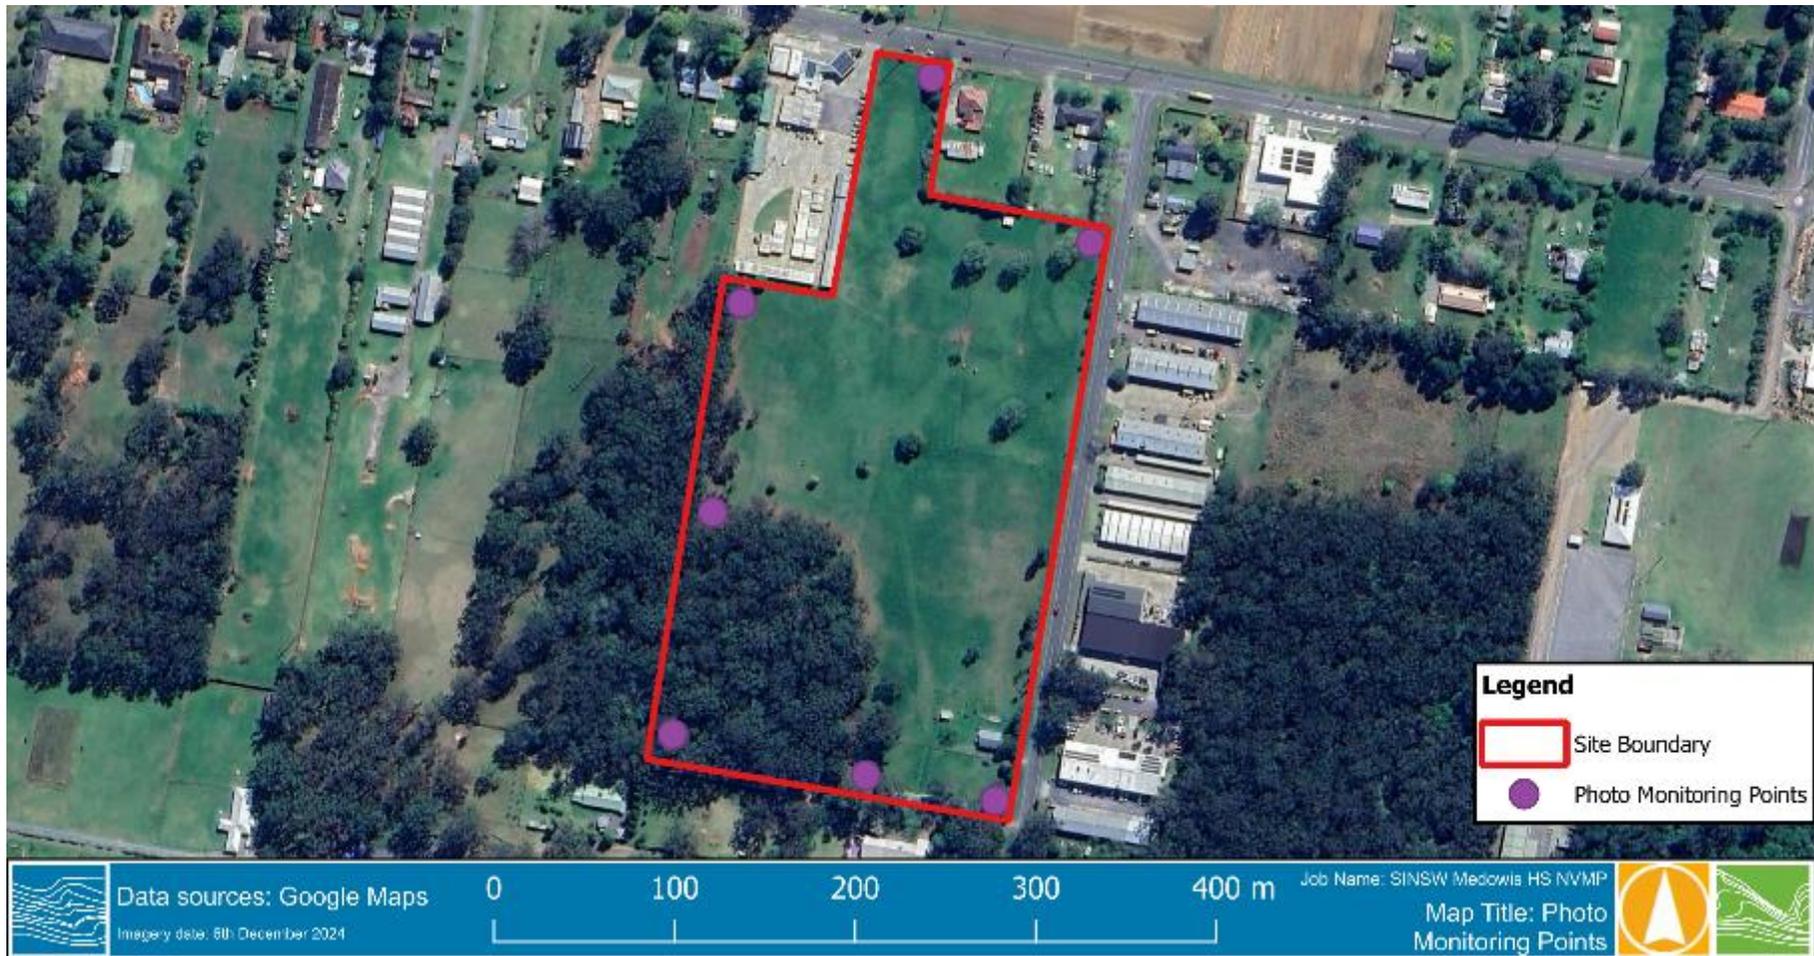
Figure 4-1 Photo Monitoring Points

During the site assessment, seven reference point locations within the rehabilitation site were identified as seen in **Figure 4-1**. The GPS coordinates are listed in Table 4-1. It was intentional to use easily identified landmarks such as the corner points for reference because conditions may change during the construction process.

Photographs showing before and after images to illustrate the extent of the rehabilitation work should be taken after the completion of the rehabilitation works then annually to document changes in vegetation condition and structure. These can be taken at the suggested photo points with the coordinates seen in Figure 6 1. We have provided photos for the photo points suggested (Appendix B).

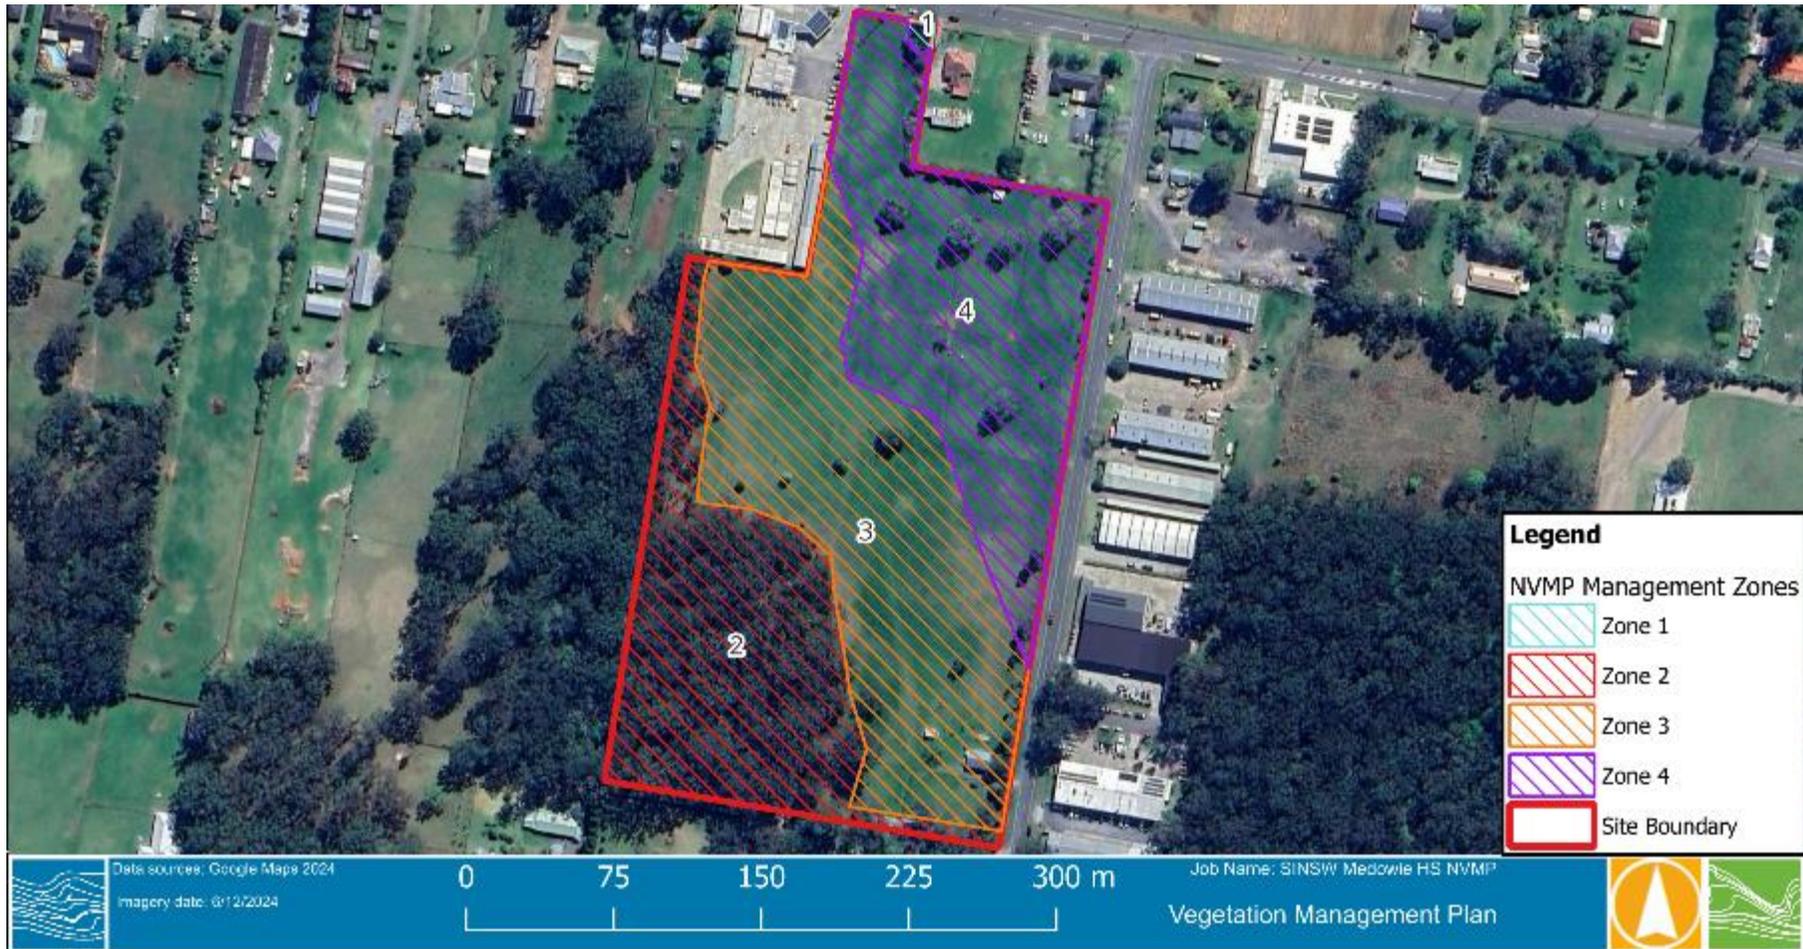
Figure 5-1 Vegetation Management Plan

The management zones have been outlined in the Vegetation Management Map (Figure 5-1). They mostly consist of the areas of primary focus such as around the threatened tree species found on site, the mapped TEC zone and the bushfire APZ area. Other areas that also need to be considered are areas around the old house, the open paddock areas and the landscaped areas around the proposed school buildings.

This area is located to the north of the site located off Ferodale Road. This area can be seen as the light blue area Zone 1 in the Vegetation Management Map (Figure 5-1). The trunk was found to have scratch marks which is likely to be from a possum due to the shallow indentation marks that were close together. It is expected that this zone would have the highest chance of being impacted by being located within the activity footprint and along the road edge and main access point to the north of the site.

It is recommended that revegetation occurs along the Abundance Road fence line to enhance the connectivity with the area. Planted species should include Preferred Koala Food Trees and species within the PCT 3995 indicative list. These would include Eucalyptus species such as Swamp Mahogany (*Eucalyptus robusta*) and Forest Red Gum (*Eucalyptus tereticornis*). Considering the entire site is classified as having a high bush fire rating, the plantings should not be dense and spread every 20 m. The area to be revegetated would be within the school fence line outside of the APZ zone. This can be seen as part of Zone 4 on Vegetation Management Plan (Figure 5-1)

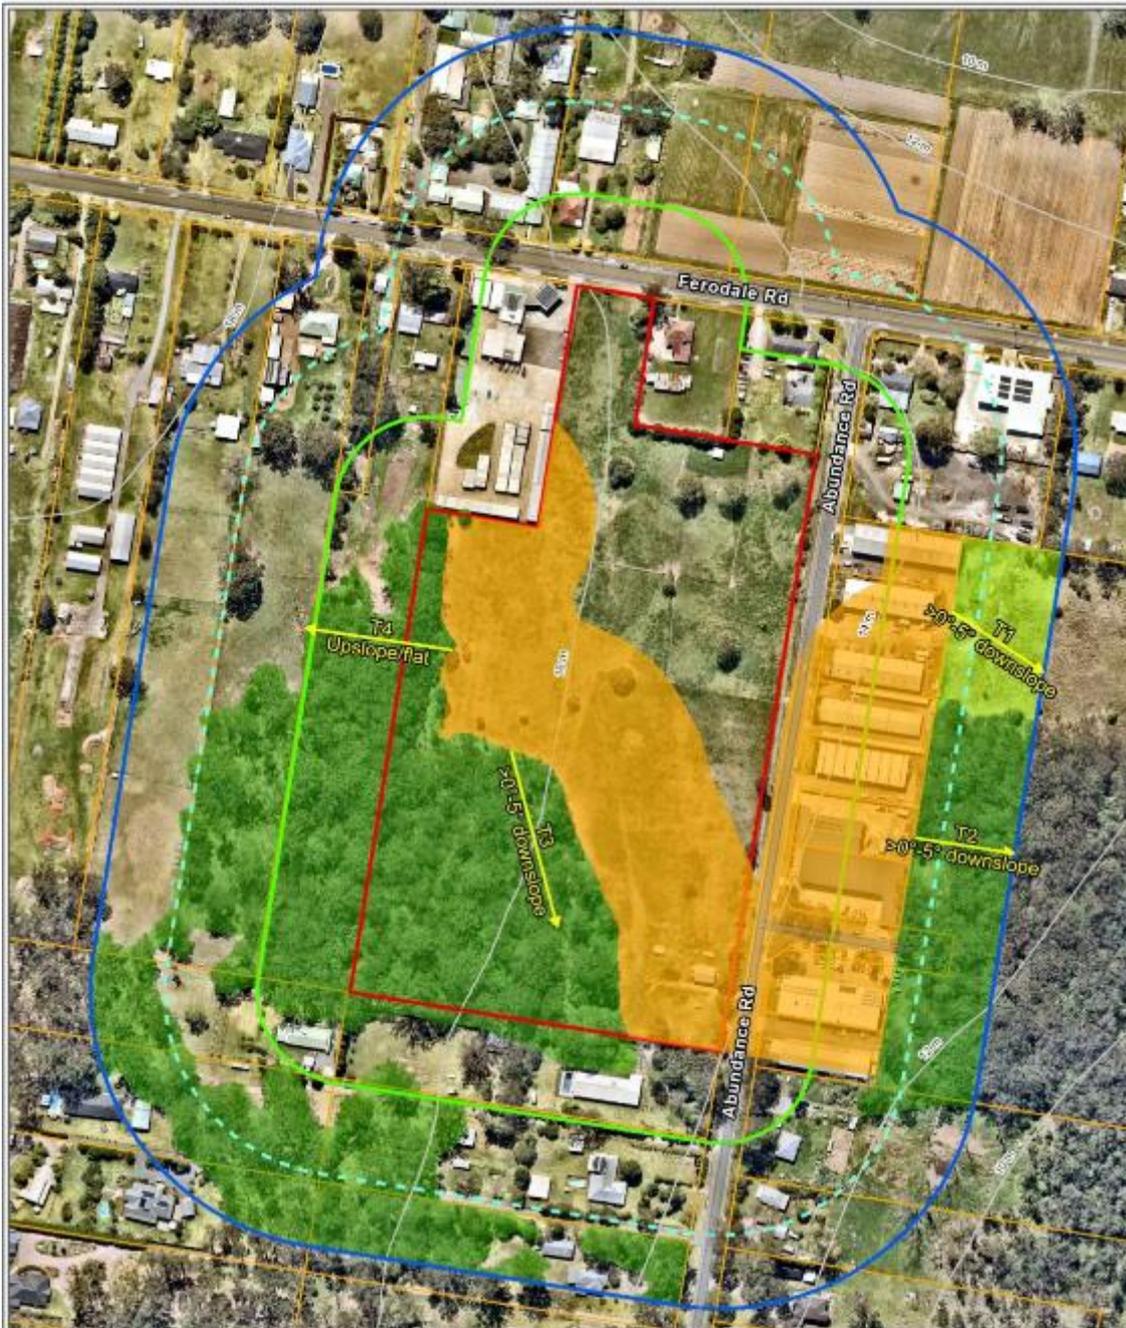
Bushfire Hazard Assessment - Site E: 6 Abundance Road

- Subject land
- Contour (2 m)
- Cadastre
- Vegetation assessment buffer (140 m)
- Slope assessment buffer (100 m)
- Grassland assessment buffer (50 m)
- Asset protection zone (SFPP) 40 - 79m
