Supplementary Geotechnical Investigation Report

New High School for Medowie

6 Abundance Road, Medowie NSW 2318

A201024.0124.00_B_v2f | Date: 30 January 2025

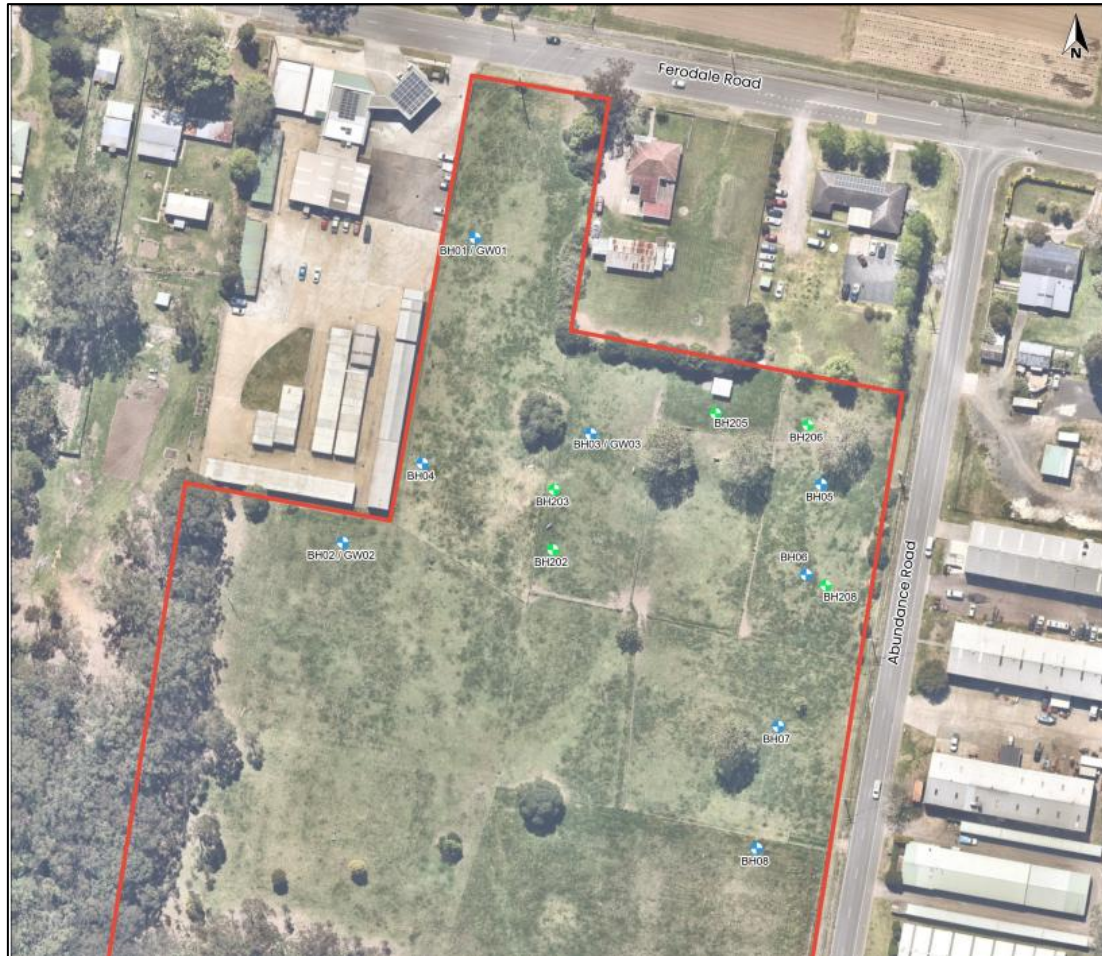
Figure 1: Survey Plan with Boreholes Indicated (Base Map Source: Nearmap)

The area surrounding the site mostly consists of industrial, rural residential, educational, and agricultural lands. Adjacent to the northwestern boundary is a Shell petrol station and mechanic garage. Adjacent to the northeastern boundary is a medical health clinic. Across Abundance Road along the eastern boundary are a number of warehouse and light industrial developments. Directly north of the site across Ferodale Road are large lots used for agricultural purposes. Medowie Public School is located on Ferodale Road, to the north west of the site, opposite the Shell petrol station. **Figure 1** presents the current state of the investigation area.
