REPORT TO NSW DEPARTMENT OF EDUCATION

ON PRELIMINARY SALINITY ASSESSMENT

**PROPOSED NEW HIGH SCHOOL IN BUNGENDORE**

AT BIRCHFIELD DRIVE, BUNGENDORE, NSW

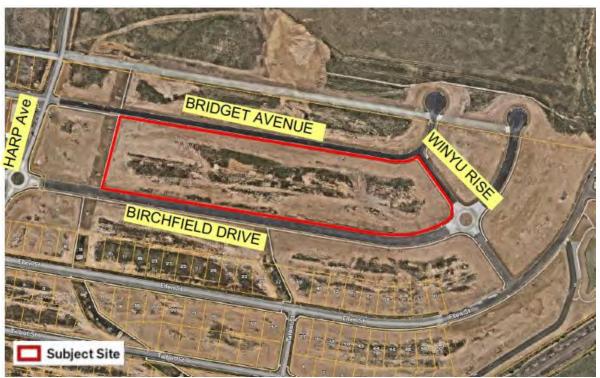
Figure 1 Aerial Photograph of the Site. Source: Urbis 2024

The current street address is part of 18 Harp Avenue, Bungendore, NSW, 2621 (the site), and is legally described as part Lot 125 in Deposited Plan 1297613. As shown on Figure 1 below, the proposed school site forms part of a larger lot which is the subject of a proposed residential subdivision.

NSW Department of Education ('the client') commissioned JK Environments (JKE) to undertake a Preliminary Salinity Assessment for the proposed high school in Bungendore at Birchfield Drive, Bungendore. The site location is shown on Figure 1 and the assessment was confined to the site boundaries as shown on Figure 2 attached in the appendices.

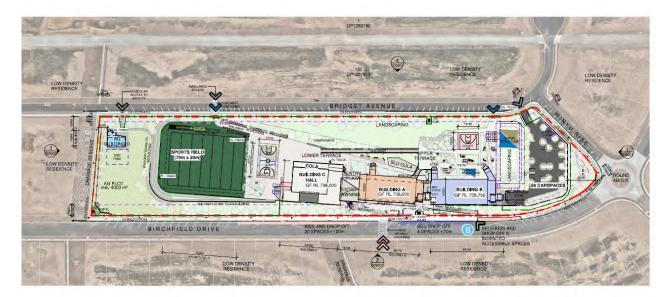
Figure 2 Site Plan Source: NBRS, 2024

Figure 2 below provides an extract of the proposed site plan.

The investigation included soil sampling from 10 locations (BH101 to BH110 inclusive) placed on a judgement sampling plan as shown on Figure 2. We note that Figure 2 also shows all locations drilling for the geotechnical investigation and the PSI. This density is equivalent to approximately 2-3 sampling points per hectare (the area of the site is approximately 4.2 hectares) and meets the requirements for an 'initial site investigation' recommended in the DLWC 2002 document for 'moderately intensive construction'. The density was considered adequate to identify large areas of salinity impacted soils at the site.

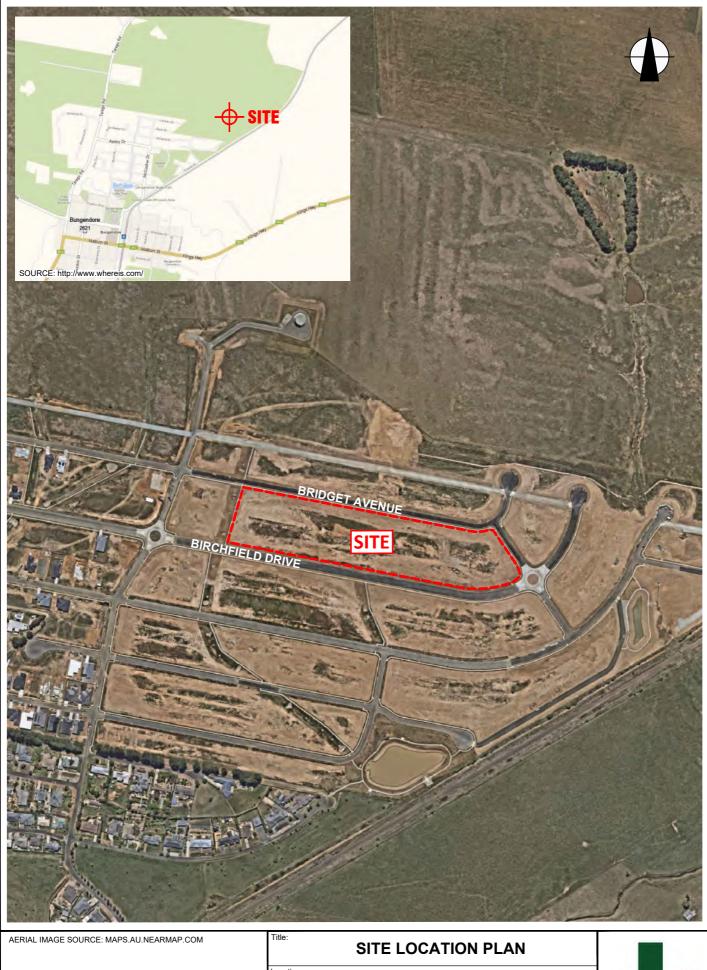
AERIAL IMAGE SOURCE: MAPS.AU.NEARMAP.COM	l itle:	SITE LOCATION PL	AN	
	Location:	BIRCHFIELD DRIVE, BUNGENDOF	RE, NSW	
	Project No:	E37084rpt2-SAL	Figure No:	
This plan should be read in conjunction with the Environmental report.		<b>JK</b> Environmer	nts

<ul> <li>BH106 (-)</li> <li>BH12 (-)</li> <li>BH18 (-)</li> <li>BH108 (-)</li> <li>BH13 (-)</li> <li>BH15 (-)</li> <li>BH19 (-)</li> <li>BH21 (-)</li> </ul>	20 (-) • BH23 (-)
BH(Fill Depth)	APPROXIMATE SITE BOUNDARY BOREHOLE LOCATION, NUMBER AND DEPTH OF FILL (m) BOREHOLE AND GROUNDWATER MONITORING WELL LOCATION, NUMBER AND DEPTH OF FILL (m)	AERIAL IMAGE SOURCE: MAPS.AU.NEARMAP.COM	Title: SA
<ul> <li>DP16</li> <li>BH101</li> </ul>	DP ADDENDUM PSI 2017 BOREHOLE LOCATION, NUMBER AND DEPTH OF FILL (m)	SCALE 1:1500 @A3 METRES This plan should be read in conjunction with the Environmental report.	Project No: E370
