# Aboriginal Objects Due Diligence Assessment

Bungendore High School  
Ngambri Country

Prepared for  
**NSW Department of Education**  
21 January 2025

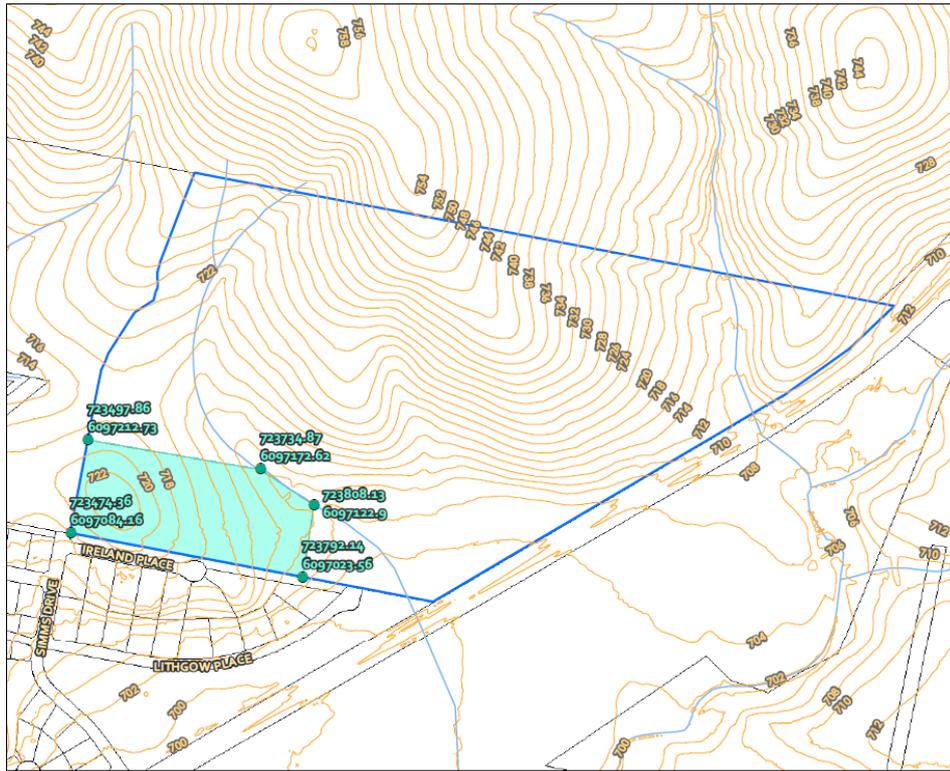
In 2021, Past Traces Heritage Consultants conducted an Aboriginal Cultural Heritage Assessment Report (ACHAR) that encompassed a much larger study area, including the present subject area. The report concluded that there is no potential for Aboriginal objects within the present subject area. Although an Aboriginal Heritage Impact Permit (AHIP) was issued for a proximate region to the southwest, this permit does not extend to the current subject area (see Figure 1).

Figure 1 – Map depicting the extent of registered AHIP 4962 within the broader subject area of Past Traces Heritage Consultants (2021) ACHAR.

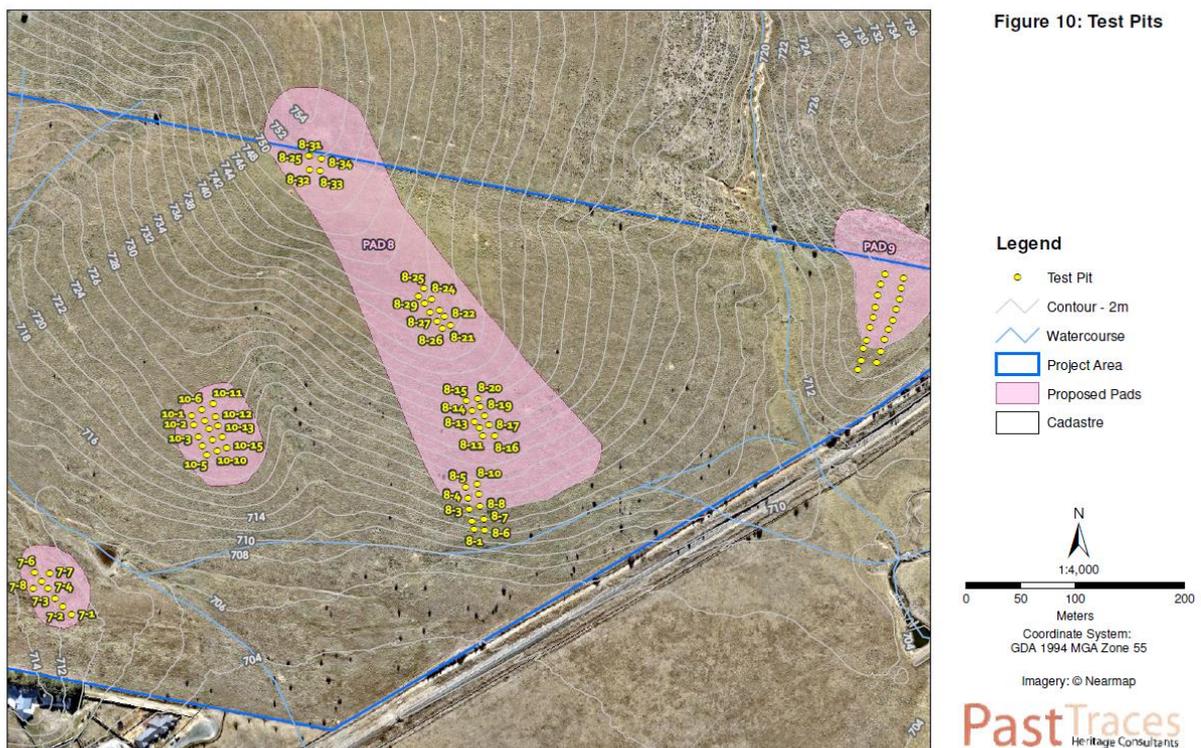
On the crest feature, two transects consisting of two test pits each (n=4) were completed. Additionally, ten test pits were excavated at each of the other three locations along the slopes. No artefacts were identified in any of these locations. The soils within the test pits consisted of silty loam overlaying a compacted red silty clay base. The soil profile was shallower on the crest (<20cm) and increased in depth along the slopes, reaching up to 40cm in the lower slopes.

The test pitting program demonstrated that no subsurface deposits are present in the area of PAD 8, despite the landform being considered potentially significant based on predictive modelling. The results of the test pitting program do not align with the landform modelling outcomes from the Stage 1 test pitting and other heritage assessments conducted in the Bungendore region.

Figure 7 – Map extracted from Past Traces Heritage Consultants illustrating the approximate location of the proposed PAD 8.

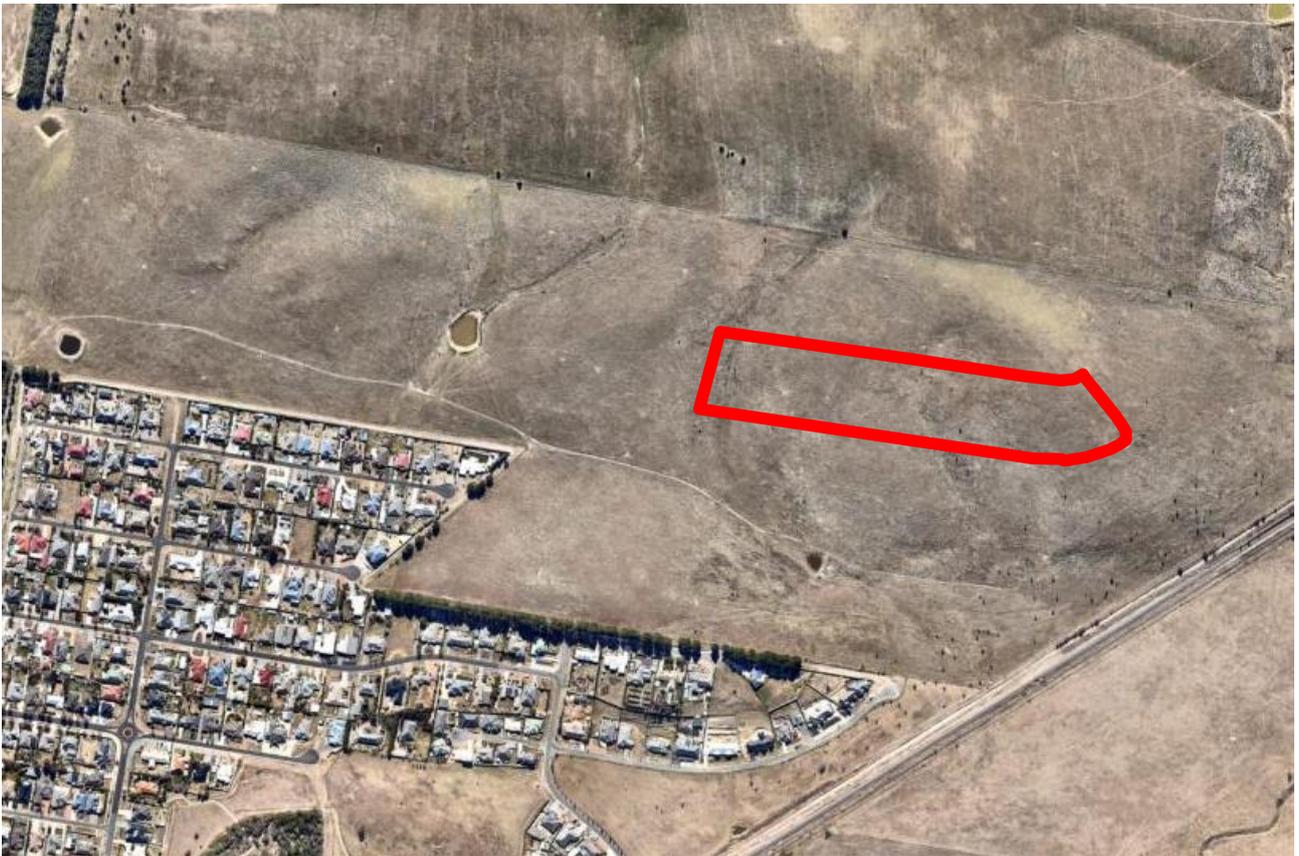
Taken together, the area has been subject to clear and observable human activity that has changed the land's surface from 2017 to 2022. All areas of the subject area appear to have been equally impacted by ground disturbing works. In light of the moderately shallow natural topsoil associated with the Bywong soil landscape, historical ground disturbance has been assessed as **High** throughout the entirety of the subject area.

Figure 10 - Aerial imagery of the subject area (red outline) [2017]

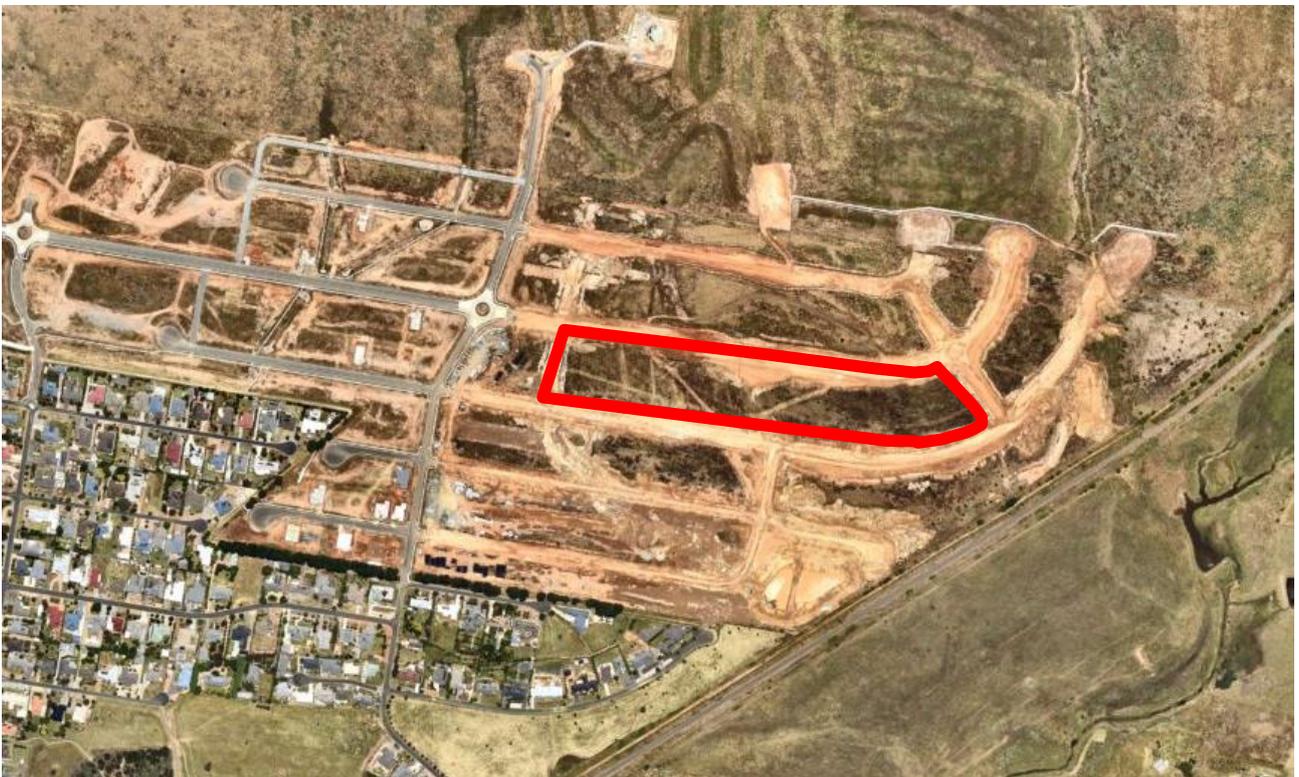
Due to a paucity in historical documentation regarding the development of Bungendore, specifically the subject area, this report bases its understanding of the historical ground disturbance upon recent aerial images. In 2017, the subject appears to be a part of a larger unoccupied field with no clear evidence of ground disturbance other than the initial clearance of the endemic native forest and woodland that characterised the region prior to colonisation (Jenkins, 2000) (see Figure 10). By 2022, the subject area has been impacted by the development and further subdivision of the estate that would likely entail earthworks and leveling of the study area (see Figure 11).

Figure 11 – Aerial imagery of the subject area (red outline) [2022]

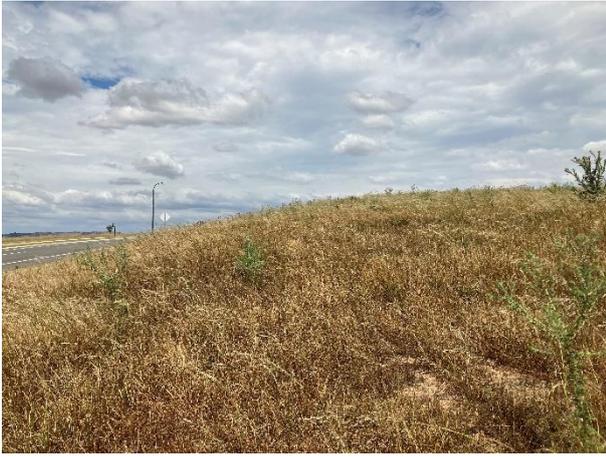
The visual inspection was undertaken in dry, windy conditions. The subject area is located within an area which has been previously cleared and stripped in preparation for residential development. Ground Surface Visibility (GSV) was estimated to be about 20% across the subject area due to ground-covering vegetation, primarily comprising grasses and thistles, with intermittent areas of thinned vegetation. Where soils were exposed, they revealed gravelly red-brown clay, confirming that the topsoils have been stripped as part of previous works. Quartz and shale gravels were observed across the exposed soils.

Figure 12 – Vegetation coverage across the site, facing west

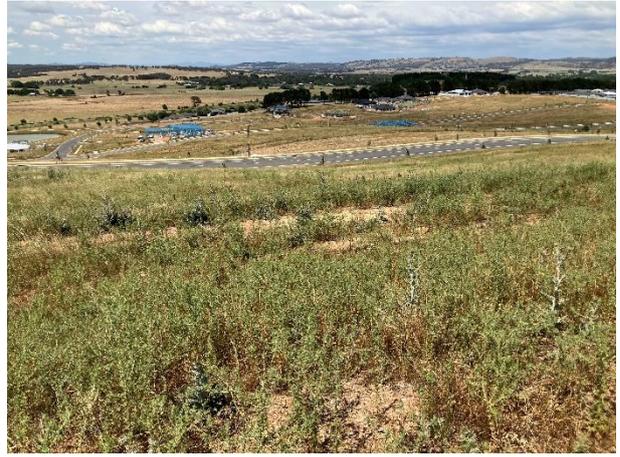
Figure 13 Vegetation cover and exposed soils facing south down slope

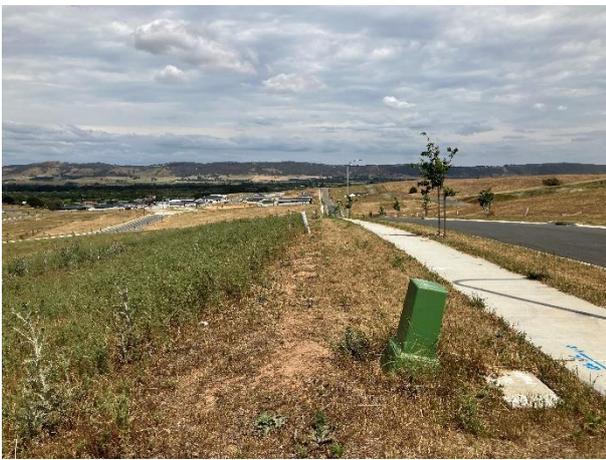
In addition to the topsoil stripping, previous works undertaken in the area included installation of underground services along the northern boundary, as well as footpaths and two substations.

Figure 14 – Presence of services and footpaths along northern boundary, facing west

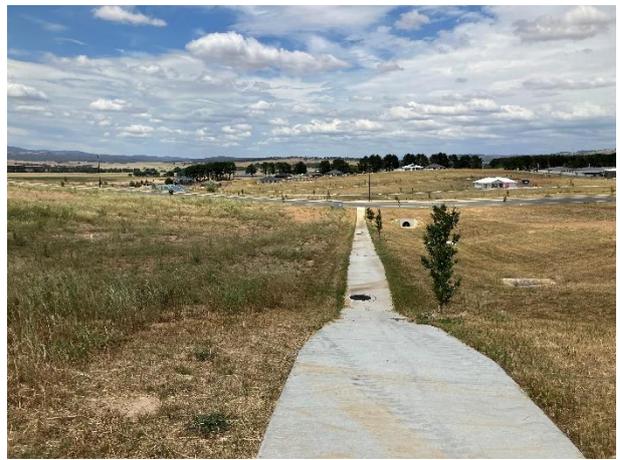
Figure 15 Stormwater and drainage along the western boundary of the subject site, facing south

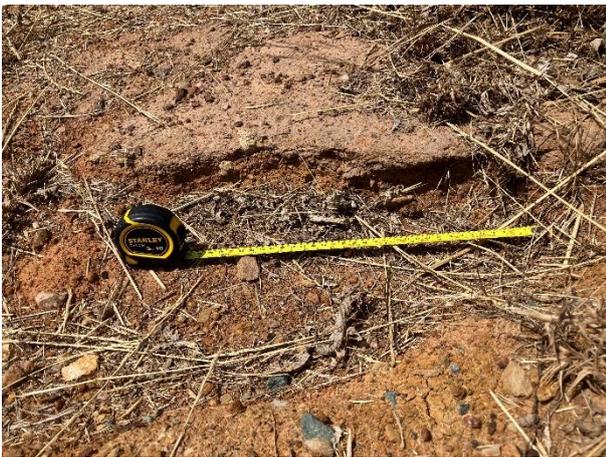
Figure 16 Red-brown clay soils with gravel

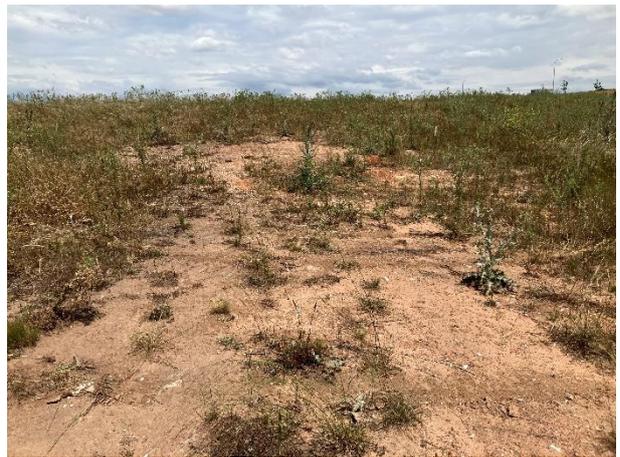
The area is highly disturbed as a result of the previous pre-construction preparation. No Aboriginal objects were identified during the inspection and no areas of potential archaeological deposit were identified.

Figure 17 Exposed soils within the subject area, facing west
