Part 1 - Preliminary Indigenous Heritage Assessment and Impact Report for new high school for Googong

School Name	New high school for Googong	Consultancy Name	Lantern Heritage Pty L:td
School ID Number	N/A	Report Status	Final
School Address	200 Wellsvale Drive, Googong NSW 2620	Report Date:	03/02/2025
School Region	Illawarra and South East NSW	Contract Number:	DDW005227/23

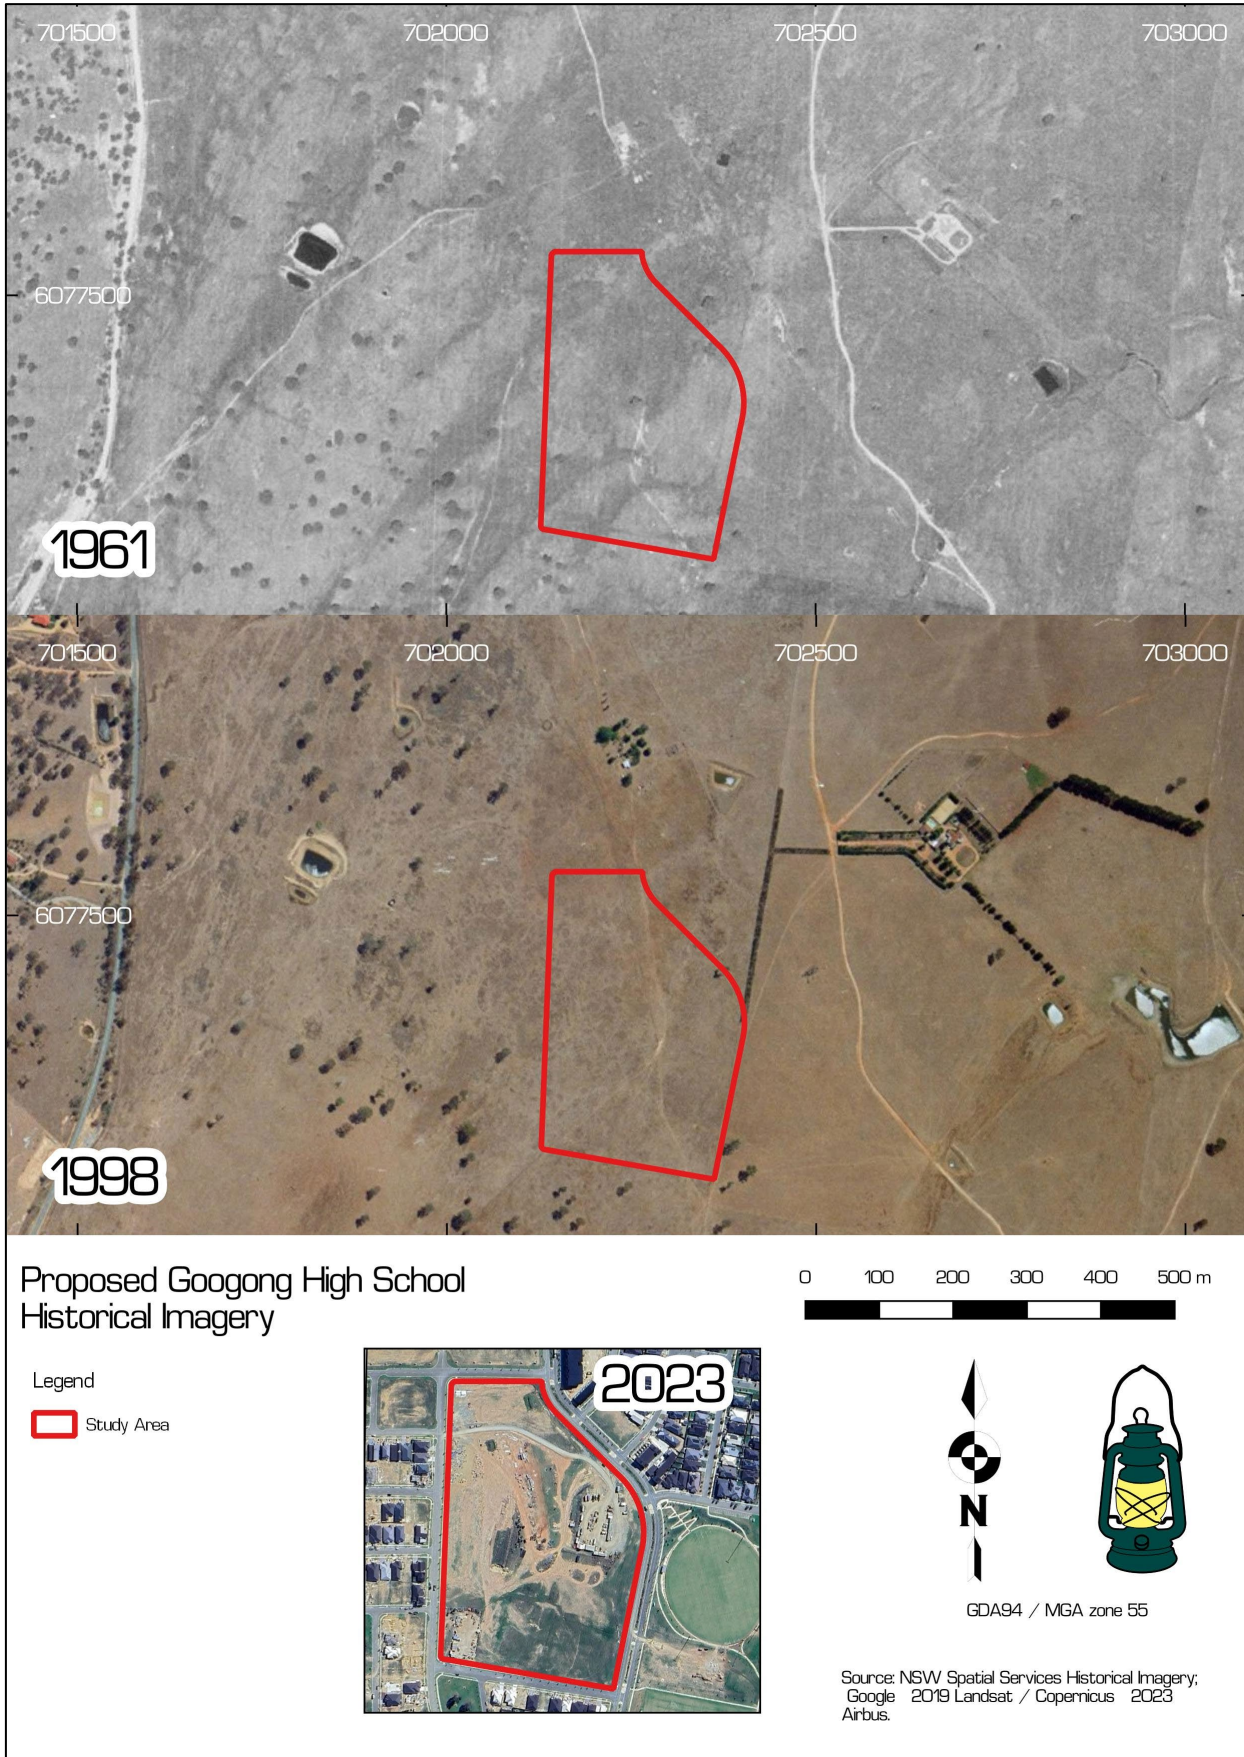
Figure 7: Historic aerial photographs and satellite imagery of study area showing lack of trees due to pastoral activities and topsoil removal (inset image) during construction of Neighbourhood 2.

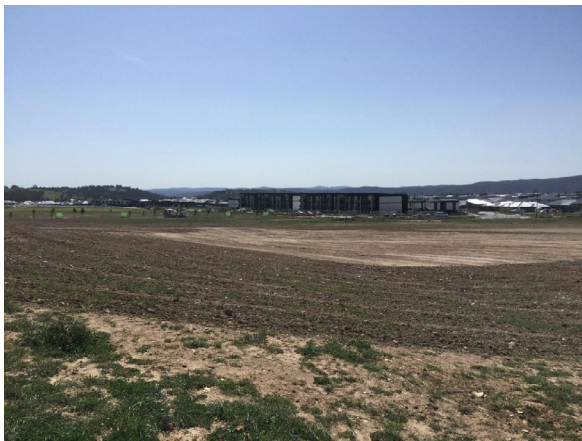
Overall, the proposed activity area was found to be highly disturbed from construction activities associated with development of Googong Neighbourhood 2 (Plate 1). Along the eastern boundary of the activity area up to 80cm of topsoil had been removed to create a drainage channel (Plate 2). Topsoil has been stripped across the remainder of the area revealing a gravelly soil containing decomposing bedrock (Plate 5). Based on test excavation of GAPAD 17 (#57-2-0595) located about 600m northeast of the activity area this decomposing bedrock indicates that approximately 15 to 25cm of soil has been removed. Testing in this area also showed that artefacts were located on the surface and within the top 10cm of soil. As a result, it is concluded that any artefact bearing soil deposit has been removed from across the activity area.

Plate 1: Survey Unit 1. Overview showing extensive removal of topsoil and gentle gradient slope (facing north).

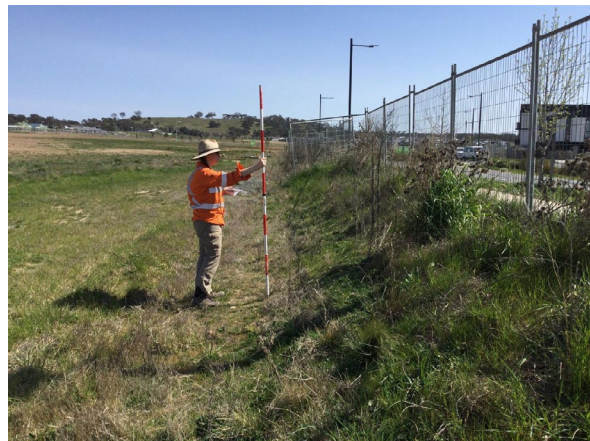
Plate 2: Survey Unit 1. East side showing cutting for drainage channel to depth of removal c. 80cm. Image oriented west-northwest.

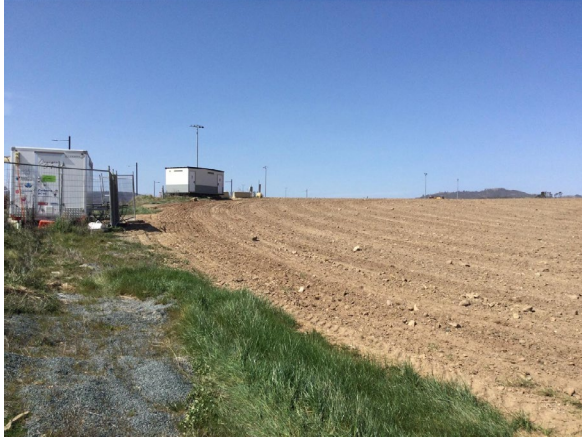
Plate 3: Survey Unit 1. East side overview facing west-southwest showing topsoil removal and rocky subsoil.

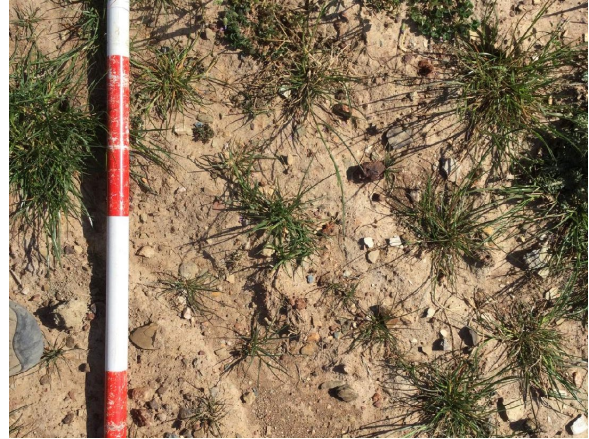
The southwest area of the SU is unvegetated loose soil of a very silty makeup with small gravels (Plate 4). Soil was very dry at the time of the survey and blown about. Exposure and visibility both average 100% within this area. Sediment has visible large 20x20cm slate inclusions, with gravels and minor amounts of background white quartz. No artefactual material observed. Despite vegetation variations, this sediment continues across the entire site.

Plate 4: Survey Unit 1. Northeast quadrant showing ground exposure, gravelly subsoil and disturbance.

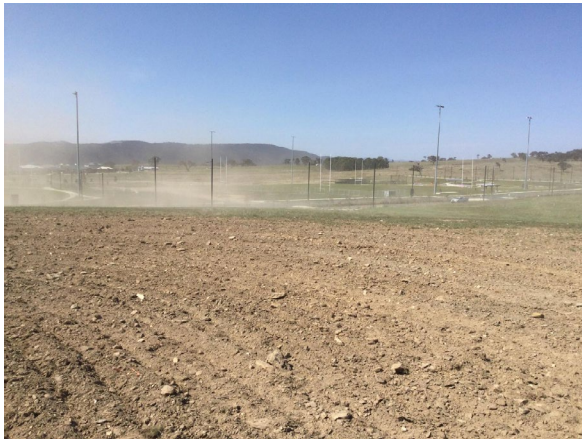
The sediment of the soil is a heavily disturbed silt sediment, with significant topsoil clearing as shown in Plates 5 and 8). Sediment has large visible background gravels visible. The majority of the SU continues to be heavily grassed, with exposure averaging 50%, with visibility within these exposures averaging 90%.

Plate 5: Survey Unit 2. Overview survey unit showing ground disturbance and rocks. Image facing southwest. Dust and wind conditions visible impeding activity.

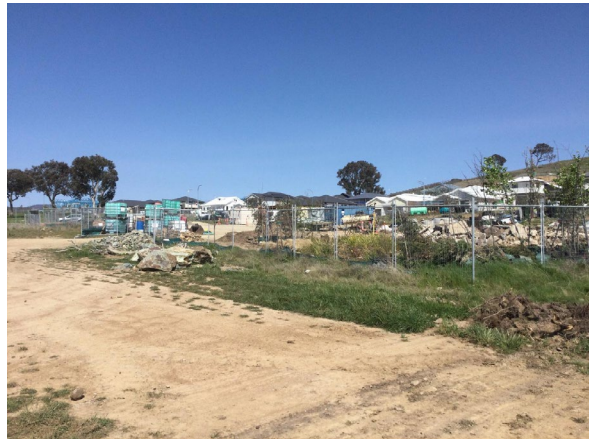
The 'site compound' is located in the southwest (Glenrock Dr/Harvest St junction) corner of the block comprises a heavily disturbed fenced area, including material storage (Plate 6). A vehicle track is present from this compound to the Glenrock Dr entrance.

Plate 6: Survey Unit 2. Site compound in the southwest corner of the study area. Image facing south.

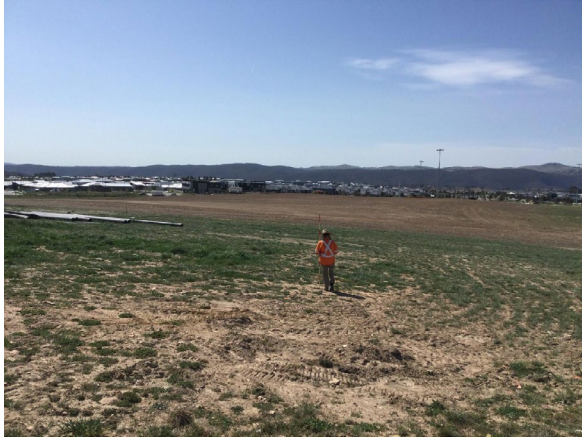
Plate 7: Survey Unit 2. West boundary of survey unit. Image facing northeast.

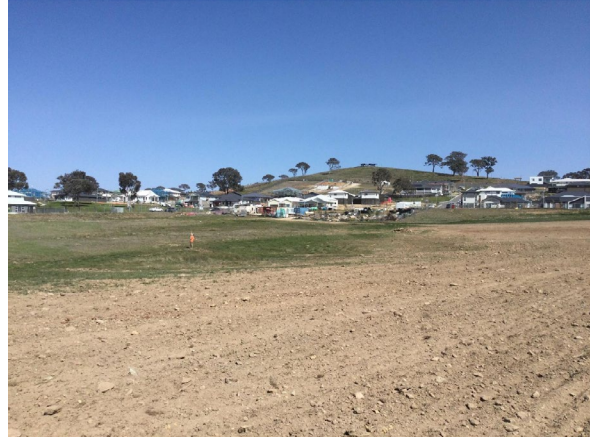
Plate 8: Survey Unit 2. Overview of the start of the survey unit, showing minor drainage channel in centre. Image facing southwest.

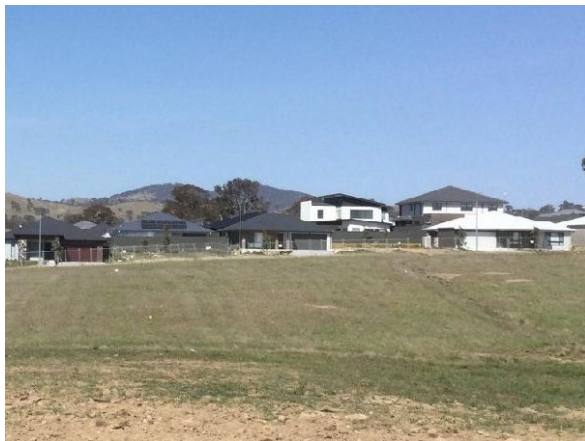
Plate 9: The location of AHIMS #57-2-0988

Visibility across the site was limited by grass cover, however based on field observations and results of previous test excavation any artefact bearing soil was removed during development of Googong Neighbourhood 2. The remaining deposit is a gravelly soil with fragments of decomposed bedrock. No artefacts were observed during the 2023 visual inspection conducted by Lantern Heritage (Plate 9).

It is considered that there is no potential for archaeological material to remain in situ. This site is located within the proposed activity area.

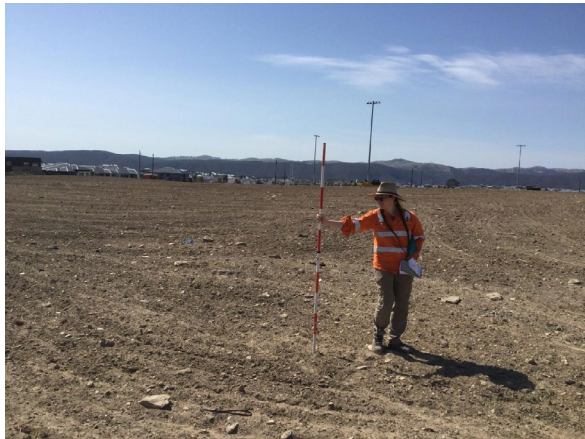
No artefacts were observed during Lantern Heritage's 2023 visual inspection.

It is considered that there is no potential for archaeological material to remain in situ. This site is located within the proposed activity area.

Plate 10: Condition of previous recorded site AHIMS #57-2-0989. Image oriented east northeast.

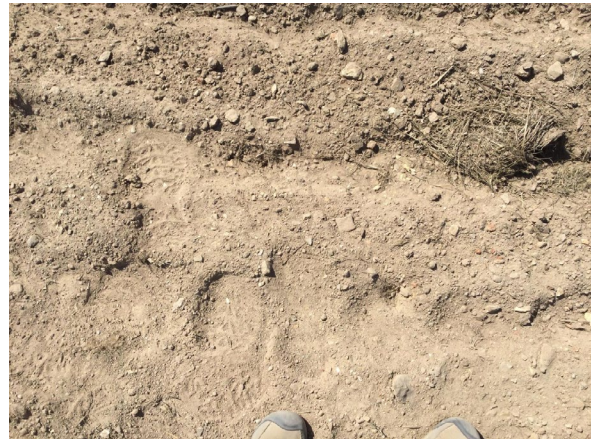
Plate 11: Ground disturbance present at site AHIMS #57-2-0989

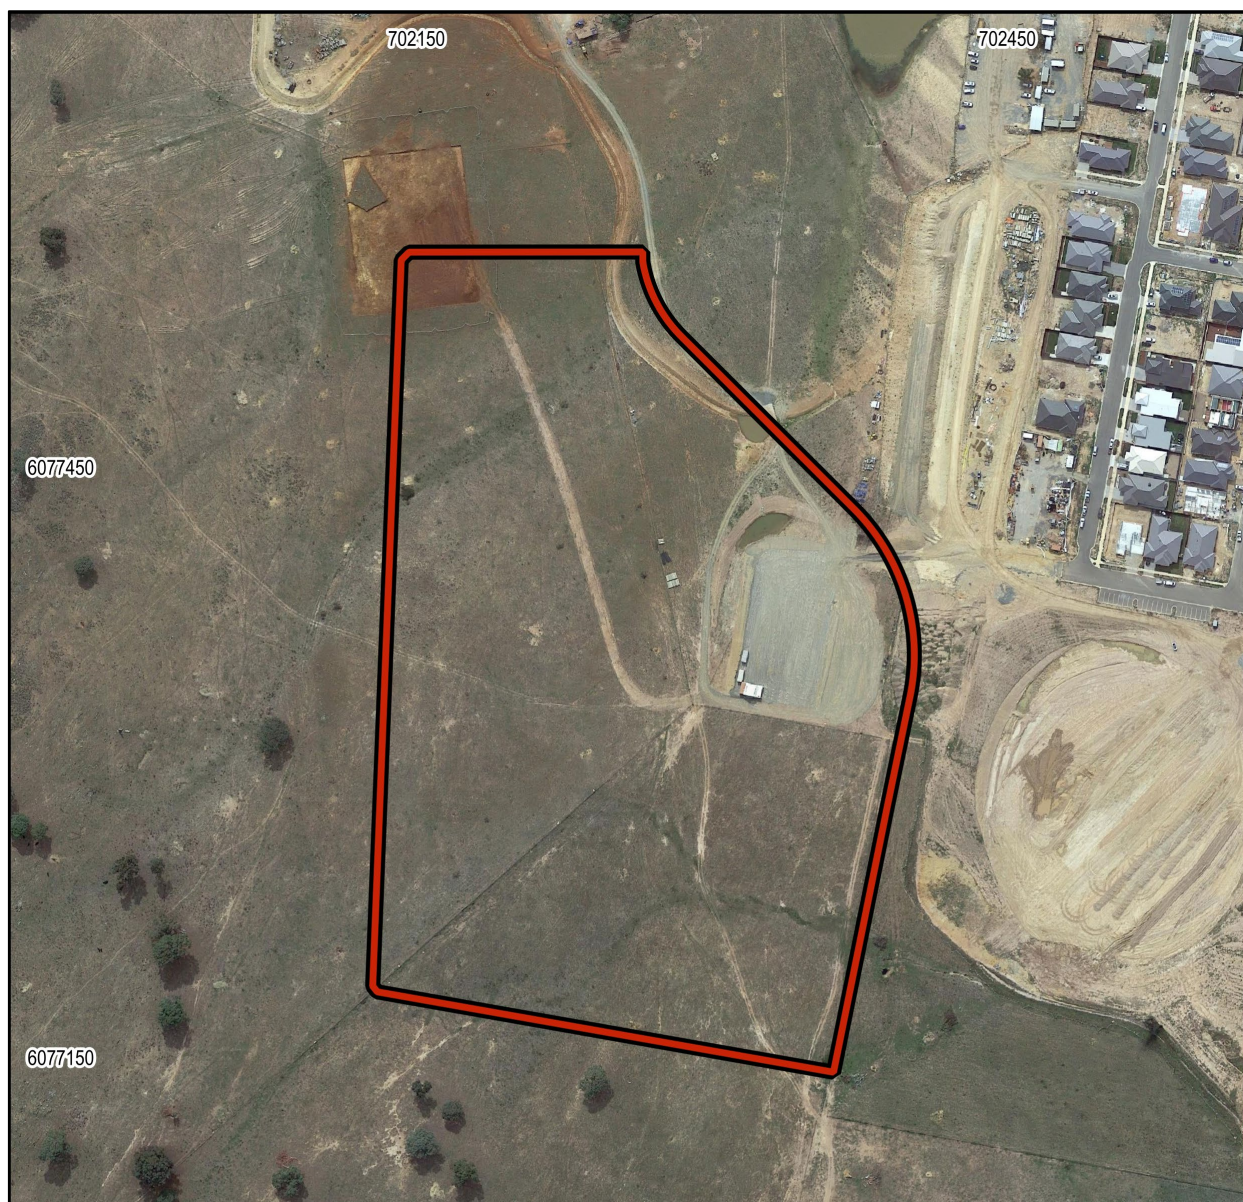
Googong Risk Map

APPENDIX 2 – MAP IDENTIFYING HIGH RISK AREAS - NONE

This map is a visual representation to be used as a guide ONLY, is based on desktop observations, aerial imagery and is limited to the result of the desktop assessment undertaken for the Schools Infrastructure Due Diligence Project - Googong Public - Preliminary Indigenous Heritage Assessment and Impact Report.
