**Report on Additional Geotechnical
Investigation**

Proposed New High School for Googong

200 Wellsvale Drive, Googong NSW

Project 224779.01

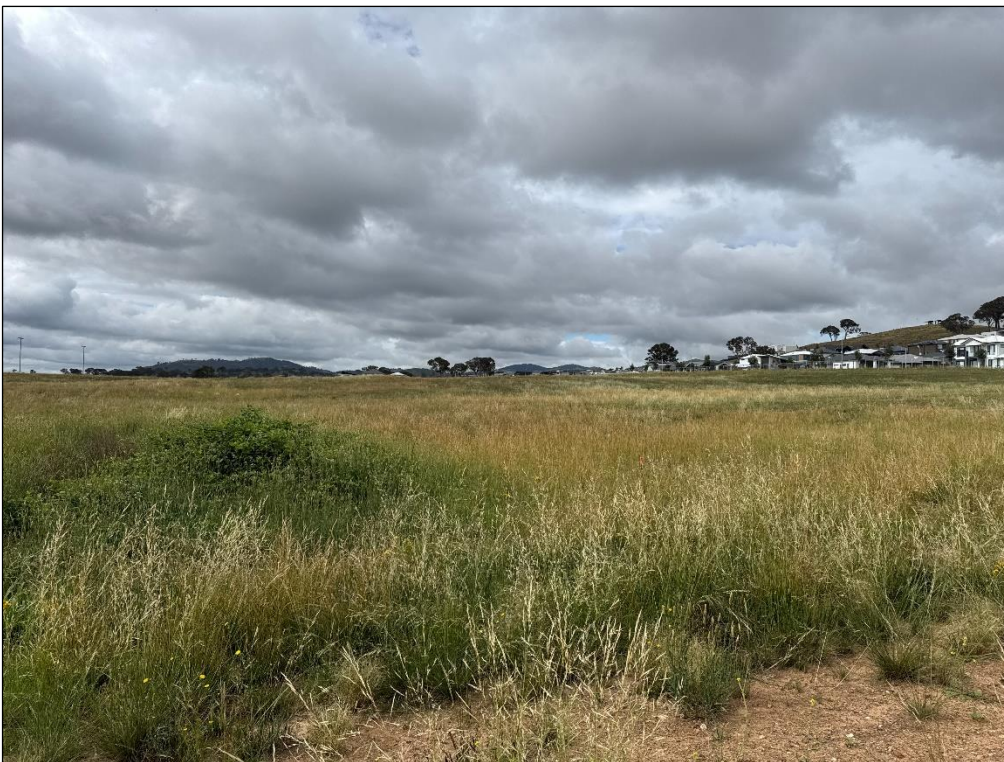
Figure 3: General site conditions looking south from Bore 304

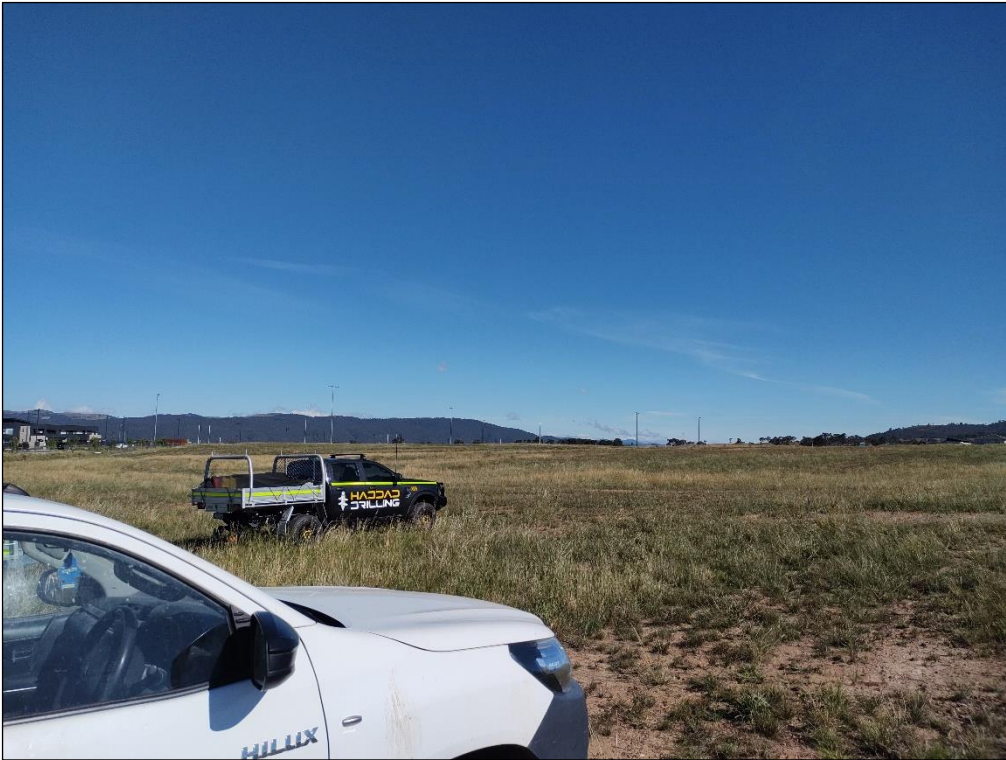
Figure 4: General site conditions looking northwest from Bore 301

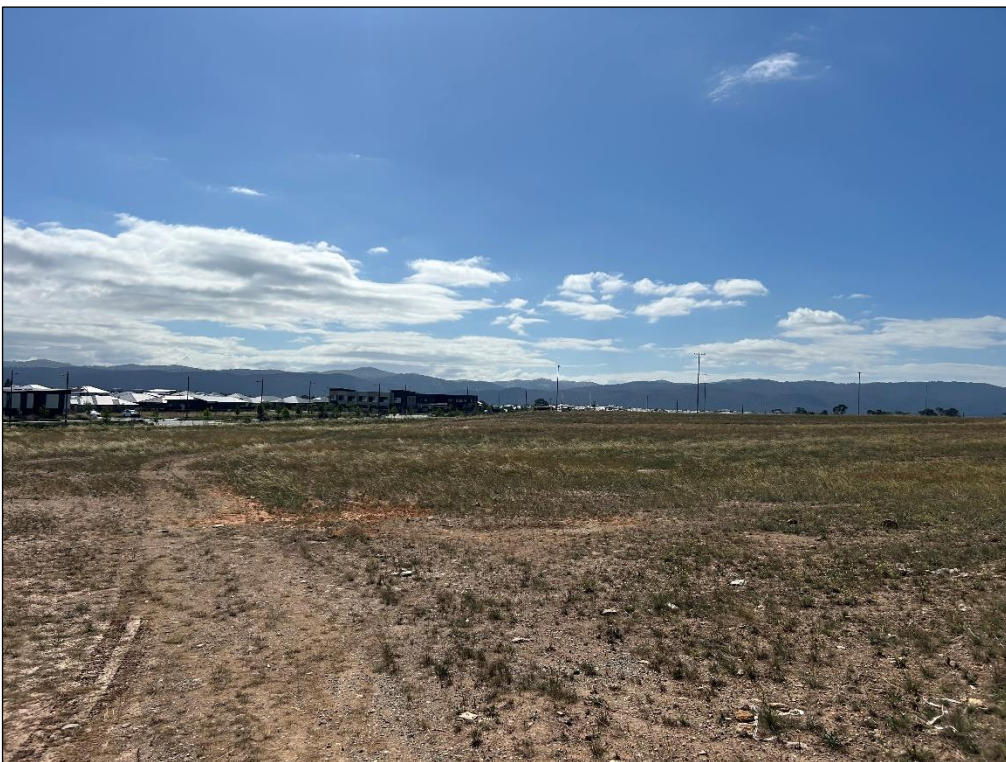
Figure 5: General site conditions looking southeast from the site entrance.

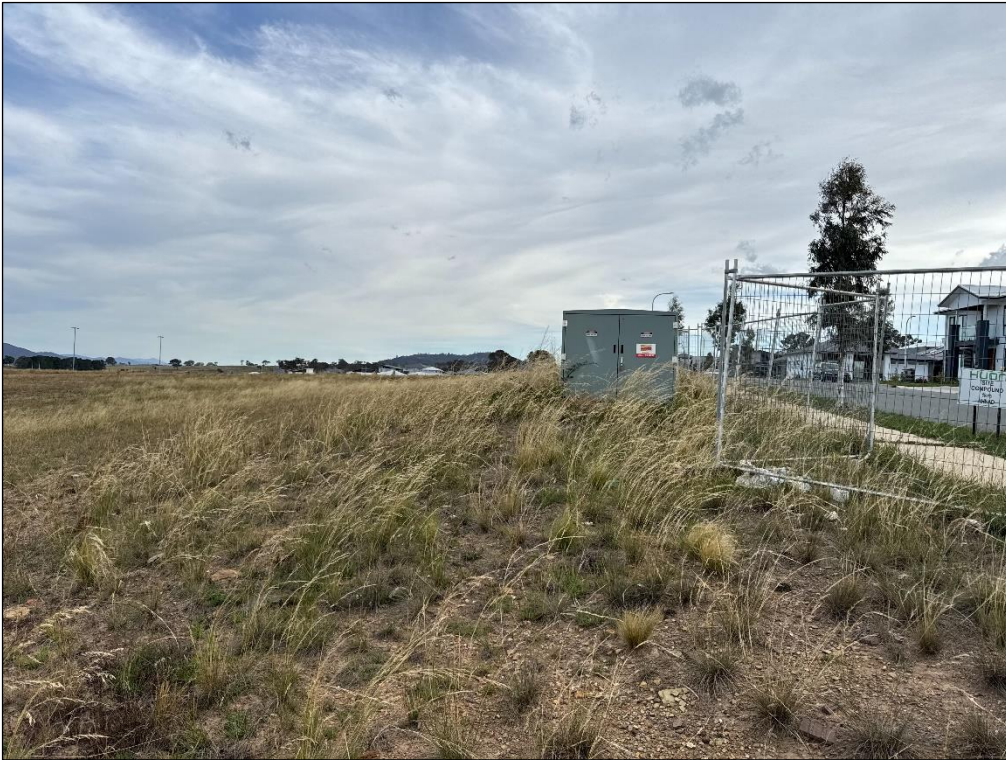
Figure 6: Essential Energy substation located to the south of the site entrance.

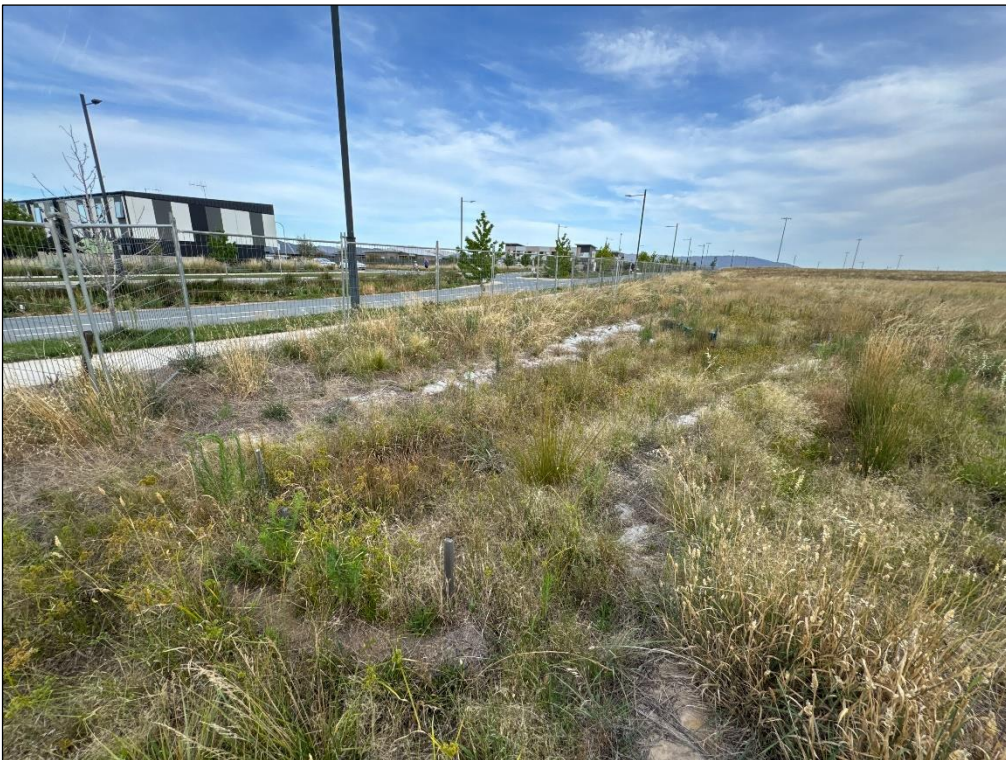
Figure 7: Possible former drainage channel with silt fences in the north-eastern corner of the site, looking east/southwest.

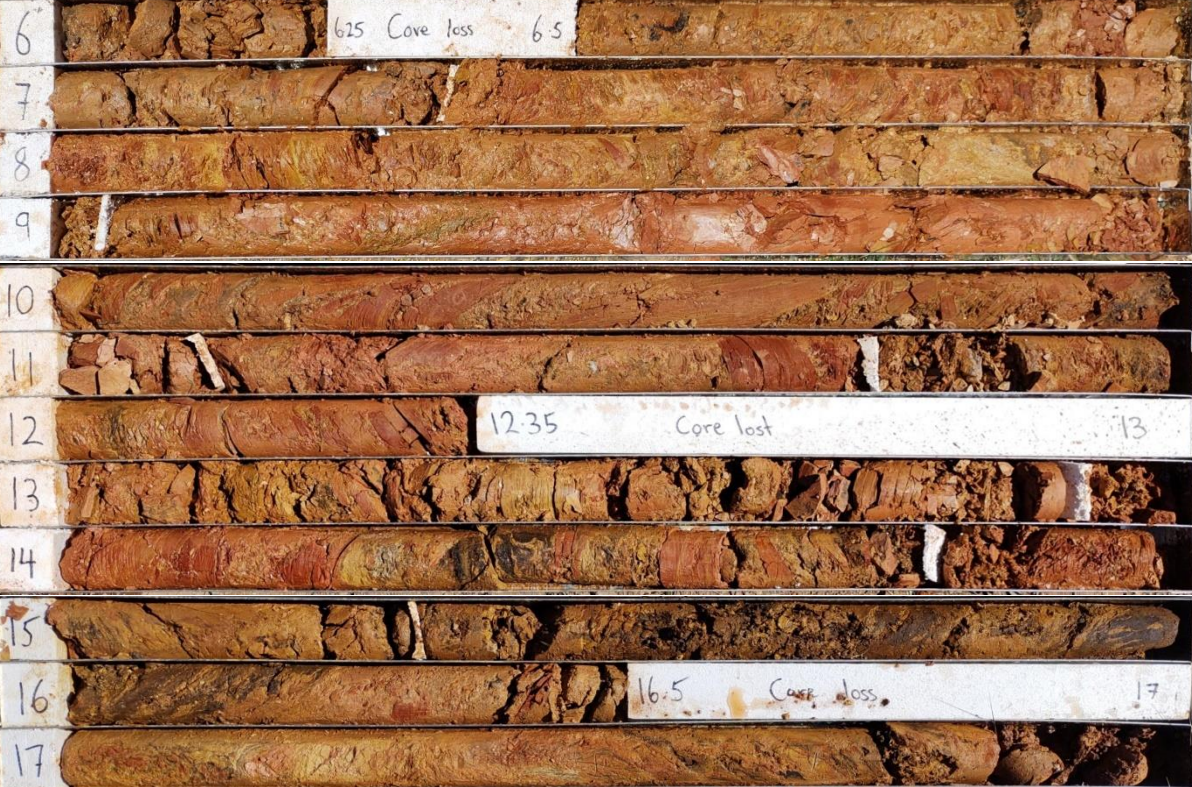
224779.01 Googong School Bore 306 Core finished @ 18m
