Our Reference: 23-0475 Soil analysis report

Re: Soil analysis results for Rouse Hill High School Upgrade

This letter report provides the results of the additional soil analysis program. It aims to provide further clarity regarding the nature and extent of the introduced fill/topsoil layers, particularly in relation to the high school's sports field.

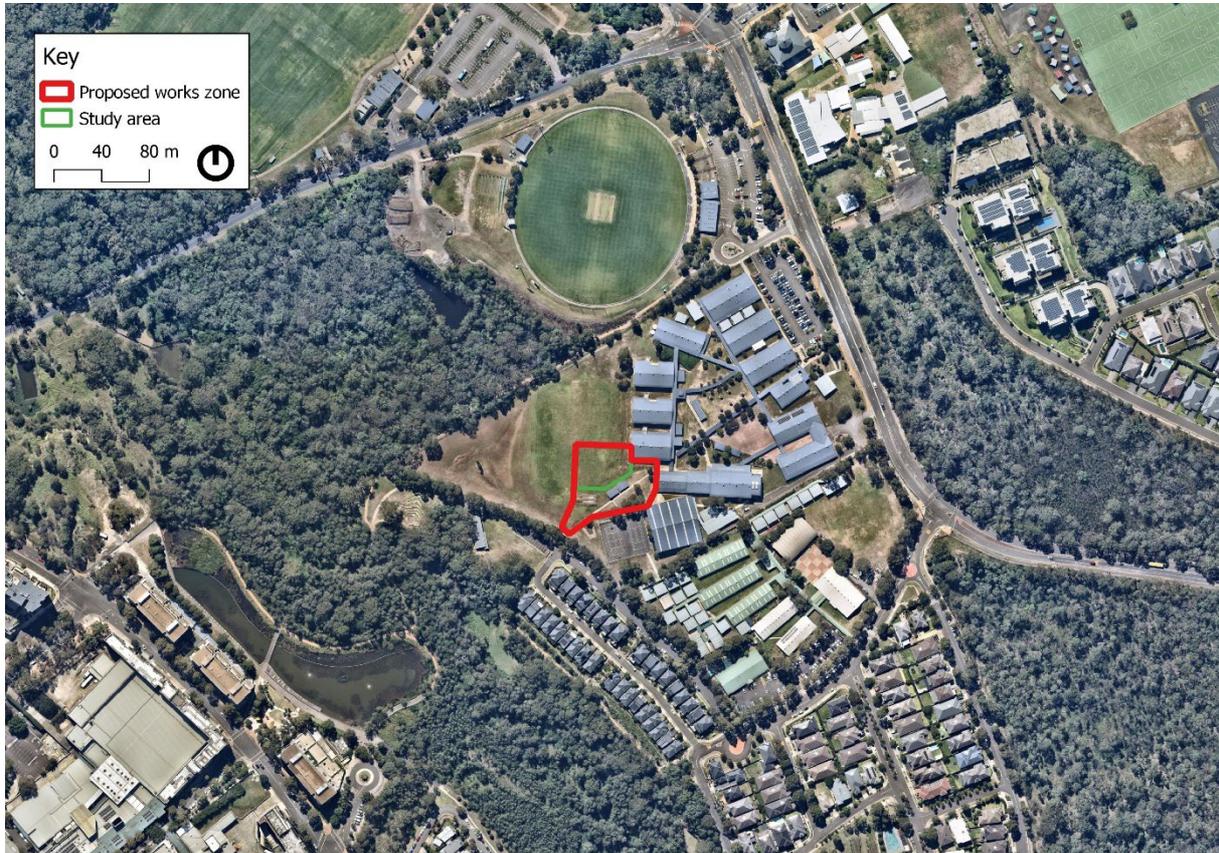
Figure 1 Rouse Hill High School. The extent of the school's upgrade project, the study area, is outlined in red. The proposed new school building will be located within this area. (Source: Nearmap 2024, with GML additions)

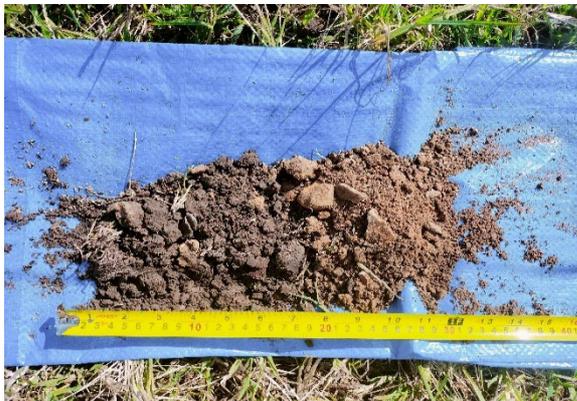
AH	Description
BH1	Unit 1 —0–15cm below ground level (bgl), very dark grey (10YR 3/1) sandy clay loam. Fine to medium granular pedal structure. Abundant rootlets, few ironstone gravels. Very few brick fragments. Moderately compacted. Sharp transition to Unit 2.
	Unit 2 —15–25cm bgl, brown (10YR 4/3) clayey sand. Frequent yellow and red mottles. Few rootlets, although a possible root channel was identified at 24cm depth (characterised by a black silty loam material).
	Auger refused at 25cm depth.

Figure 4 BH1, Unit 1 on the left.

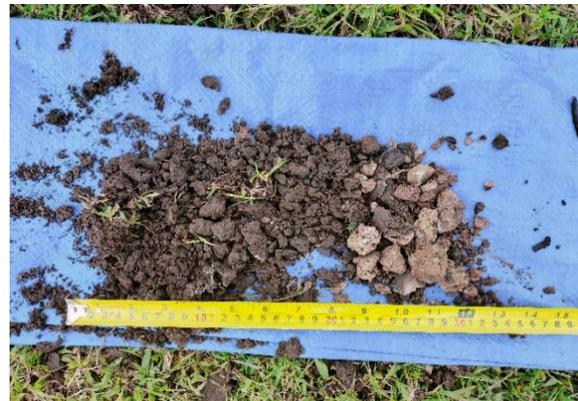
AH	Description
BH2	<p>Unit 1—0–25cm bgl, black (10YR 2/1) sandy loam. Abundant rootlets, few charcoal flecks and very few crushed sandstone inclusions (at 5cm depth). Loosely consolidated to approximately 5cm depth, below increased clay content is associated with increased compaction and friability. Clear boundary to Unit 2.</p> <hr/> <p>Unit 2—25–28cm bgl, light yellowish brown (10YR 6/4) medium clay. Common mottling (white, dark brown, brown, red brown, red), few crushed sandstone inclusions.</p>
BH2	Auger refused at 28cm bgl.
BH3	<p>Unit 1—0–30cm bgl, loosely consolidated black (10YR 2/1) silty clay loam. Fine granular pedal structure. Abundant rootlets, common ironstone nodules and few yellowish-brown mottles. Clay content increased noticeably from around 5–10cm depth. Mixed boundary to Unit 2.</p> <hr/> <p>Unit 2—30–45cm bgl, brown (10YR 4/3) heavy clay. Few large (>1cm) ironstone gravels, crushed sandstone inclusions and very few quartz gravels (<1cm). Common yellow, brown, red and black mottles. Clear transition to Unit 3.</p>

Figure 5 BH2, Unit 1 on the left.

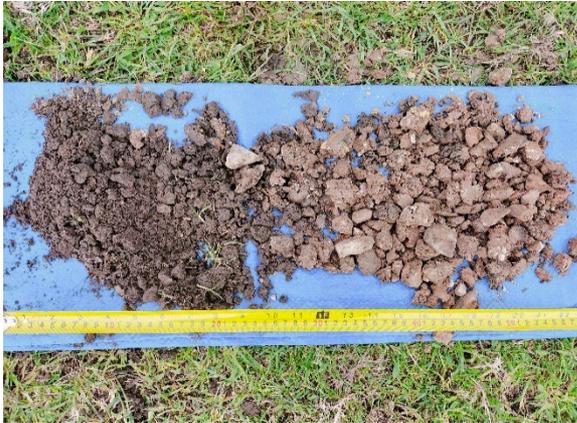
BH3	Unit 3 —45–54cm bgl, strong brown (7.5YR 4/6) heavy clay. Few large (>1cm) ironstone gravels, very few crushed sandstone inclusions. Few red and yellow mottles.
BH4	Auger terminated upon identification of likely subsoil clays.
	<p>Unit 1—0–10cm, loosely consolidated dark grey (10YR 3/1) silty loam. Abundant rootlets, few charcoal flecks, ironstone gravels and very few brick fragments. Few brown and yellow mottles.</p> <hr/> <p>Unit 2—10–23cm, dark grey (10YR 3/1) silty clay loam. Few ironstone gravels, brick fragments and rootlets.</p>
BH4	Unit 3 —23–30cm, light olive brown (2.5YR 5/4) light clay. Common grey-brown, white, brown and red-brown bands. Mixed boundary to Unit 4.
BH5	<p>Unit 4—30–54cm, reddish brown (5YR 4/4) heavy clay with yellow (10YR 5/6) and brown (10YR 4/3) mottles. Few small (<5mm) ironstone gravels. Unclear boundary with Unit 5.</p> <hr/> <p>Unit 5—54–65cm, reddish brown (5YR 4/4) light clay. Common sandstone, ironstone gravels, very few quartz gravels. Common brown and white mottles.</p> <hr/> <p>Unit 6—65–69cm, brown (7.5YR 4/2) clayey sand. Common sandstone, ironstone gravels, very few quartz gravels.</p>

Figure 6 BH3, Unit 1 on the left.

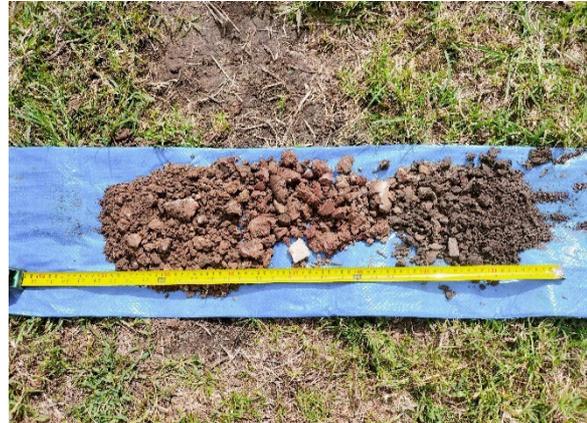
Figure 7 BH4, Unit 1 on the right.

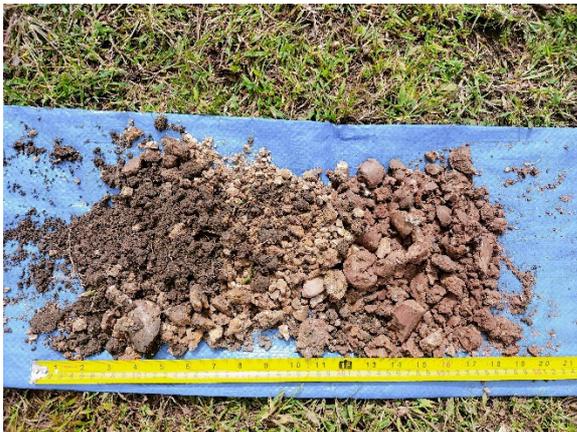
Auger refused at 69cm bgl. Unit 6 may represent a subsoils clay.
	<p>Unit 1—0–15cm bgl, very dark brown (10YR 3/2) silty loam with very fine granular pedal structure. Abundant rootlets. Clear transition to Unit 2.</p> <hr/> <p>Unit 2—15–25cm bgl, yellowish brown (10YR 5/6) clayey sand. Few small (<1cm) ironstone gravels and very few crushed sandstone inclusions. Red, yellow and white mottling. Clear transition to Unit 3.</p>
BH5	Unit 3 —25–45cm, reddish brown (2.5YR 4/4) heavy clay. Few large (>1cm) ironstone inclusions, very few charcoal flecks and gravels (unknown material). Common yellowish-brown and brown mottles.
BH6

Figure 8 BH5, Unit 1 on the left.

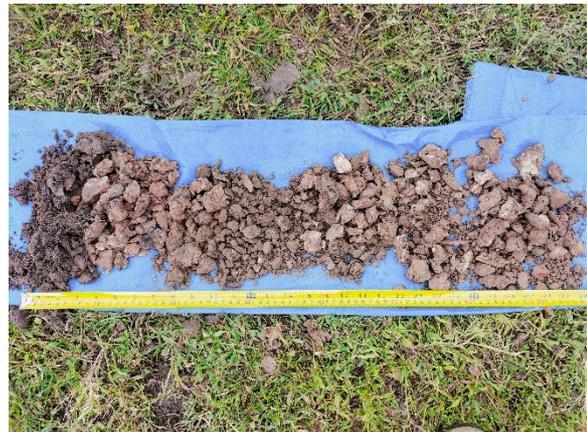
Unit 1—0–15cm bgl, dark greyish brown (2.5YR 4/2) silty loam. Apedal structure. Abundant rootlets, few small (<5mm) ironstone gravels, very few crushed sandstone inclusions. Mixed boundary to Unit 2.

Unit 2—15–25cm bgl, strong brown (7.5YR 4/6) heavy clay, common rootlets, small (<1cm) ironstone gravels, crushed sandstone. Few red, brown and grey-brown mottles. Clear transition to Unit 3.

BH6 Unit 3—25–45cm bgl, yellowish-brown (10YR 4/4) heavy clay. Common mottles (brown, red, yellow, white). Very few small (<1cm) ironstone gravels, rootlets. Mixed boundary to Unit 4.

Unit 4—45–67cm bgl, brown (10YR 4/3) medium clay. Very few small ironstone gravels and charcoal flecks. Few white and yellow mottles.

Unit 5—67–73cm bgl, reddish brown (2.5YR 4/4) heavy clay. Few ironstone gravels and very few sandstone inclusions.

Figure 9 BH6, Unit 1 on the left.
