Arboricultural Impact Assessment Report

**Rouse Hill High School Upgrade
240 Withers Road
Rouse Hill NSW 2155**

December 2024
Updated March 2025
FINAL

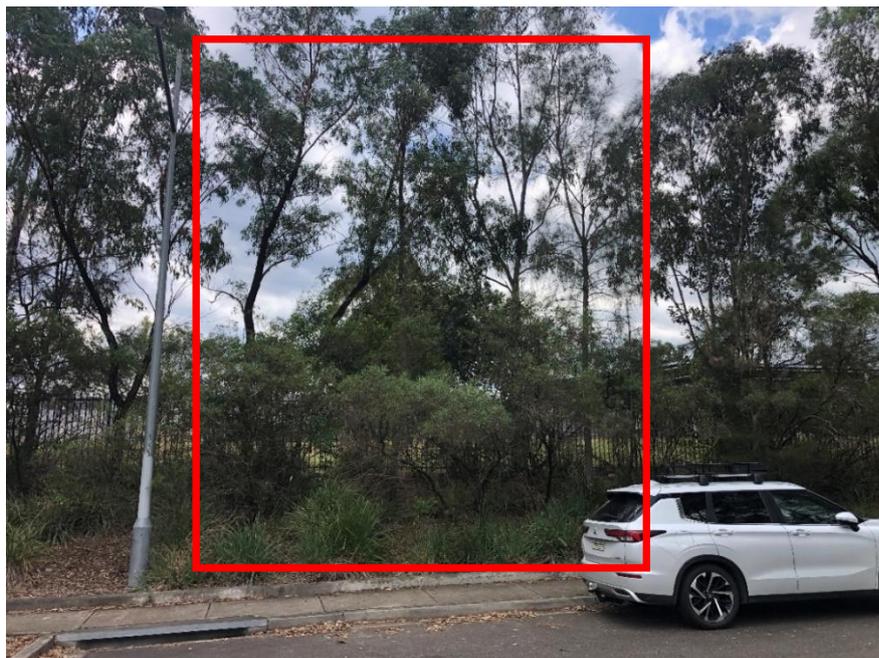
Plate 1: Image showing Trees 1-5 (red area). P. Vezgoff.

- 3.5** Trees 1-5 are located along Caballo Street (Plate 1). The species consist of Iron bark (*Eucalyptus crebra*), Forest red gum (*Eucalyptus tereticornis*), Swamp she oak (*Casuarina glauca*), Black wattle (*Acacia decurrens*). These specimens are quite young and have been planted along a raised embankment along the school boundary.

- 4.2 Trees numbered as 1-4, 10-12 are required to be removed for the project. Tree 5 appears possible to retain.
- 4.3 Trees 6, 7, 8, 9 and 13 – 20 have been approved for removal under The Hills Shire Council Tree Management Permit 261/2025/TR, dated 19/2/2025

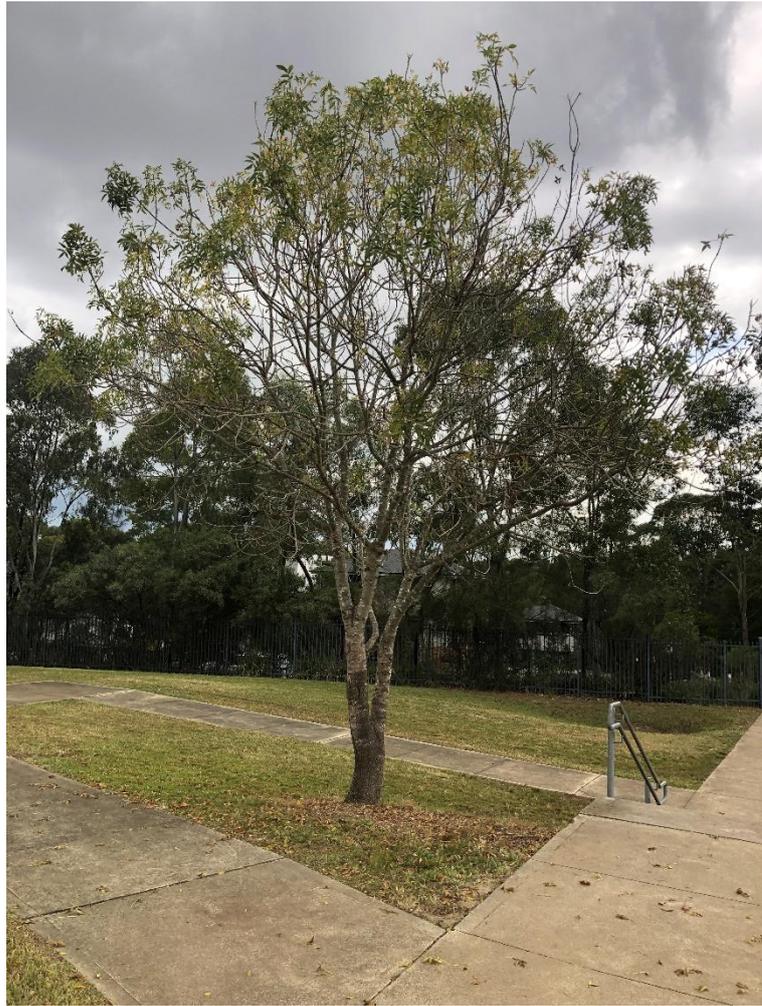
Plate 2: Image showing Tree 6. P. Vezgoff.

- 3.6** Trees within the site include Trees 6-13. Trees 6, 7 and 8 are single specimens of Claret Ash (*Fraxinus oxycarpa*) 'Raywoodii'. These trees are growing in harsh, compacted conditions.

- 3.14** Trees 6, 7 and 8 are all exotic specimens of Claret Ash (*Fraxinus oxycarpa*) 'Raywoodii' and would be considered low value specimens.
- 3.15** Trees 1-4 and 10-12 are proposed to be removed under Chapter 2 through Review of Environmental Factors (REF) pathway. Trees 6, 7, 8, 9 and 13 – 20 have been approved for removal under The Hills Shire Council Tree Management Permit 261/2025/TR, dated 19/2/2025

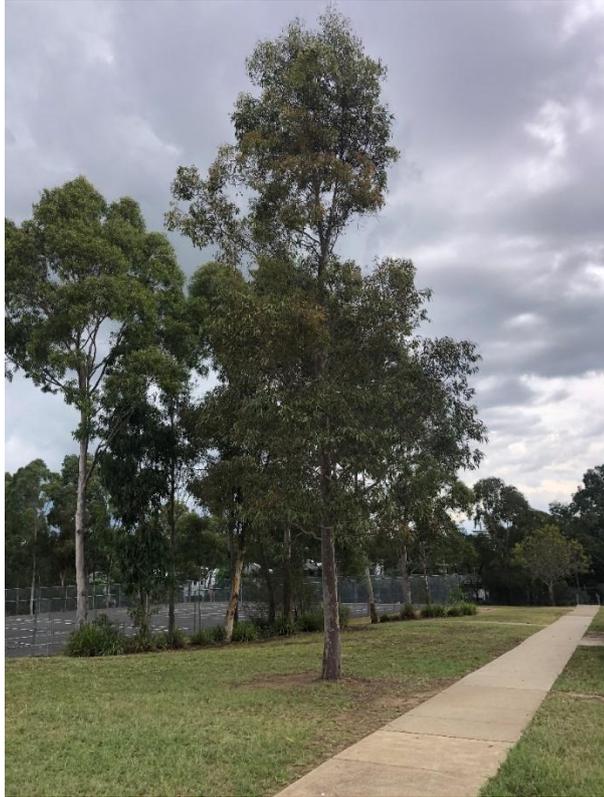
Plate 5: Image showing Tree 9. P. Vezgoff.

- 3.7** Trees 9-13 are specimens of Spotted gum (*Corymbia maculata*), Grey box (*Eucalyptus moluccana*), Lemon-scented (*Corymbia citriodora*, Forest red gum (*Eucalyptus tereticornis*). These trees have been planted as a group and are of a similar size and condition to each other (Plate 7).

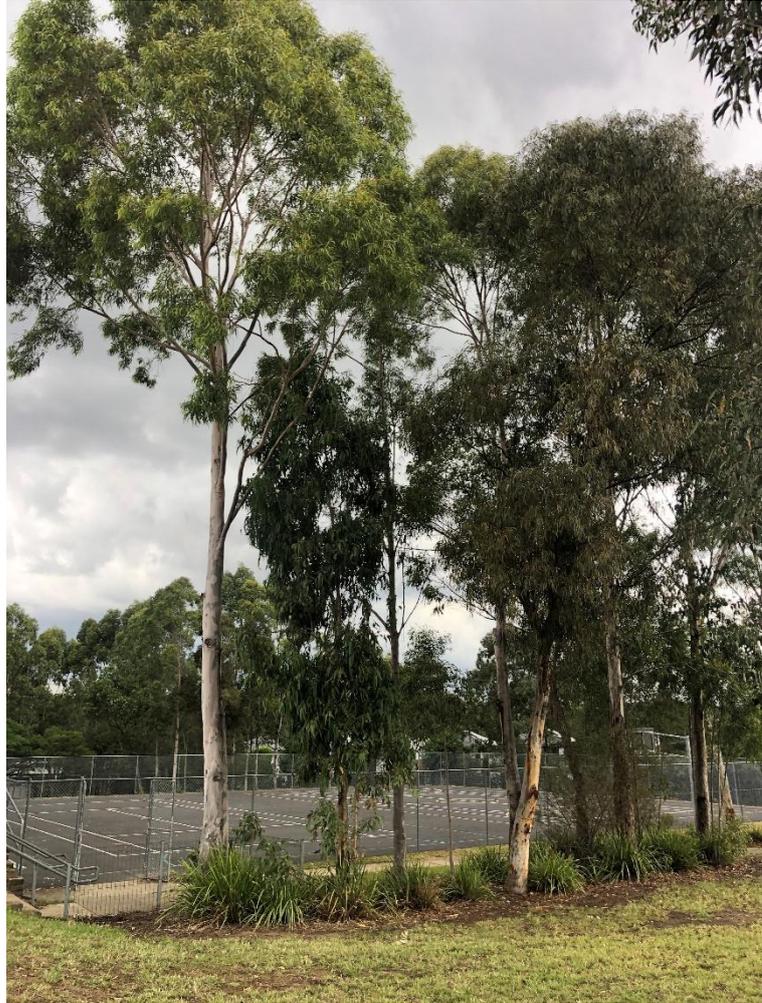
Plate 7: Image showing Tree group 13. P. Vezgoff.

- 3.13** Within the site, Trees 6-12 are within the footprint of the new Emergency Accessway and the hall and, as such, will be removed. Tree group 13 which contains nine (9) trees is mostly outside the building footprint, however it is more than likely Tree group 13 will ultimately be removed due to surface level changes required for the Emergency Accessway construction. Tree group 13 is a collection of trees would not be considered highly significant specimens and could be readily replaced with new plantings.

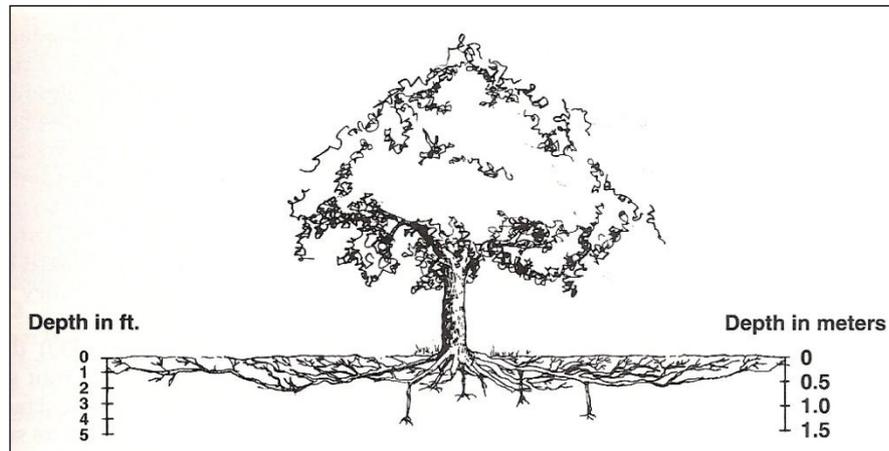
- 3.16** Root growth is opportunistic; that is, roots proliferate in areas conducive to root growth. In fertile soils, in the absence of competition, individual roots may extend in more or less a symmetrical manner. Roots of most plants, including large trees, grow primarily in the top one (1) metre of soil (Diagram 3). For this reason, it will be important to limit root damage and severing of roots for the proposed works. It should be noted that Diagram 3 shows a tree growing in ideal ground conditions. The roots from Tree group 13 are likely to be quite close to the surface and easily impacted.

Diagram 3: In the mature tree the tap root is either lost or reduced in size. The vast majority of the root system is composed of horizontally oriented lateral roots (Harris, Clark, Matheny, 1999).

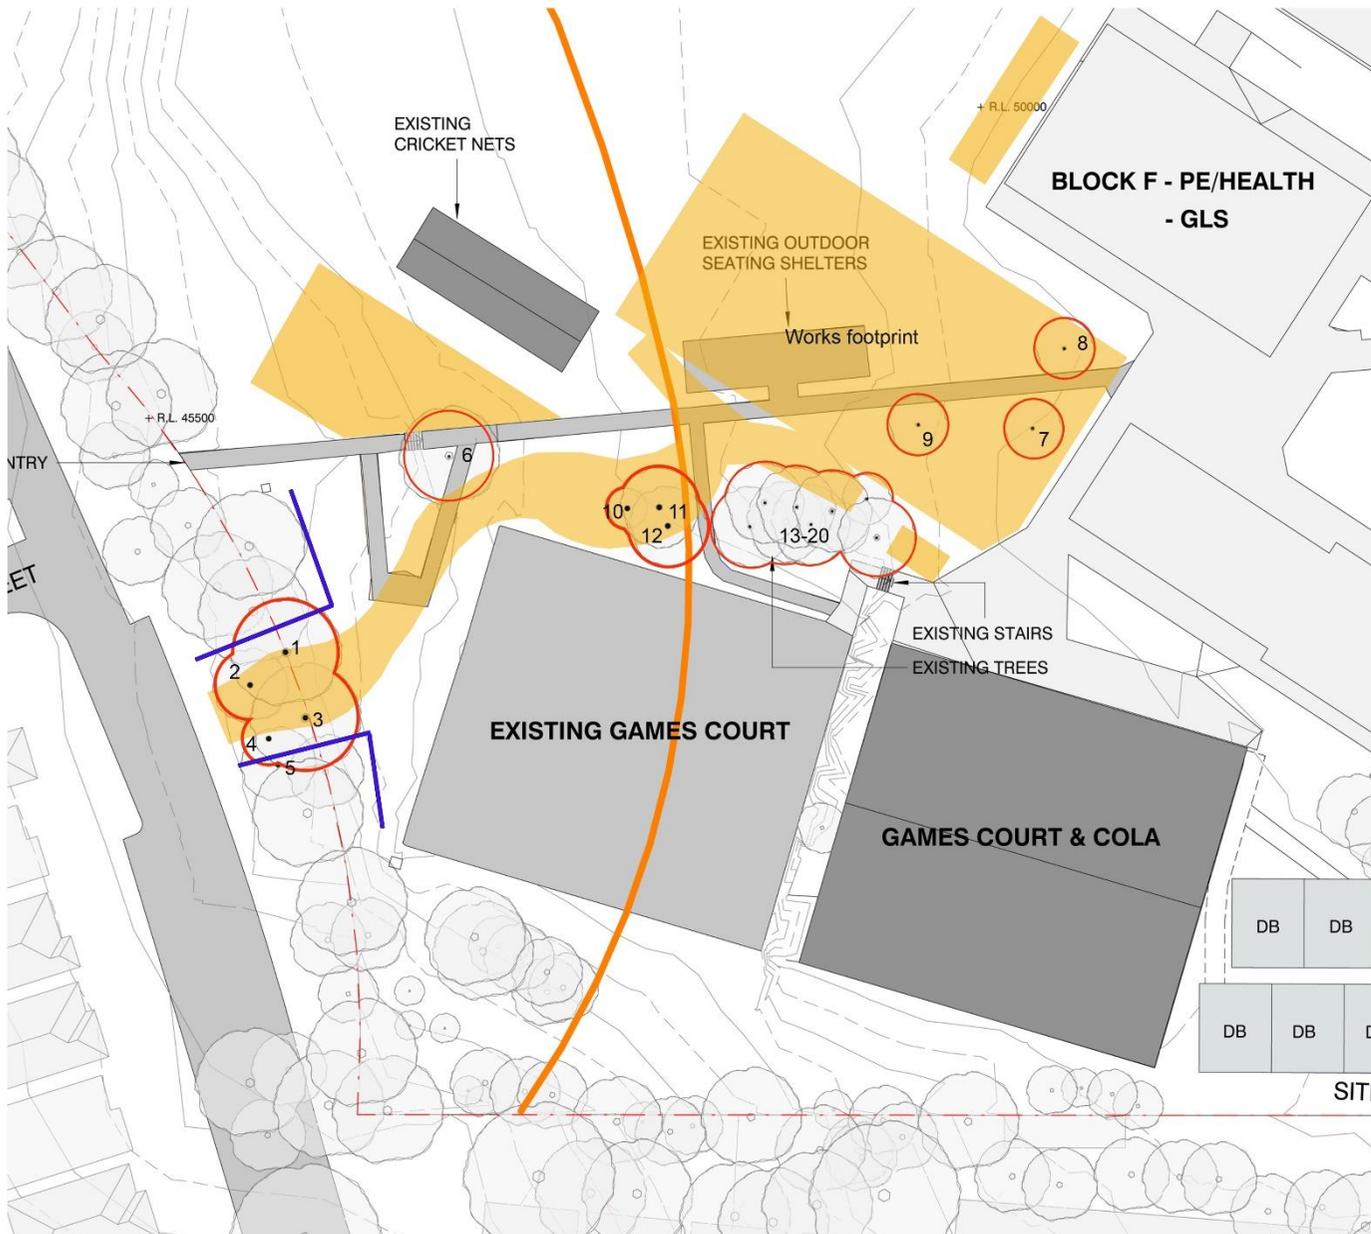
Fence. Implementation of tree protection zone (TPZ). All tree protection works should be carried out before the start of demolition or building works. It is recommended that chain mesh fencing with a minimum height of 1.8 metres be erected

5.1 Trees to be protected: The trees located near the new Emergency Accessway will be required to be fenced for protection. All fencing shall be installed as specified in Section 5.2 (Tree Protection – Implementation of Tree Protection Zone). Indicative locations of the fencing are shown in the Tree Protection Plan (Appendix 1).

5.2 Implementation of Tree Protection Zone: All tree protection works should be carried out before the start of demolition or building work. It is recommended that chain mesh fencing with a minimum height of 1.8 metres be erected as shown in the Tree Protection Plan (Appendix 1). Specifications for this fencing are shown in Tree Protection Fencing Specifications (Appendix 5).

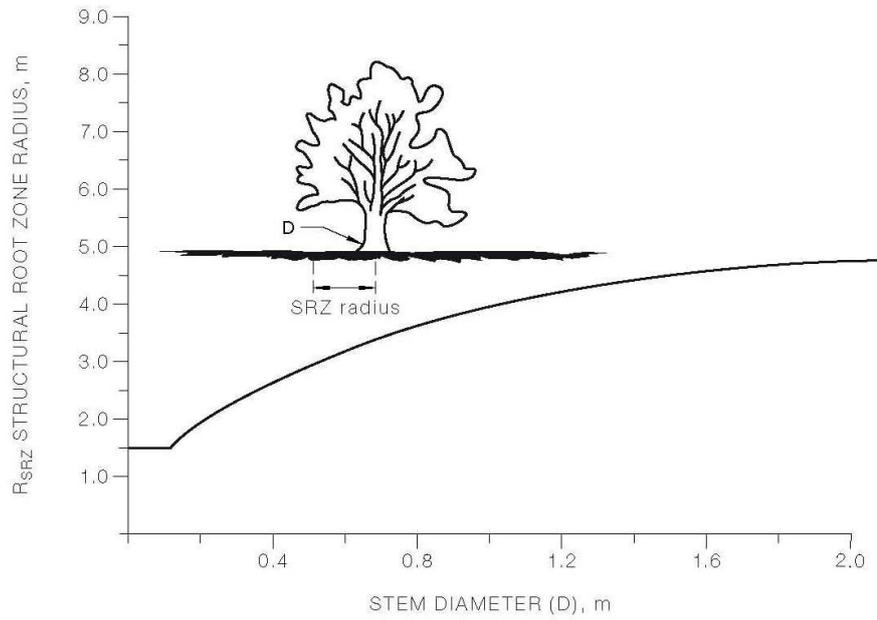
FIGURE 1 - STRUCTURAL ROOT ZONE

NOTE: The SRZ for trees with trunk diameters less than 0.15m will be 1.5m (see Figure 1).

The curve can be expressed by the following formula:
 $R_{SRZ} = (D \times 50)^{0.42} \times 0.64$

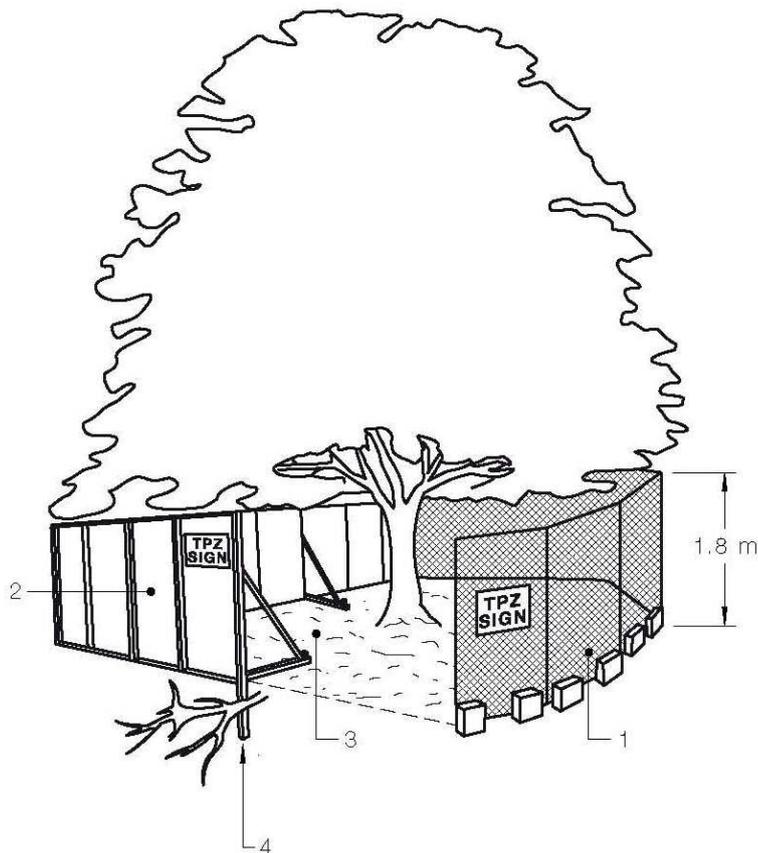
Tree protection fencing
specifications

- 1 Chain wire mesh panels with shade cloth (if required) attached, held in place with concrete feet.
- 2 Alternative plywood or wooden paling fence panels. This fencing material also prevents building materials or soil entering the TPZ.
- 3 Mulch installation across surface of TPZ (at the discretion of the project arborist). No excavation, construction activity, grade changes, surface treatment or storage of materials of any kind is permitted within the TPZ.
- 4 Bracing is permissible within the TPZ. Installation of supports should avoid damaging roots.
