Report on
Detailed Site Investigation (Contamination)

Rouse Hill High School Upgrade
240 Withers Road, Rouse Hill

Prepared for
NSW Department of Education

Project 215851.00
April 2024

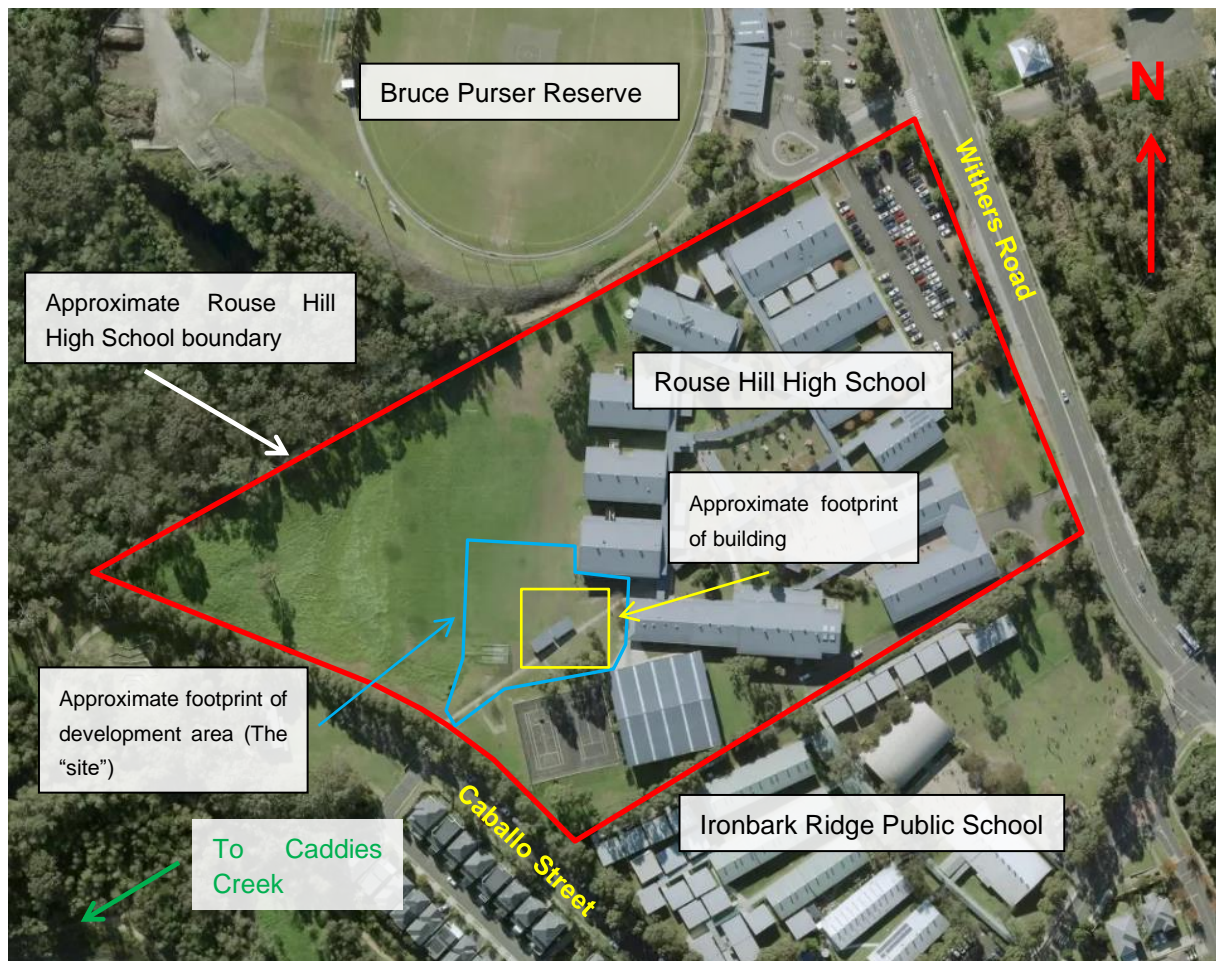
Figure 1: Site Location Plan (Source: Metro Map)

Item	Details
Site Address	240 Withers Road, Rouse Hill
Legal Description	Lot 105 DP 1108407
Area	Larger school site 5.8 hectares (approximately) Site development area 0.4 hectare (approximately)
Zoning	Medium Density Residential R3
Local Council Area	The Hills Shire Council
Current Use	High School
Surrounding Uses	North – Bruce Purser Reserve East – Withers Road South – Ironbark Public School West – Caballo Street with residential properties beyond

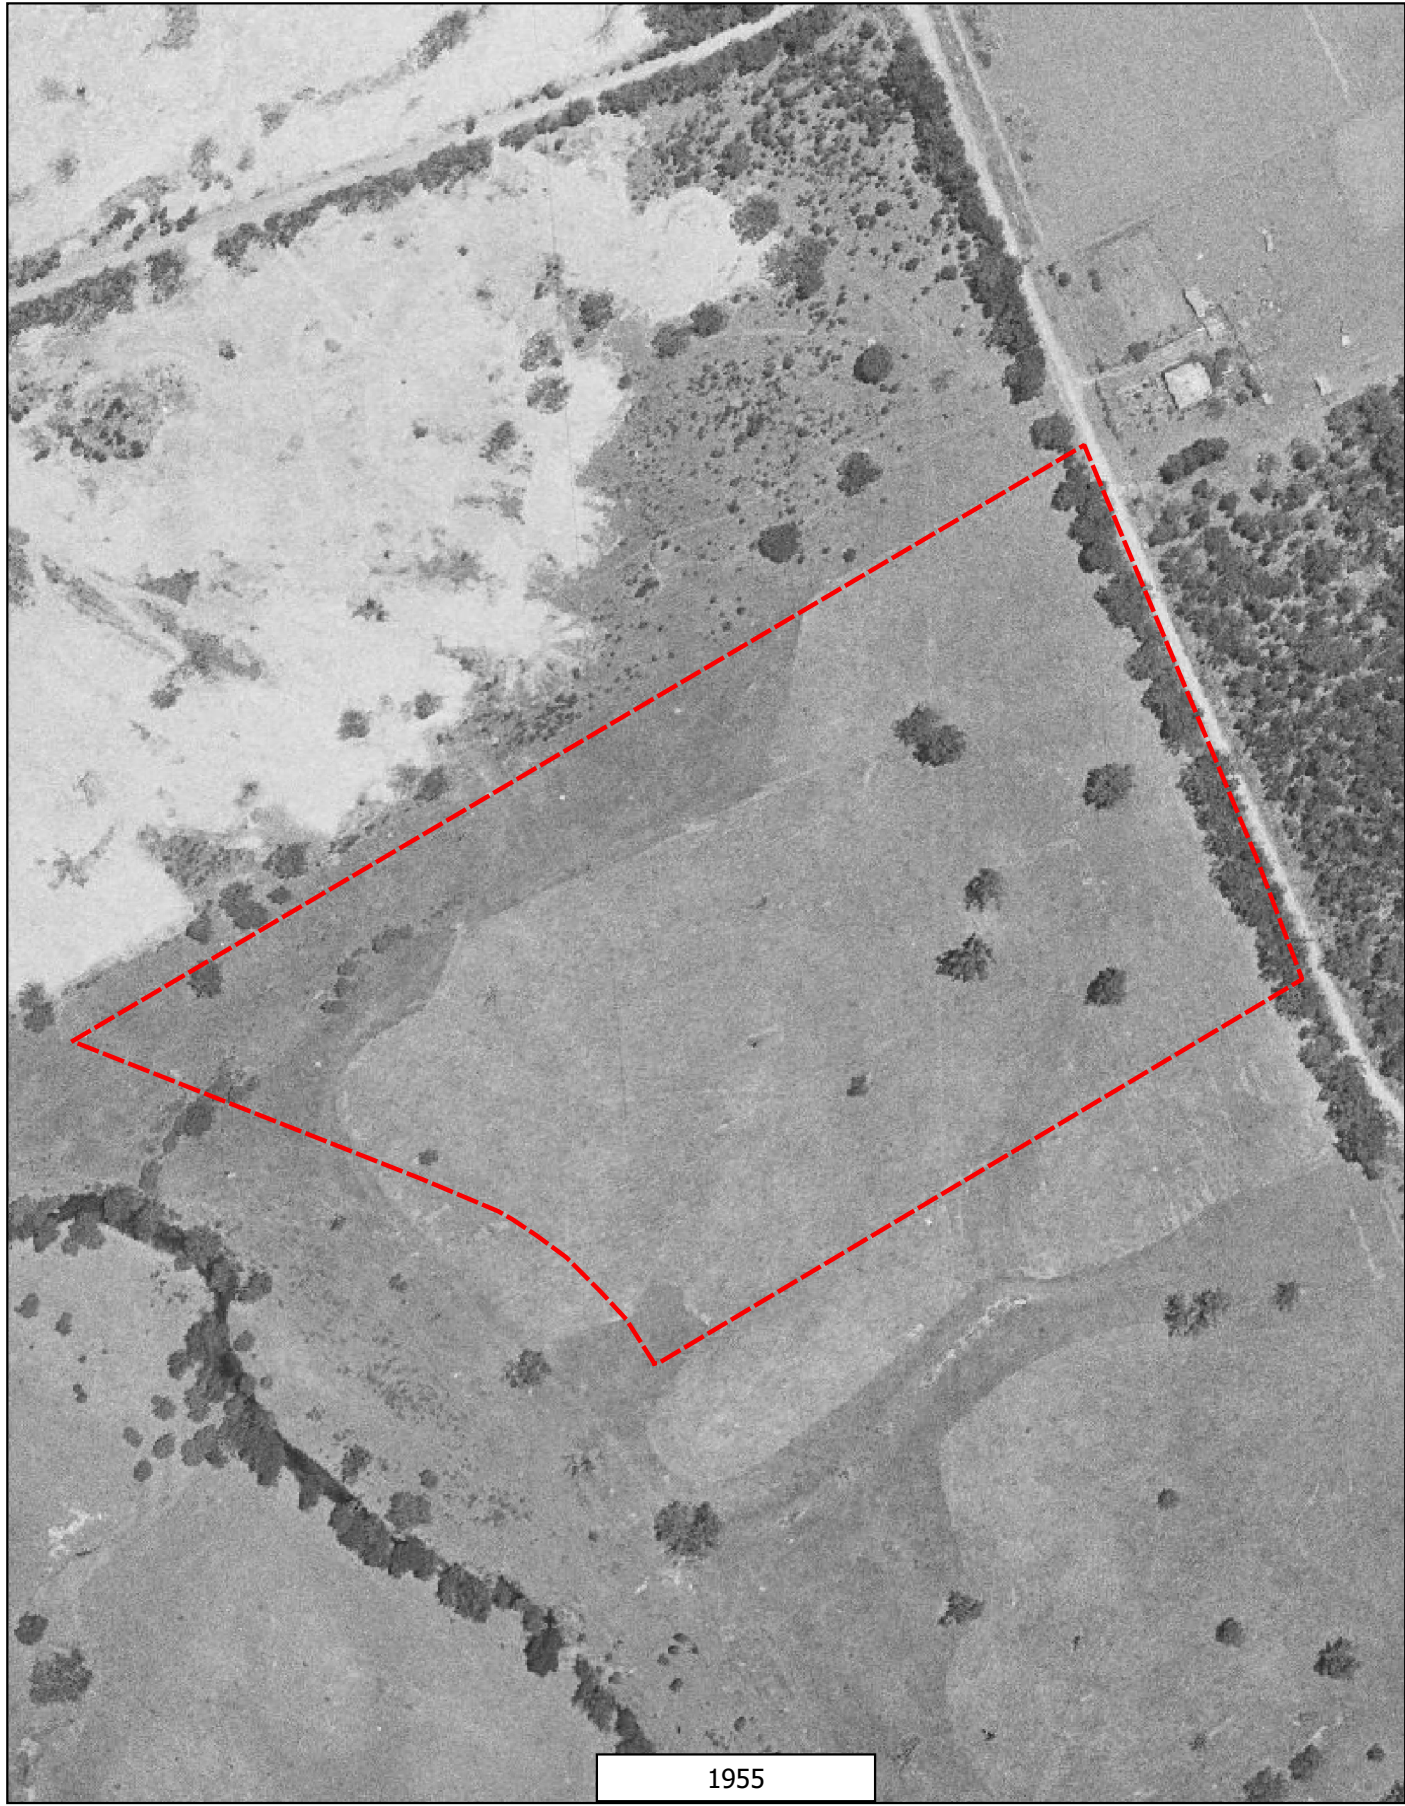
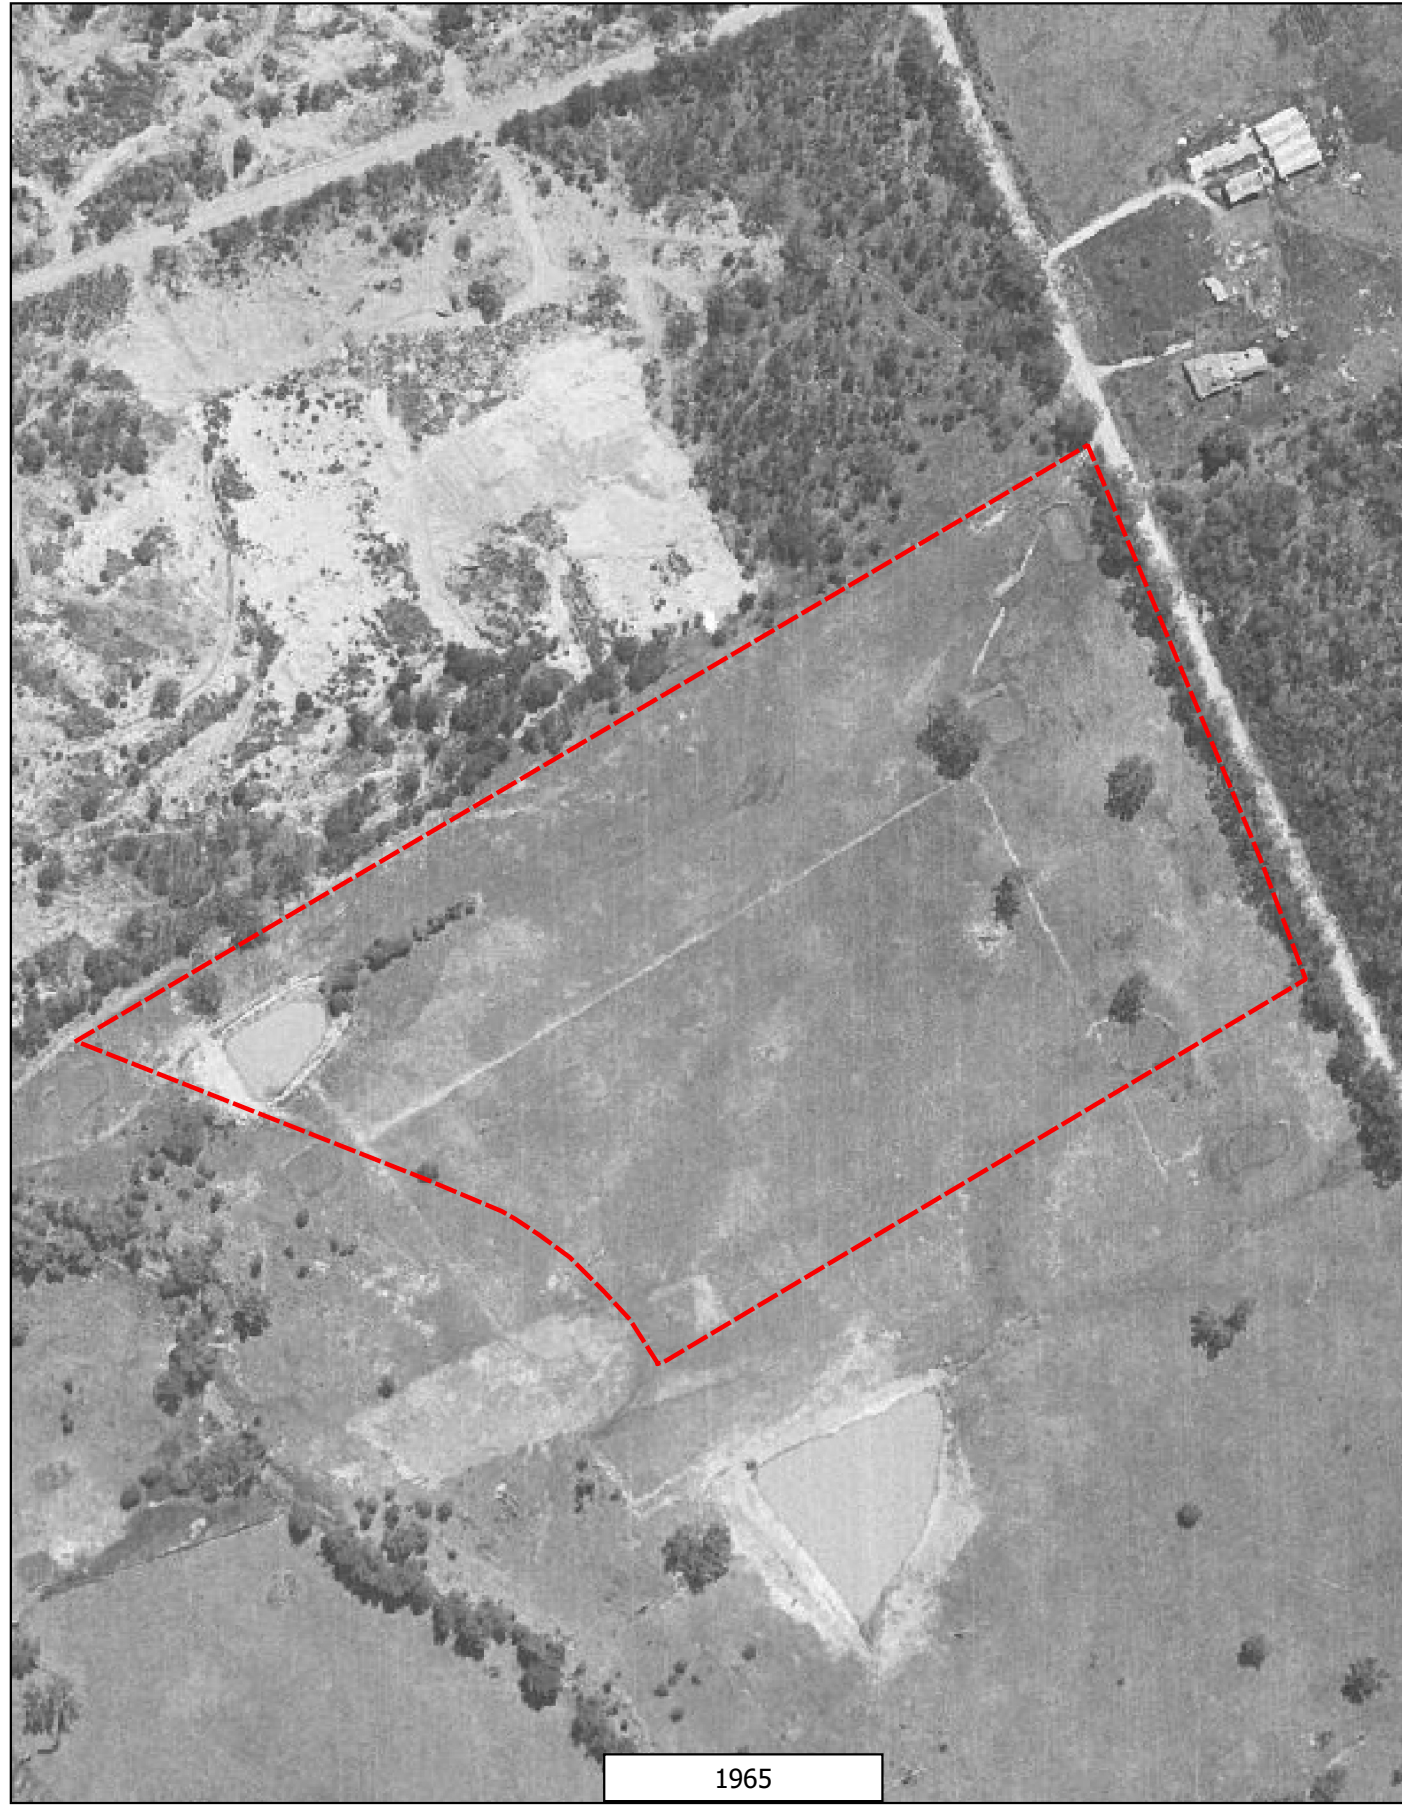
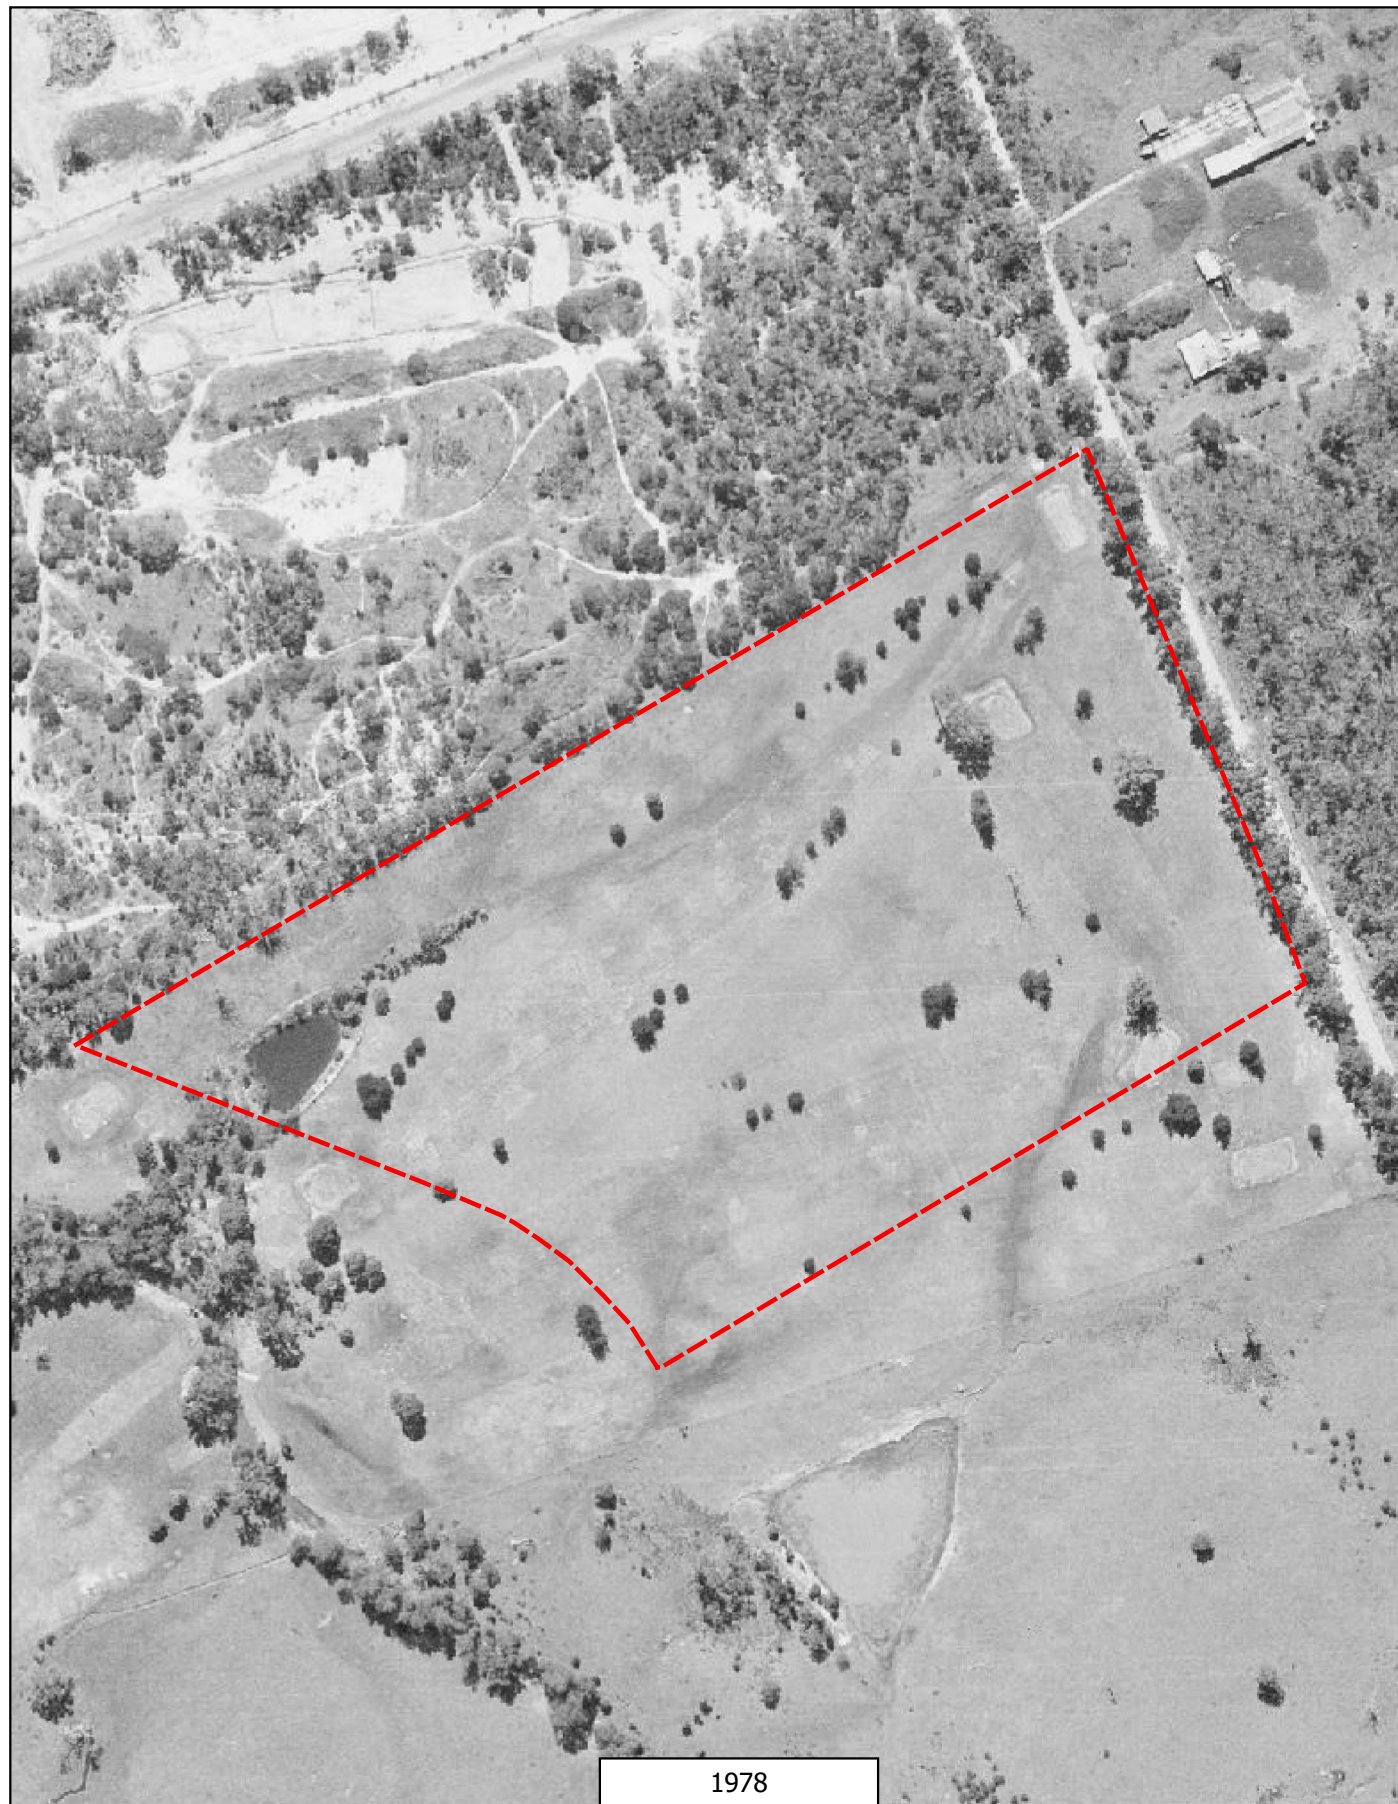
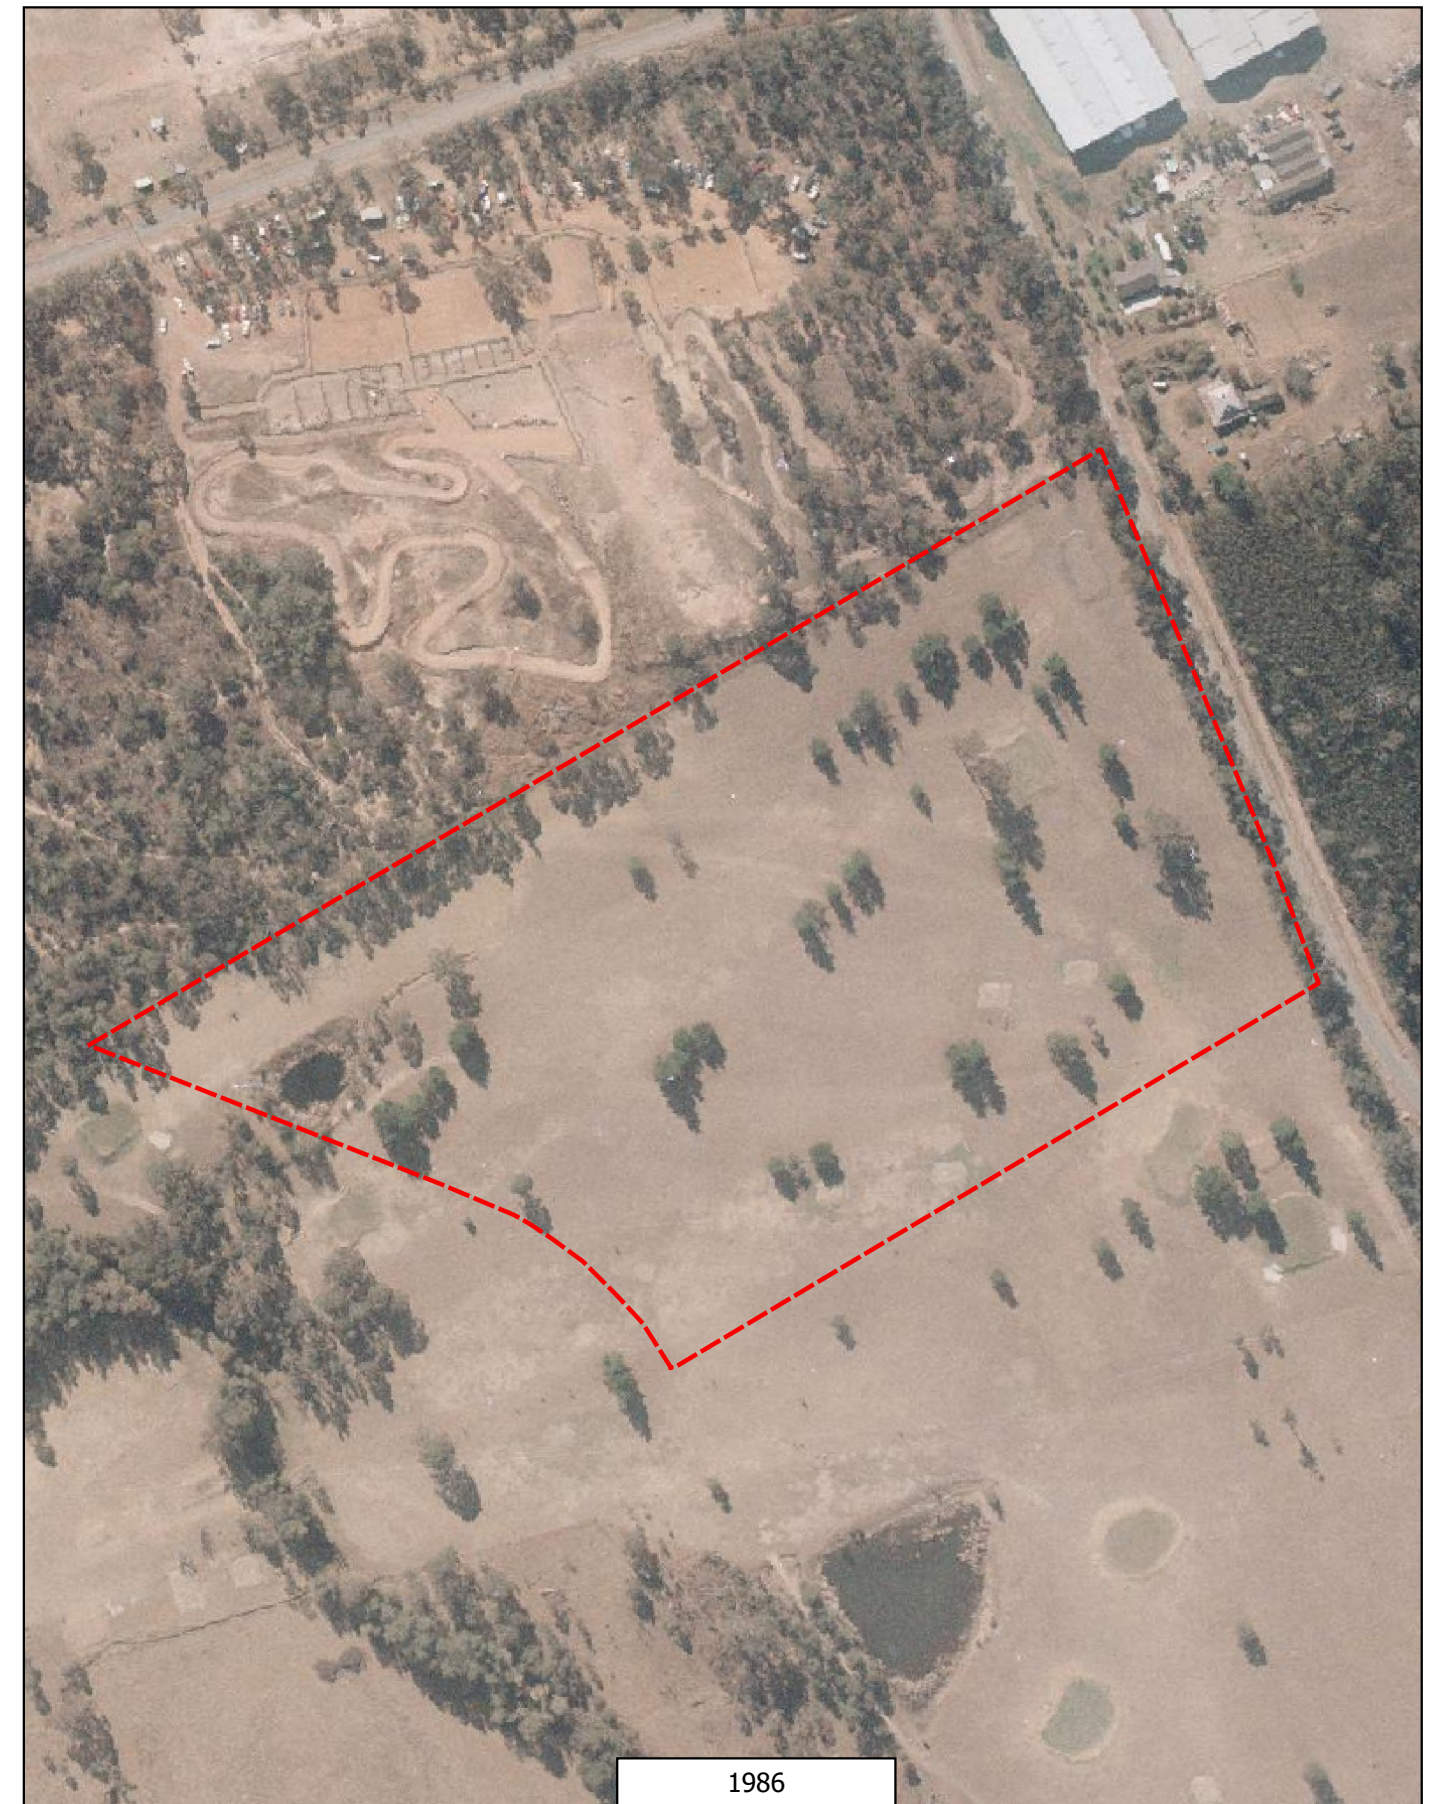
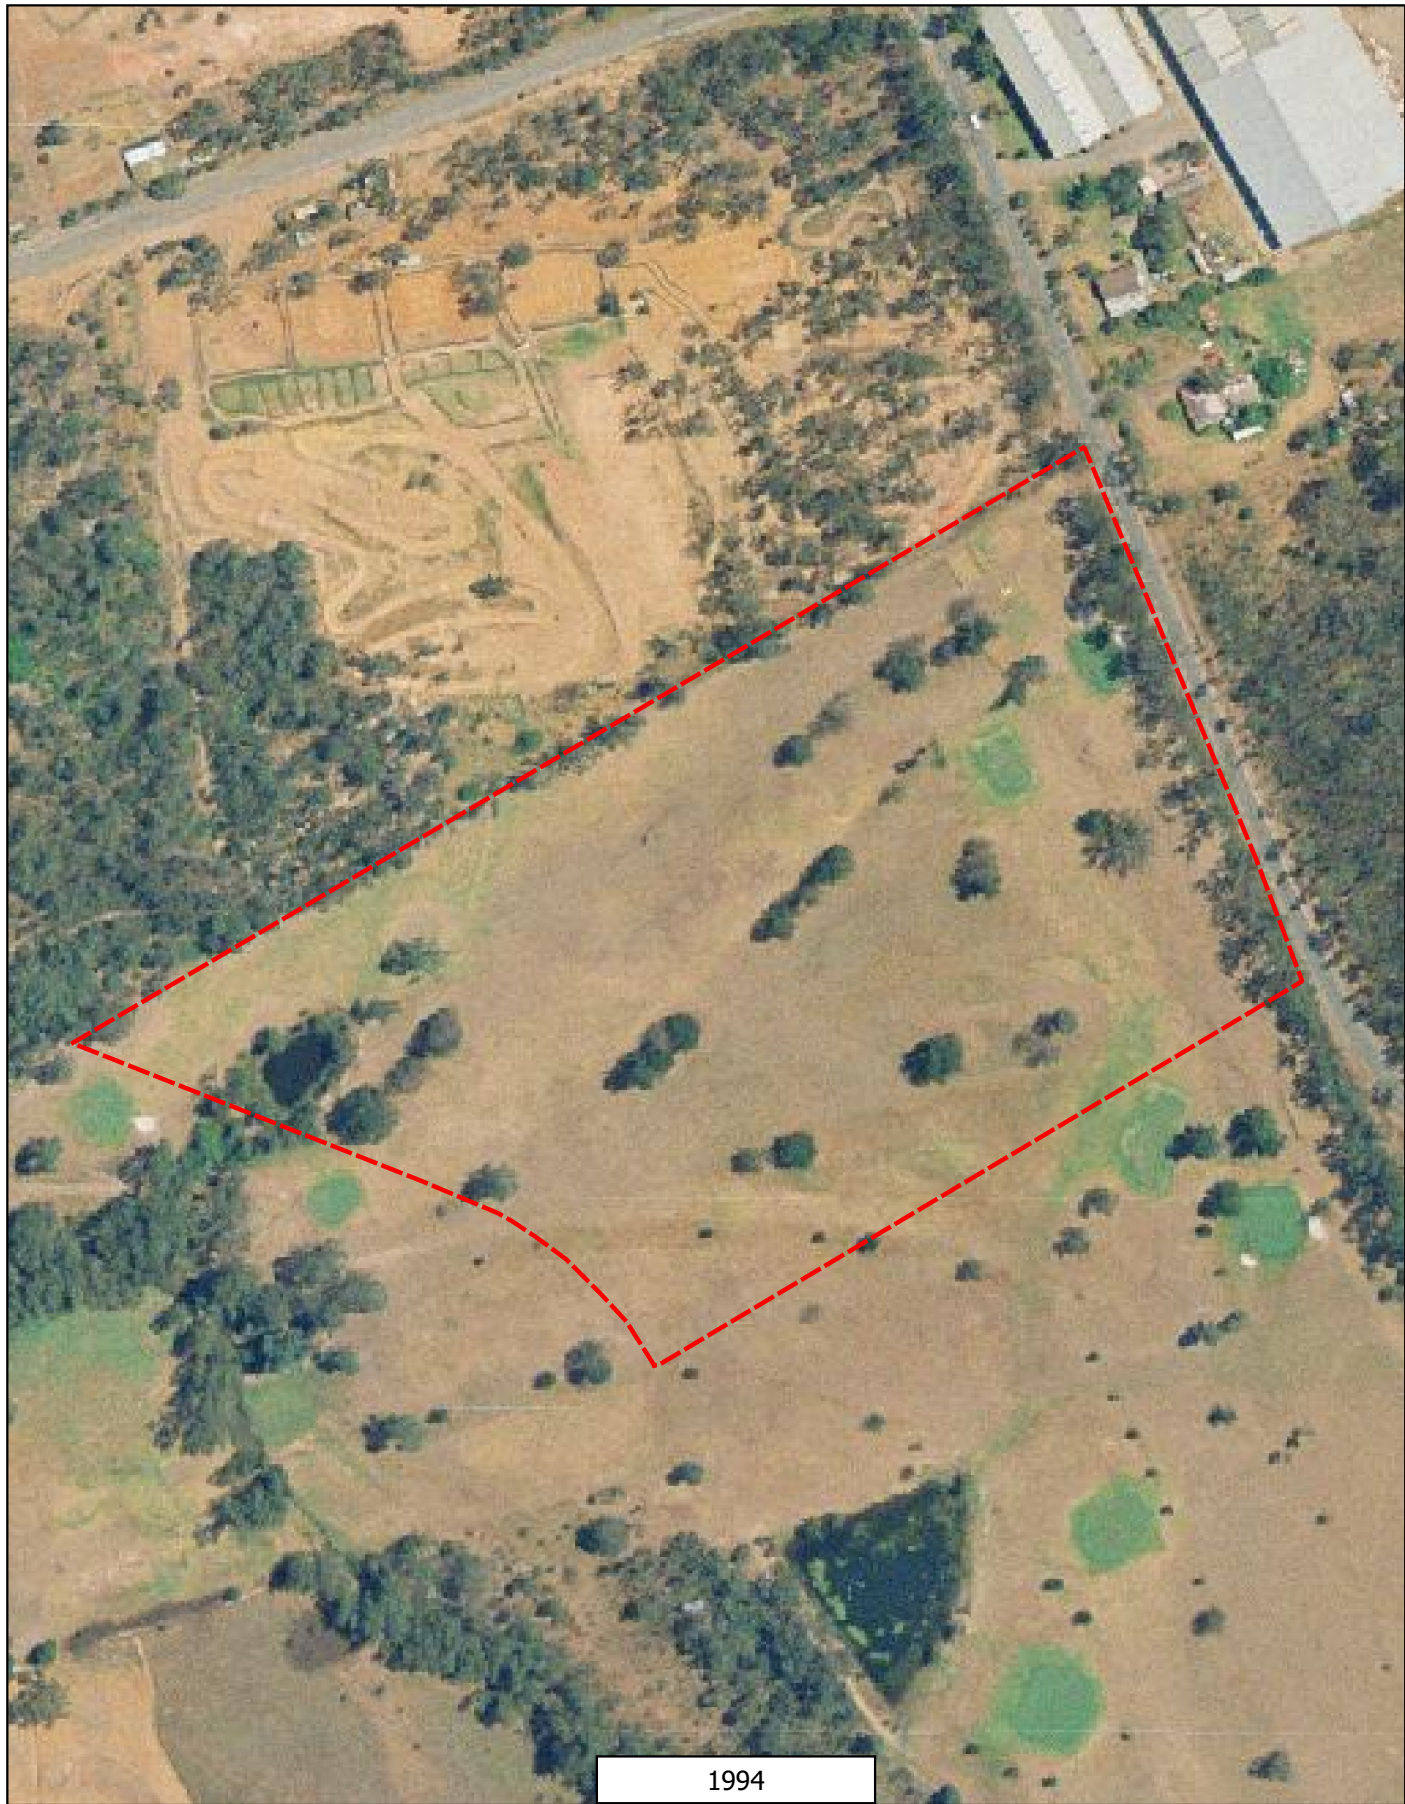
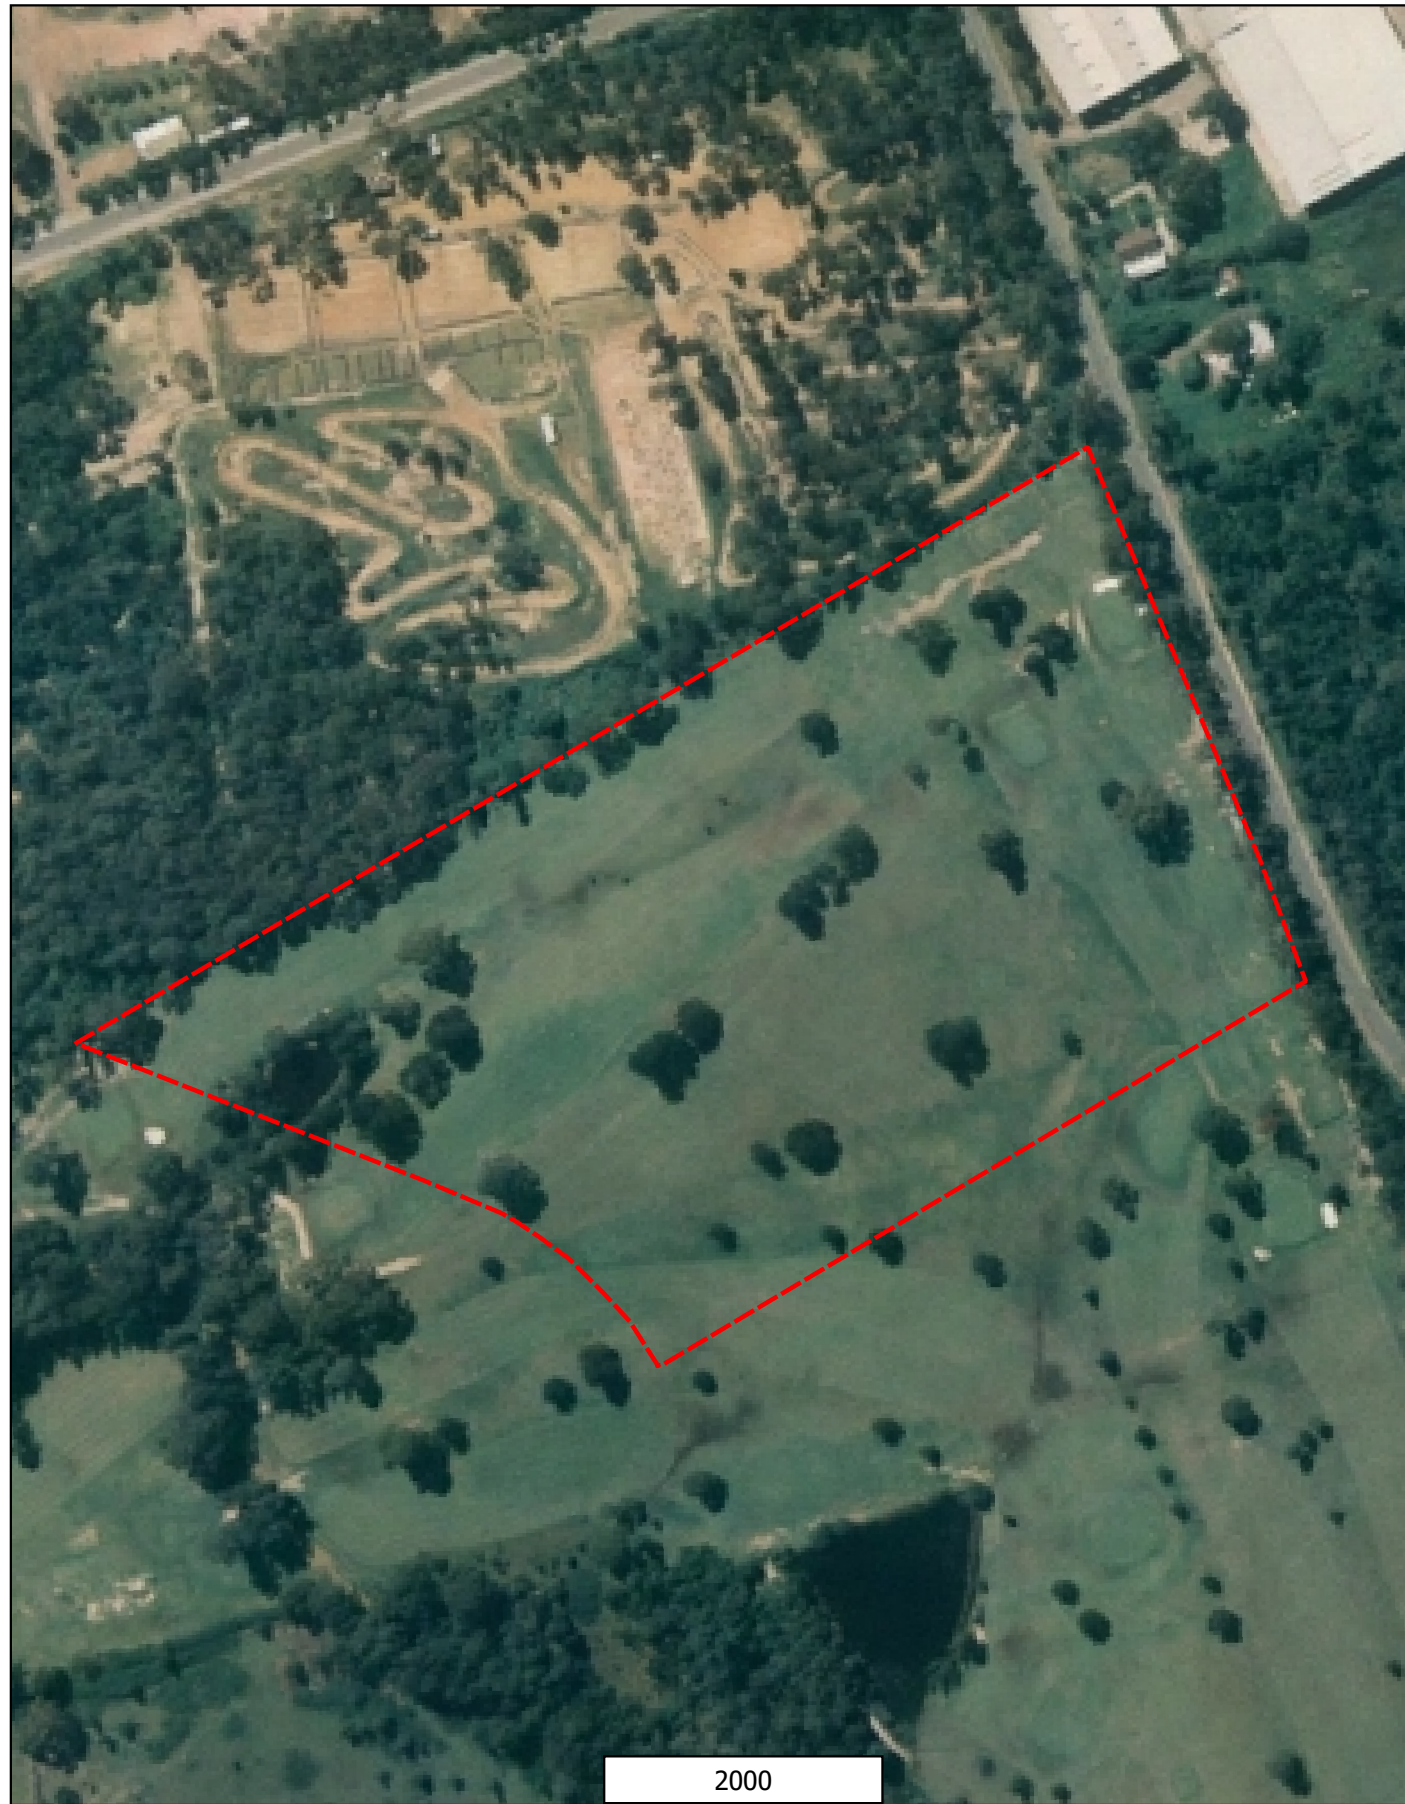
Historical Aerial Photographs Drawing Nos 2 to 7

A brief review of satellite images from Metro Map from 2000 to 2022 was also carried out. A summary of key features observed for the larger school site and surrounding land is presented in Table 4. Selected aerial photographs are included in Drawings 4 to 7 in Appendix D.
