Report on
Detailed Site Investigation (Contamination)

Rouse Hill High School Upgrade
240 Withers Road, Rouse Hill

Prepared for
NSW Department of Education

Project 215851.00
April 2024

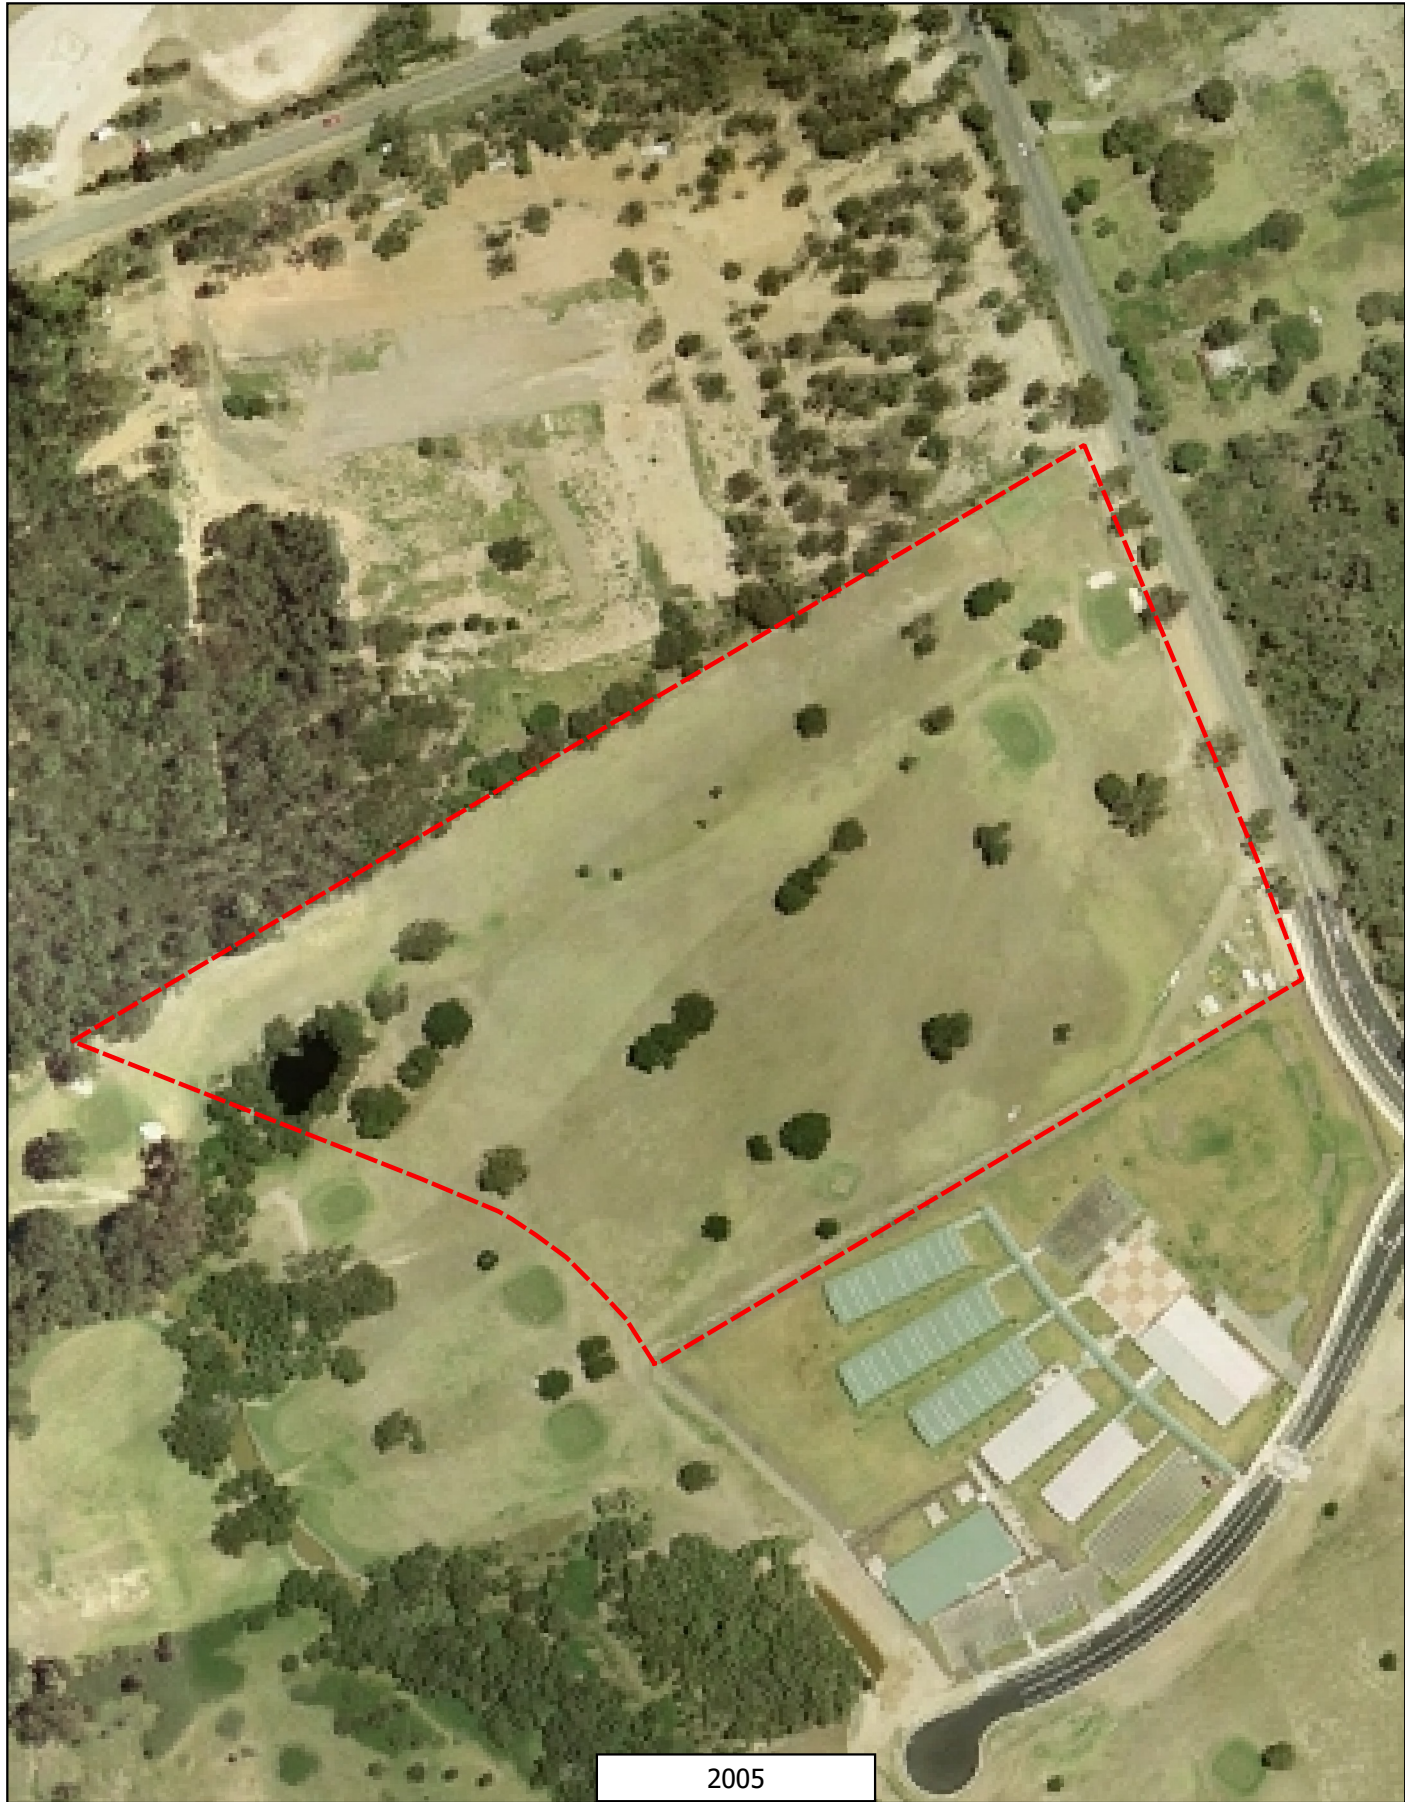
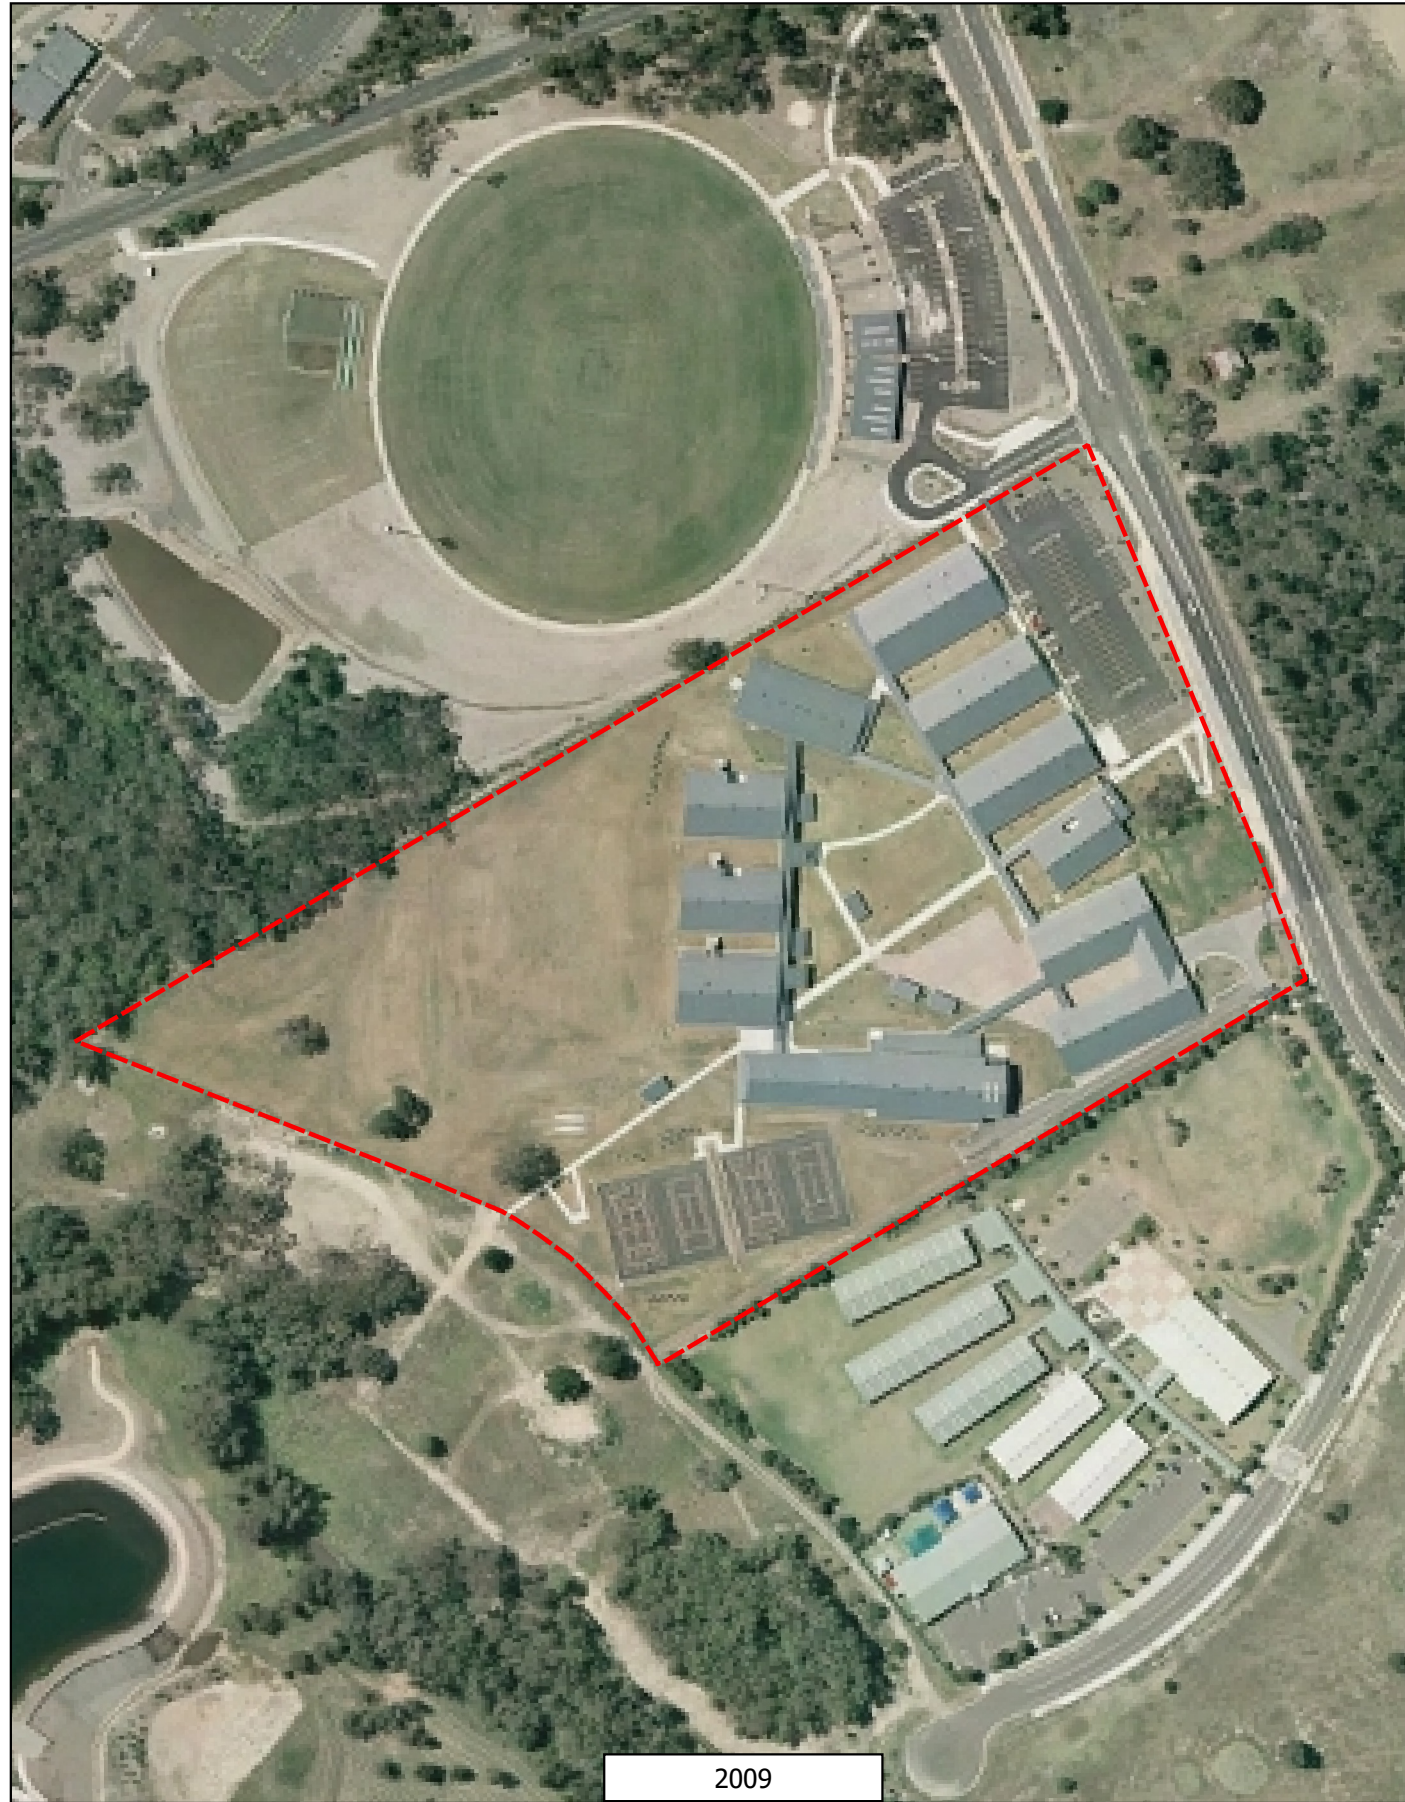
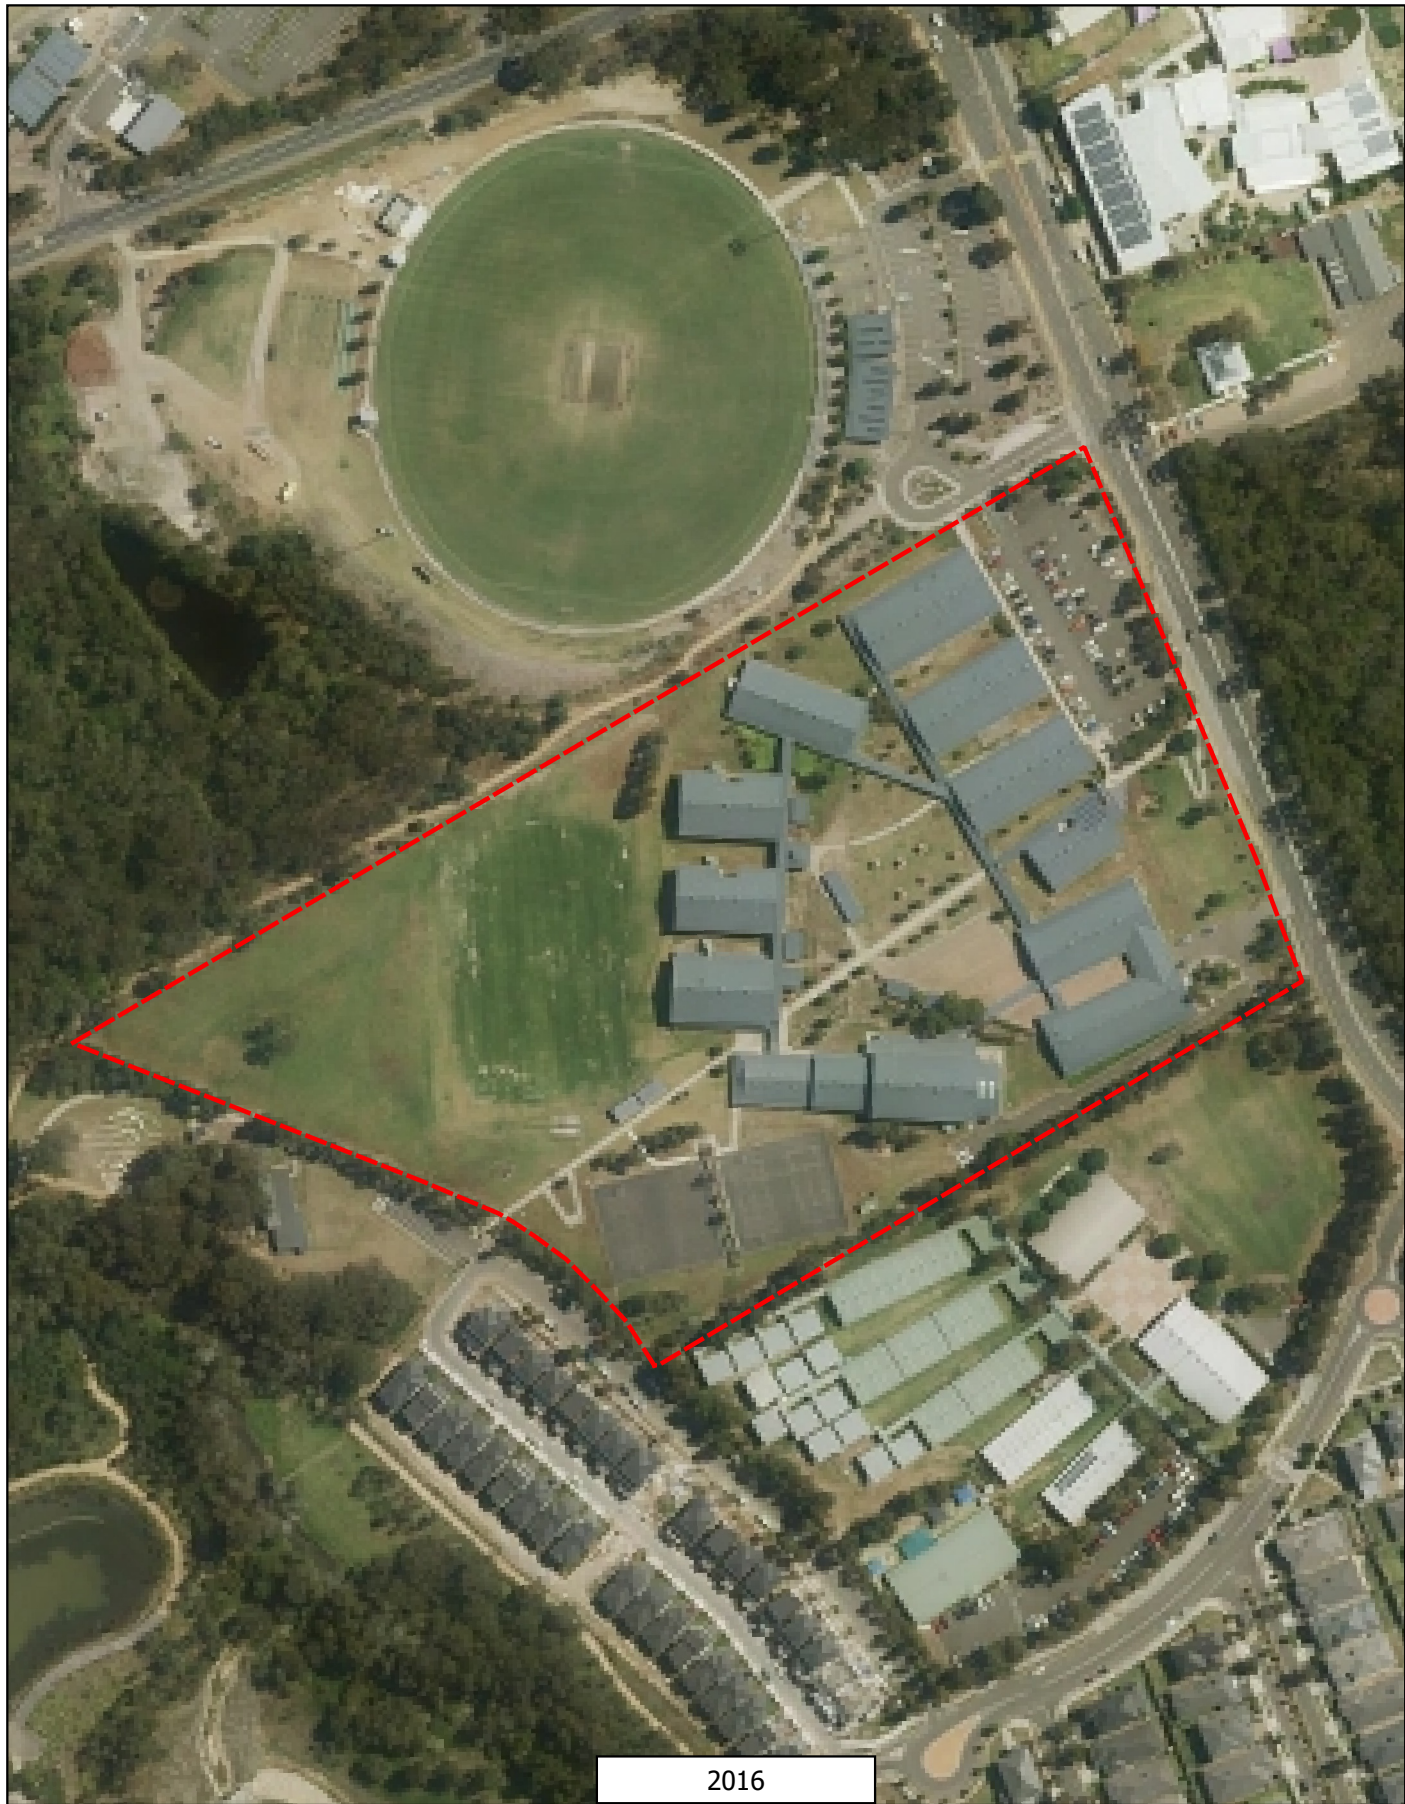
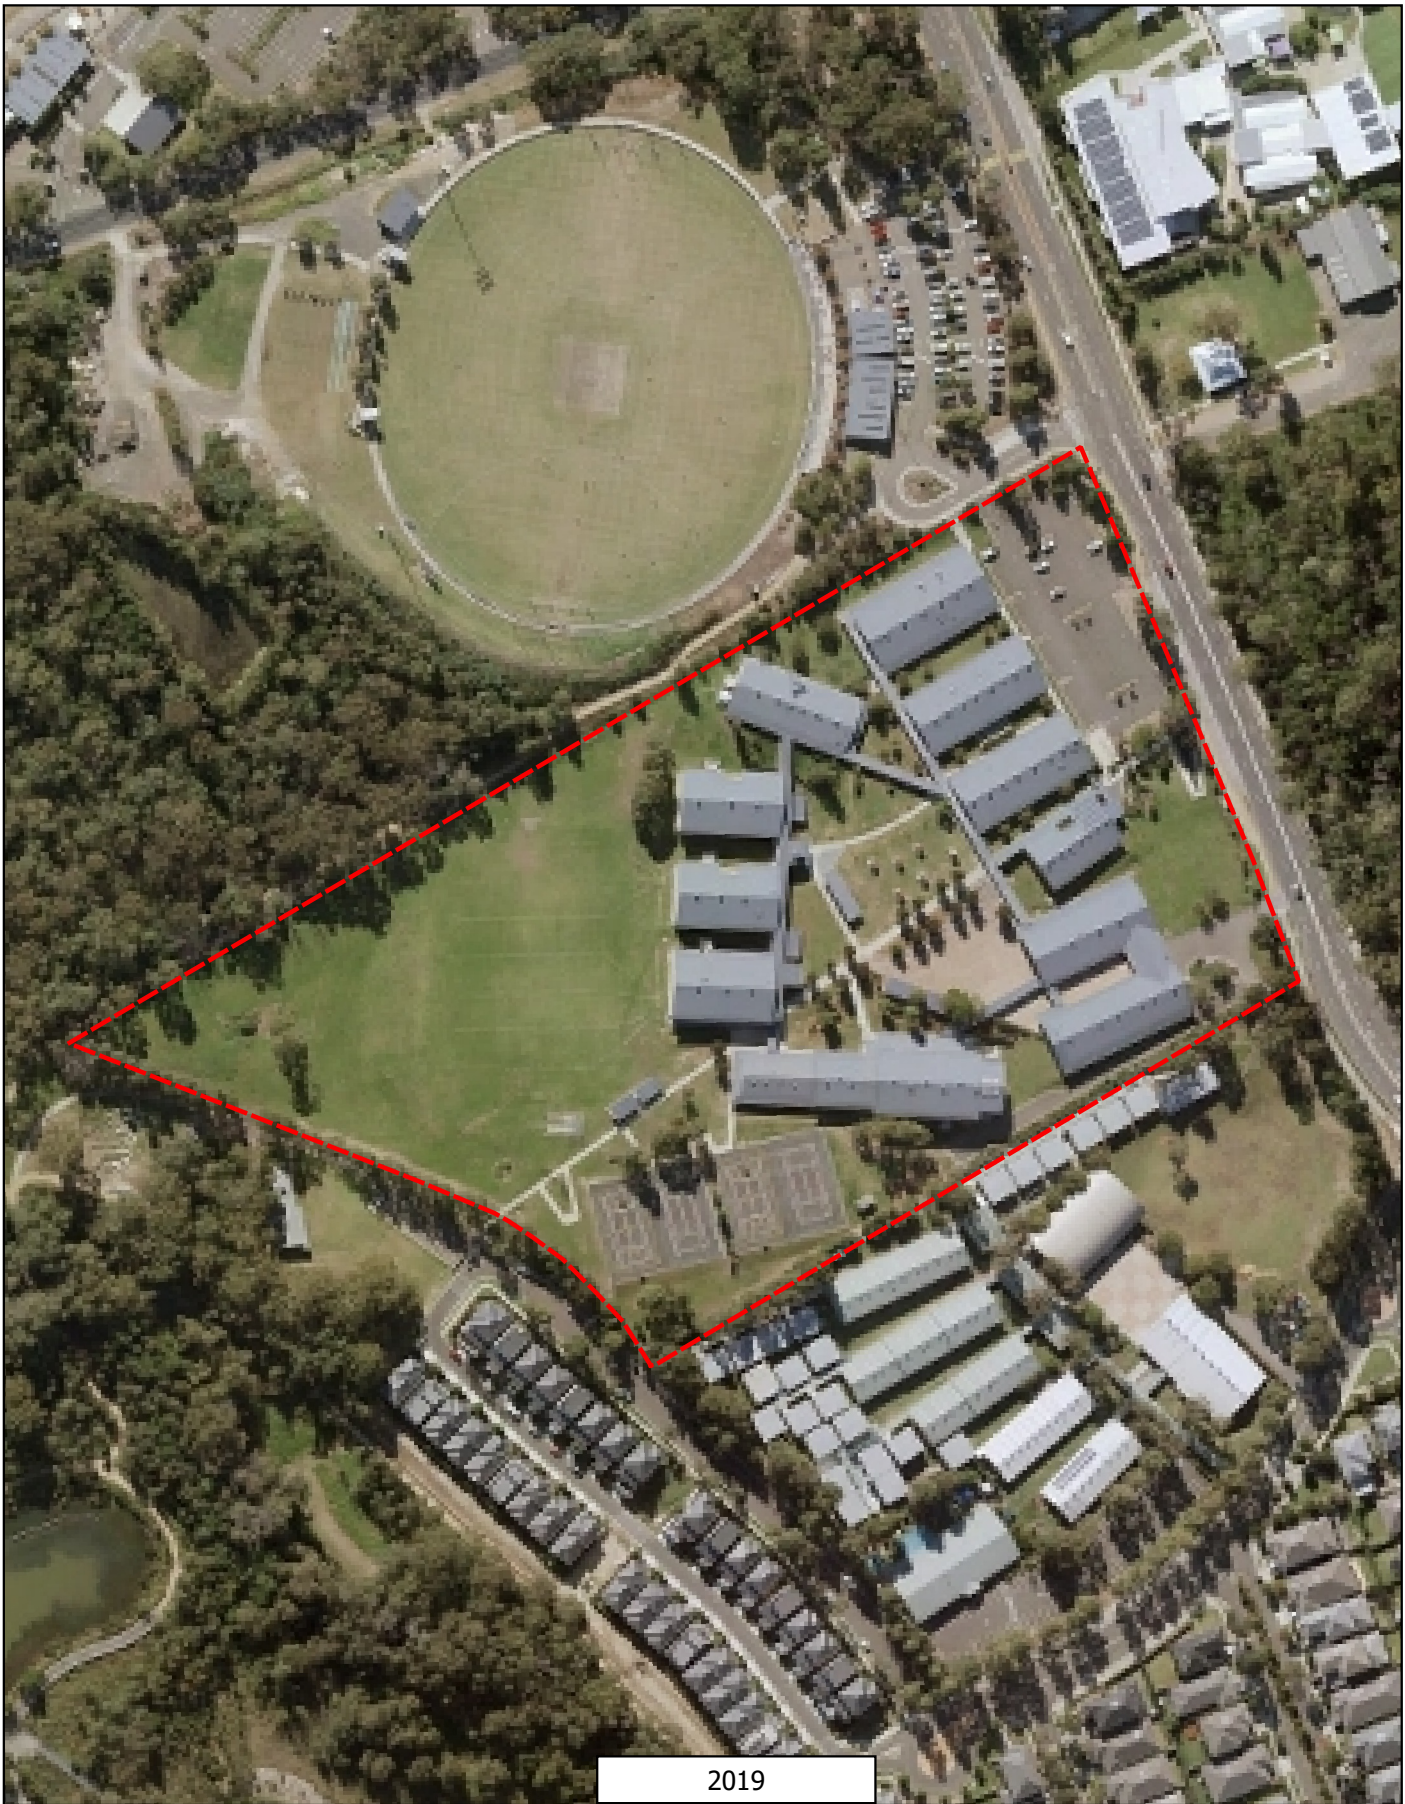
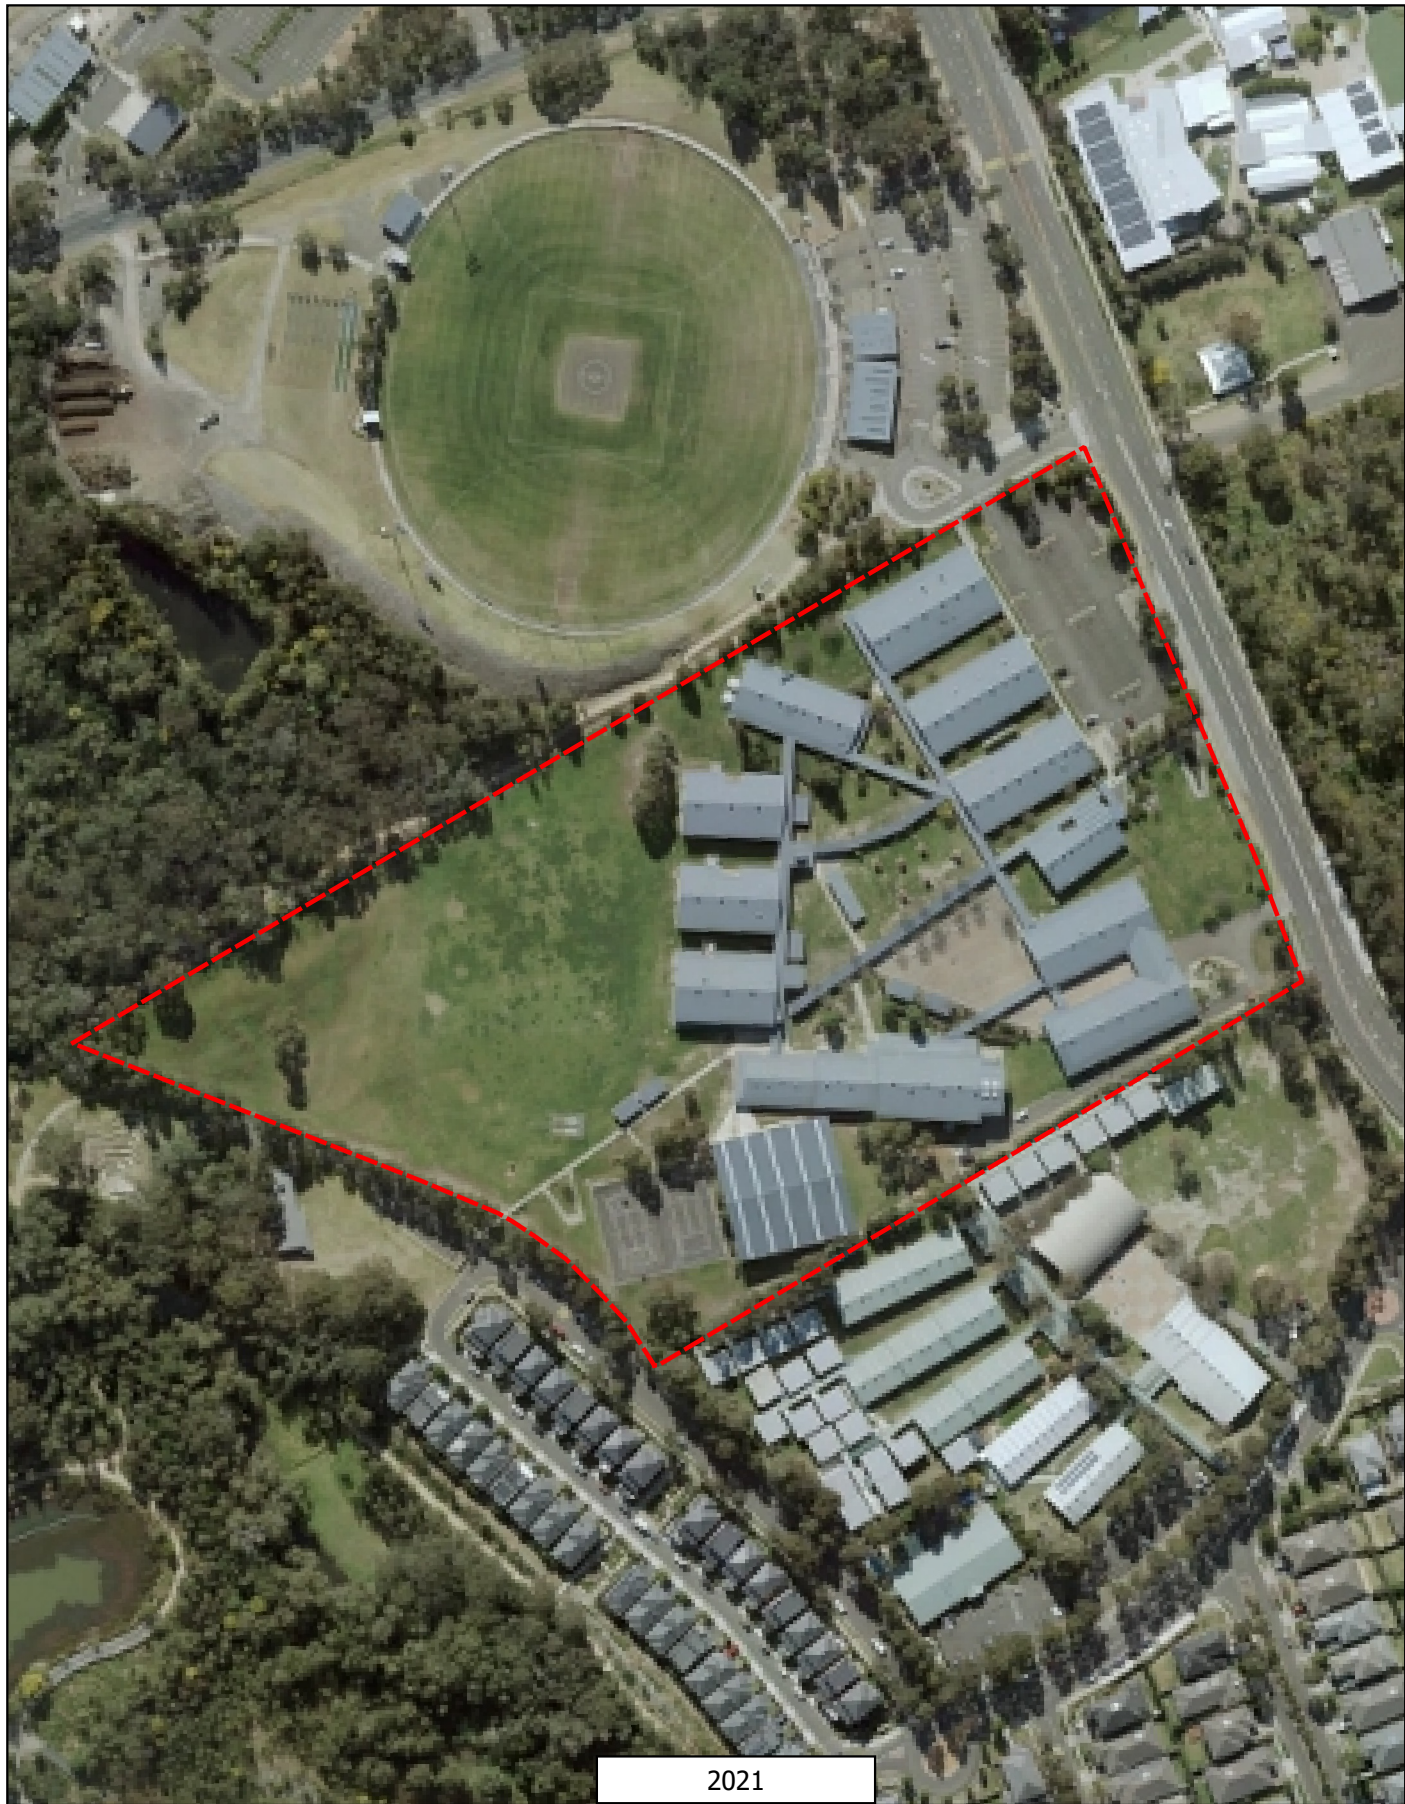
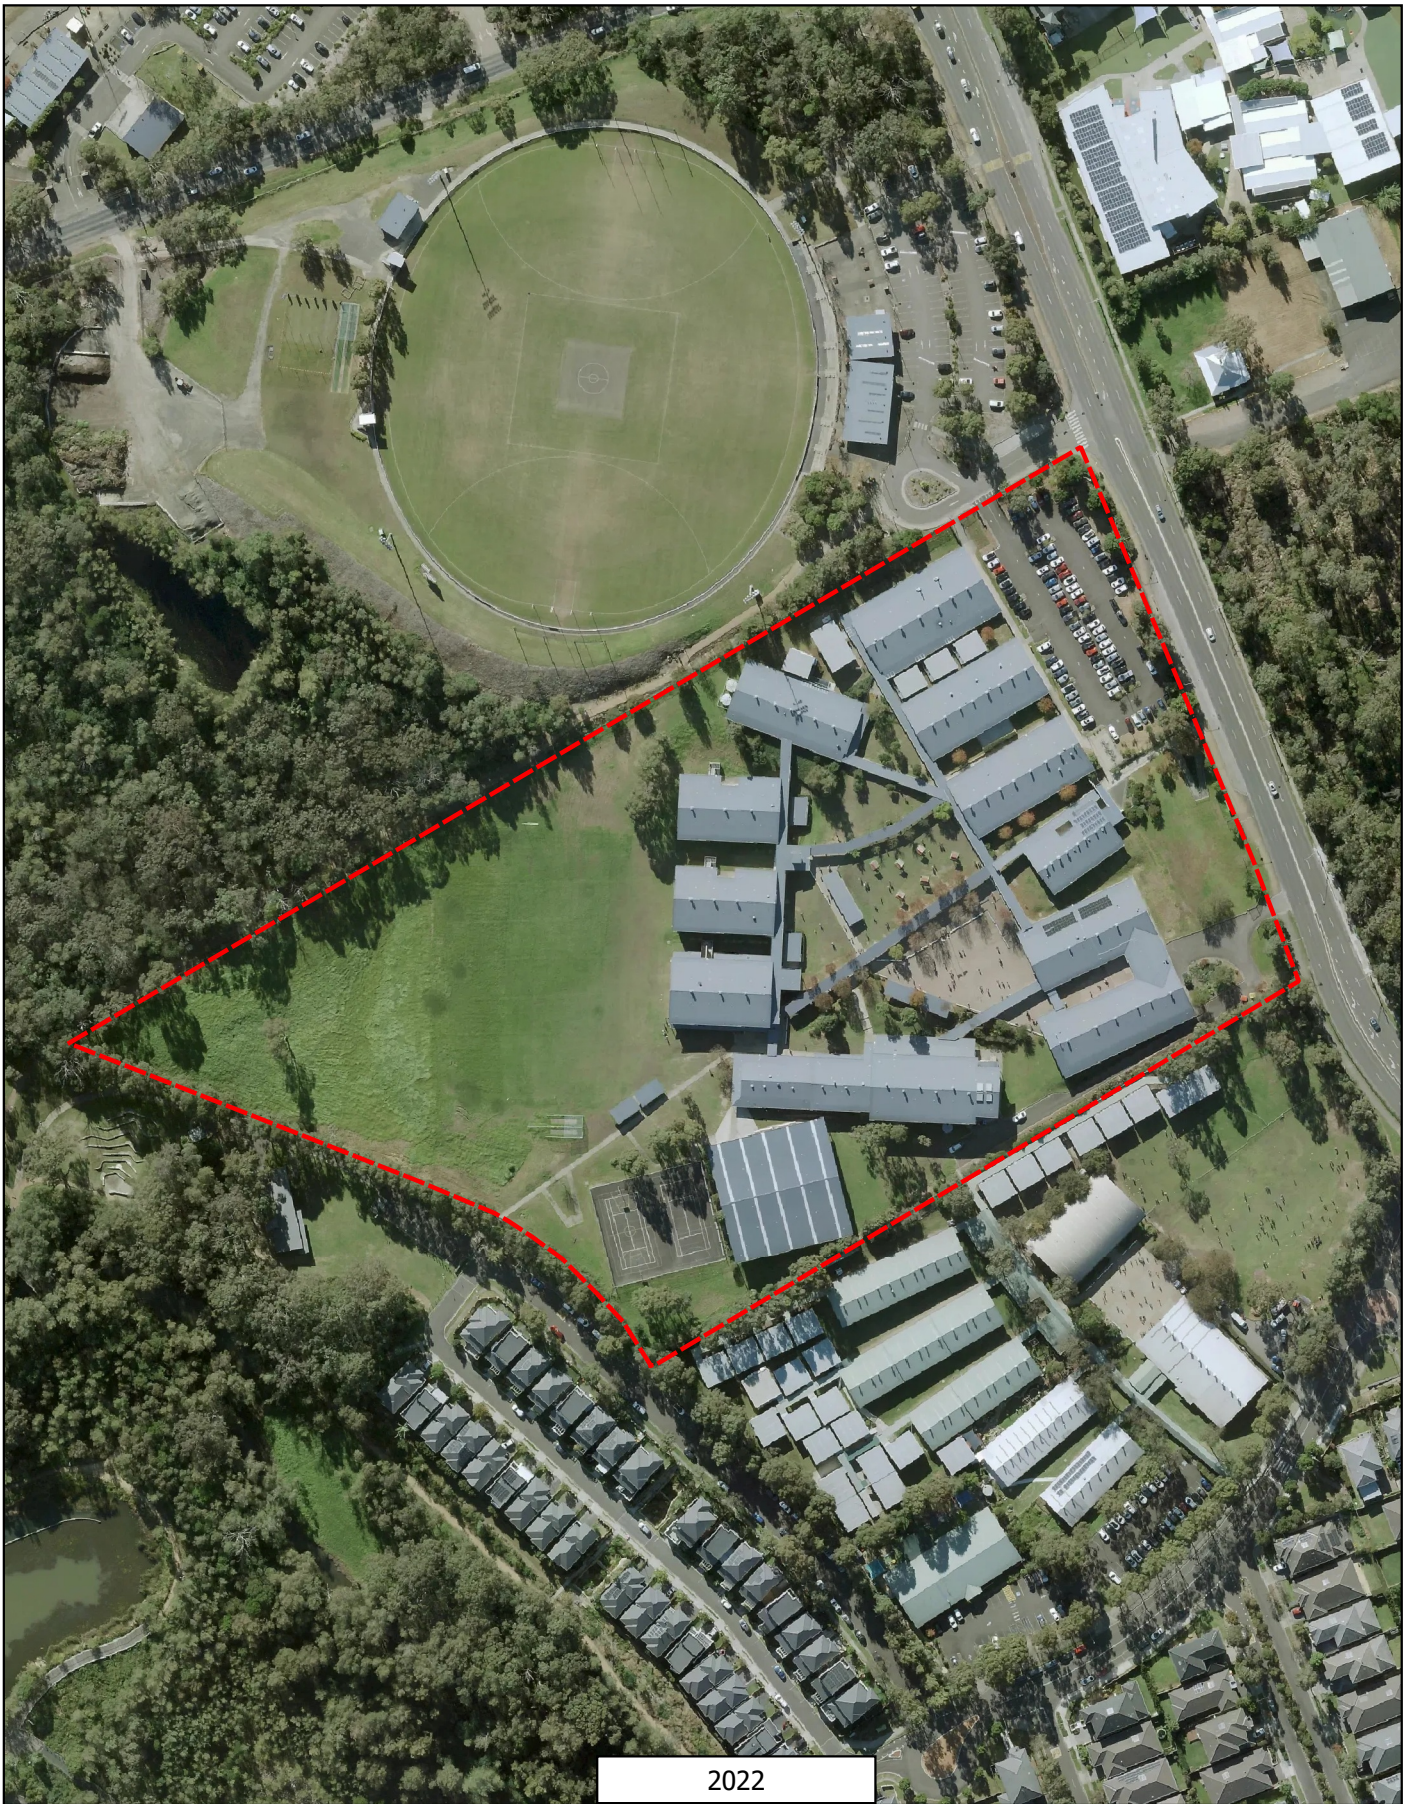
A brief review of satellite images from Metro Map from 2000 to 2022 was also carried out. A summary of key features observed for the larger school site and surrounding land is presented in Table 4. Selected aerial photographs are included in Drawings 4 to 7 in Appendix D.

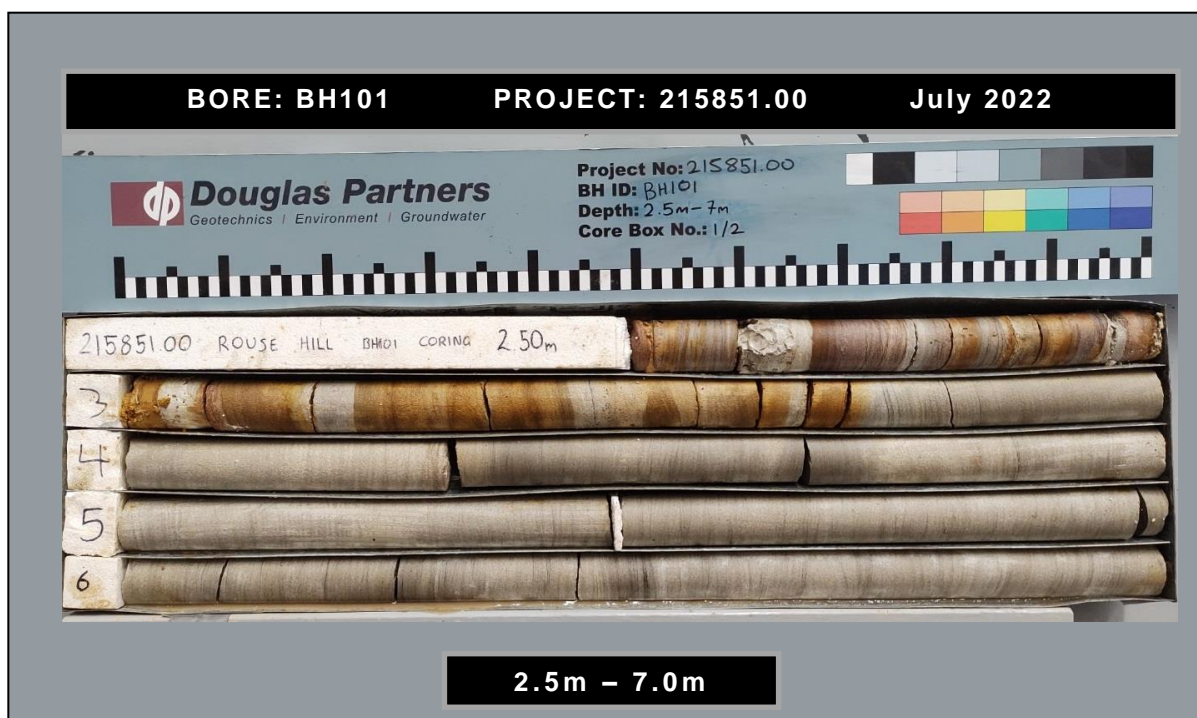
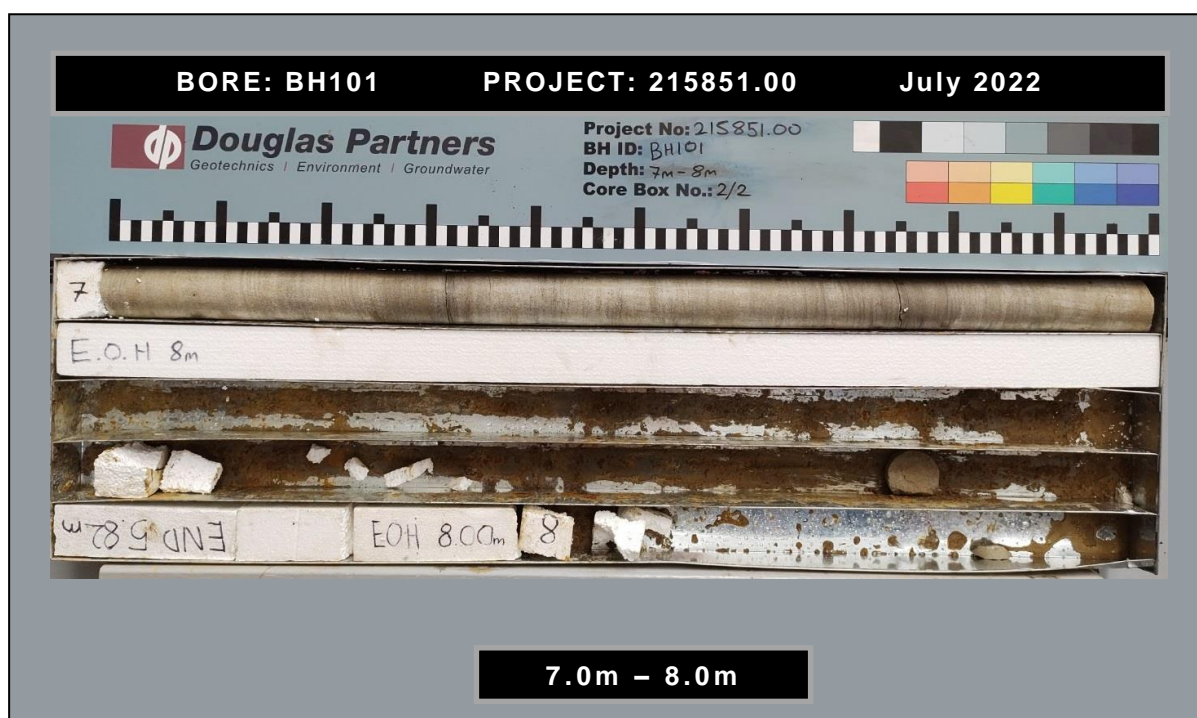
REMARKS: Well construction: Gatic cover, Blank 0 - 2.5m, Screen 2.5 - 8.04m, Backfill: Bentonite 0 - 2.5m, Gravel 2.5 to 8.04m

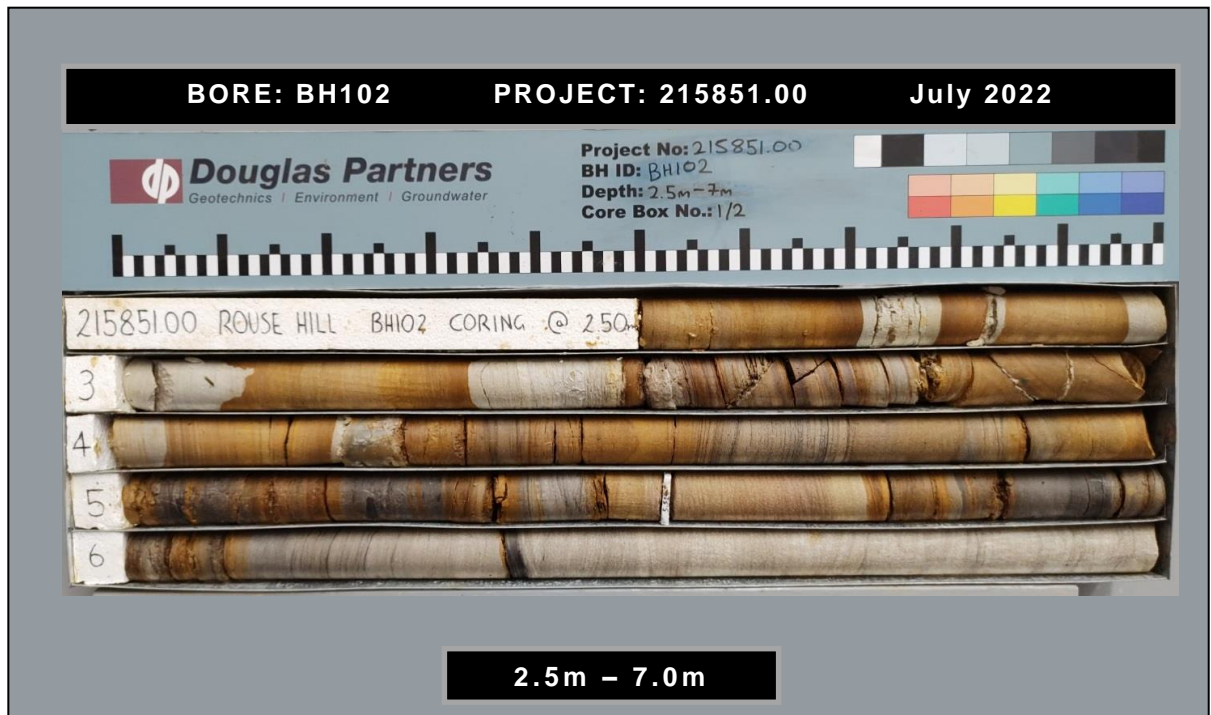
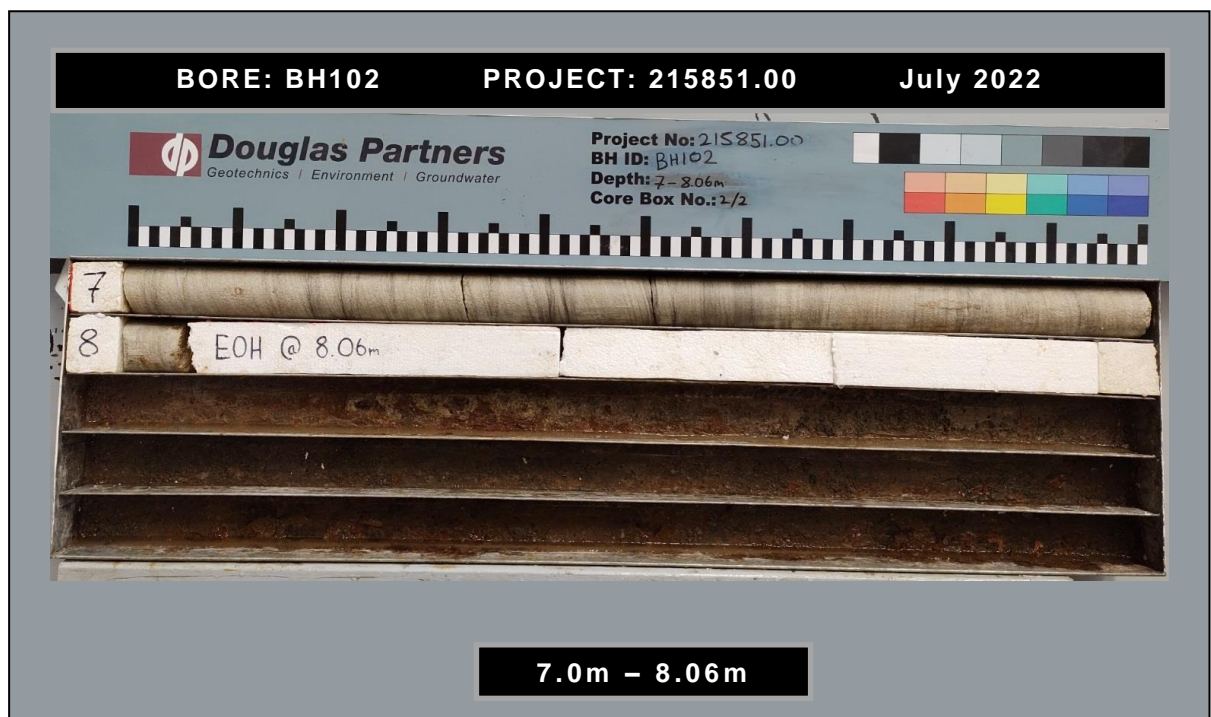
REMARKS: Well construction: Gatic cover, Blank 0 - 2.5m, Screen 2.5 - 8.06m, Backfill: Bentonite 0 - 2.5m, Gravel 2.5 to 8.06m

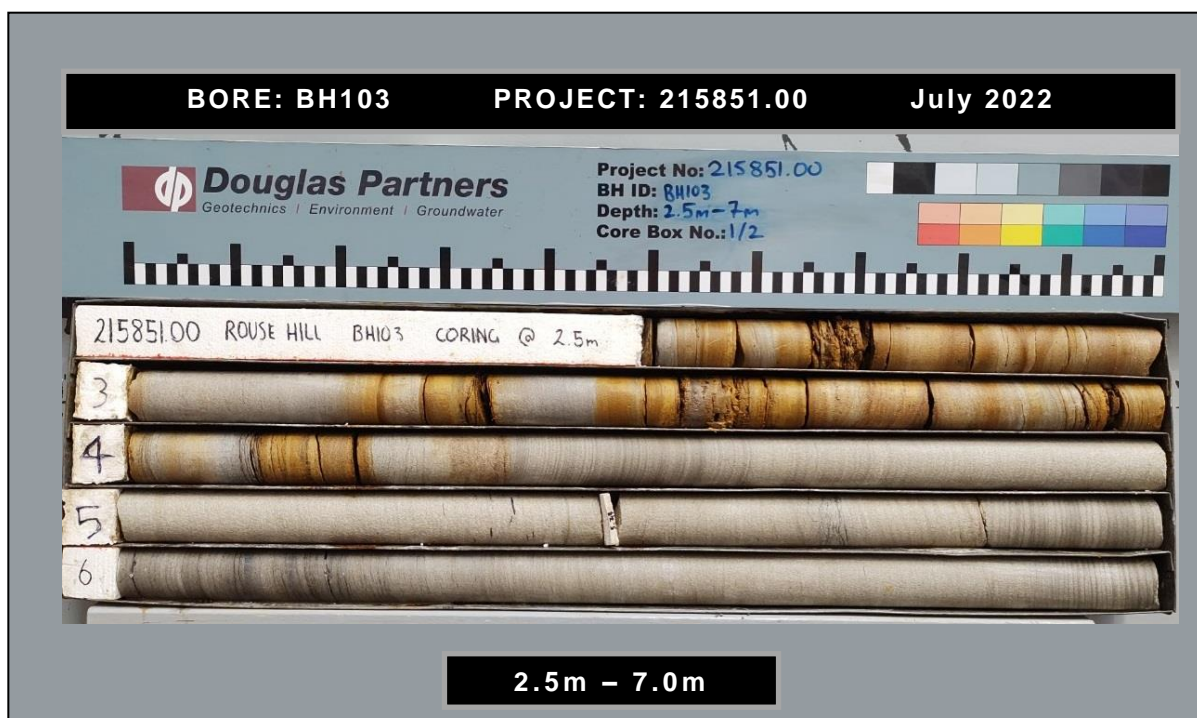
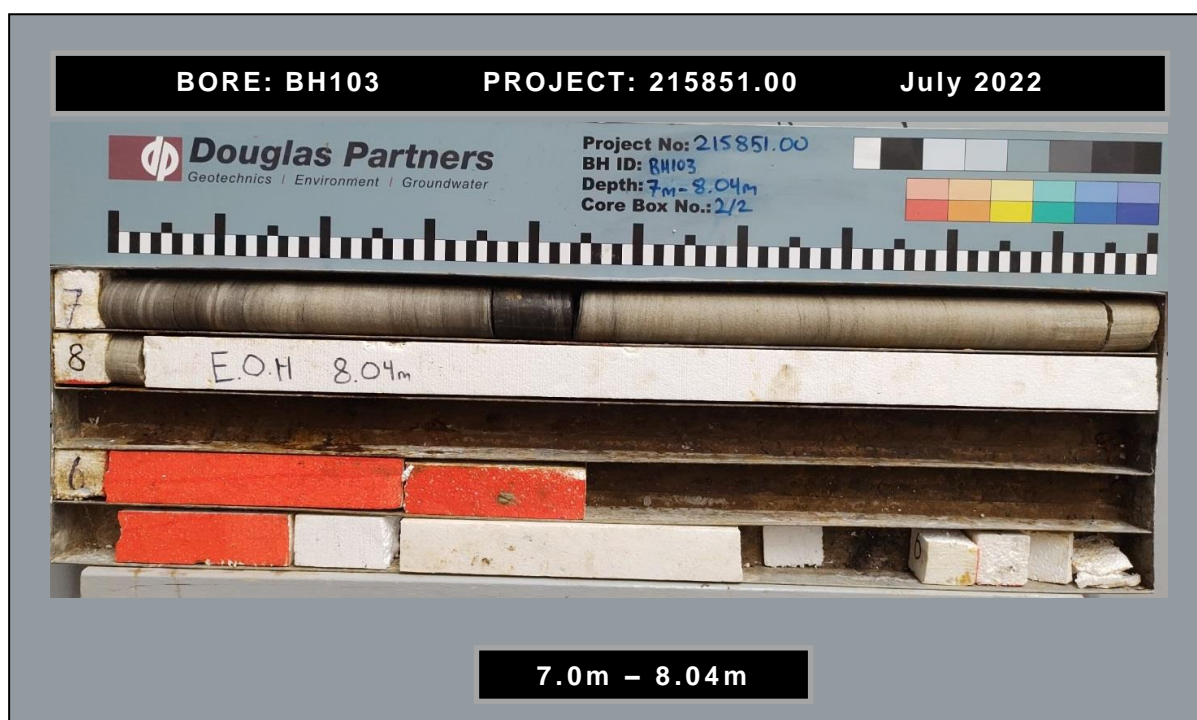
REMARKS: Well construction: Gatic cover, Blank 0 - 2.5m, Screen 2.5 - 8.04m, Backfill: Bentonite 0 - 2.5m, Gravel 2.5 to 8.04m

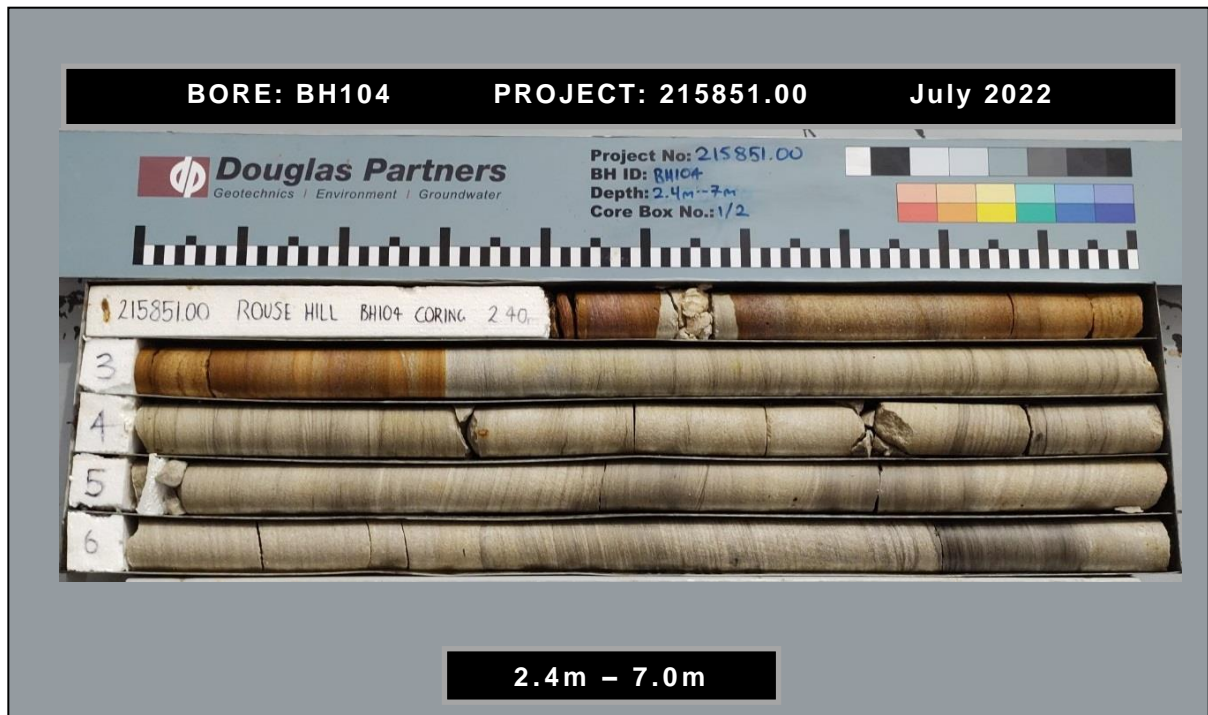
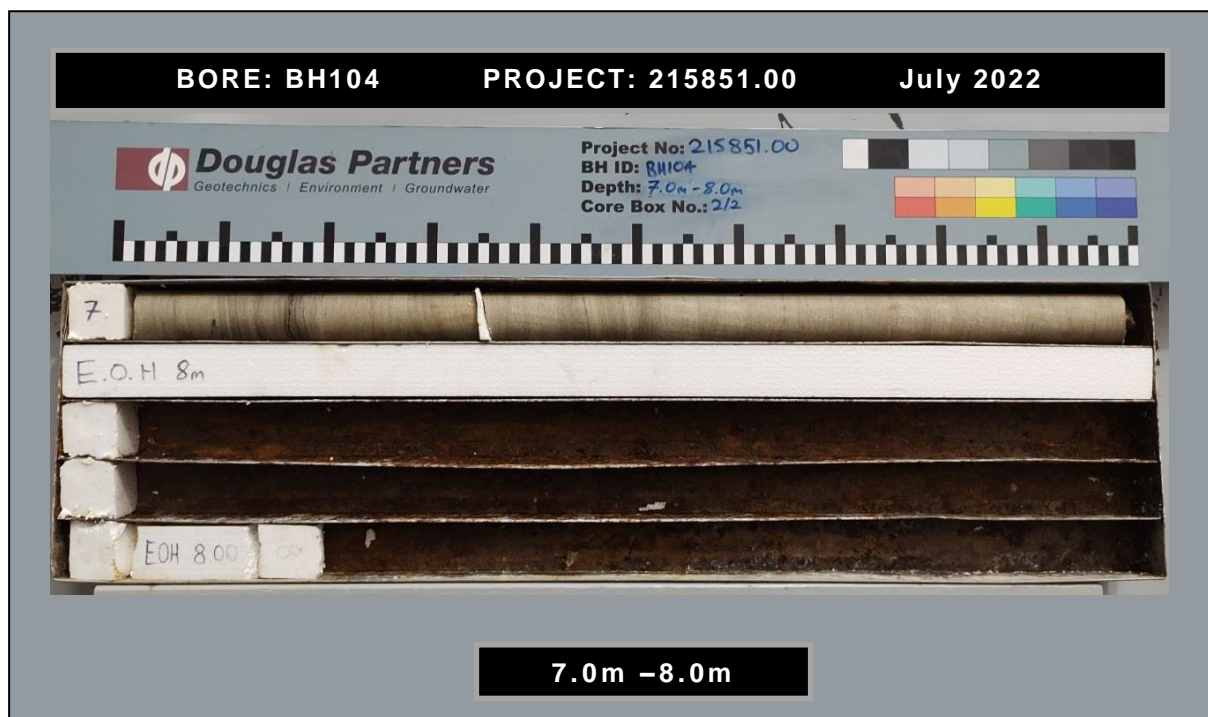
REMARKS: Well construction: Gatic cover, Blank 0 - 2.5m, Screen 2.5 - 8.0m, Backfill: Bentonite 0 - 2.5m, Gravel 2.5 to 8.0m
