Report on
Detailed Site Investigation (Contamination)

Rouse Hill High School Upgrade
240 Withers Road, Rouse Hill

Prepared for
NSW Department of Education

Project 215851.00
April 2024

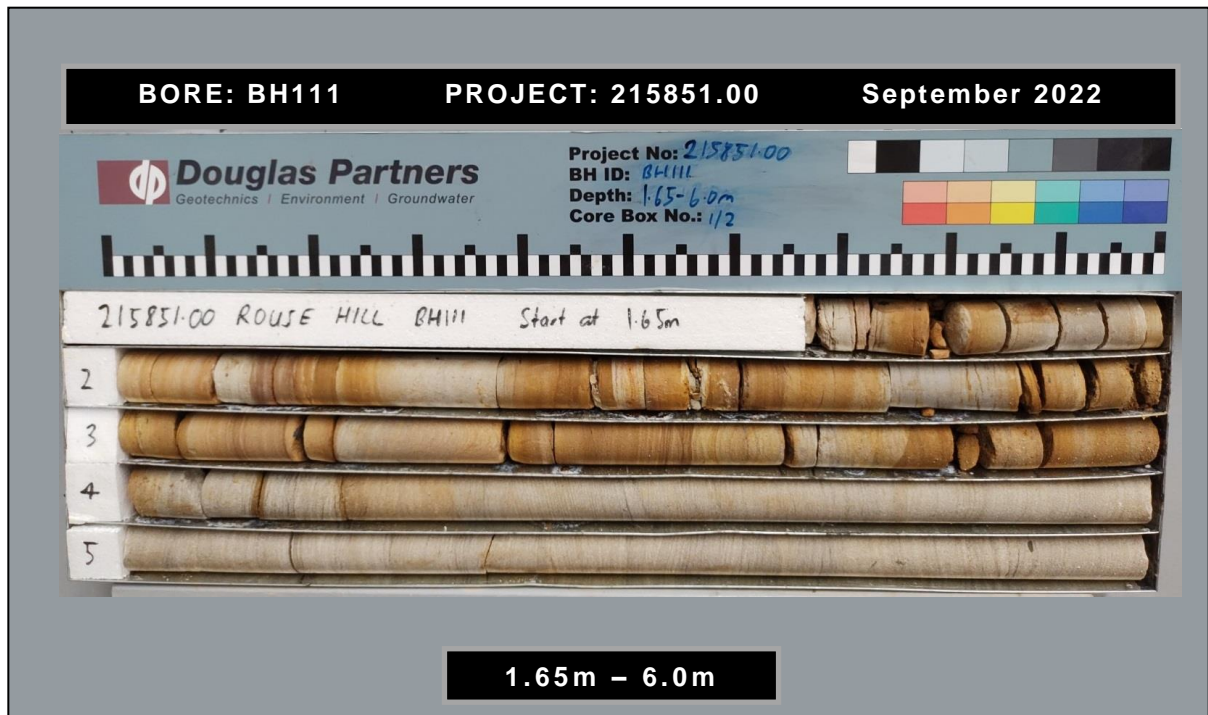
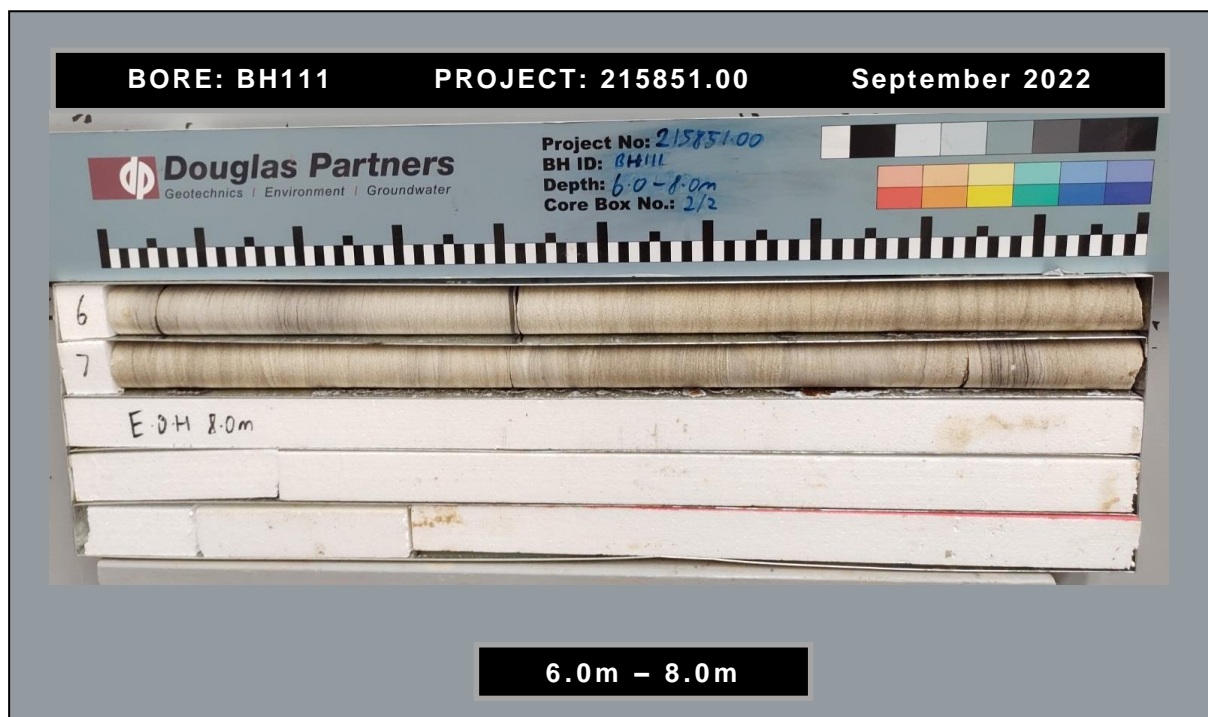
BOREHOLE LOG

REMARKS: Well construction: Gattic cover, Blank 0-2.8m, Screen 2.8-5.8m, Backfill: Bentonite 0-0.5m, Gravel 0.5-1.8m, Bentonite 1.8-2.3m, Gravel 2.3-5.8m

BD2-13/09/2022 sample taken from 0.4 - 0.5m depth
