## L01 – Peer Review of SCA, Liverpool Boys and Girls High School (Rev 0)

13 December 2023

### Environmental Peer Review and Strategic Advice – Liverpool Boys and Girls High School, Liverpool, NSW, 2170

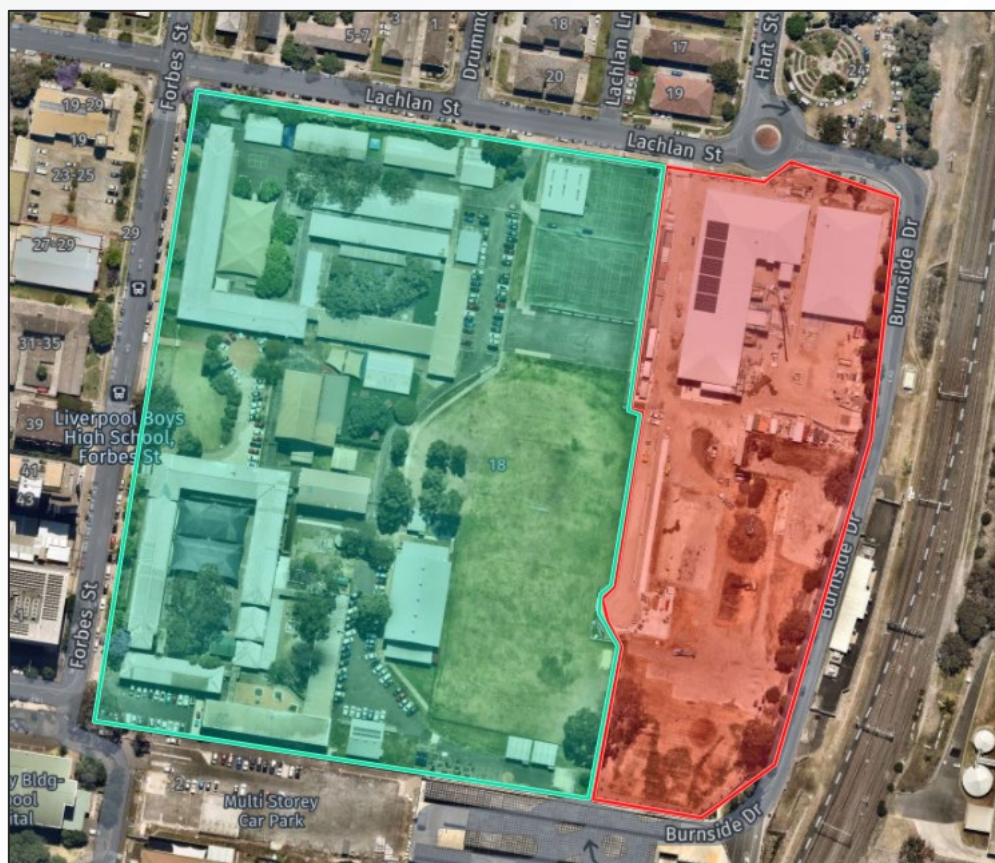
**Image 1: The site (shown in green) and the newly constructed Liverpool Primary School which is excluded from 'the site'. The site area (green area) covers an area of approximately 5.2 hectares (ha).**

JBS&G Australia Pty Ltd (JBS&G) was engaged by School Infrastructure NSW (SINSW), care of Colliers, for the provision of environmental/contamination peer review and strategic advice to facilitate the redevelopment of Liverpool Boys and Girls High School (LBHS and LGHS, respectively, located at Forbes Street, Liverpool (collectively referred to as the site). It is understood that LBHS and LGHS form part of the Liverpool Education Precinct Development (which also includes the newly constructed Liverpool Primary School). The site location and layout are shown on **Figures 1 and 2** attached (and **Image 1**, below).

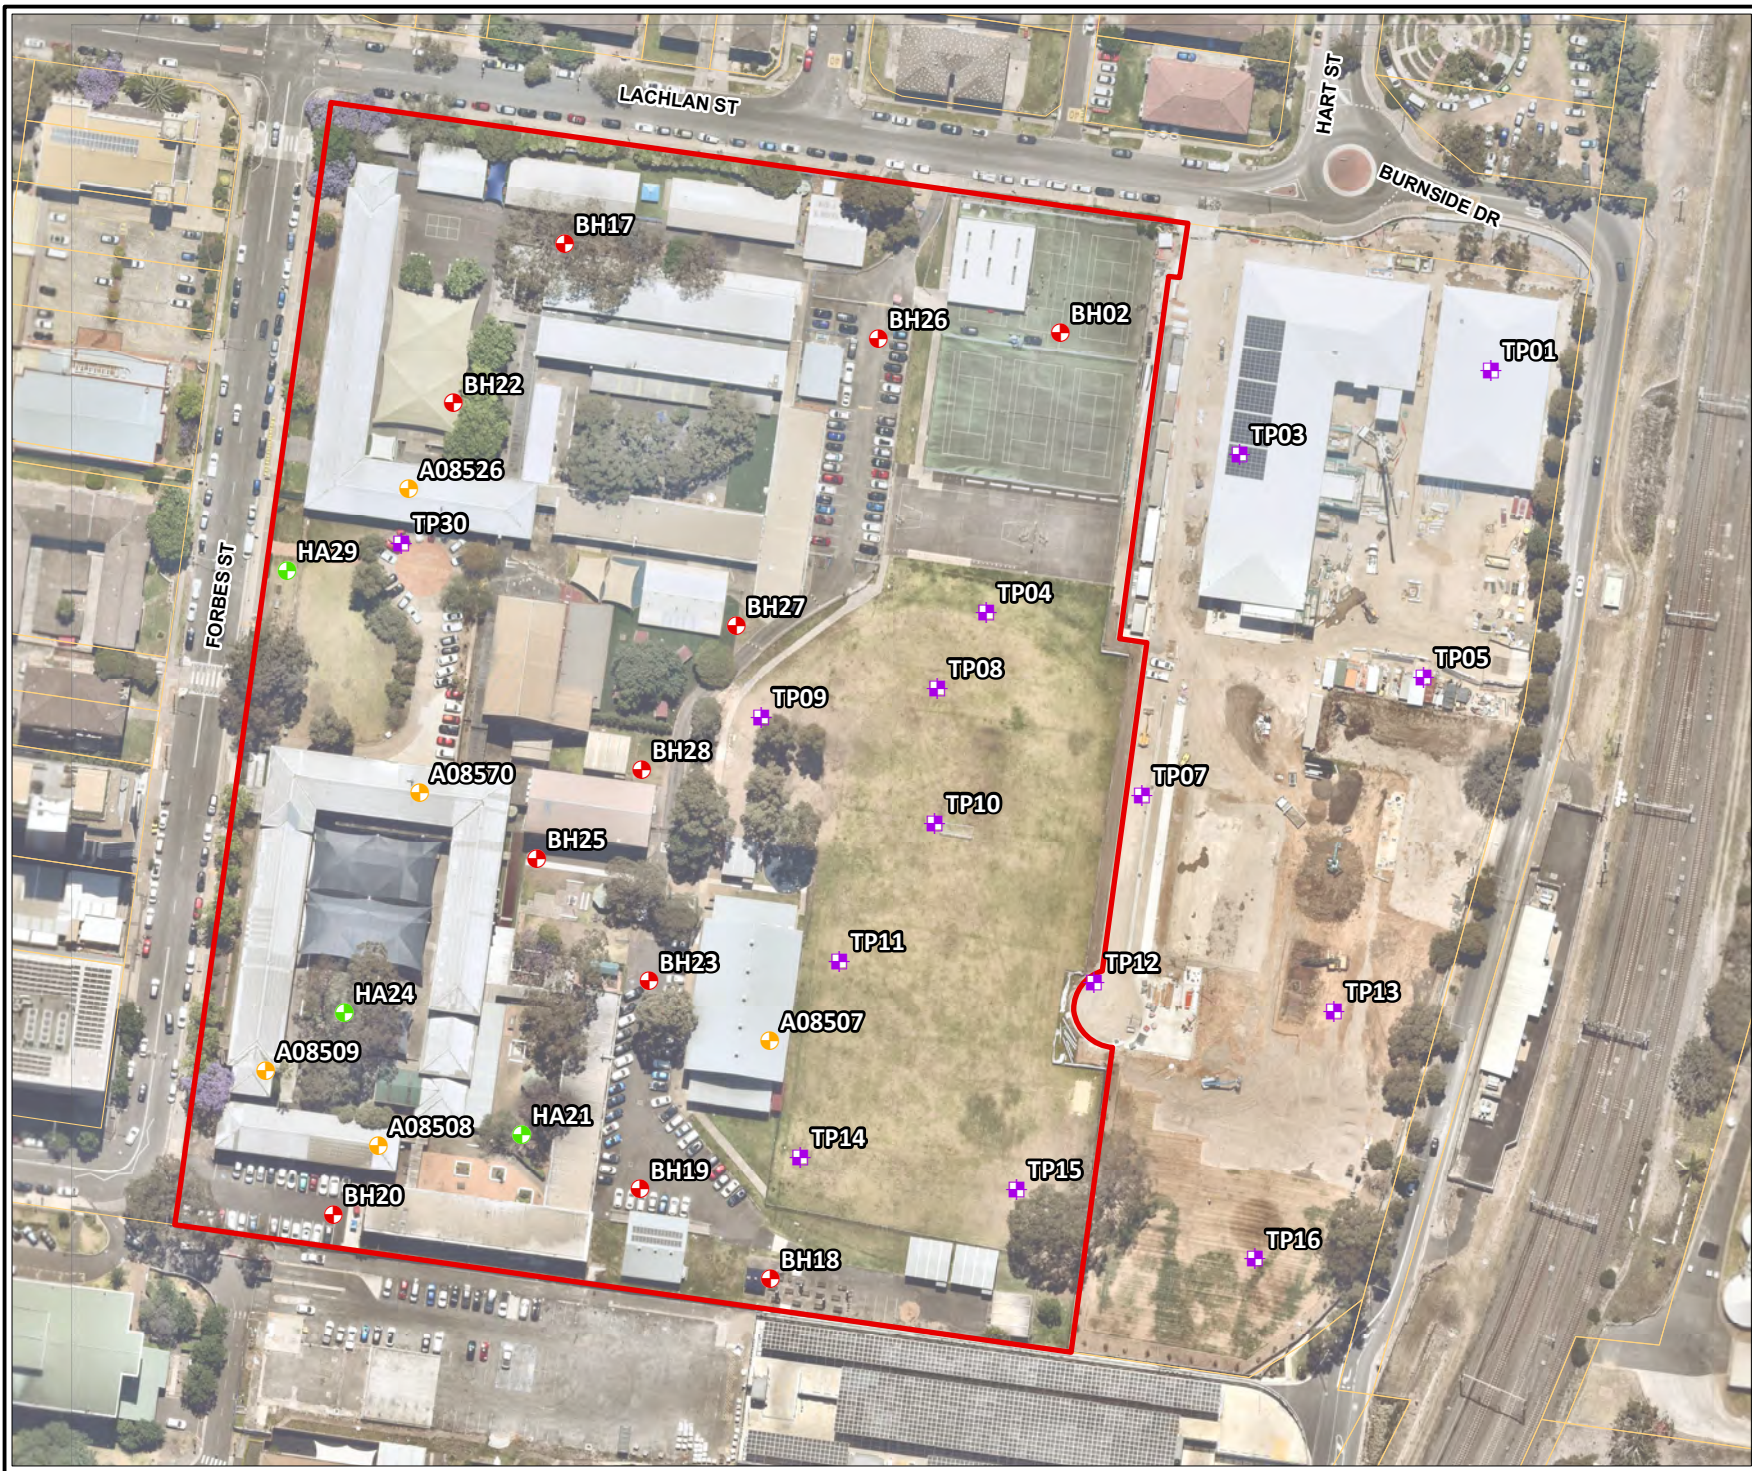
FIGURE 3

- Legend
- Approximate Site Boundary
  - NSW Cadastre
- Historical Sample Locations (Coffey, 2019)
- Borehole
  - Hand-augered Borehole
  - Sub Floor Grab Sample
  - Test Pit

HISTORICAL SAMPLE LOCATIONS

- JBS&G notes that 27 sample locations were positioned within the site (i.e. the proposed development area) which comprises an area of approximately 5.2 hectares.

- It is further noted that limited test pitting has been conducted across the western portion of the site due to restricted access. This would have reduced the potential to observe anthropogenic inclusions including potential asbestos contamination within fill material, particularly in proximity to current and

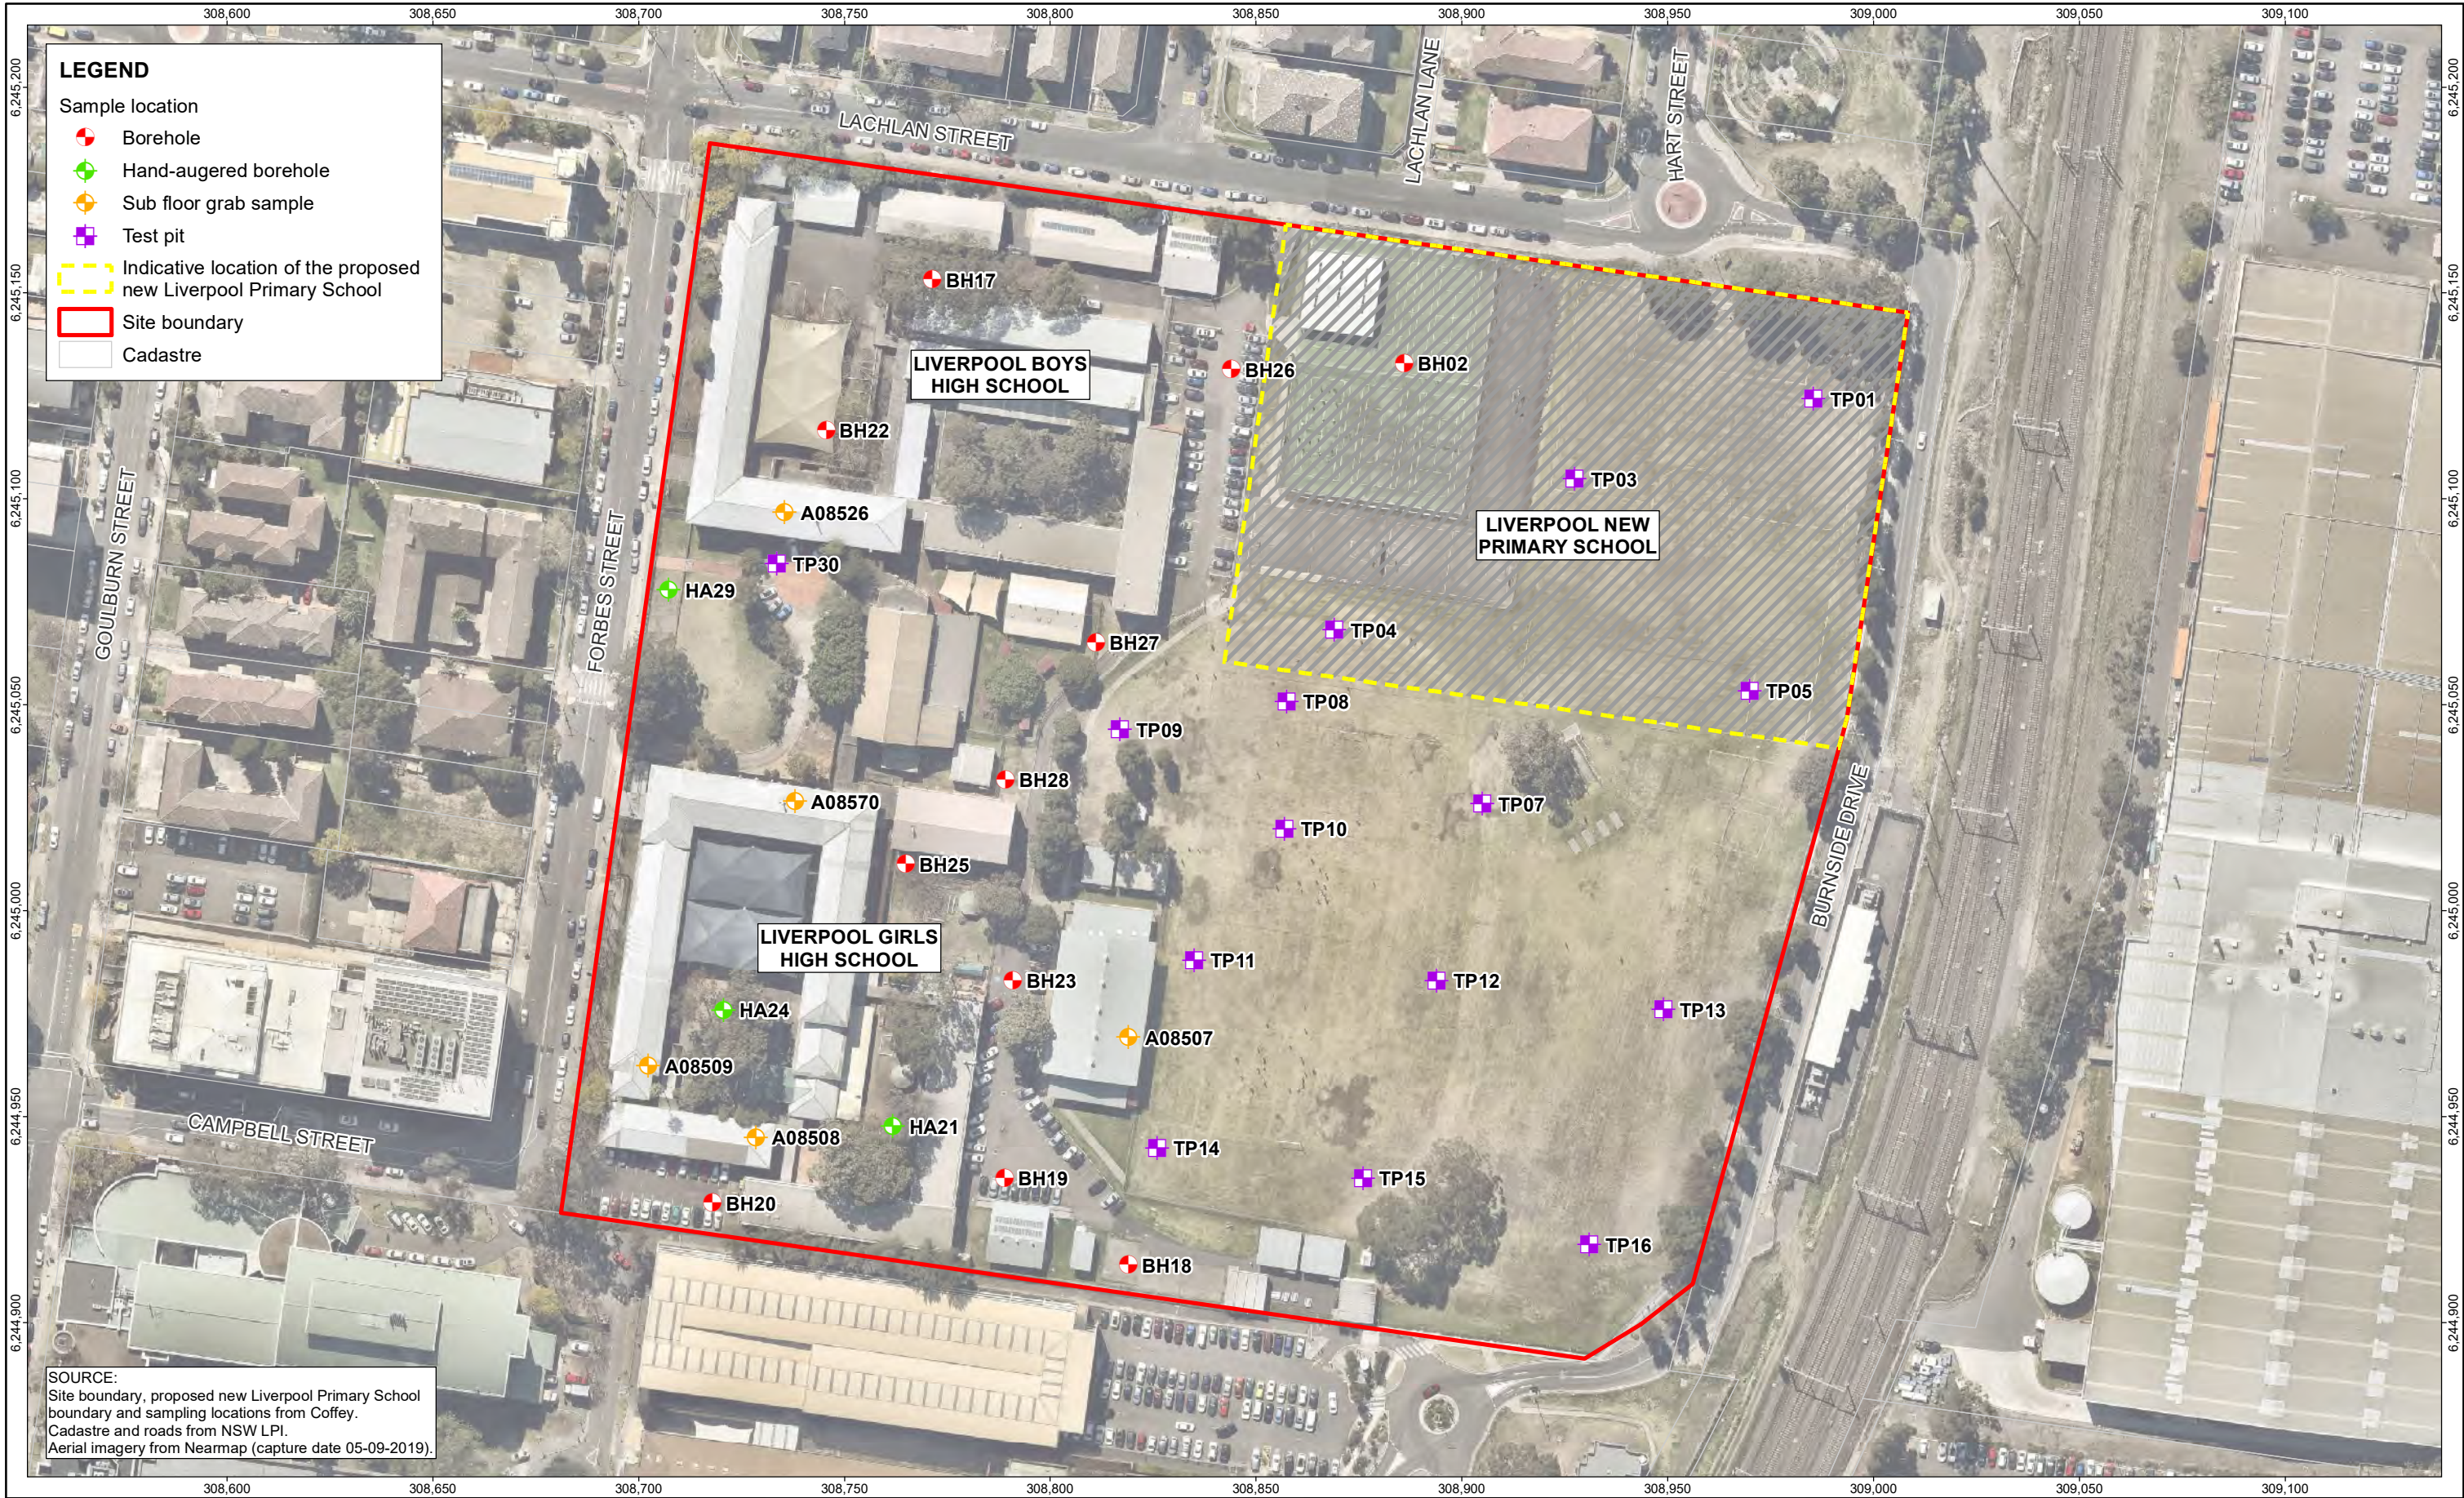
| project no: | 754-SYDEN231101-R02 | figure no: FIGURE 3 |

| title:<br>SAMPLING LOCATION PLAN | | |

The investigation area undertaken as part of the SCA covers the entire Liverpool Education Precinct site, as shown in the figure provided in **Attachment 3**.

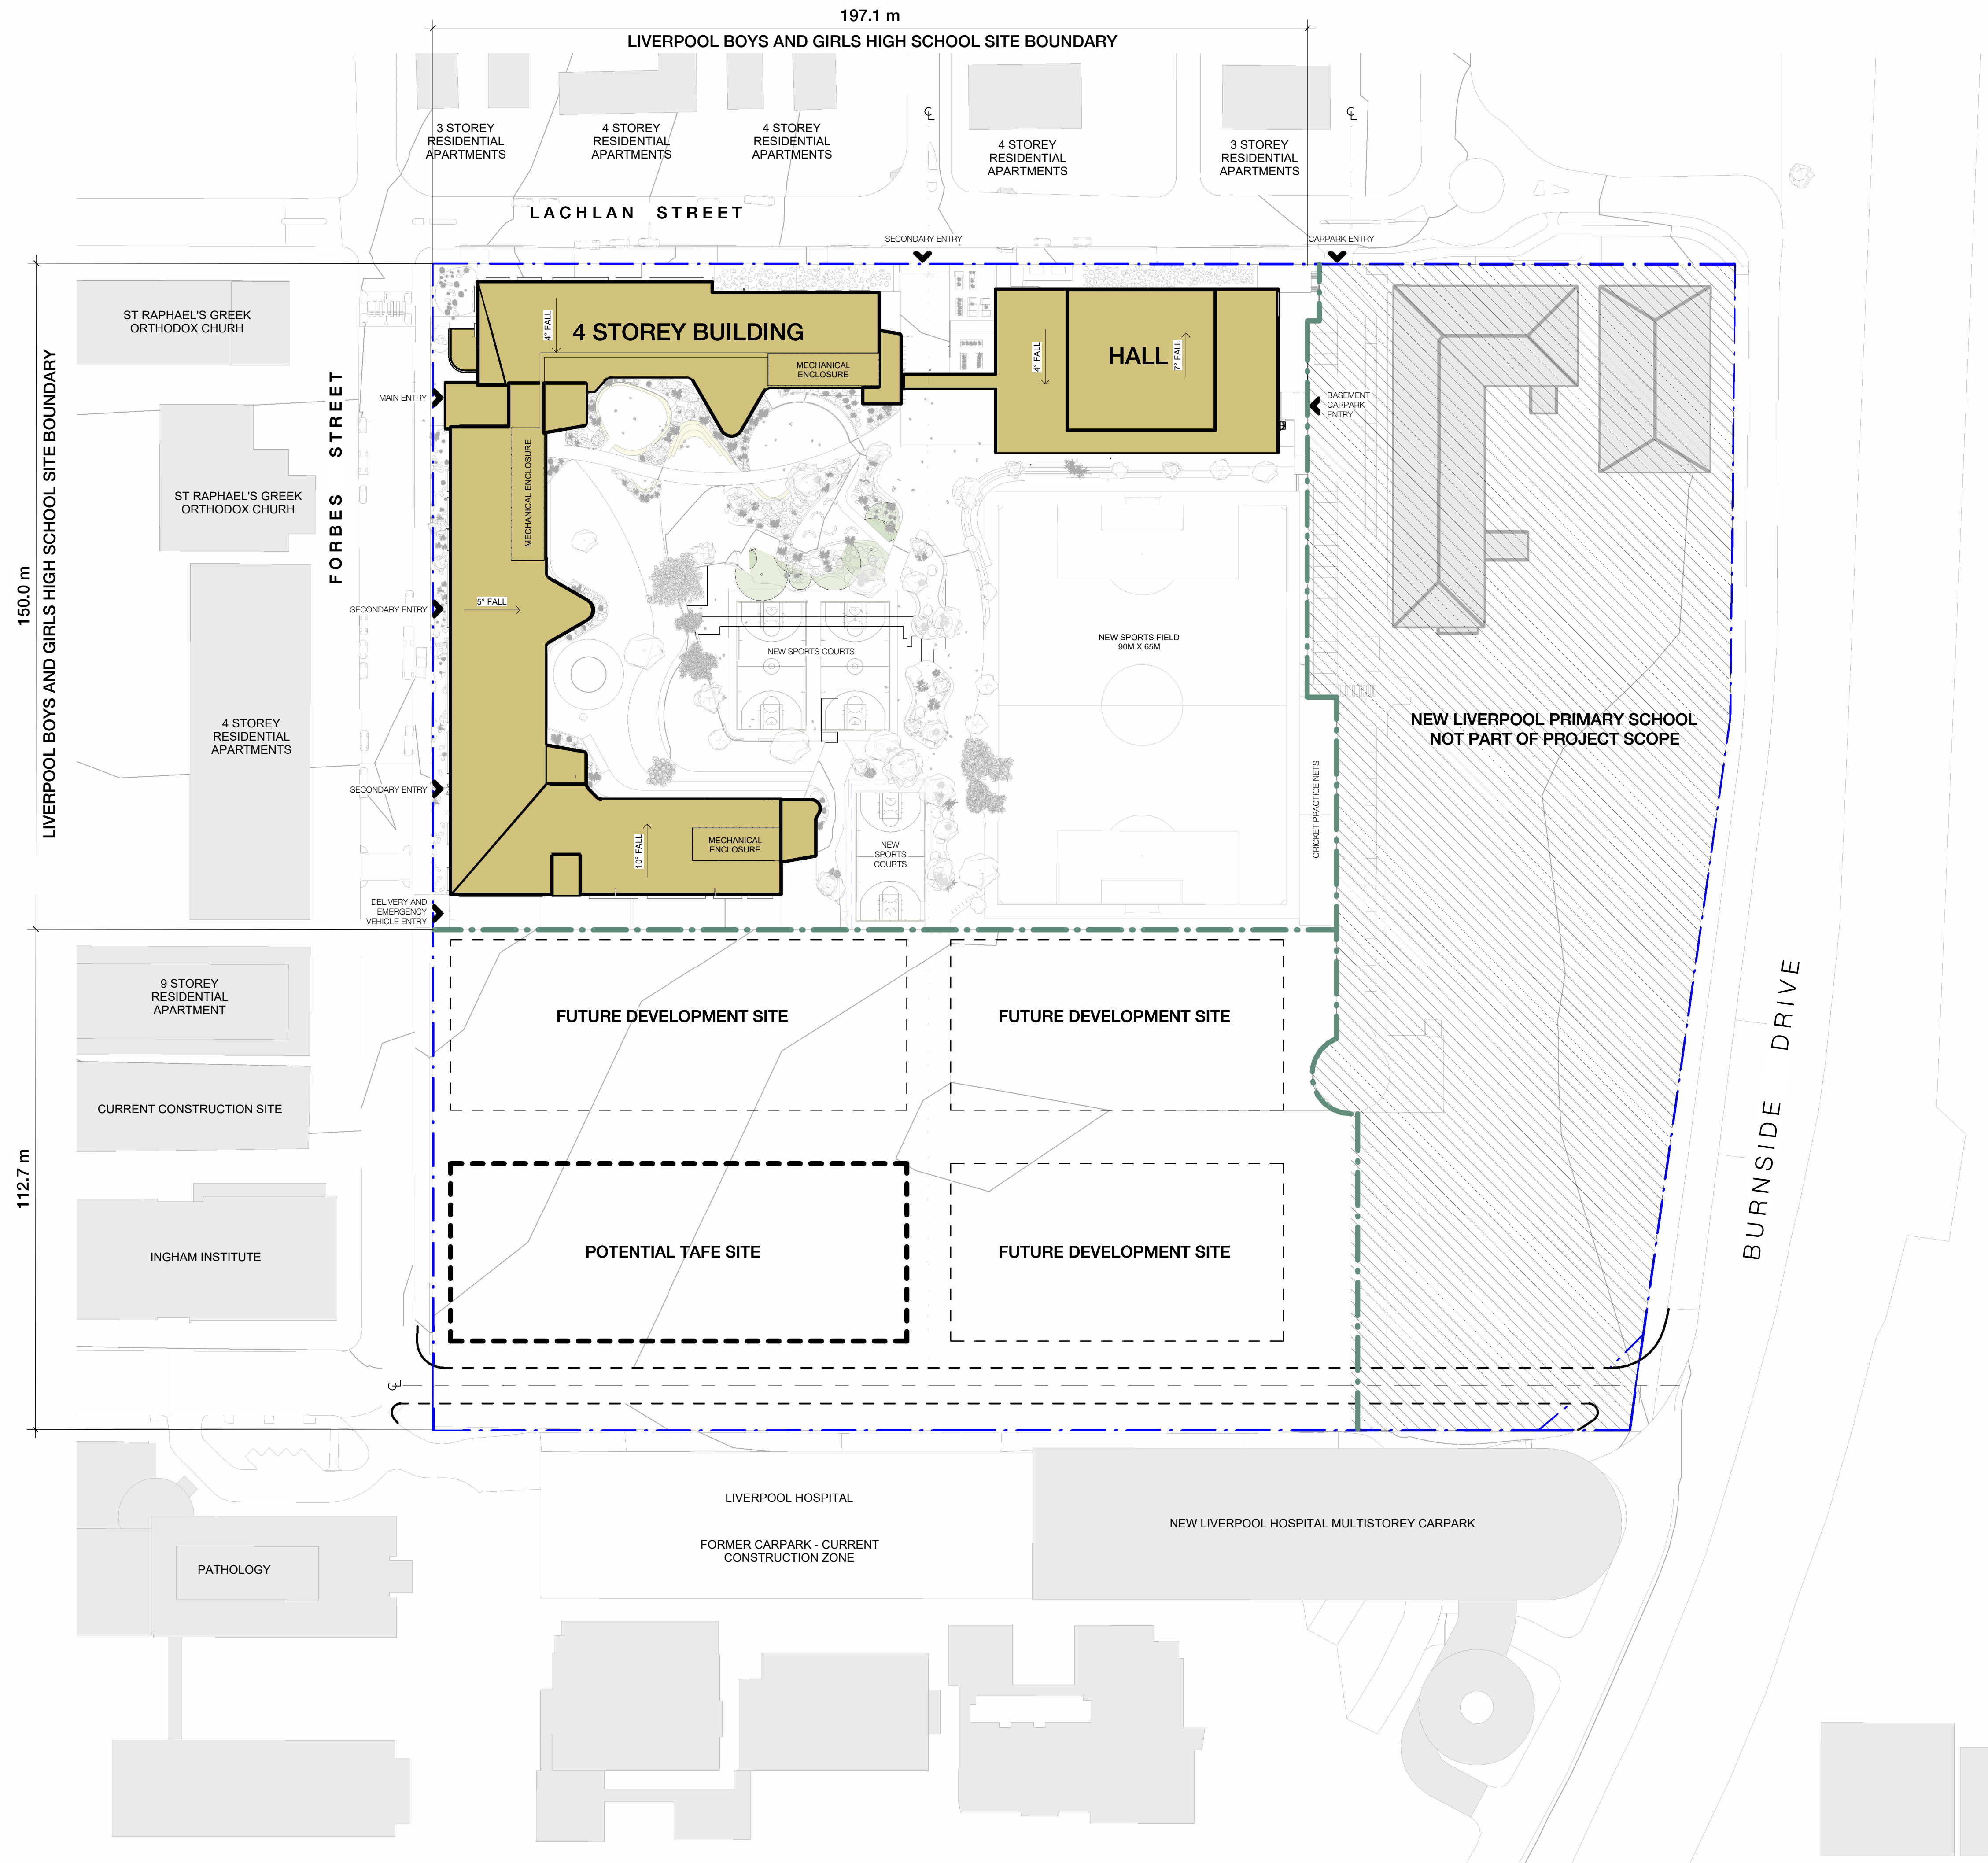
Drawing No.  
**LBGHS-TKD-DR-AR-1000**

- SITE BOUNDARY
- BOUNDARY BETWEEN HIGH SCHOOL AND PRIMARY SCHOOL
- EXISTING BUILDINGS
- PROPOSED BUILDINGS

Drawing Title  
**SITE PLAN - BASEMENT CARPARK**

Based on the review of the site design plans, provided in **Attachment 3**, it is understood that the proposed redevelopment area (i.e., the site) is split into a northern area proposed for the redevelopment of the school facilities and a southern area designated for future development. The proposed school facilities include a multi-storey educational structure with associated outdoor recreational and sporting areas as well as a single storey underground basement carpark located in the central northern boundary of the site.
