**Report on Geotechnical, Salinity and Acid Sulfate Soils  
Assessment**

**Proposed Liverpool Boys and Girls High School  
Upgrade Project**

**Forbes Street, Liverpool NSW**

**Project 92370.03**

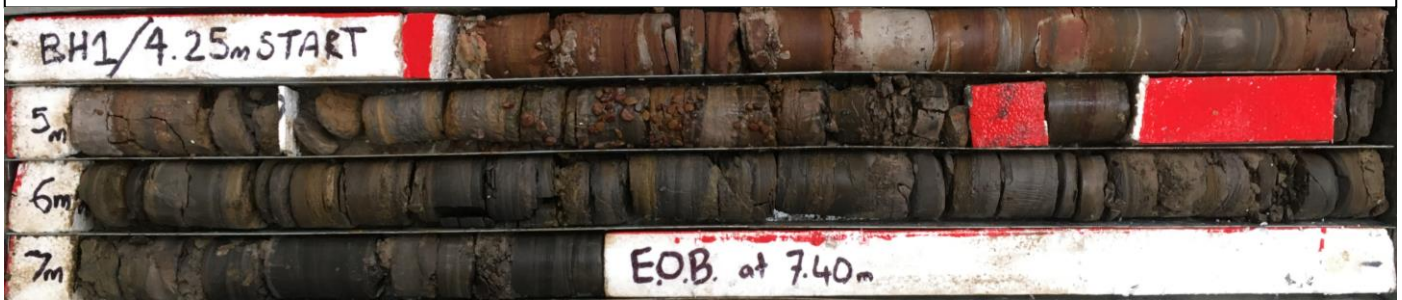
BORE: 1    DEPTH: 4.25 – 7.40m    PROJECT: 92370.00    OCTOBER 2019

End of Bore at 7.40 m

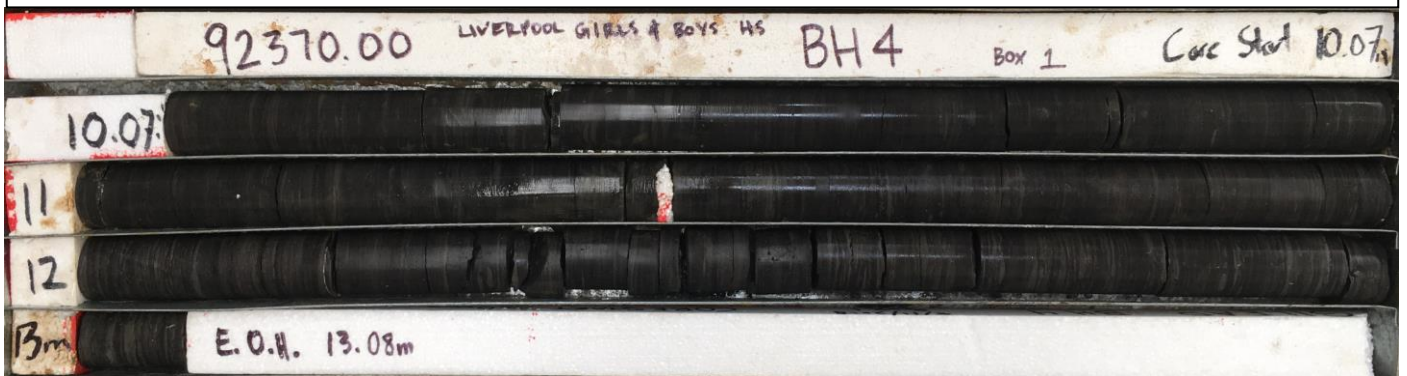
BORE: 4    DEPTH: 10.07 – 13.08m    PROJECT: 92370.00    OCTOBER 2019

End of Bore at 13.08 m

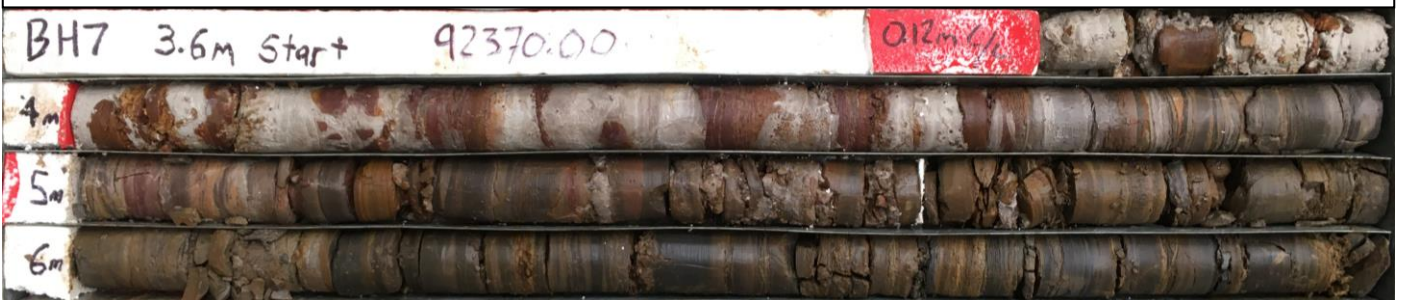
BORE: 7    DEPTH: 3.60 – 7.00m    PROJECT: 92370.00    OCTOBER 2019

End of Bore at 7.00 m

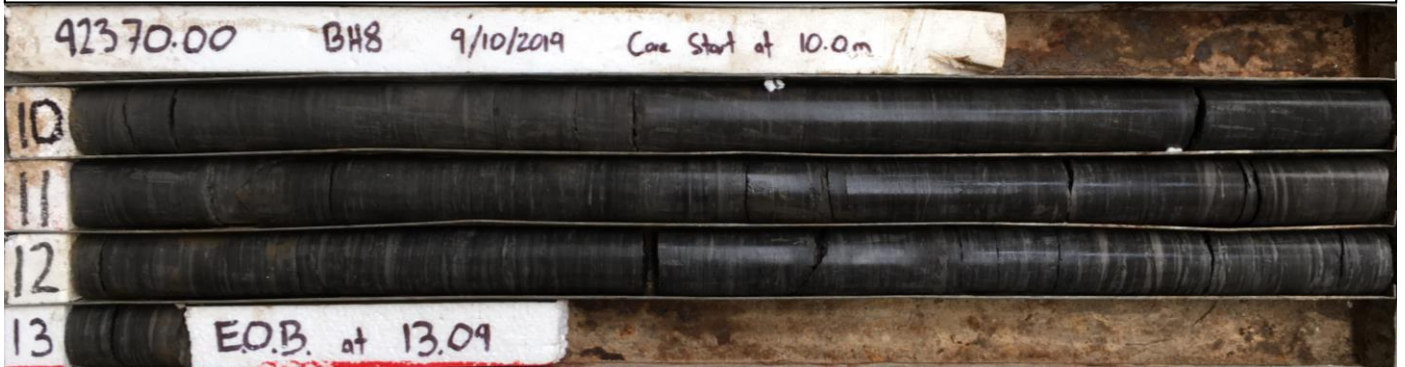
BORE: 8    DEPTH: 10.00 – 13.09m    PROJECT: 92370.00    OCTOBER 2019

End of Bore at 13.09 m

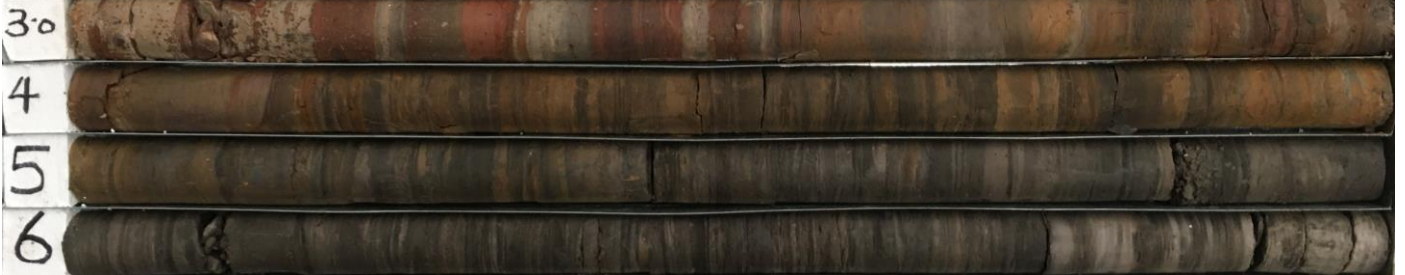
BORE: 12    DEPTH: 2.80 – 7.00 m    PROJECT: 92370.00    OCTOBER 2019

92370.00    BH12    10/10/2019    Core Start at 2.80m

End of Bore at 7.00 m

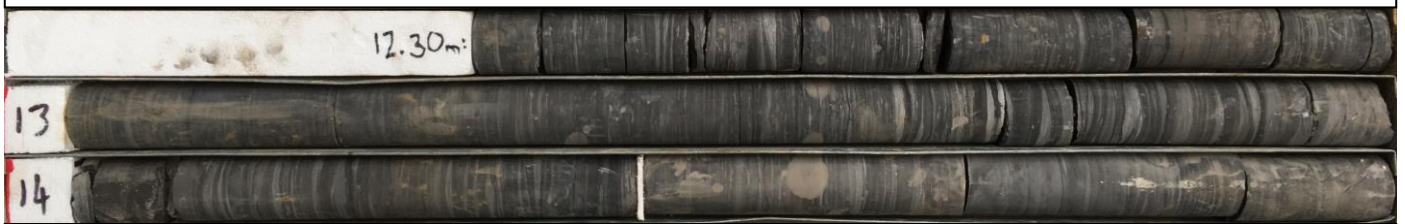
BORE: 20    DEPTH: 12.30 – 13.00m    PROJECT: 92370.00    OCTOBER 2019

End of Bore at 13.00 m

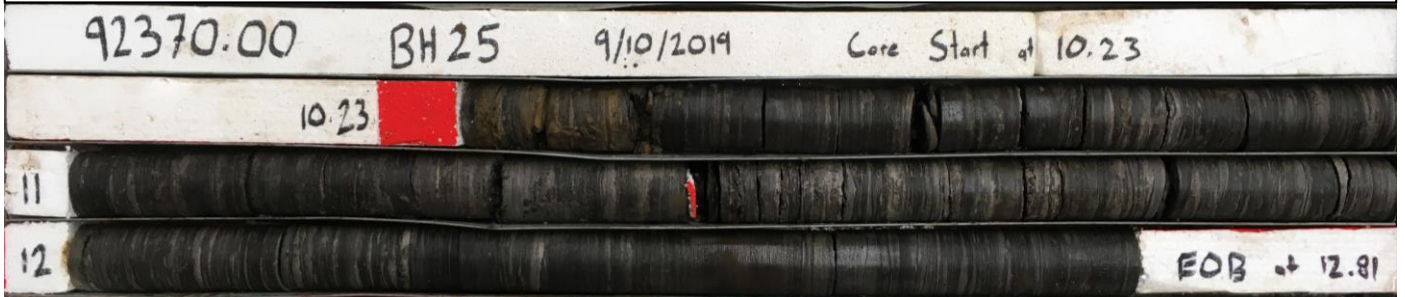
BORE: 25    DEPTH: 10.23 – 12.81m    PROJECT: 92370.00    OCTOBER 2019

End of Bore at 12.81 m

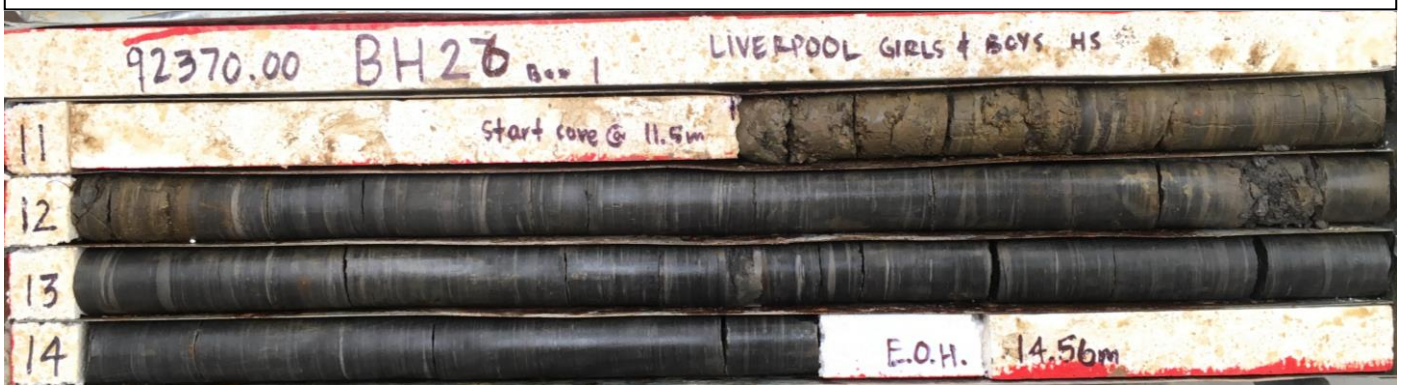
BORE: 26    DEPTH: 11.5 – 14.56m    PROJECT: 92370.00    OCTOBER 2019

End of Bore at 14.56 m
