# Liverpool Boys and Girls High School Upgrade Project

## Remedial Action Plan

165,444 | 68150 (Rev 0)

14 February 2025

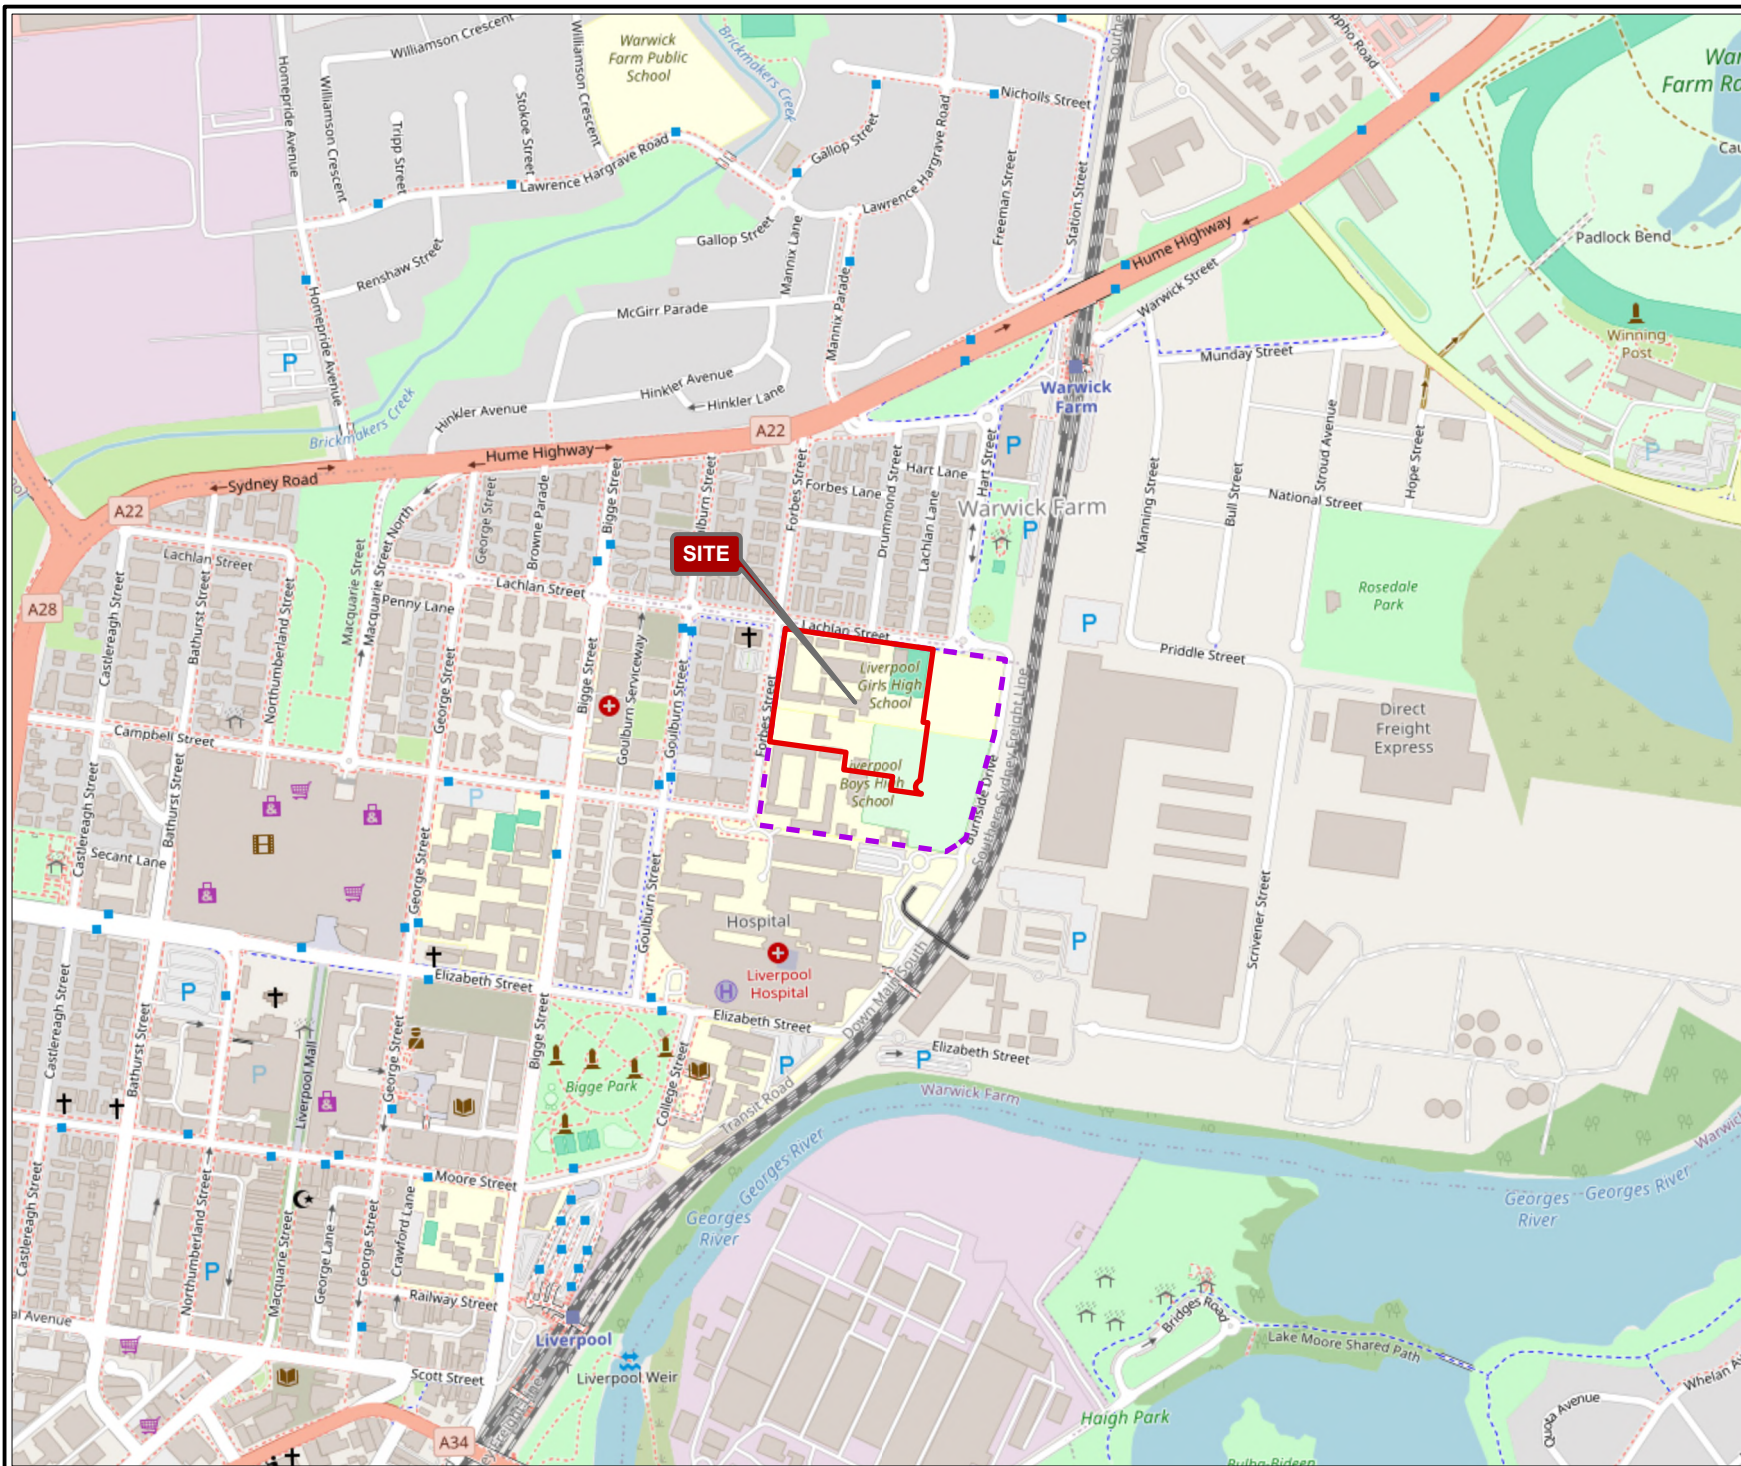
**FIGURE 1**

**SITE LOCATION**

| Environmental Aspect | Characteristics |
|---|---|
| Topography | Review of NSW Topographic Maps available through NSW Spatial Services <sup>11</sup> indicated that the site is sloping from the north-west to the south-east, in the direction of Burnside Drive and the rail corridor. The site lies at elevations between 9 m Australian Height Datum (AHD) in the south-east of the site and 14 m AHD in the north-west. The site is consistent with the general topography of the area which slopes south-east towards the Georges River located approximately 400 m to the south of the site, as indicated in <b>Figure 1</b> . |

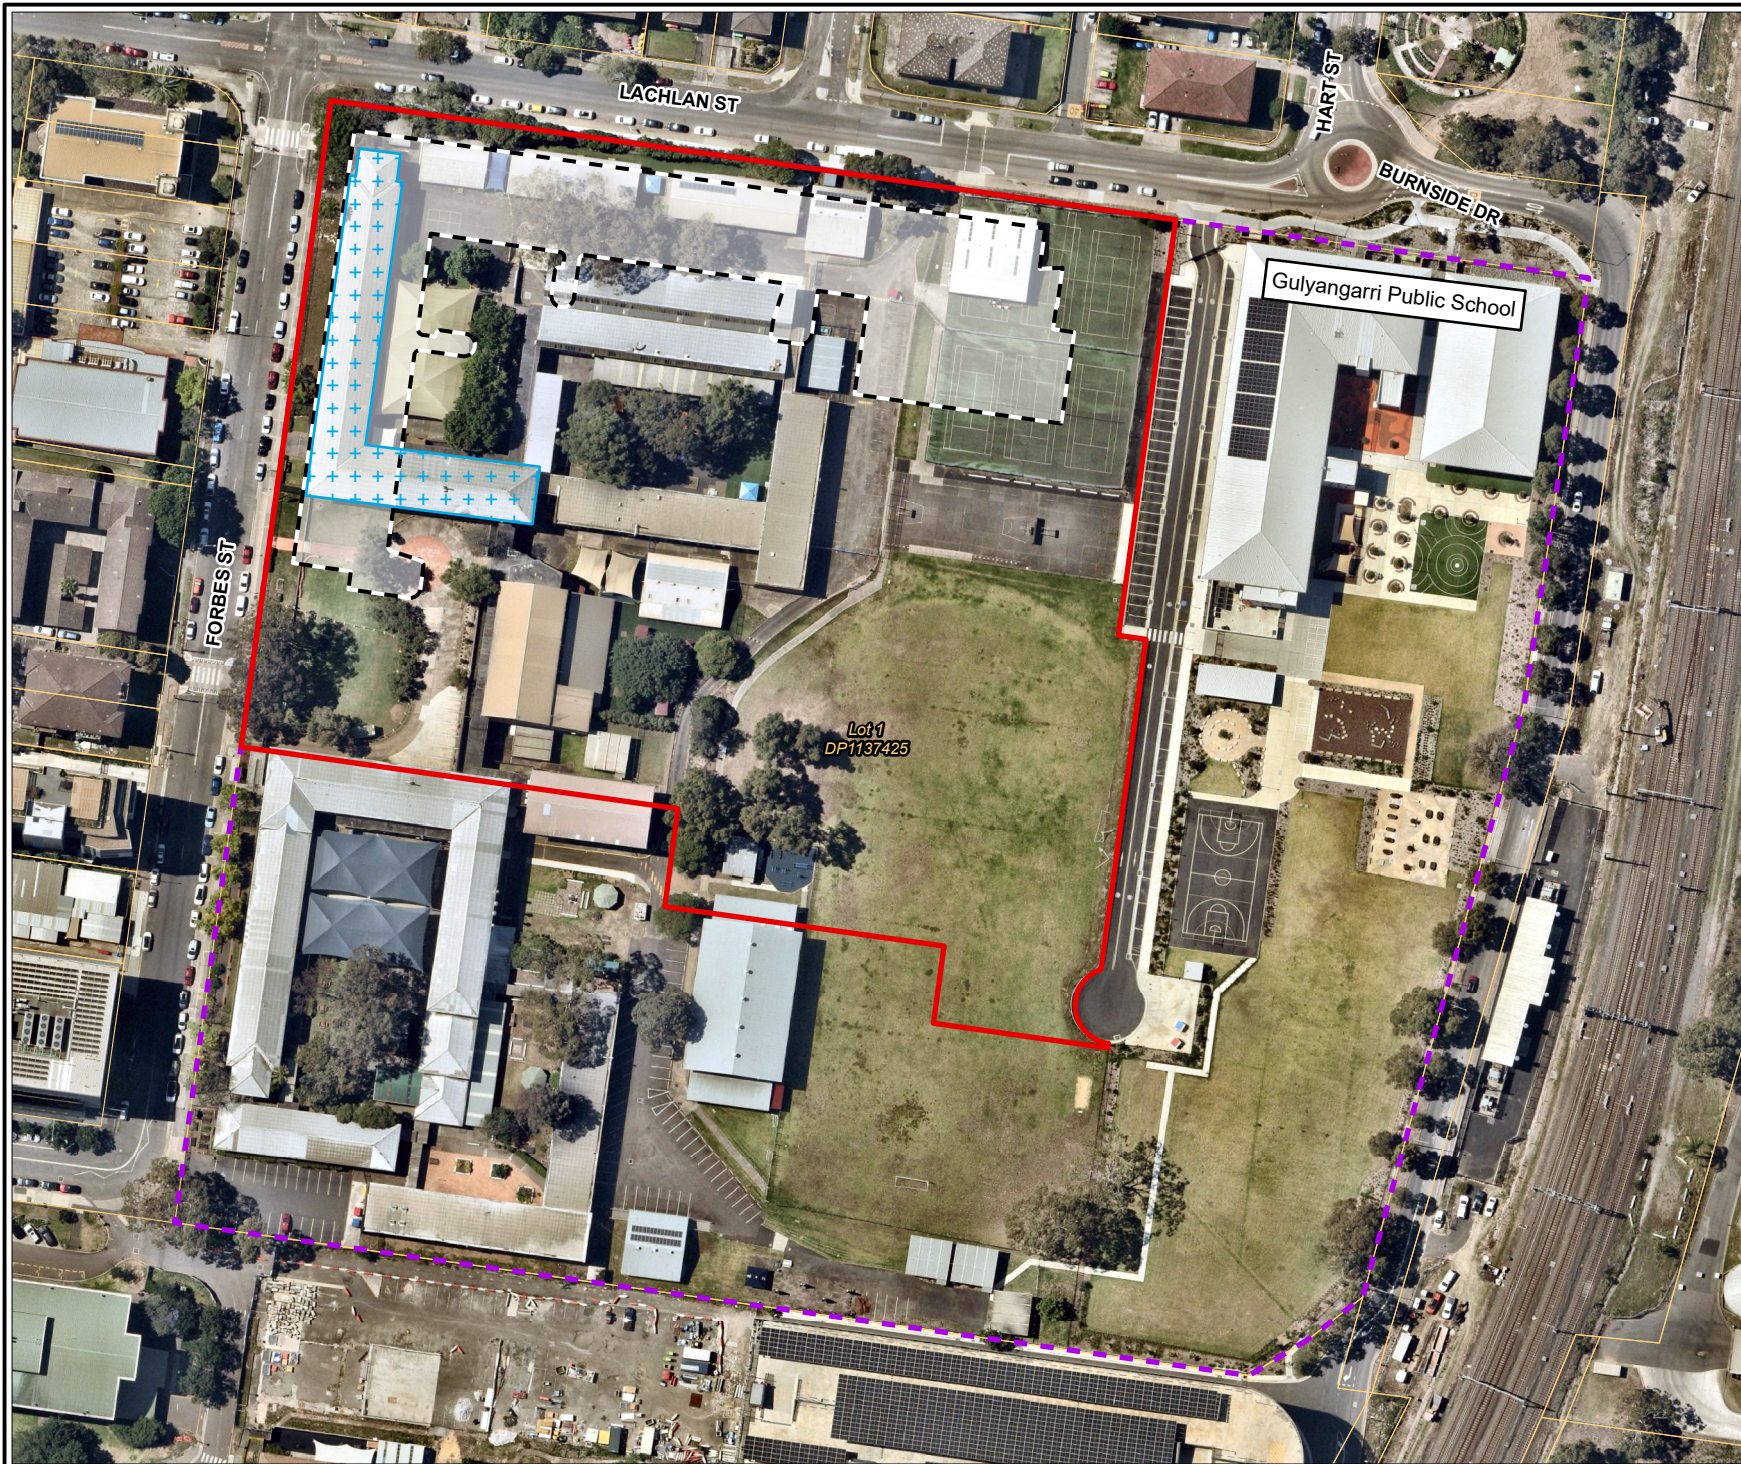
**FIGURE 2**

- Legend**
- Approximate Site Boundary
  - Approximate SINSW Boundary
  - NSW Cadastre
  - Current Site Features**
  - Building A
  - Proposed Site Features**
  - Proposed Building Footprint

**SITE LAYOUT**

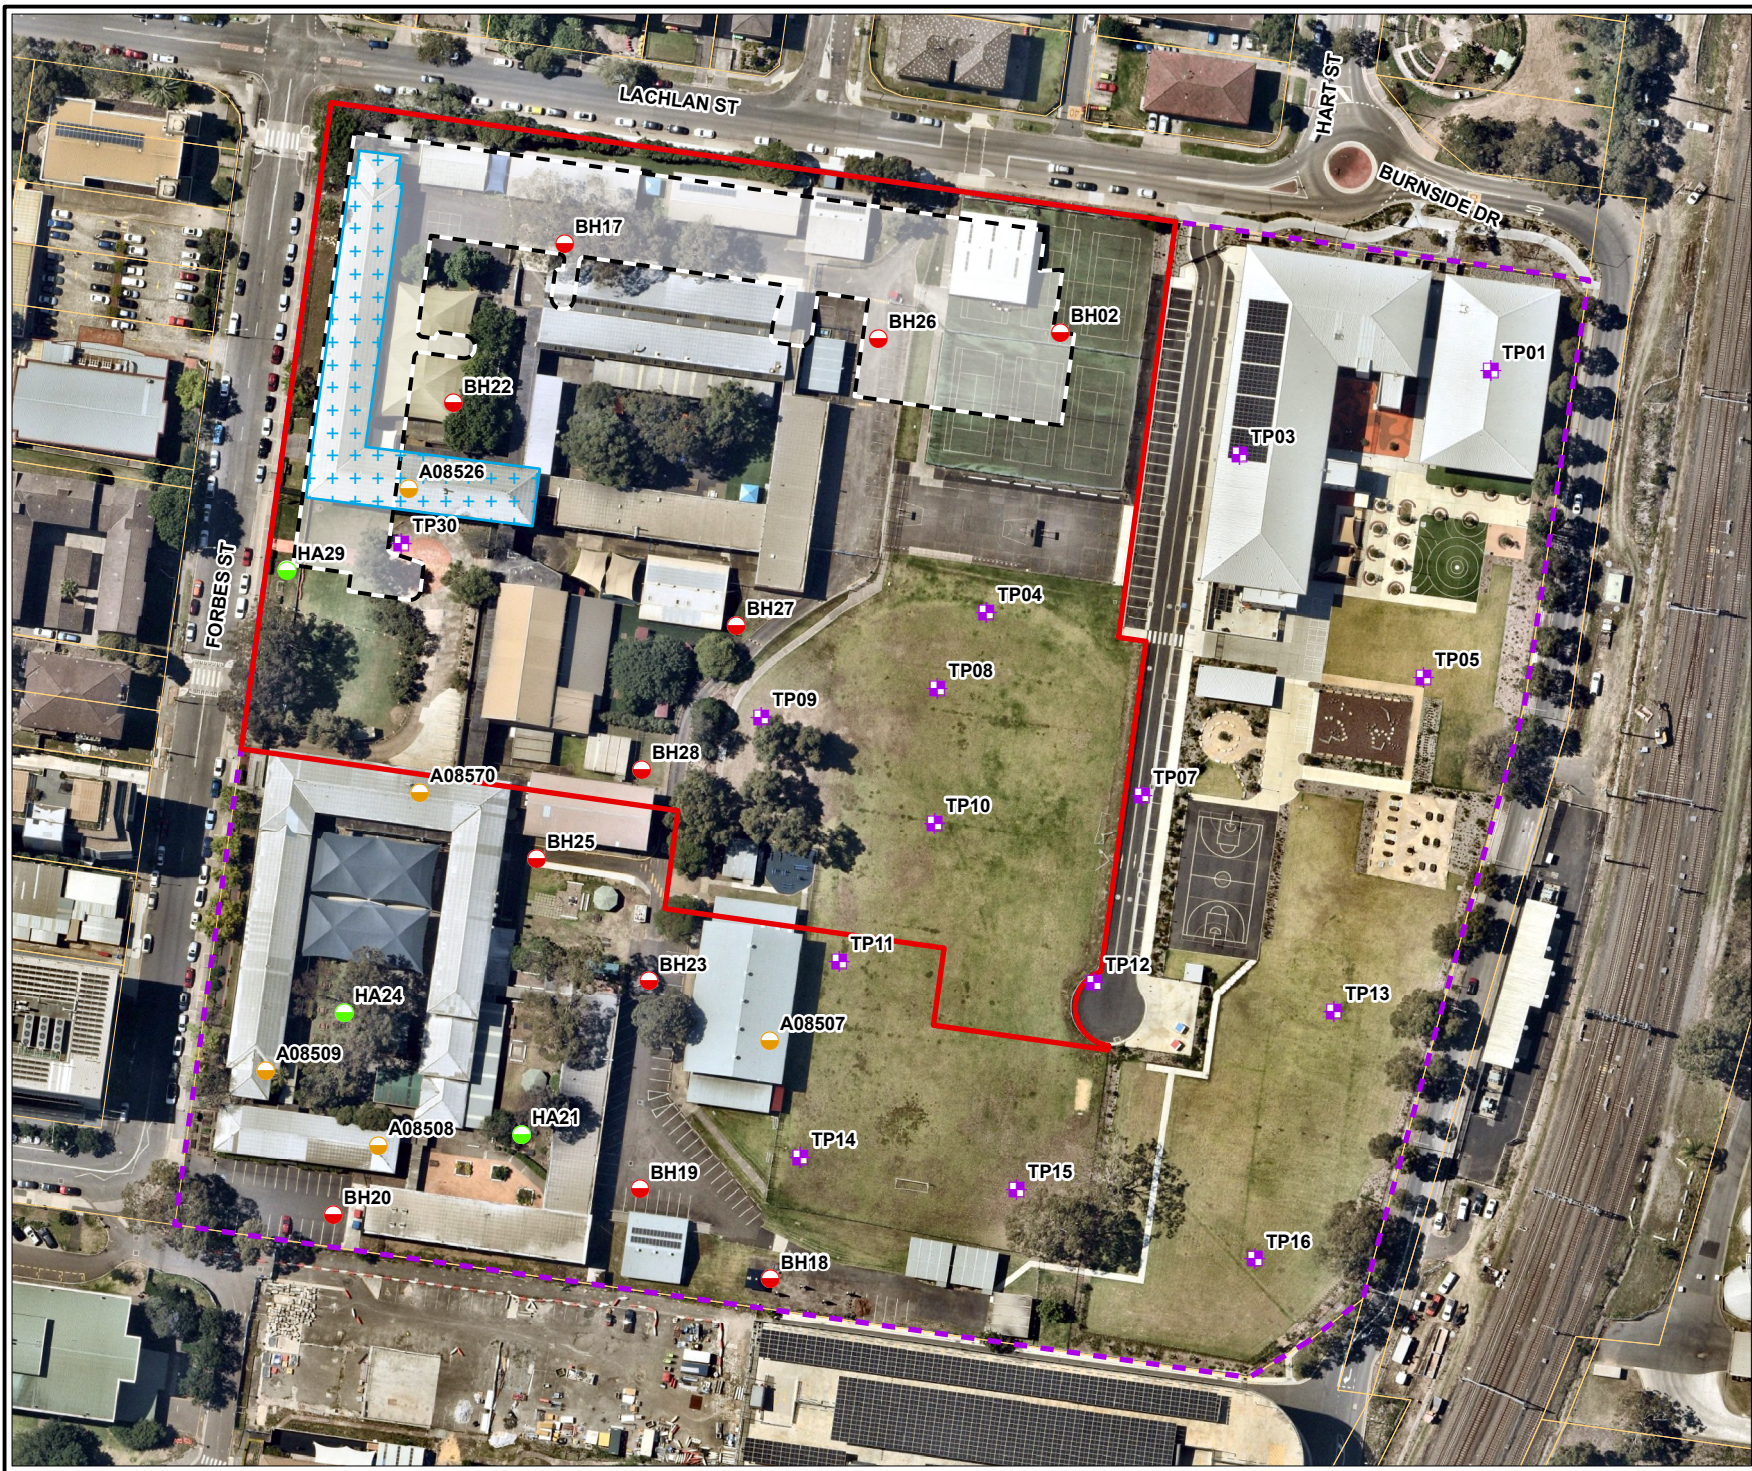
**FIGURE 3**

- Legend**
- Approximate Site Boundary
  - Approximate SINSW Boundary
  - NSW Cadastre
  - Current Site Features**
  - Building A
  - Proposed Site Features**
  - Proposed Building Footprint
  - Historical Sample Locations (Coffey 2019a)**
  - Test Pit
  - Borehole
  - Hand Auger
  - Sub Floor Grab Sample

**HISTORICAL SAMPLE LOCATIONS**

Regarding the asbestos impacted sample location A08570, this location was noted in the SCA text as being present in the crawl space of Block A within LBHS. However, the sample location was instead shown on Figure 3 of the SCA to be in the footprint of a building within LGHS and another sample location (A08526) within the LBHS Block A footprint. Given the ambiguity of the which sample location was located within the LBHS Block A footprint and the potential for mislabelling of sample location names, the impact was conservatively assumed to be associated with the LBHS and the identified asbestos impacted A08570 assumed to be located within LBHS Block A footprint in the position of A08526 as noted in the SCA. This is consistent with the body text of the SCA and descriptions of this impact. Given this assumption, the copper concentration reported for sample location A08570 exceeding ecological criteria were considered to also be present in the crawl space of Block A of the boy's campus and within the boundary of the current investigation.

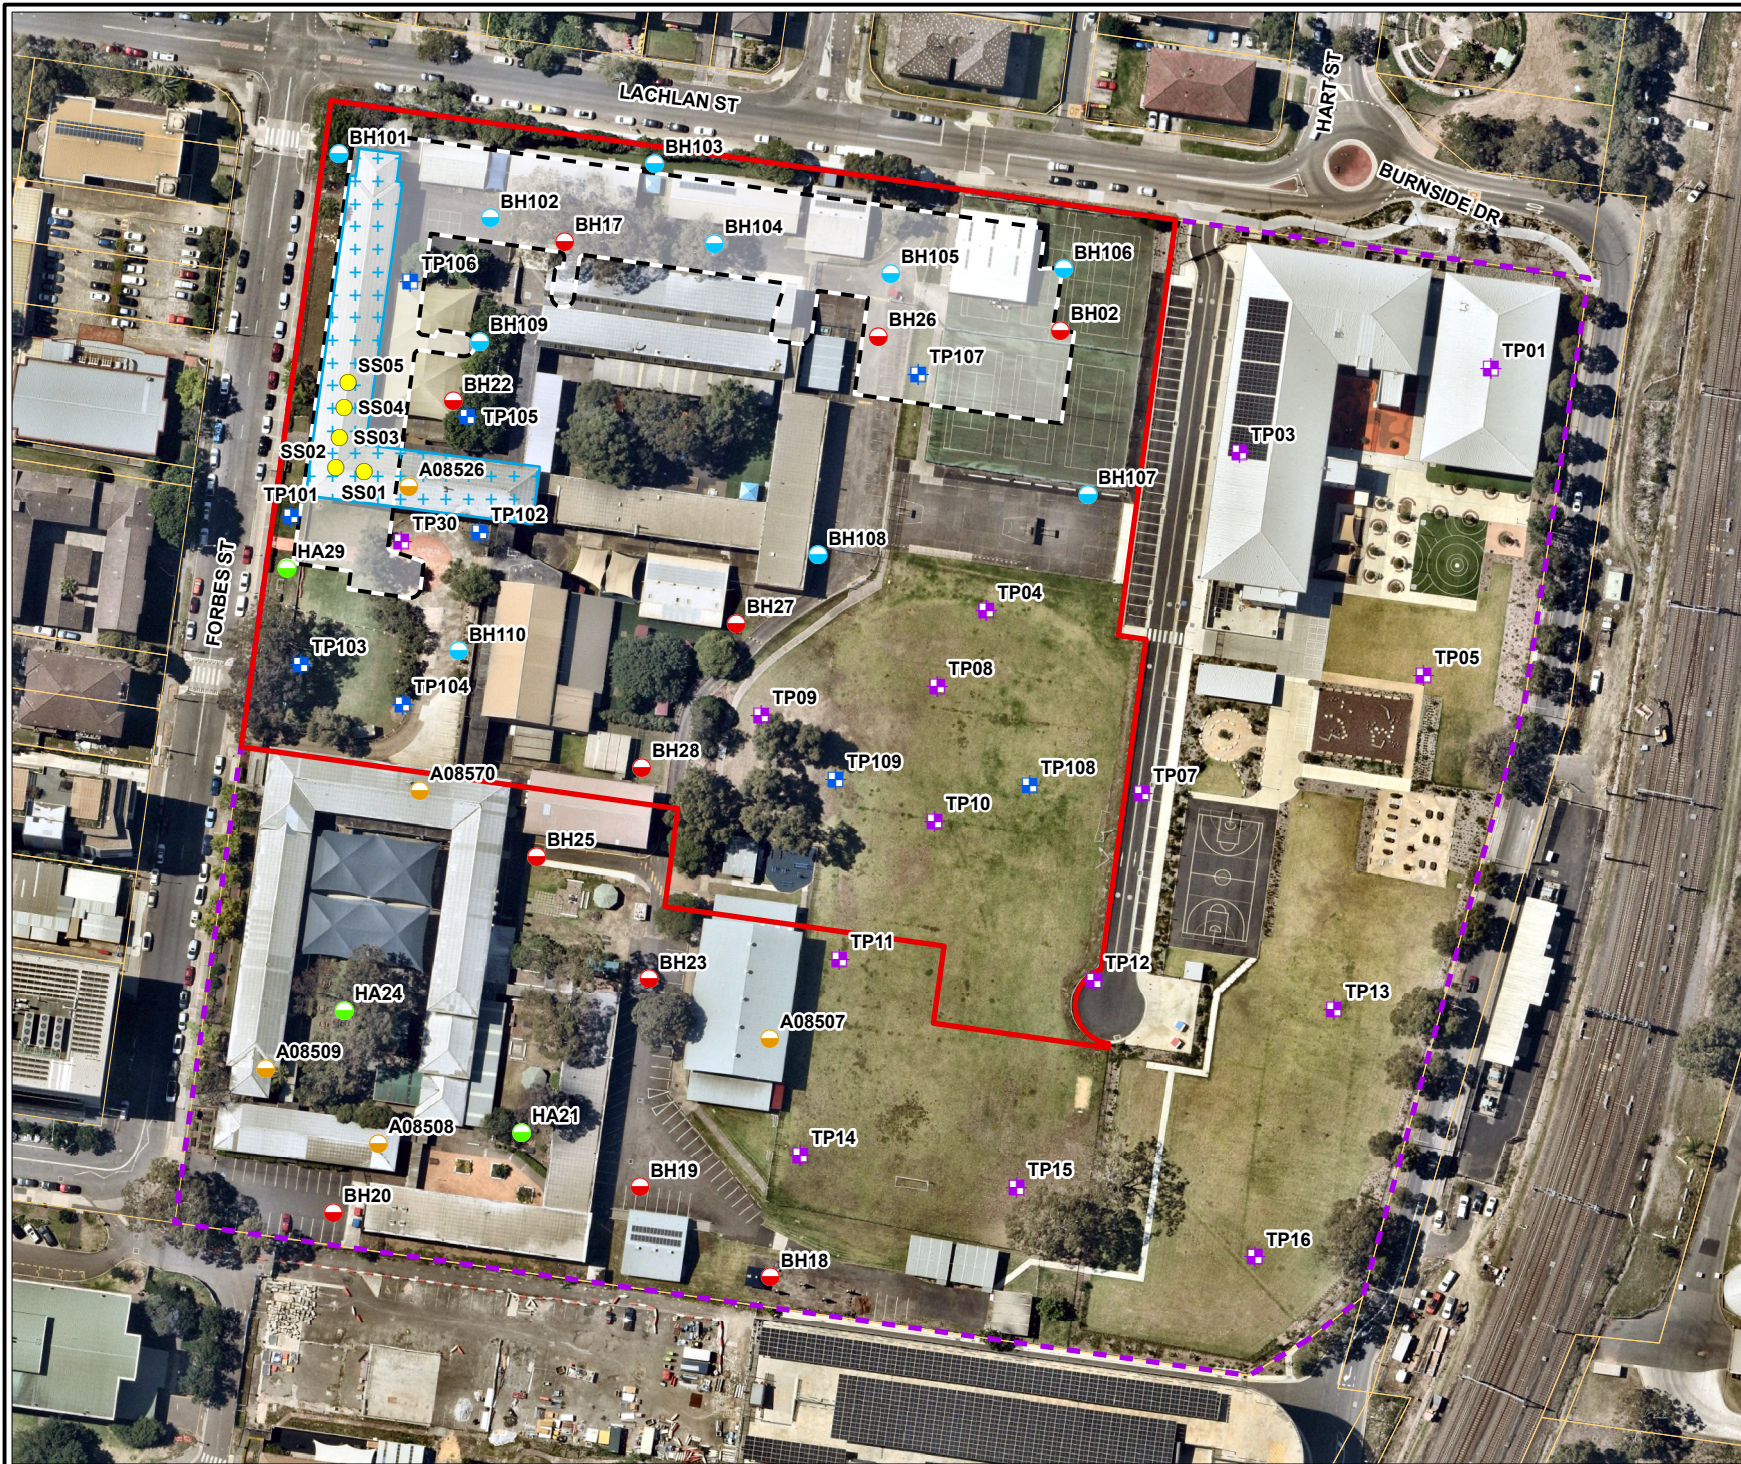
**FIGURE 4**

- Legend**
- Approximate Site Boundary
  - Approximate SINSW Boundary
  - NSW Cadastre
  - Current Site Features**
  - Building A
  - Proposed Site Features**
  - Proposed Building Footprint
  - Historical Sample Locations (Coffey 2019a)**
  - Test Pit
  - Borehole
  - Hand Auger
  - Sub Floor Grab Sample
  - Sample Locations (JBS&G 2025)**
  - Test Pit
  - Borehole
  - Sub Floor Grab Sample

**SAMPLE LOCATIONS**

In total, 24 sample locations were advanced across the redevelopment site area as part of this DGI, including nine (9) test pits and ten (10) boreholes across accessible site areas and five (5) surface soil samples within the sub-floor area of Block A. Sample locations were advanced utilising a combination of a targeted and stratified approach in order to achieve a broad data coverage of the site and target known impacted areas and those areas with higher potential for contamination. It is noted that the northern portion of the Block A subfloor space was unable to be inspected and sampled due to access restrictions.

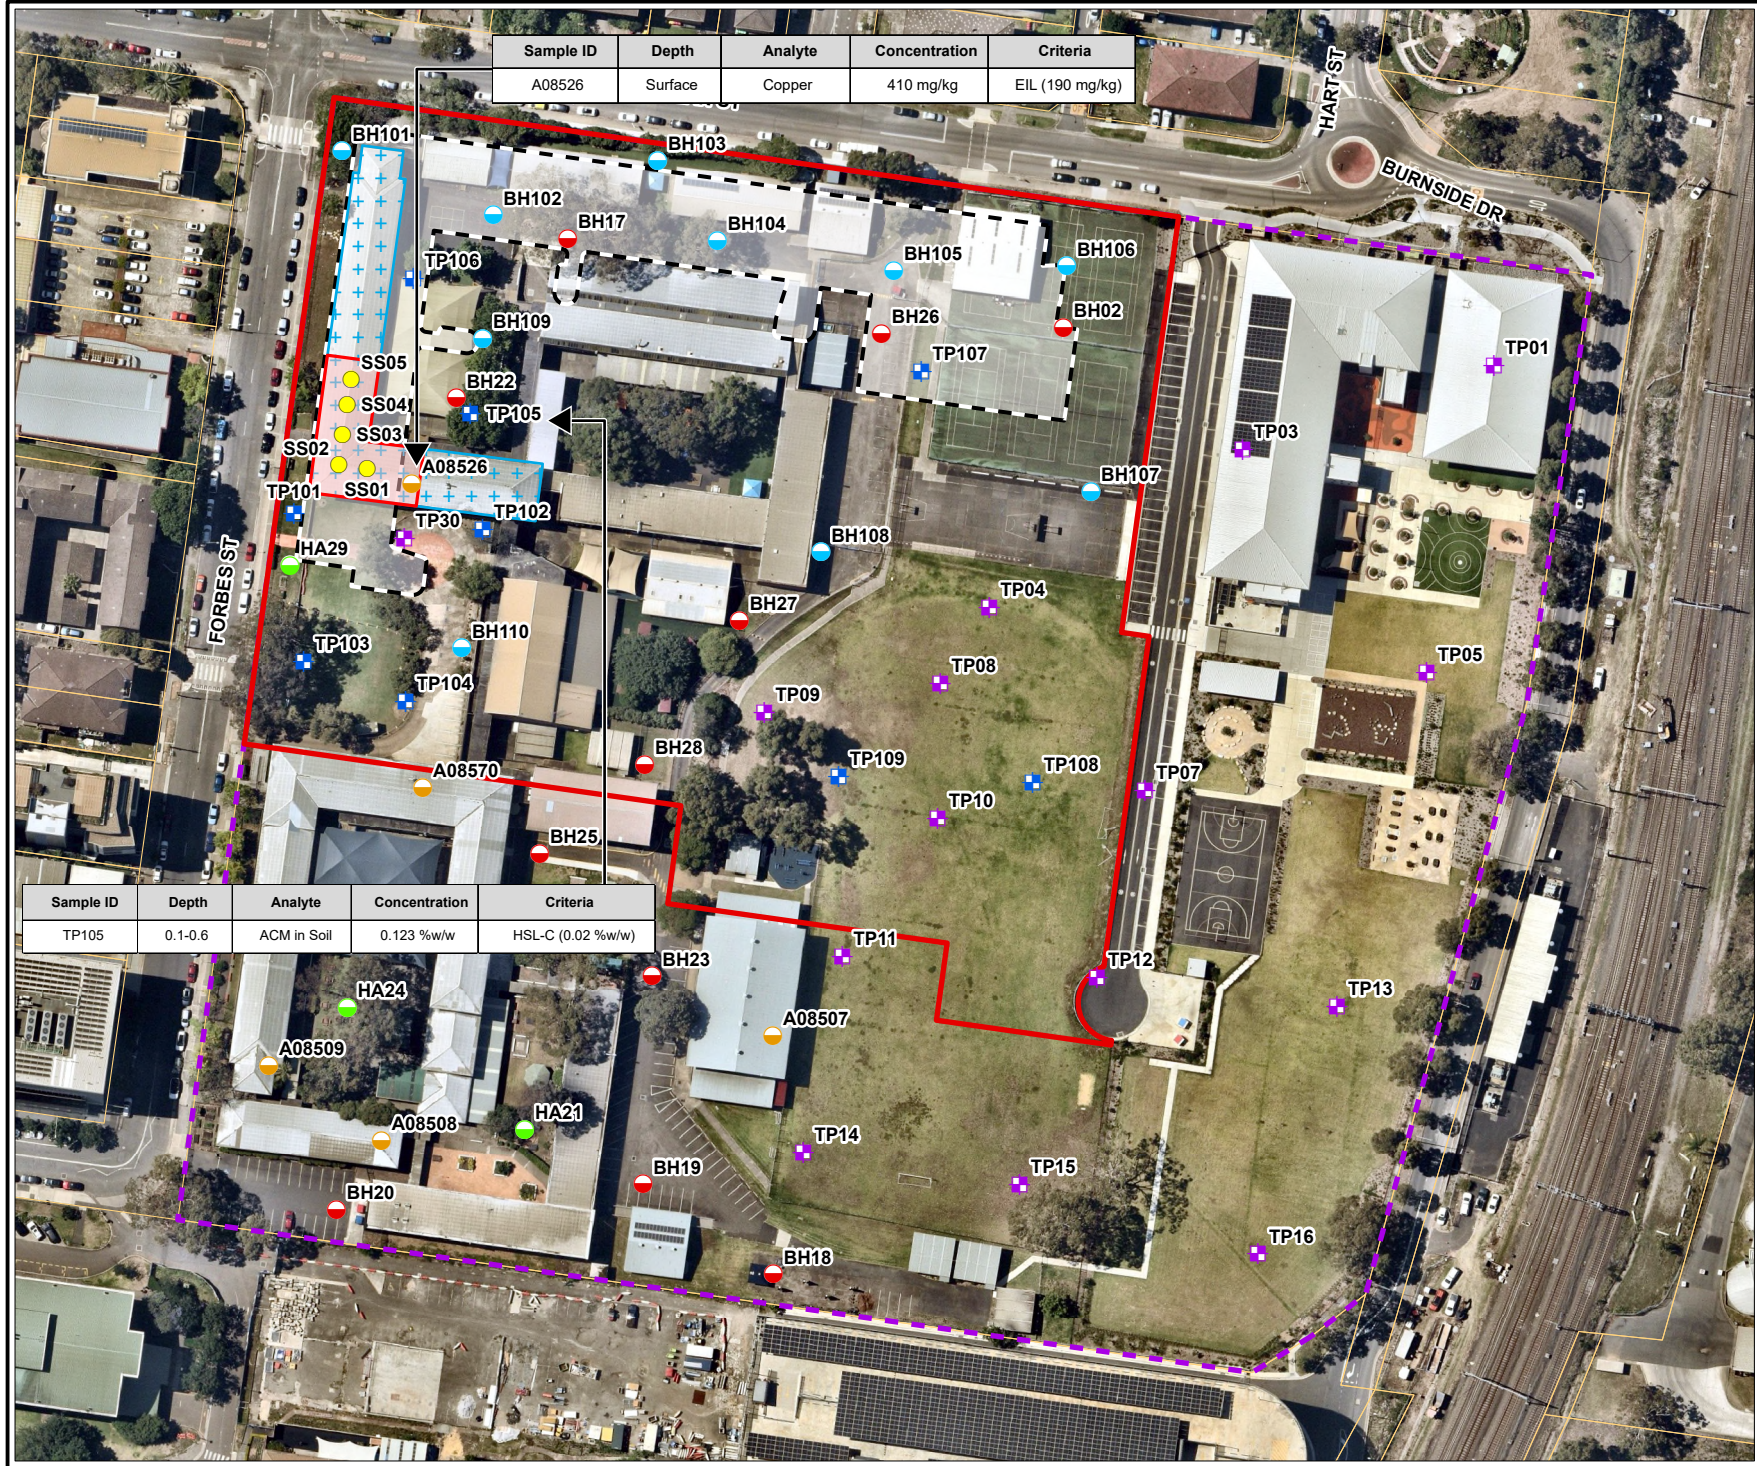
FIGURE 5

| Sample ID | Depth | Analyte | Concentration | Criteria |
| A08526 | Surface | Copper | 410 mg/kg | EIL (190 mg/kg) |

**EXCEEDANCES**

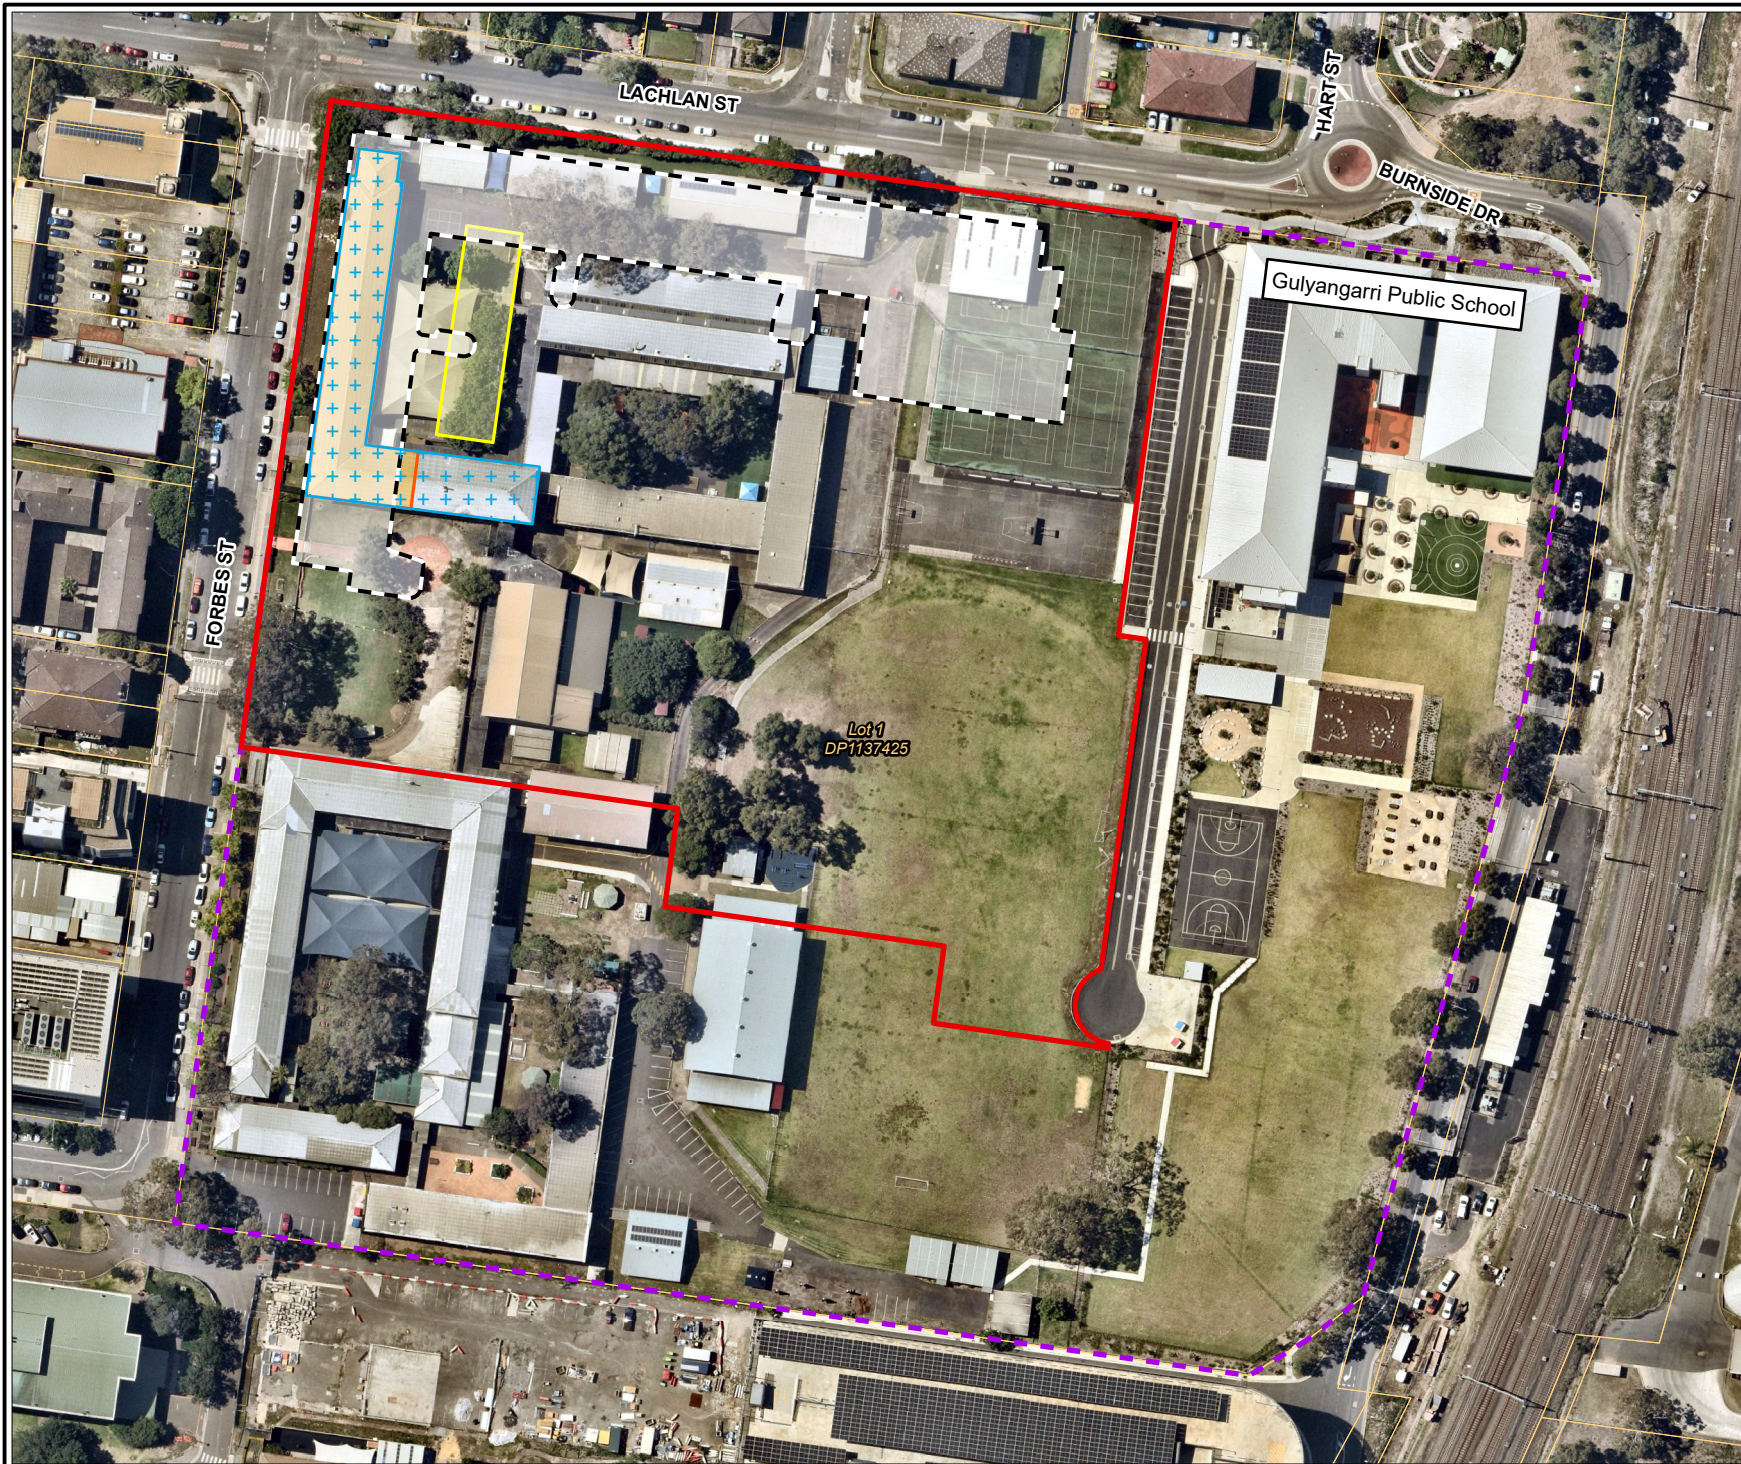
- Legend**
- Approximate Site Boundary
  - Approximate SINSW Boundary
  - NSW Cadastre
  - Current Site Features**
  - Building A
  - Remedial Extents**
  - Remedial Extent (Copper and Asbestos)
  - Remedial Extent (Asbestos)
  - Proposed Site Features**
  - Proposed Building Footprint

Based on the appraisal of site contamination presented in **Section 4.2**, the approximate extent of contamination requiring remediation at the site based on currently available data is presented in Table 5.1. It is noted that the remedial extents will in practice be guided by validation outcomes. Approximate remedial extents are shown on **Figure 6**.

It is noted that with regards to Block A, the eastern most portion of the building footprint is underlain by learning spaces through which the crawl space is accessed to the west of these spaces. The extent of the crawl space as requiring remediation has been identified on **Figure 6**.
