**Subject: P25011 - Bungendore North Campus High School, Majara Street, Bungendore.**

The objective of this letter was to assess whether the site may have changed since the 2024 investigation was completed and provide advice to support a Review of Environmental Factors (REF) for the NSW Department of Education (DoE) for the construction and operation of the Bungendore North Campus High School.

A suitably qualified environmental consultant from Lanterra visited the site on 10 February 2025. The purpose of the investigation was to visually assess the site for any changes since the contamination assessment was completed in 2024 and to determine whether there were new activities that could introduce contamination to the site.

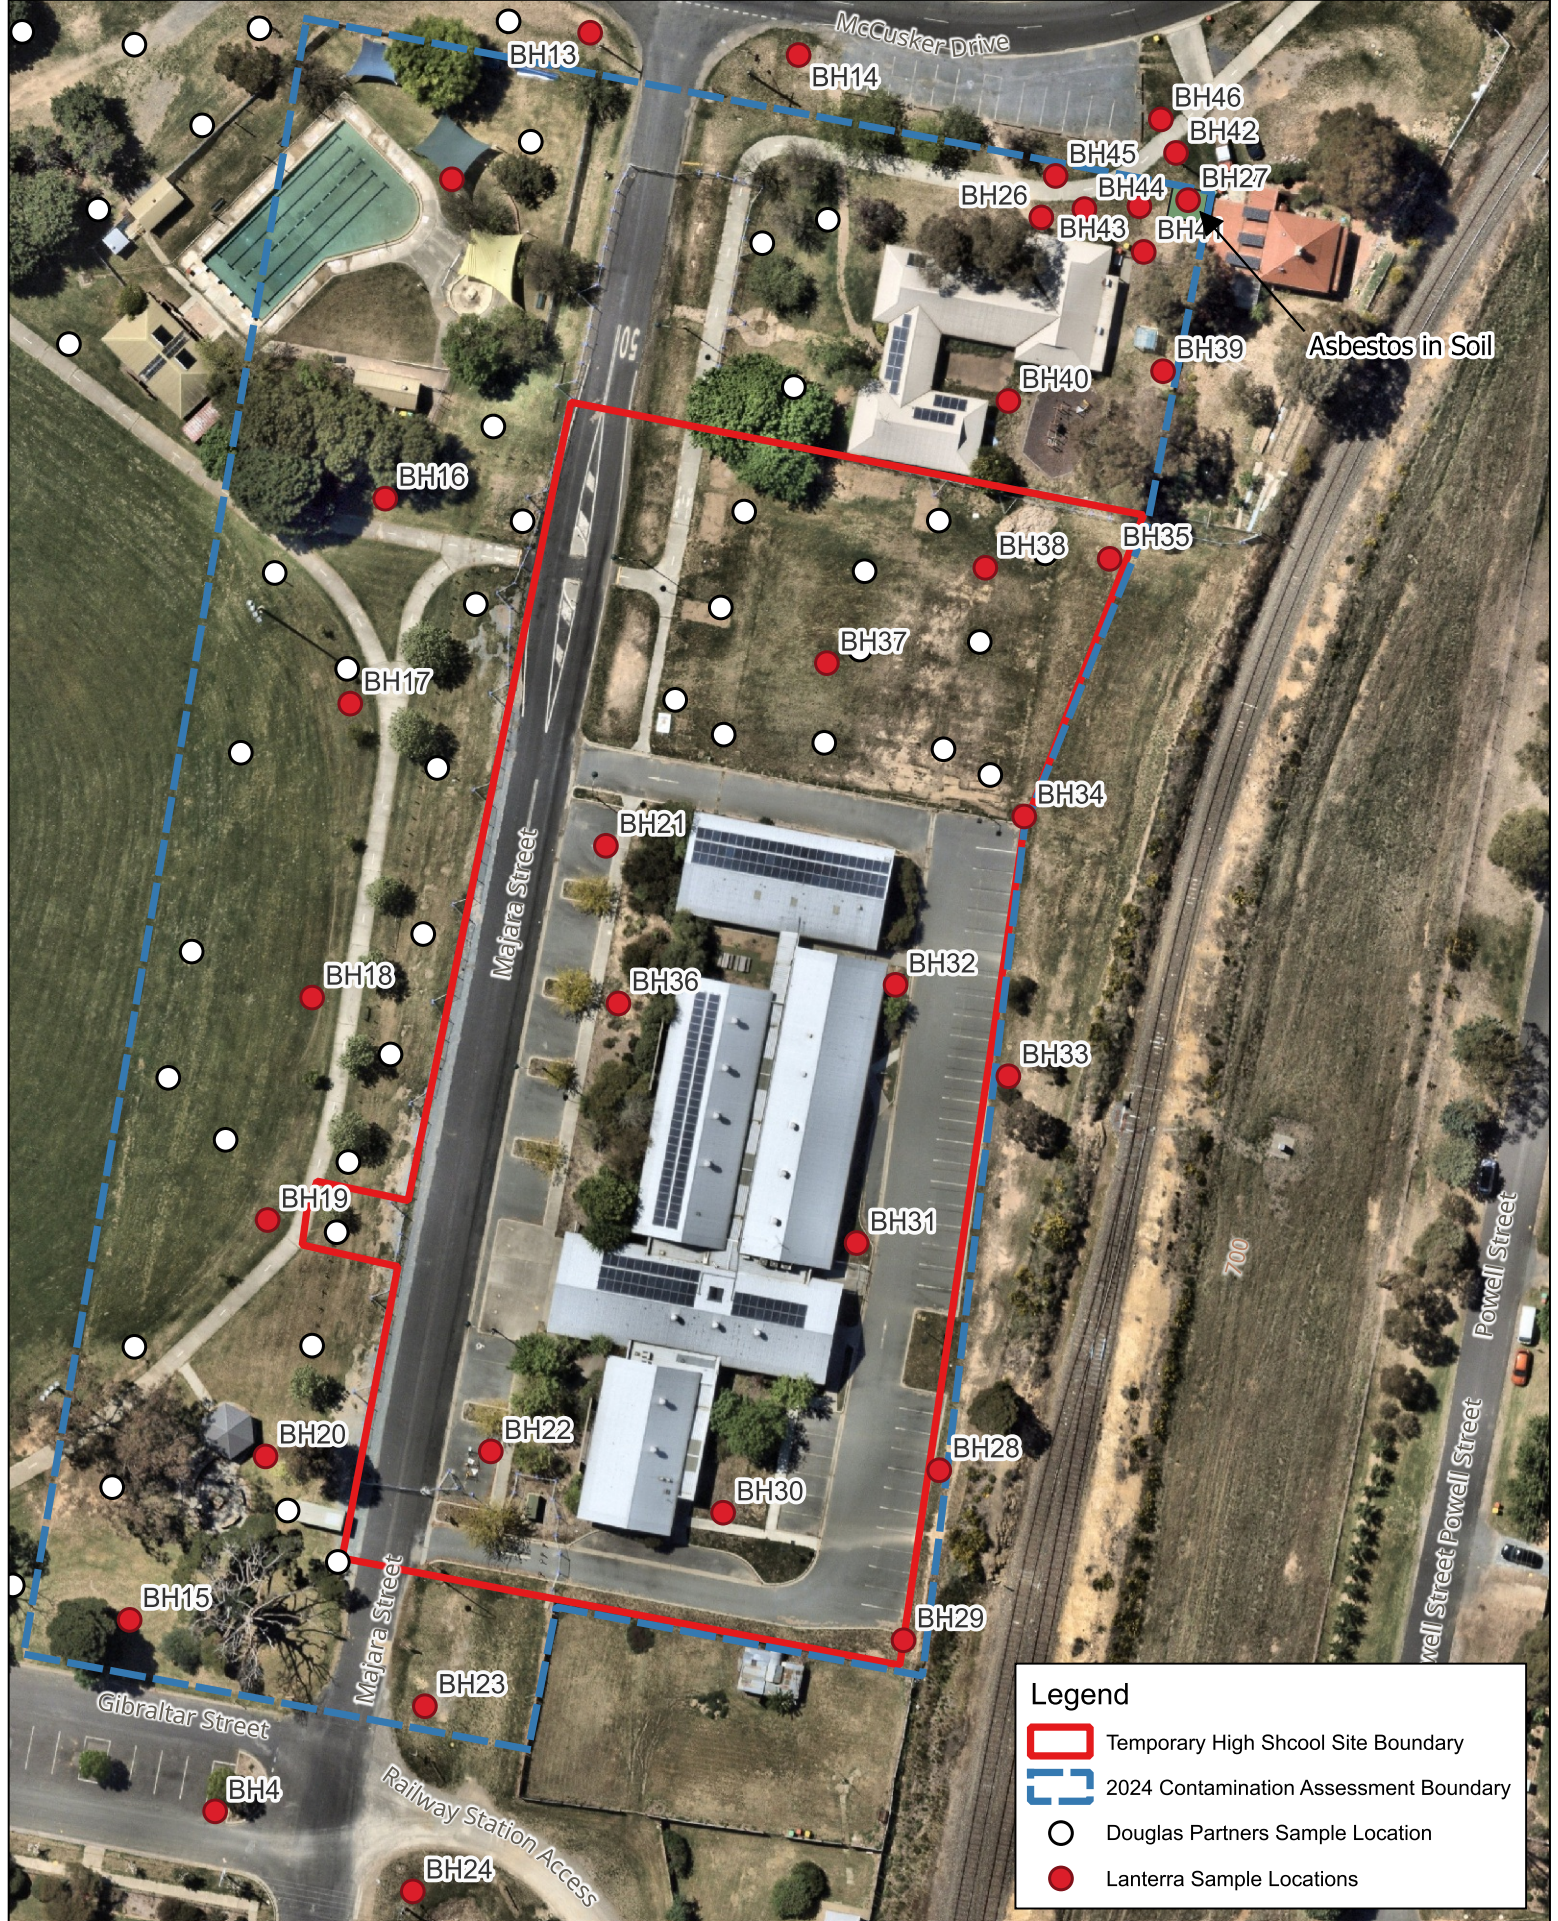
FIGURE 1: Site Location Plan

**Figure 1, Appendix A**, shows the locations where samples were collected by Douglas Partners and Lanterra.

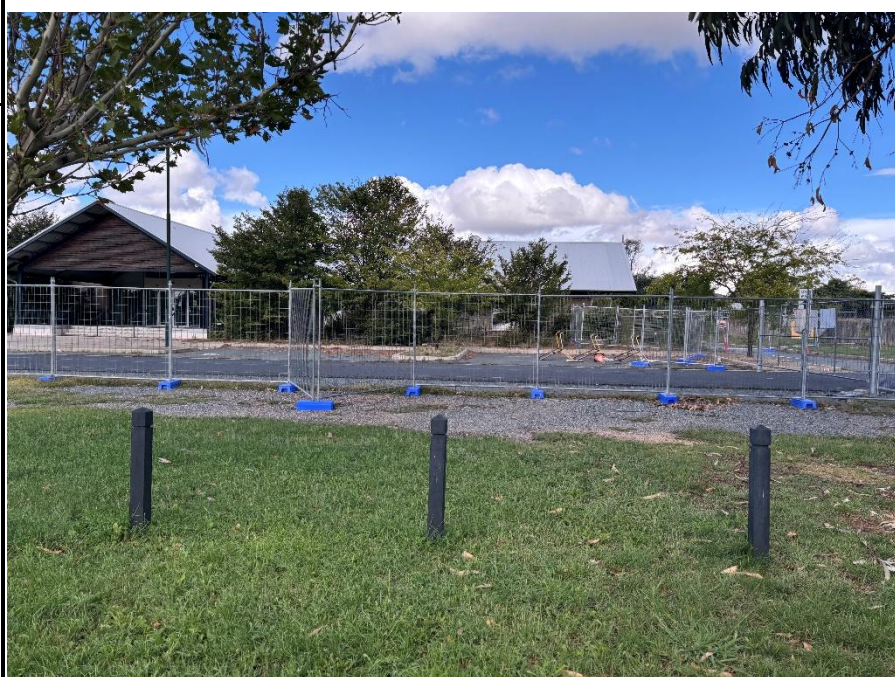
1.

Photograph looking east at the southern extent of the former Council Building which is to be converted to the temporary Bungendore High School

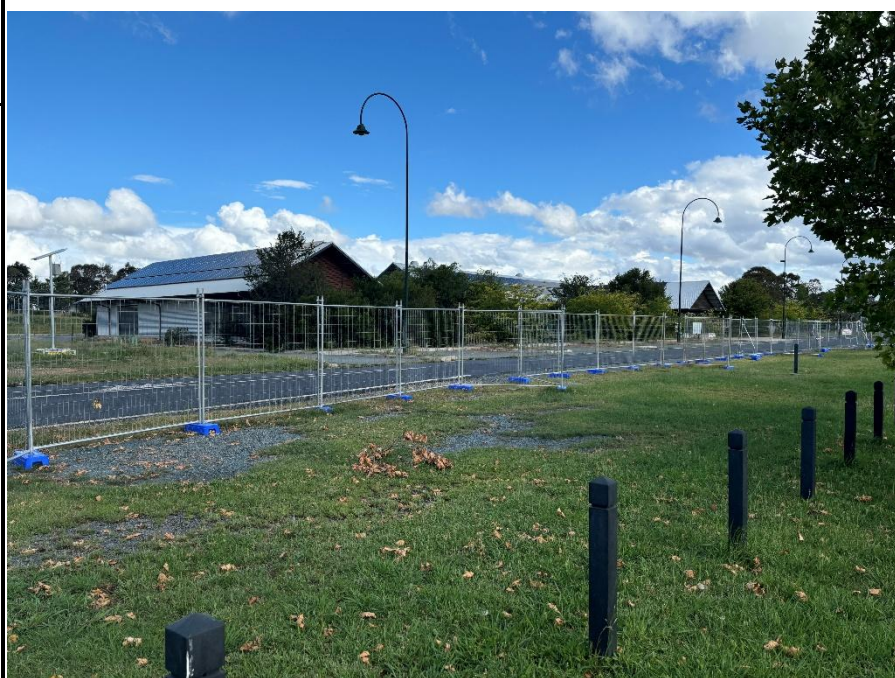
2.

Photograph looking southeast at the former Council Building which is to be converted to the temporary Bungendore High School

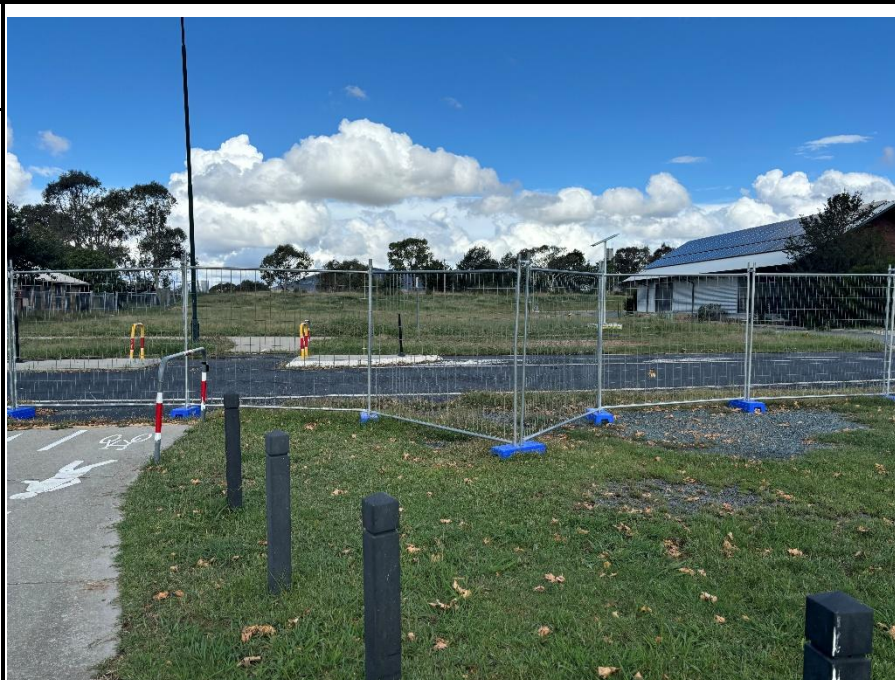
3.

Photograph looking east at the northern extent of the former Council Building which is to be converted to the temporary Bungendore High School

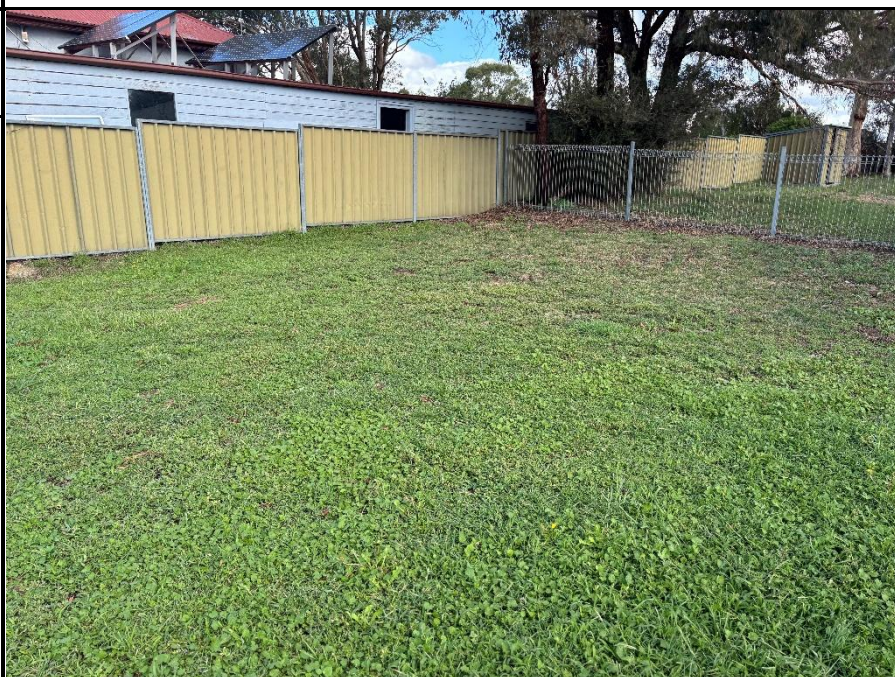
4.

- Concentrations of TRH, BTEX, PAH, OCP/OPP, PCB, Phenols and heavy metals were below the adopted assessment criteria for the protection of human health and ecological receptors.
- Asbestos was detected in sample BH27 0.0-0.1 where a fragment of cement sheeting was found. This was found outside the area which is subject to the REF.
- No asbestos fines or fibrous asbestos (AF/FA) was identified in any analysed samples.

- Based on the investigation's results, remediation of approximately 200 m<sup>2</sup> where the asbestos containing materials were detected in the soil. The impacted area is located to the north of the Bungendore Community Centre building and outside the REF area.
- The site was considered suitable for the new Bungendore North Campus High School.
- It was recommended that a construction environmental management plan (CEMP), which includes an unexpected finds protocol (UFP) to manage any unexpected occurrences of contamination should they be encountered during the site's development, be prepared prior to any construction work commencing.

Location of asbestos impacted soil north of the Community Centre Building which is outside the proposed temporary Bungendore High School

Due to the presence of asbestos being identified to the north of the Bungendore Community Centre, a remedial action plan (RAP) outlining the remediation strategy for the asbestos contamination soil was prepared in May 2024. The RAP was reviewed by Mr Loek Munnichs who is a NSW EPA accredited Contaminated Land Auditor who supported the proposed remedial strategy. However, as the location of the asbestos impact is outside the site boundary, the advice provided by the Auditor is not relevant.
