Intrusive Geotechnical Investigation (IGI) for New Primary School at Wilton Junction

Project Name	New primary school at Wilton Junction
Report Title	Intrusive Geotechnical Investigation (Geotechnical)
File Name	IGI_Geotechnical_GG11529.001_Wilton Junction NEW PS_Rev2_Final

School Name	Wilton Junction New Primary School	Consultancy Name	Green Geotechnics Pty Ltd
School ID Number	NA	Report Status	Final
School Address	200 Fairway Drive, Wilton, NSW 2571	Report Date:	21 February 2025
School Region	Sydney Metro	Contract Number:	DDWO05924/24

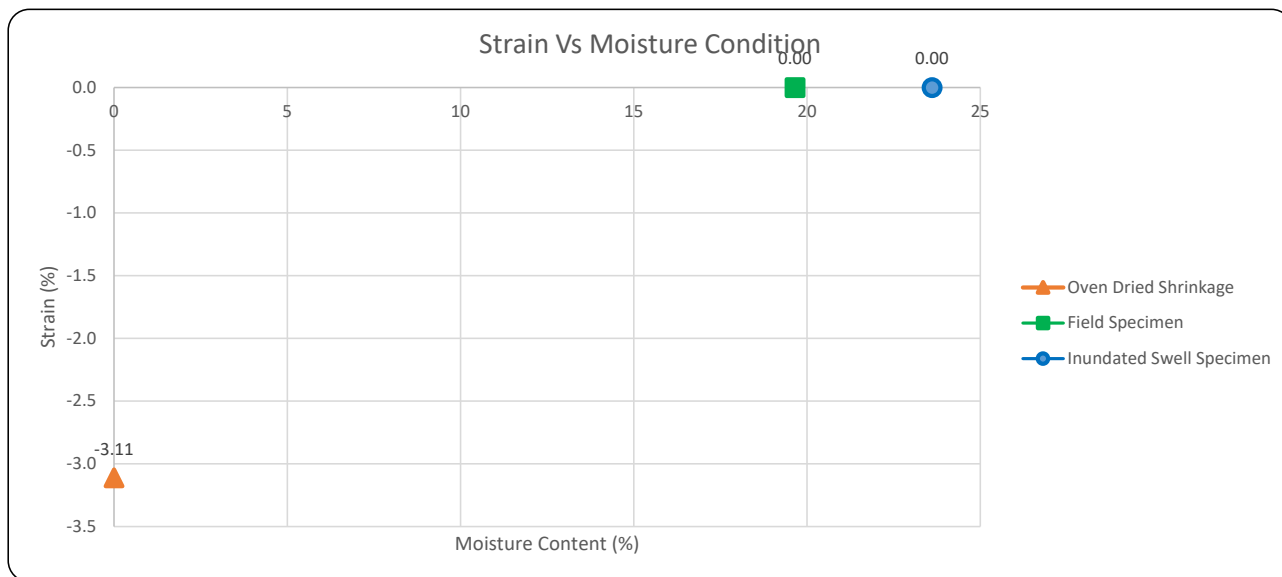
Sample Number	Sample Date	Chainage/Location	Offset	Level of Test	Test Depth
24237	27/05/2024	BH2	-	0.6 - 0.9	-

Parameters	Units	Test Results	Soil Description
Shrinkage - Field Moisture Content	%	19.8	CH Silty CLAY red,brown
Swell - Field Moisture Content	%	19.5	
Swell - Inundated Moisture Content	%	23.6	
Inert Inclusions in the soil	%	0	
Extent of Soil Crumbling	-	None	
Extent of Soil Cracking	-	Minor	
Shrink-Swell Index	%	1.7

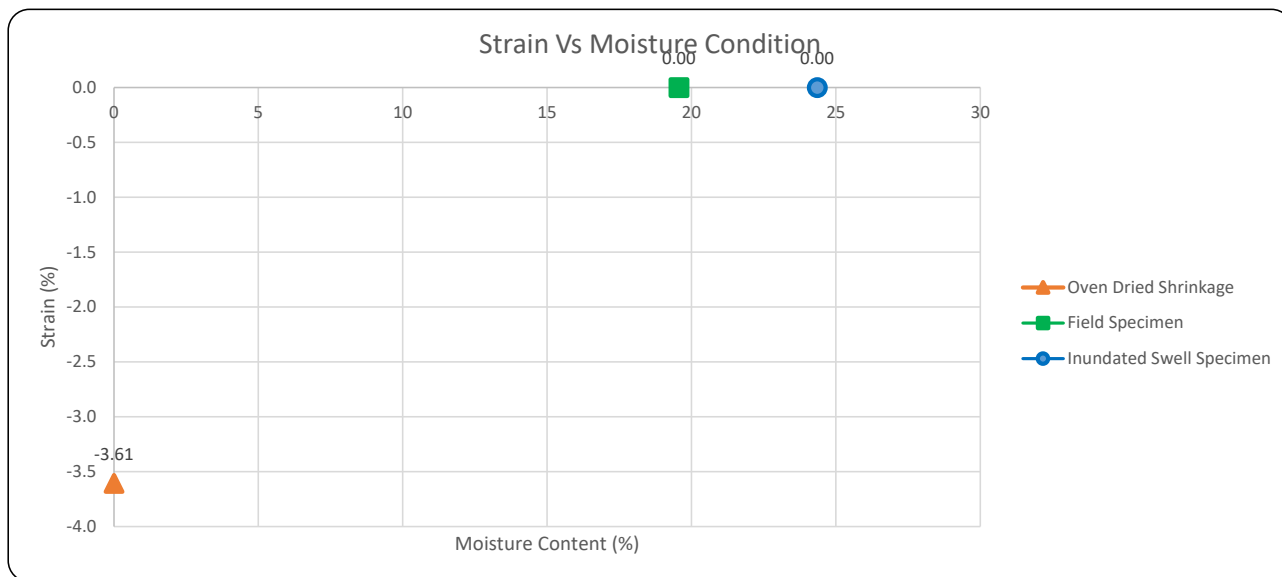
Sample Number	Sample Date	Chainage/Location	Offset	Level of Test	Test Depth
24238	27/05/2024	BH6	-	0.6 - 0.8	-

Parameters	Units	Test Results	Soil Description
Shrinkage - Field Moisture Content	%	19.3	CH Silty CLAY red
Swell - Field Moisture Content	%	19.8	
Swell - Inundated Moisture Content	%	24.4	
Inert Inclusions in the soil	%	0	
Extent of Soil Crumbling	-	None	
Extent of Soil Cracking	-	Minor	
Shrink-Swell Index	%	2.0

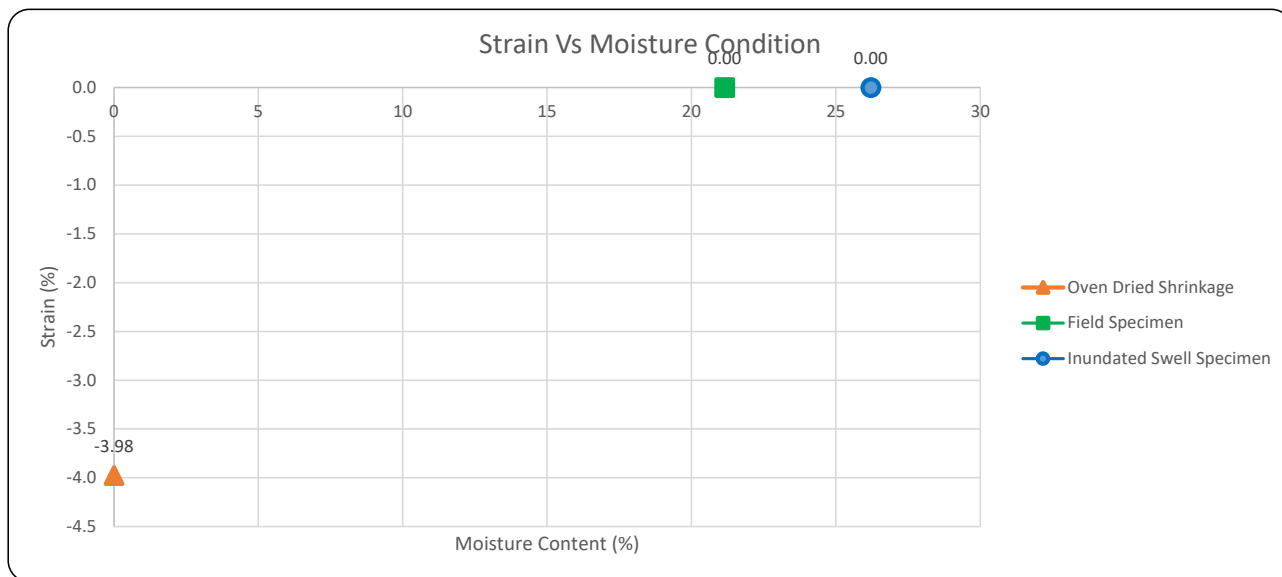
Sample Number	Sample Date	Chainage/Location	Offset	Level of Test	Test Depth
24239	27/05/2024	BH7	-	0.6 - 0.8	-

Parameters	Units	Test Results	Soil Description
Shrinkage - Field Moisture Content	%	21.1	CH Silty CLAY red
Swell - Field Moisture Content	%	21.2	
Swell - Inundated Moisture Content	%	26.2	
Inert Inclusions in the soil	%	0	
Extent of Soil Crumbling	-	None	
Extent of Soil Cracking	-	Minor	
Shrink-Swell Index	%	2.2

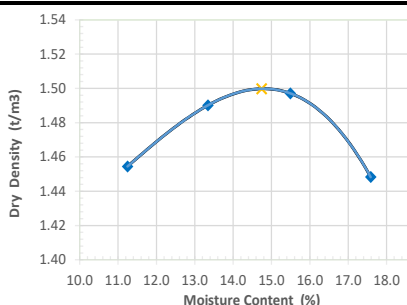
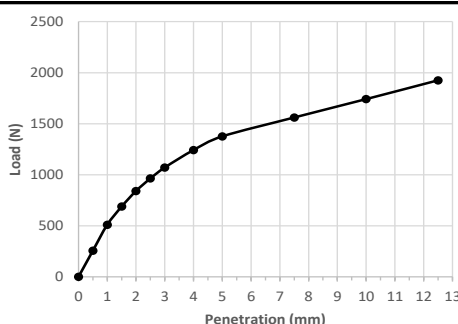
Dry Density Vs Moisture Content

Load-Penetration Curve

Material CBR Value (%)

7

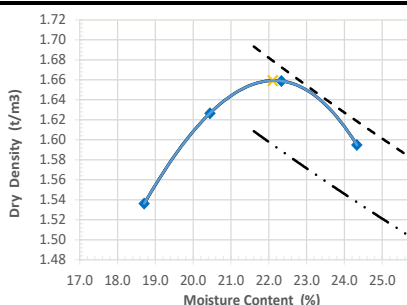
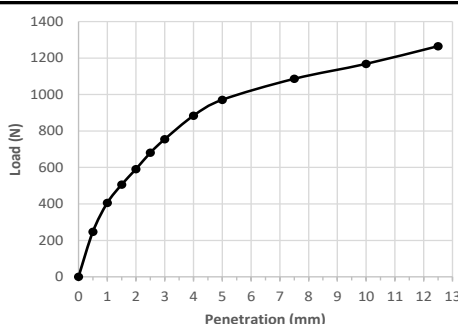
Dry Density Vs Moisture Content

Load-Penetration Curve

Material CBR Value (%)

5.0

Based on the laboratory test results, a CBR value of 5% is recommended for the design of flexible and rigid pavements.
