**REPORT TO  
NSW DEPARTMENT OF EDUCATION**

**ON  
REMEDIATION ACTION PLAN**

**FOR  
LISMORE SOUTH PUBLIC SCHOOL – FLOOD  
RECOVERY REBUILD**

**AT  
69-79 KYOGLE STREET, SOUTH LISMORE, NSW**

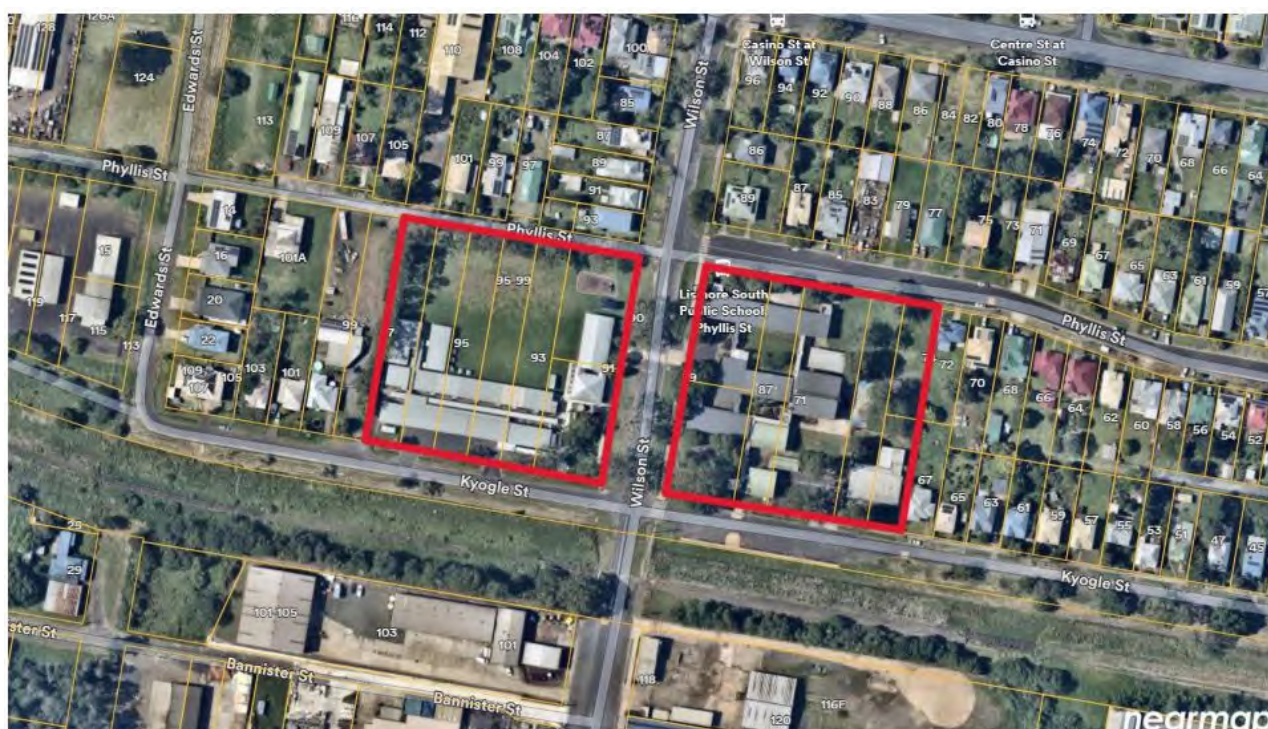
Figure 1 Aerial image of site (Source: Nearmap)

The site, located at 69-79 Kyogle Street, South Lismore, consists of two separate land parcels situated on either side of Wilson Street. The proposed activity will be undertaken on the eastern parcel, where most of the school’s existing structures are located. The western parcel contains sports fields and temporary learning facilities. Figure 1 outlines the school’s boundary, covering approximately 2.5 hectares. Due to flood damage, the existing buildings on the eastern parcel are currently unused, and students are temporarily using facilities on the sports field and oval, located on the western side of Wilson Street, adjacent to the primary school.
