REPORT TO
NSW DEPARTMENT OF EDUCATION

ON
DETAILED SITE INVESTIGATION

FOR
ULLADULLA PUBLIC SCHOOL UPGRADES

AT
241 GREEN STREET, ULLADULLA, NSW

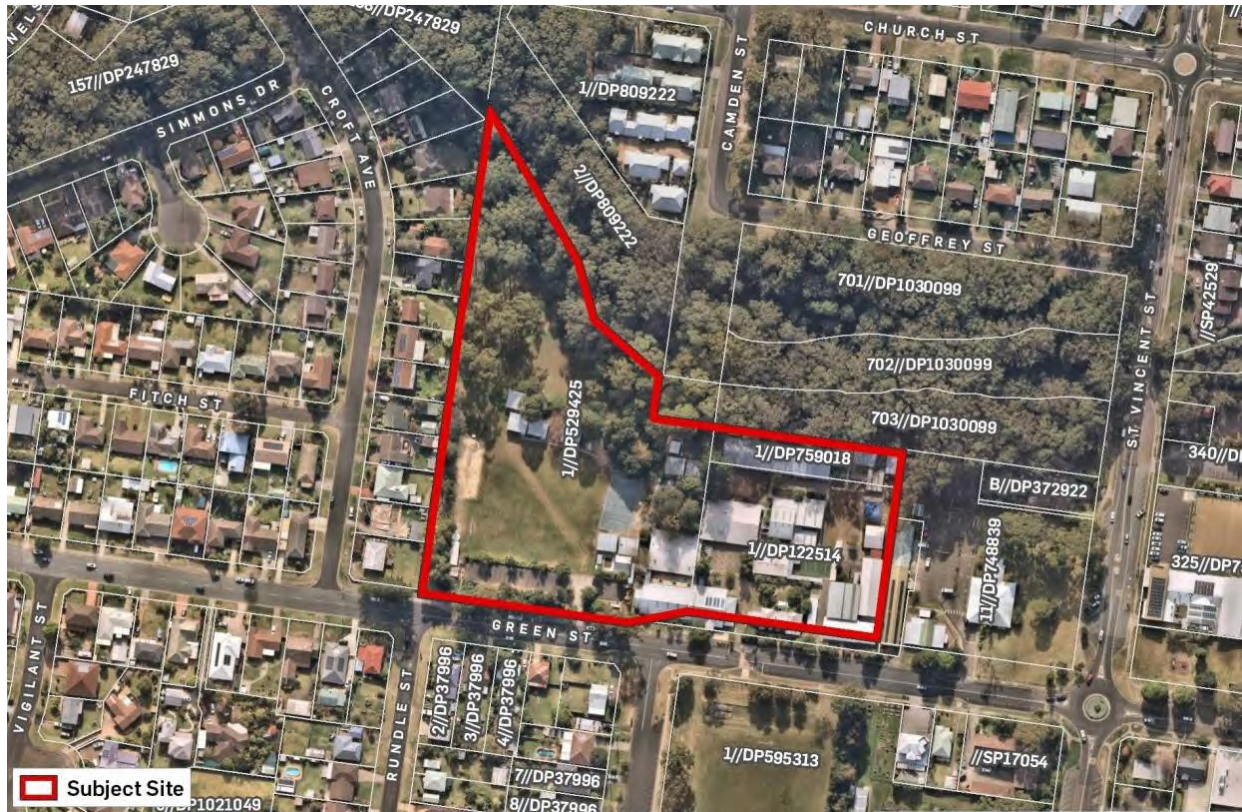
Figure 1 Aerial Photograph of the Site
Source: Urbis, January, 2024

Ulladulla Public School is located at 241 Green Street, Ulladulla NSW 2539. The site is located within the Shoalhaven Local Government Area (LGA) and has an approximate area of 3.5 hectares. An aerial photograph of the site is provided at Figure 1. The site is comprised of three lots, legally referred to as follows:

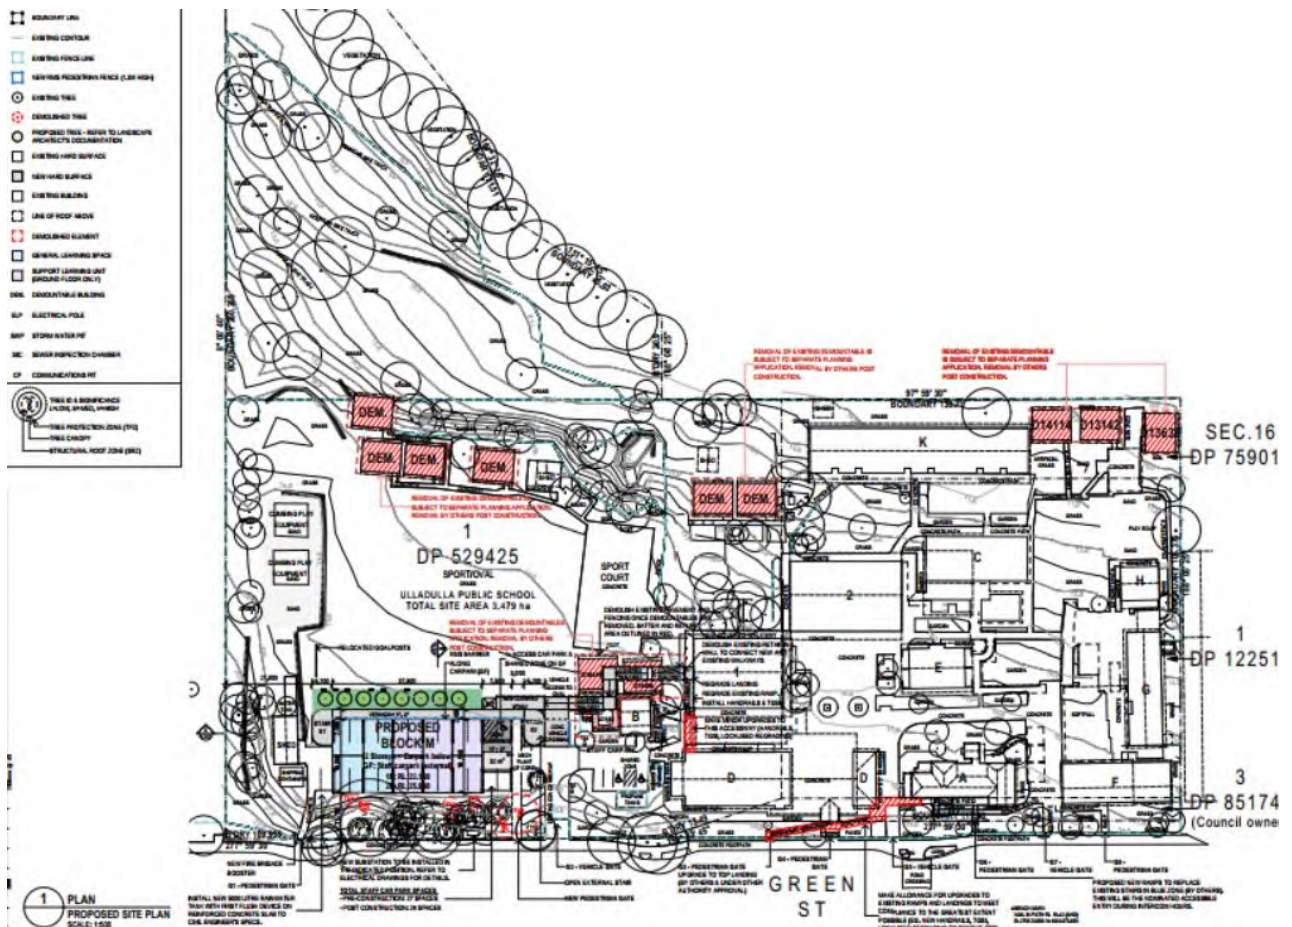
Figure 2 Proposed Building Site Plan
Source: Fulton Trotter, 2025

Figure 2 provides an extract of the proposed site plan.

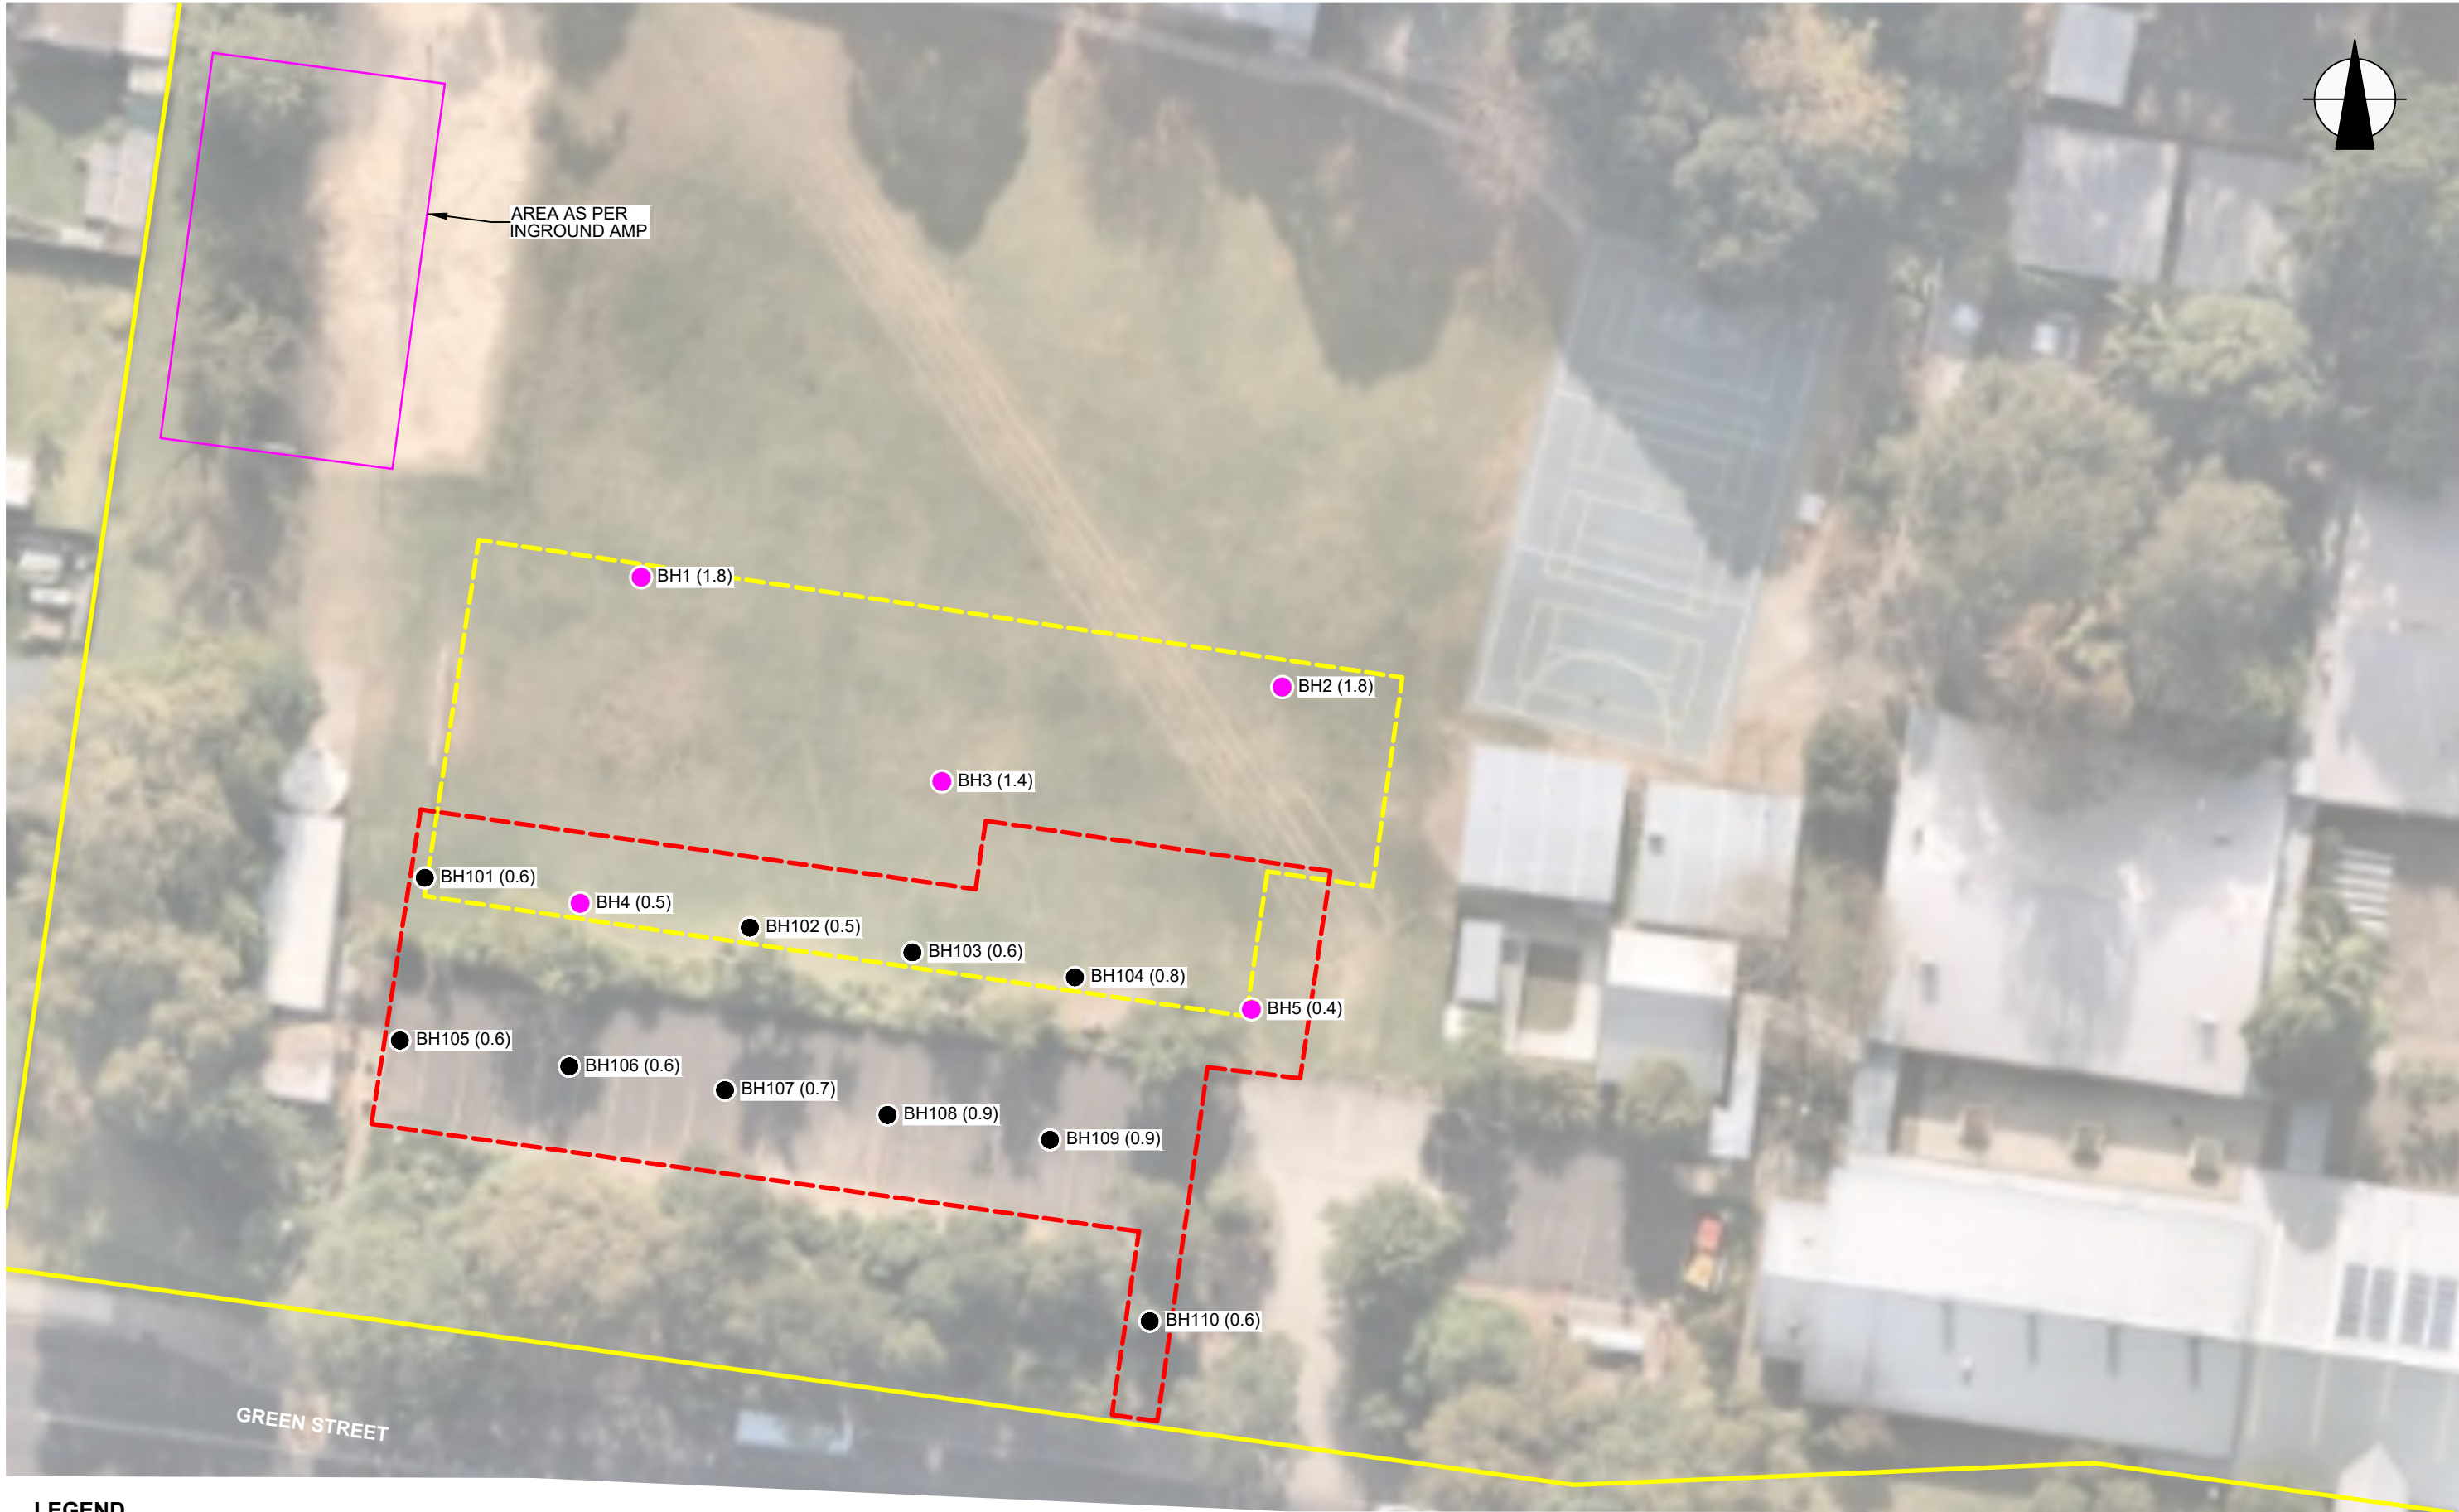
- APPROXIMATE DSI SITE BOUNDARY
 - APPROXIMATE PSI SITE BOUNDARY
 - APPROXIMATE WIDER PROPERTY BOUNDARY
 - BH(Fill Depth)
 - BH101
- BOREHOLE LOCATION, NUMBER AND DEPTH OF FILL (m) (JKE, PSI 2023)
- BOREHOLE LOCATION, NUMBER AND DEPTH OF FILL (m) (JKE, DSI, 2024)

NSW Department of Education ('the client') commissioned JK Environments (JKE) to undertake a Detailed Site Investigation (DSI) for the upgrades at Ulladulla Public School, 241 Green Street, Ulladulla, NSW ('the site'). The site location is shown on Figure 1 and the investigation was confined to the site boundaries as shown on Figure 2 in Appendix A.

<p><u>Use of pesticides</u> – Pesticides may have been used around the site and wider school property.</p>	<p>Heavy metals and OCPs.</p>
<p><u>Hazardous Building Material</u> – Hazardous building materials may be present as a result of former building and demolition activities. Hazardous building materials may have also impacted the soils due to the demolition of the former buildings/structures and movement of soils (i.e. via filling) around the site. The area identified in the AMP is in relatively close proximity to the site and is shown on Figure 2 in Appendix A.</p>	<p>Asbestos, lead and PCBs.</p>
