**VINCENTIA HIGH SCHOOL UPDATE
INTRUSIVE GEOTECHNICAL
INVESTIGATION REPORT**

31 March 2025

Prepared for:
NSW Department of Education (DoE)

Prepared by:
Stantec Australia Pty Ltd

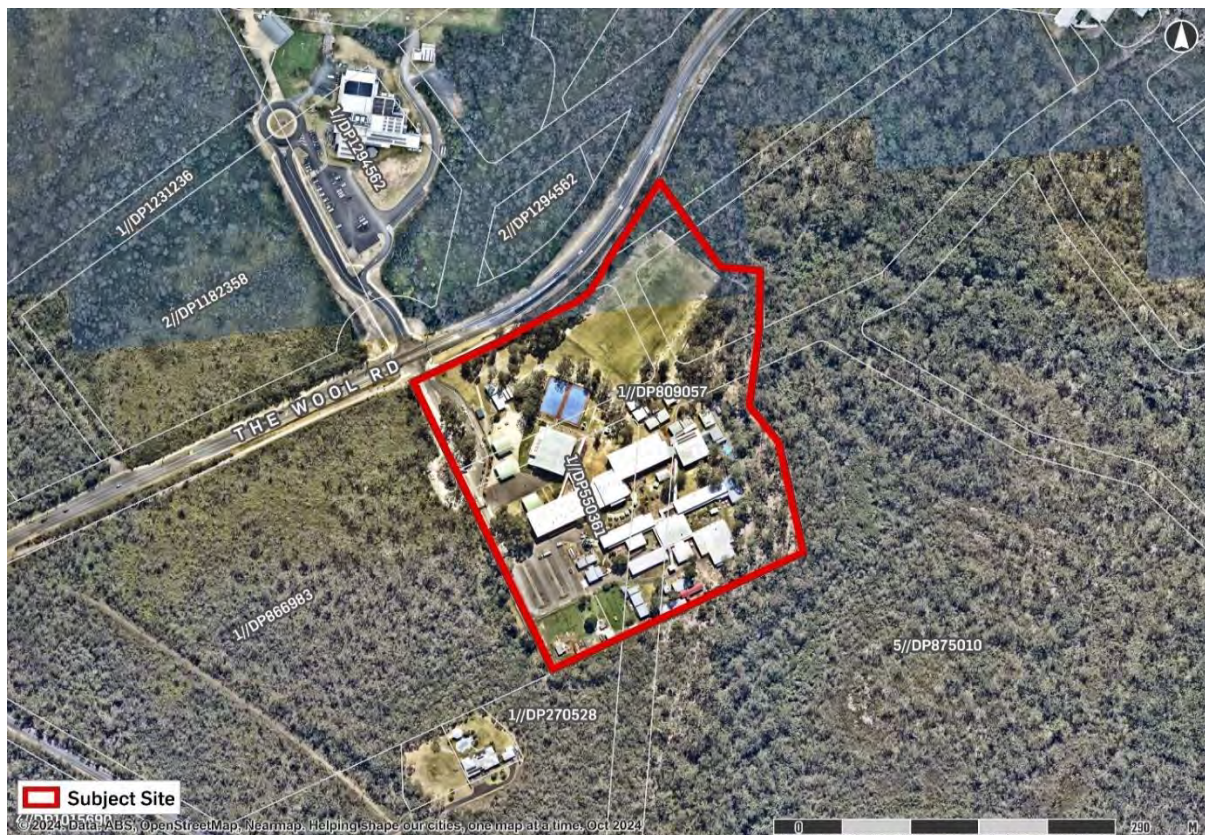
Figure 2-1 – Aerial Photograph of the Site, Urbis, January 2024

The site is shown in the following Figure 2-1, The detailed site layout plan and its surrounds are attached in Appendix A.

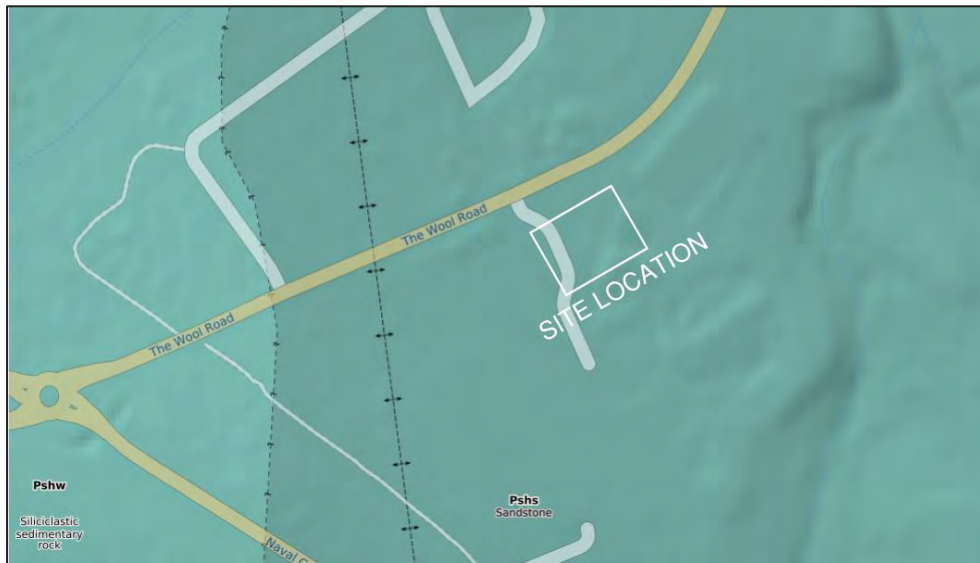
Figure 2-2 Site Geological Condition

Reference to the Seamless Geology from Minview website (NSW Department of Planning, Industry and Environment, 2023) indicates that the site is underlain by the following geological units as shown in Figure 2-2 **Error! Reference source not found.** below.

- Pshs – Snapper Point Formation – fine to medium grained sandstone, pebbly sandstone and polymictic pebble conglomerate, medium to coarse grained sandstone with lithic pebbles and fragments, minor siltstone.

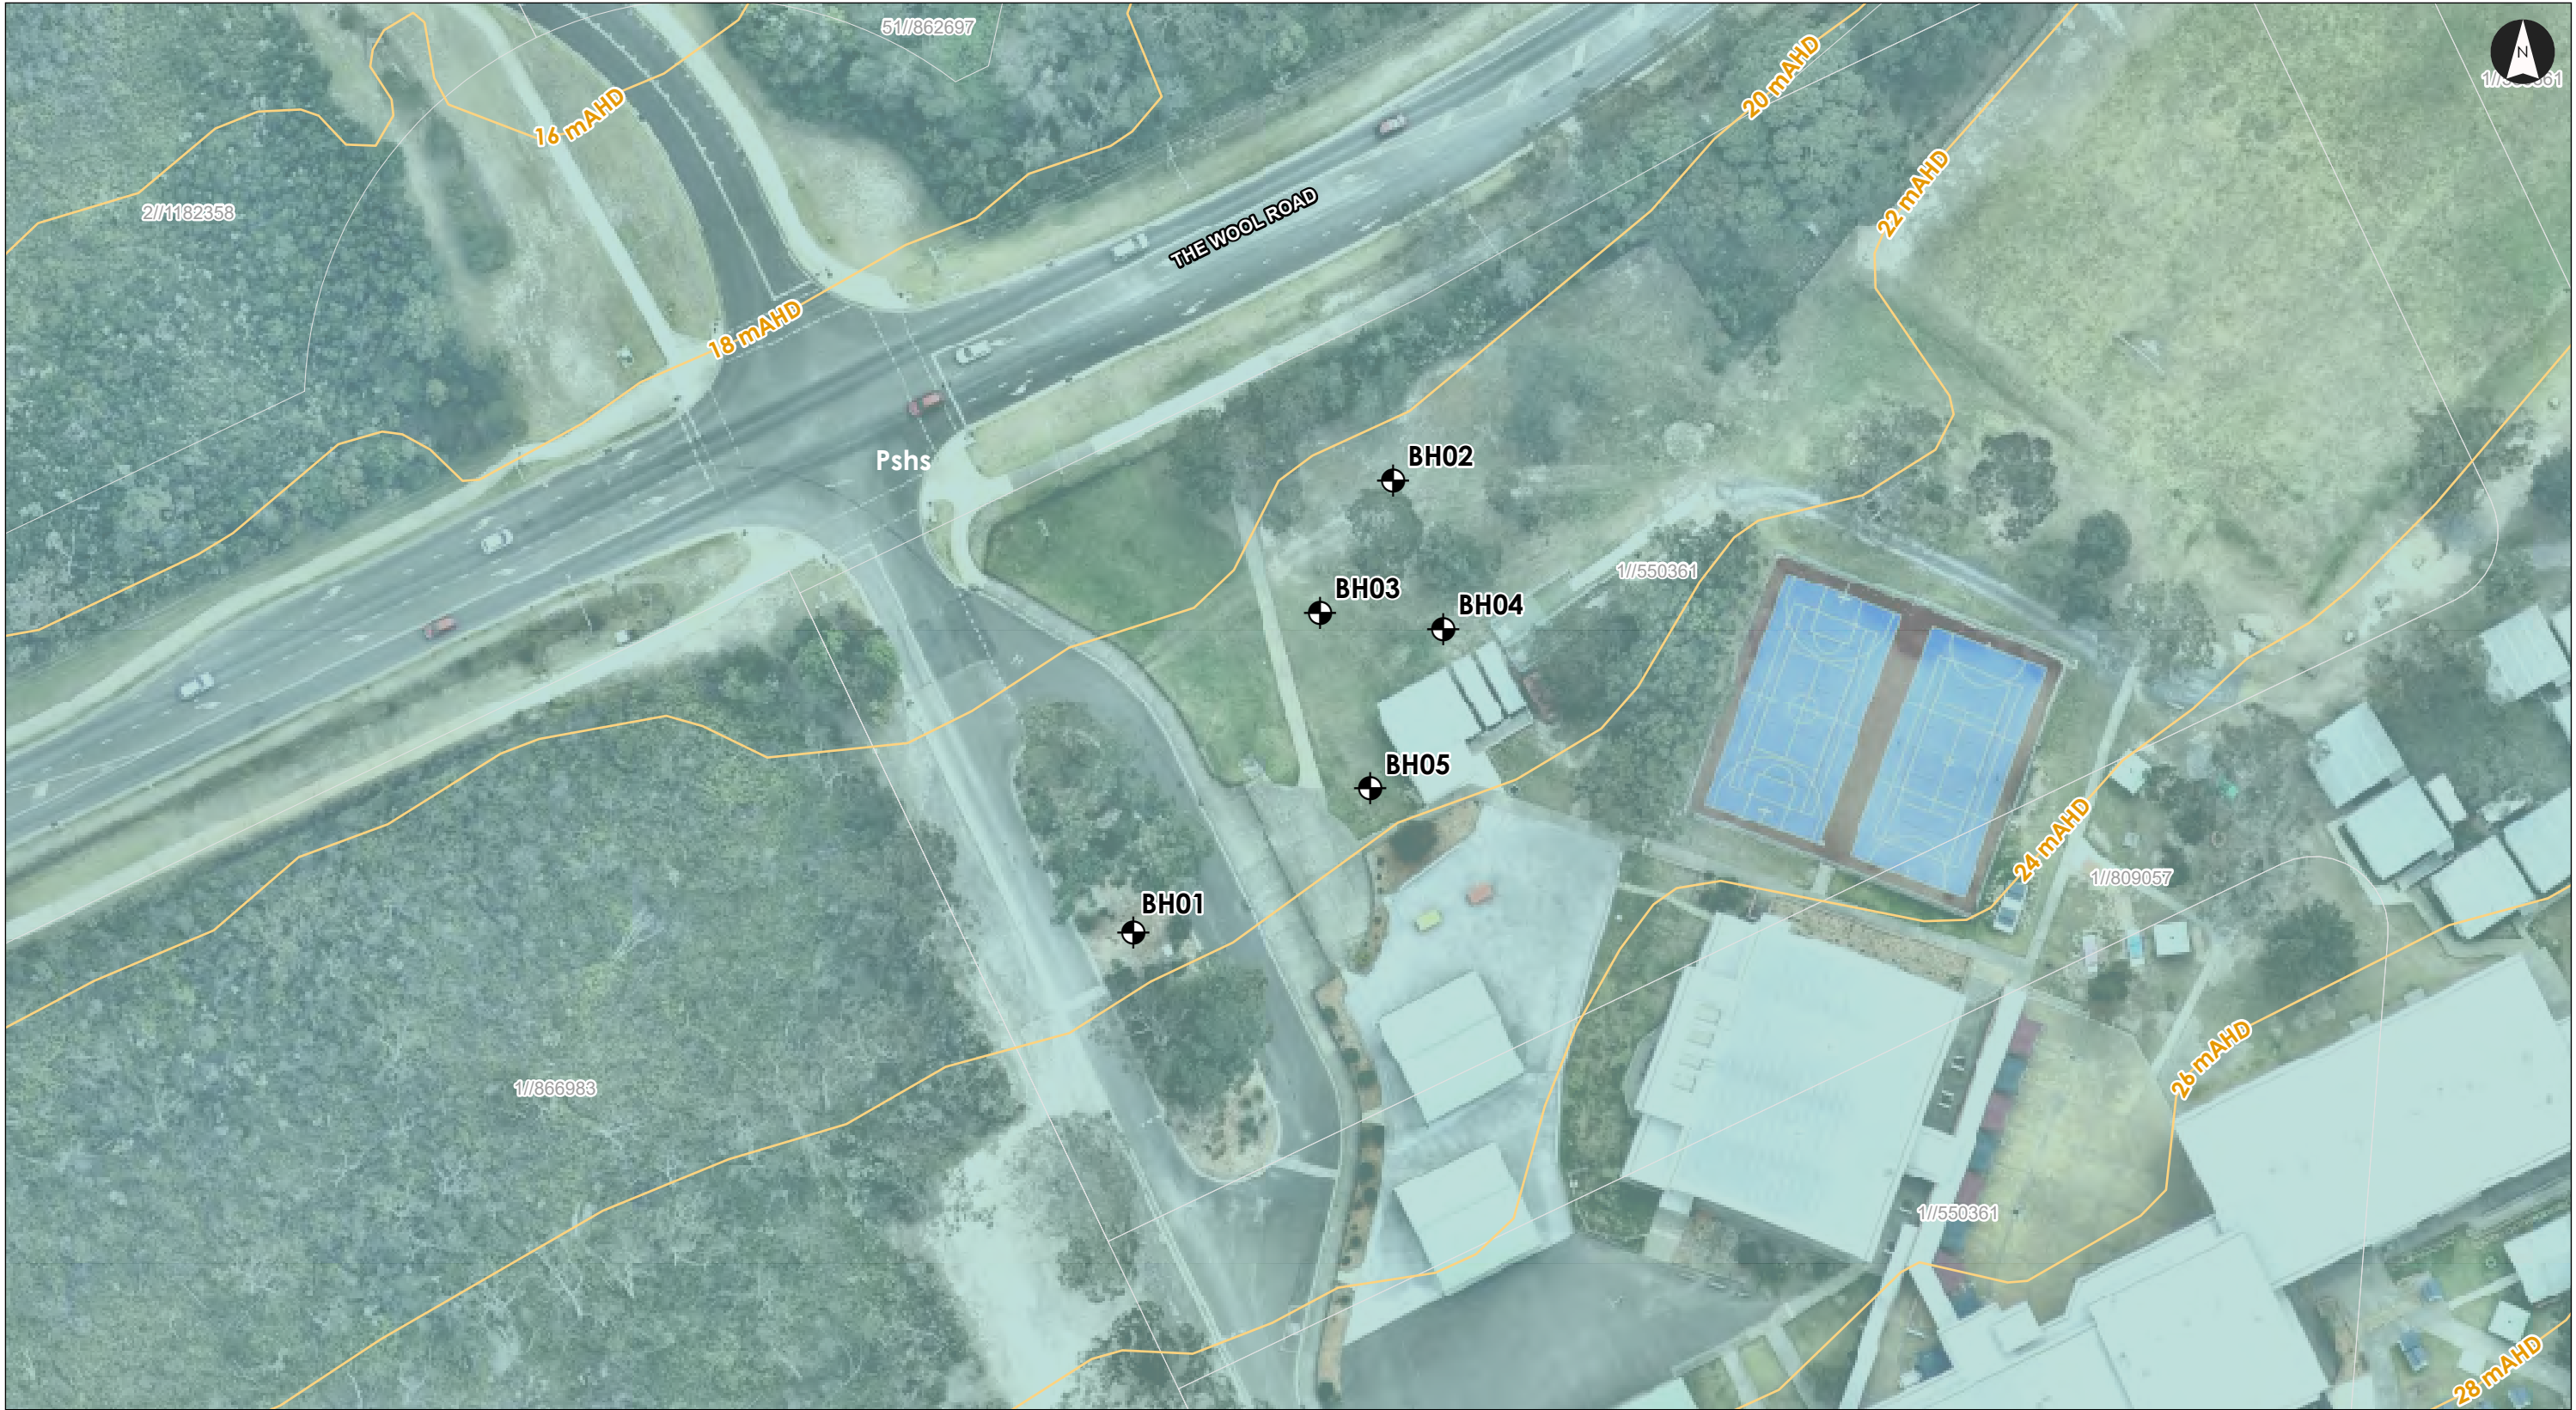
Geology Plan

1. Basemap (Nearmap - October, 2023)
2. 2m Contour (NSW SS, 2019)
3. Cadastre (NSW SS, 2023)
4. NSW Seamless Geology (GSNSW, 2021)
