**Proposed Construction of a  
New multi-purpose hall at  
Sutherland Public School,  
38-54 Eton Street, Sutherland,  
Sutherland Shire Council, NSW**

Preliminary Indigenous Heritage Assessment and Impact Report

Prepared for School Infrastructure NSW on behalf of the NSW Department of Education

September 2024

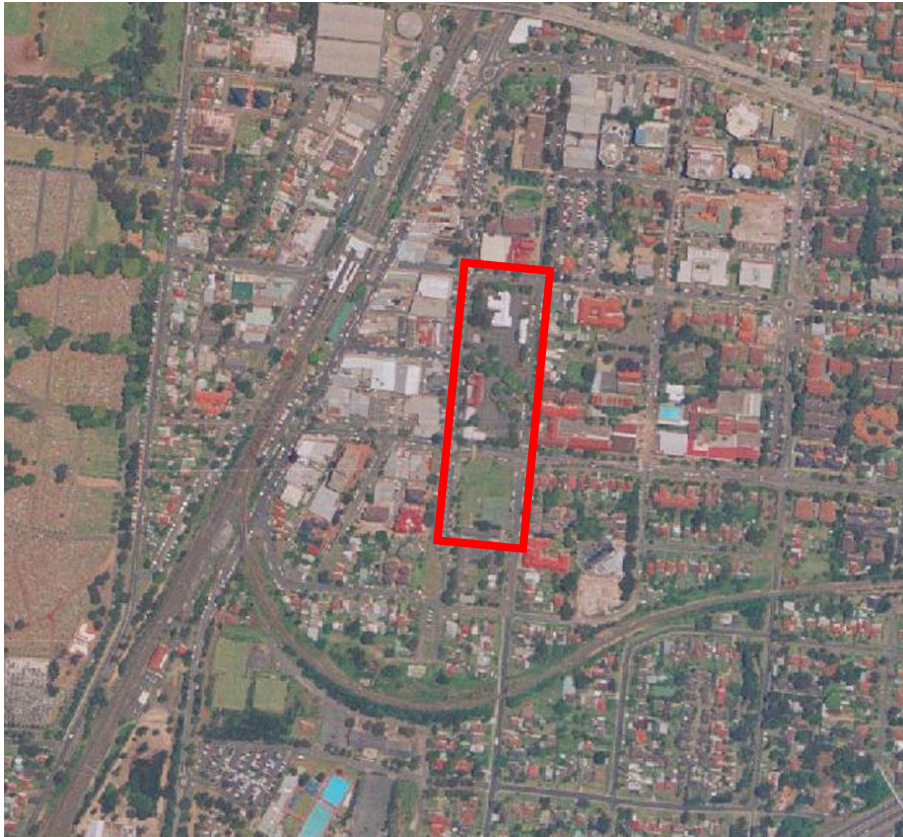
**Plate 6:** 1998 Aerial Photograph (source: NSW Historical Imagery Viewer)

| Date | Description |
|---|---|
| <b>1998</b> | This first colour aerial photograph displays the northern site in further clarity, depicting developed buildings and trees. The aerial indicates that the entire playground area has been covered in hardstand surface. The Subject Area and surroundings remain mostly unchanged from the previous photographs.<br>The southern site remains unchanged. |

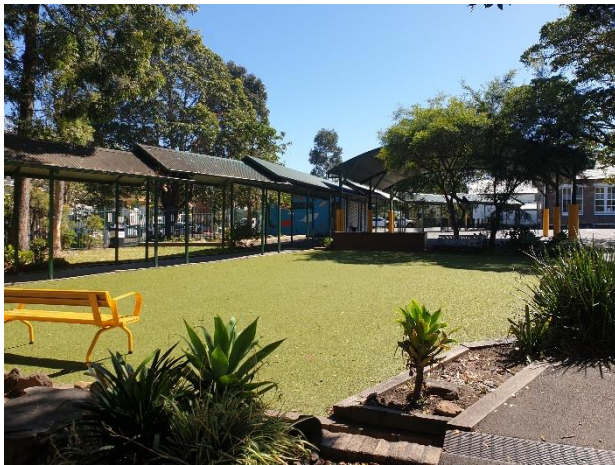
**Plate 7:** Looking northwest across the northern site

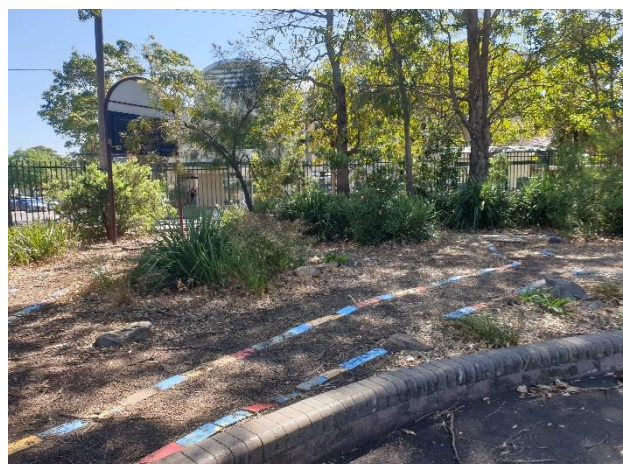
**Plate 10:** Example of a garden bed at the Flora Street end of the northern site

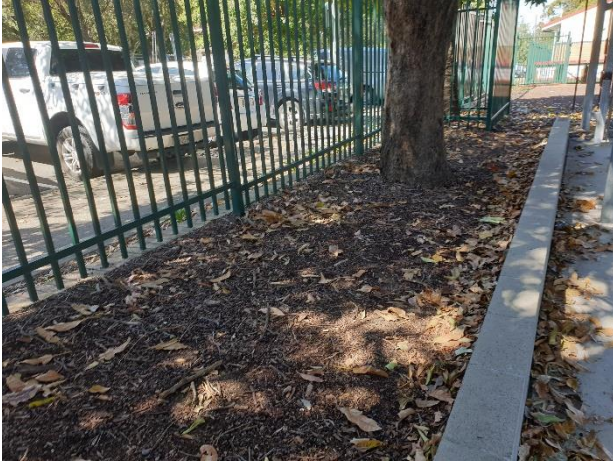
**Plate 17:** Example of a garden bed along the eastern boundary of the northern site
