Remediation Action Plan

Proposed Multi-Purpose School Hall

Sutherland Public School 38-54 and 66 Eton Street, Sutherland NSW

Project 224456.00

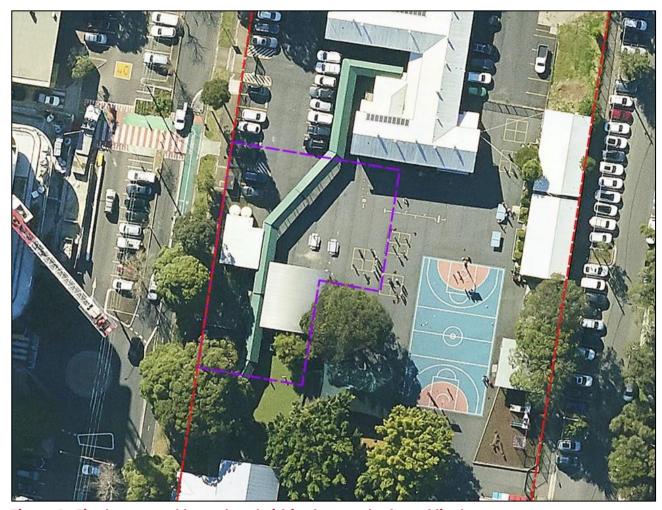
Figure 1: Site layout and boundary (within the purple dotted line)

The site layout is shown in Figure 1 and Drawing 1, Appendix A1.

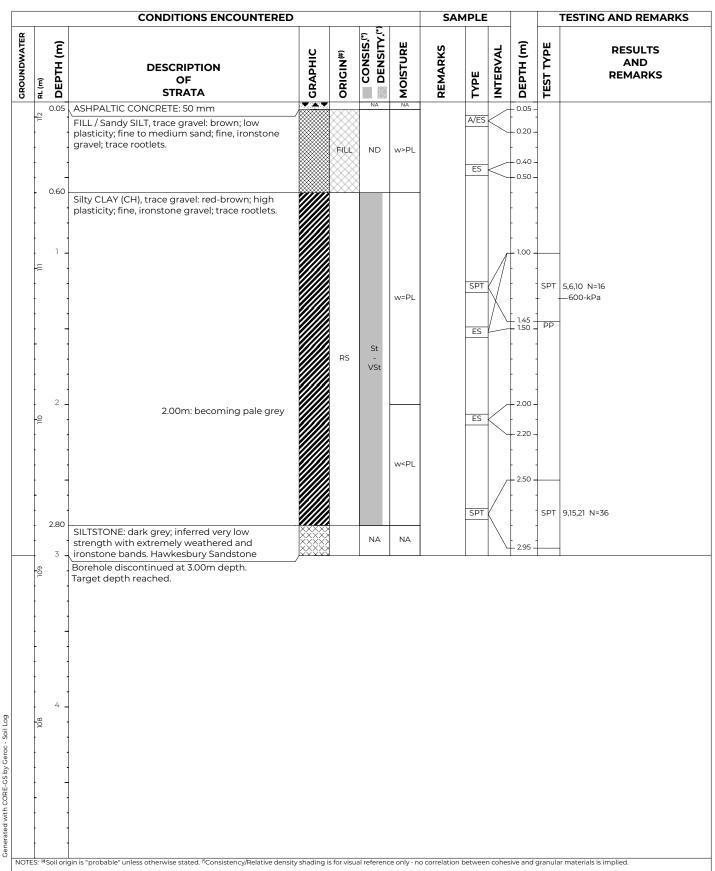
LOCATION ID: BH104
PROJECT No: 2244560

PLANT: Bobcat
 OPERATOR: Ground Test (C.S.)
 LOGGED: CSY

METHOD: AD/T to 3.0 m
 CASING: Uncased
