**Report on Supplementary Geotechnical  
Investigation**

**Proposed Multi-purpose Medium Hall**

**38-54 and 66 Eton Street, Sutherland NSW**

**Project 224456.01**

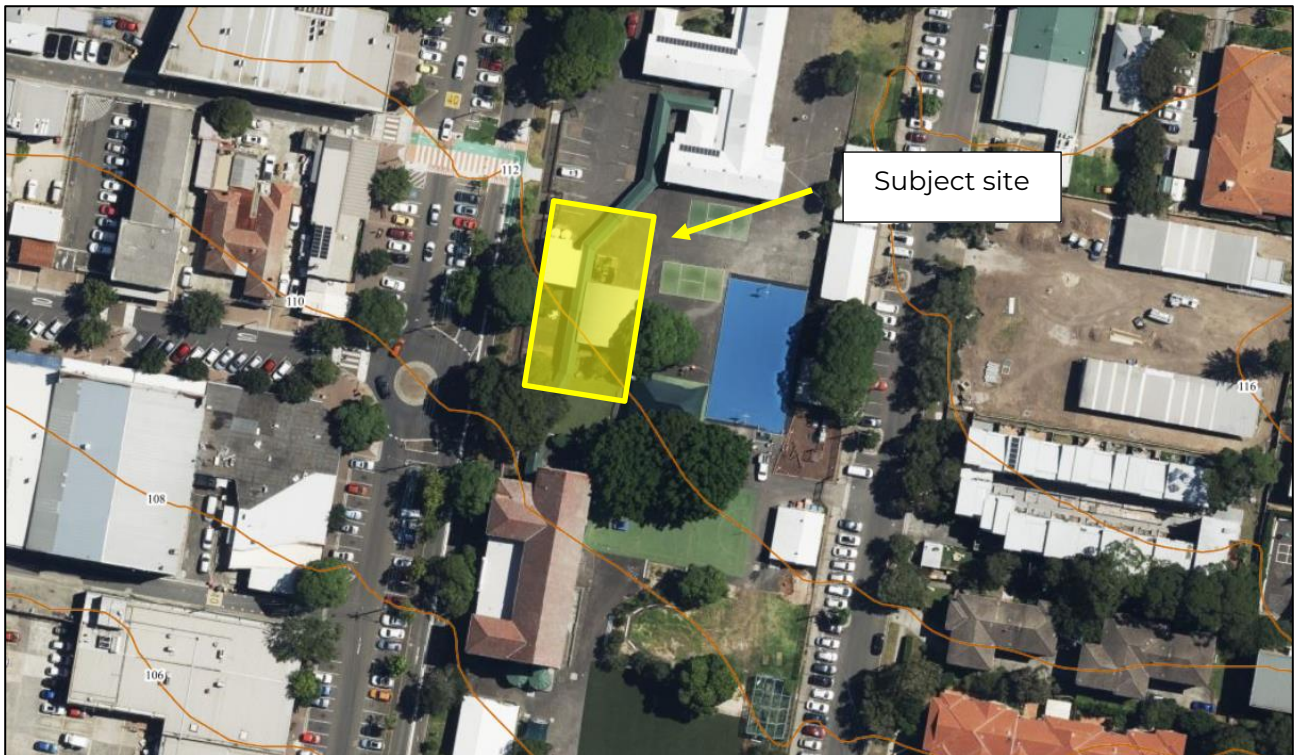
The subject site slopes gently from about RL 113 in the north to RL 111 in the south, as shown in Figure 1 overleaf (levels are relative to the Australian Height Datum, AHD).

**Figure 1: Aerial image of site overlain by 2 m surface contours to AHD**

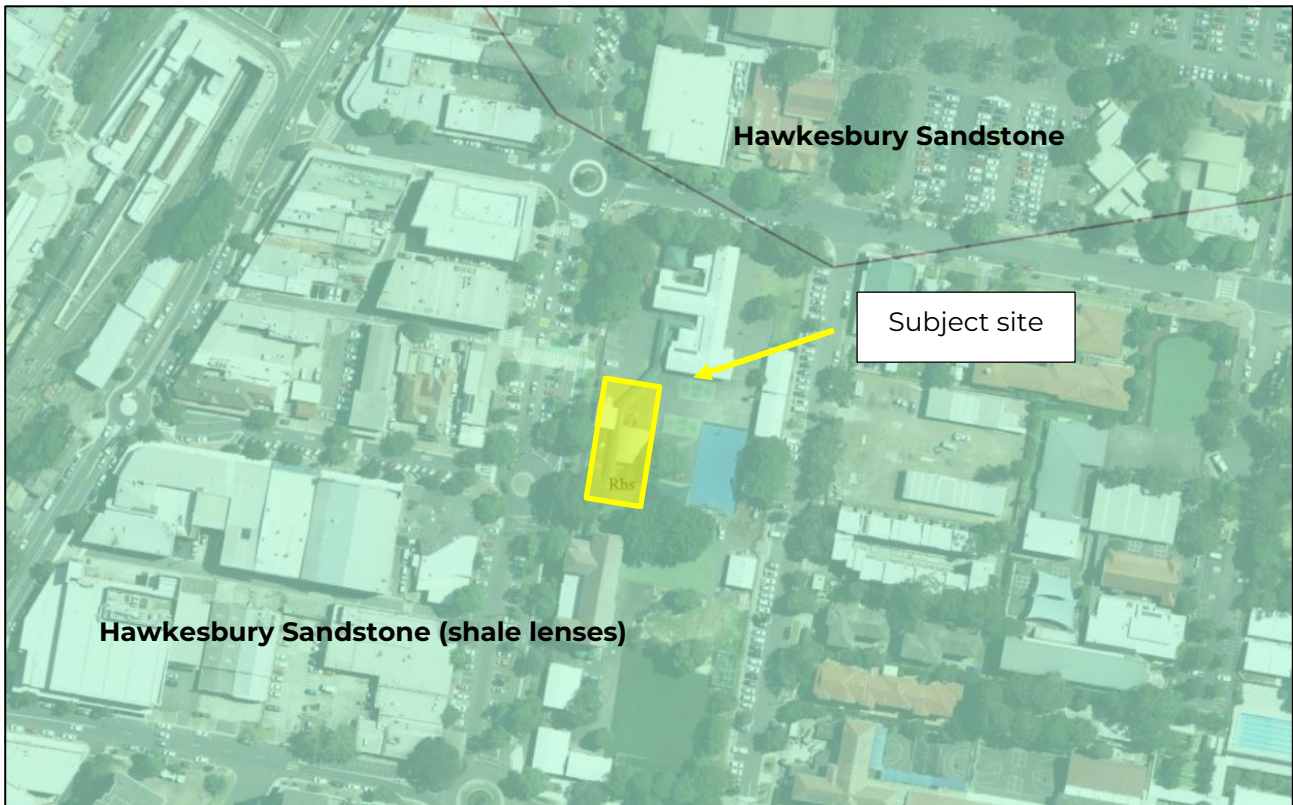
Reference to the Sydney 1:100 000 Geological Series Map indicates that the site is underlain by Hawkesbury Sandstone (shale lenses) of the Triassic period, which typically comprises fluviially deposited laminated mudstone, claystone, siltstone and sandstone. An extract of the geological map is shown in Figure 3 overleaf.

**Figure 3: Extract from Sydney 1:100 000 Geological Series Map**
