## **Dalmeny Public School Upgrade**

Geotechnical Interpretive  
Report

March 2025

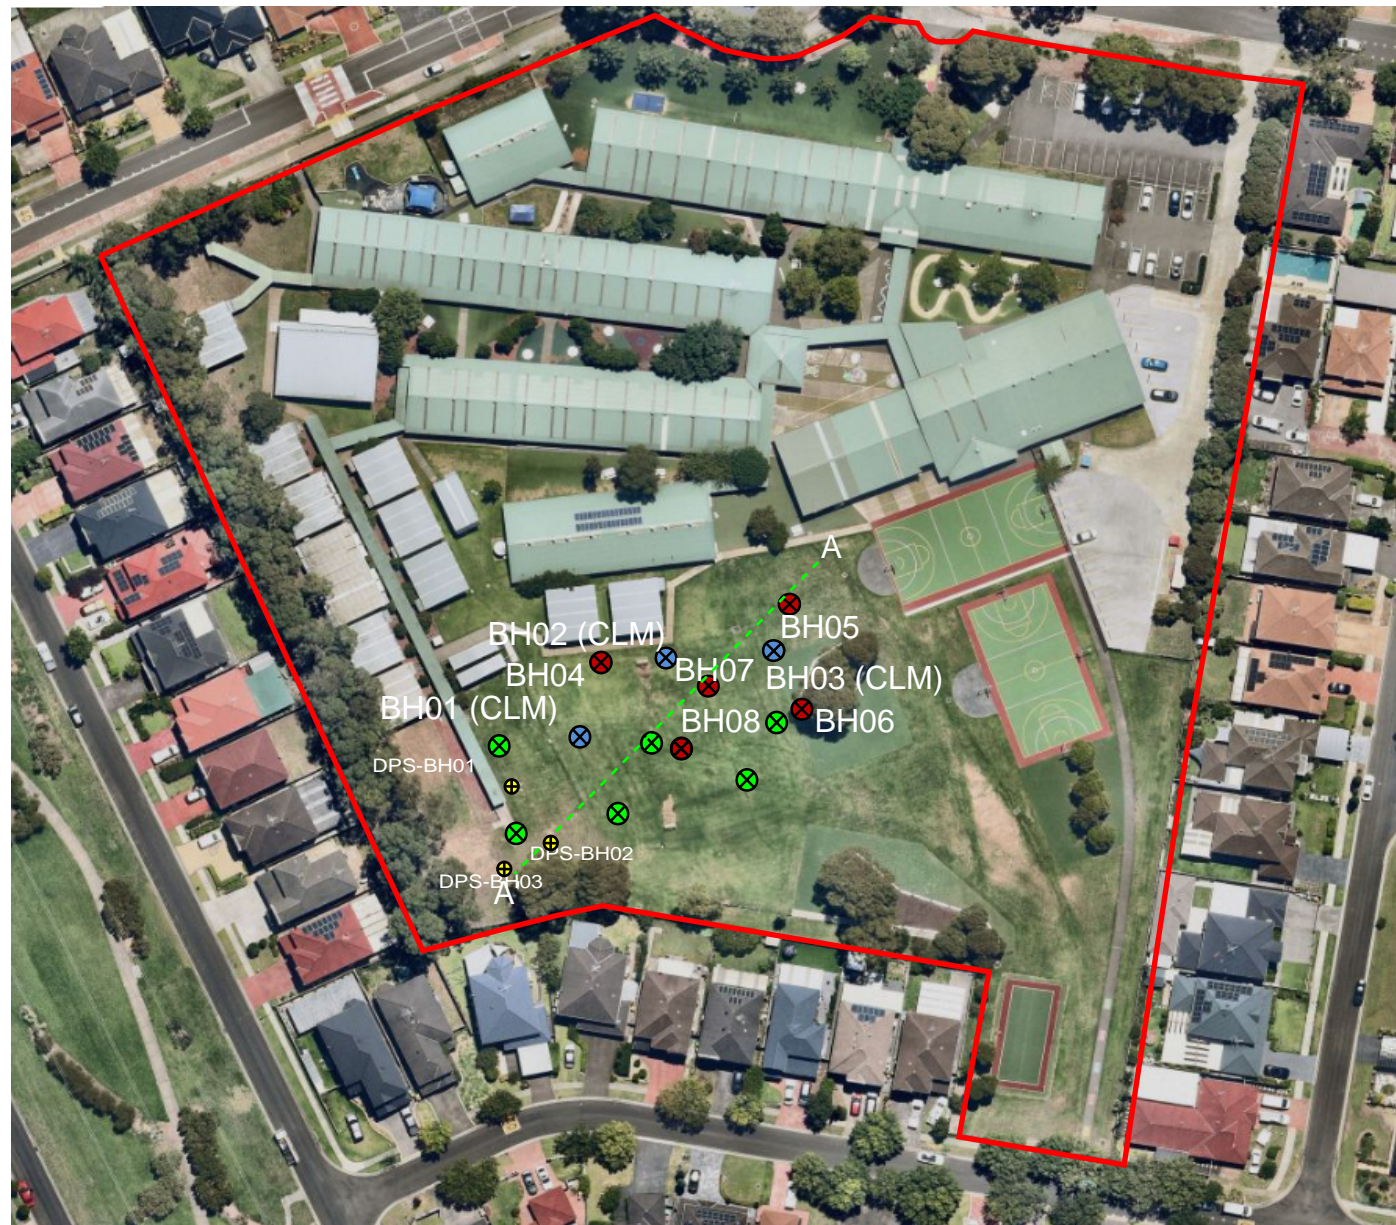
**Figure 1**  
Borehole location plan

- Site boundary
- ⊗ Geotechnical Assessment Location
- ⊗ Environmental Assessment Location
- ⊗ 2nd Environmental Assessment Location
- ⊗ 2nd Geotechnical Assessment Location
- Geological Cross Section

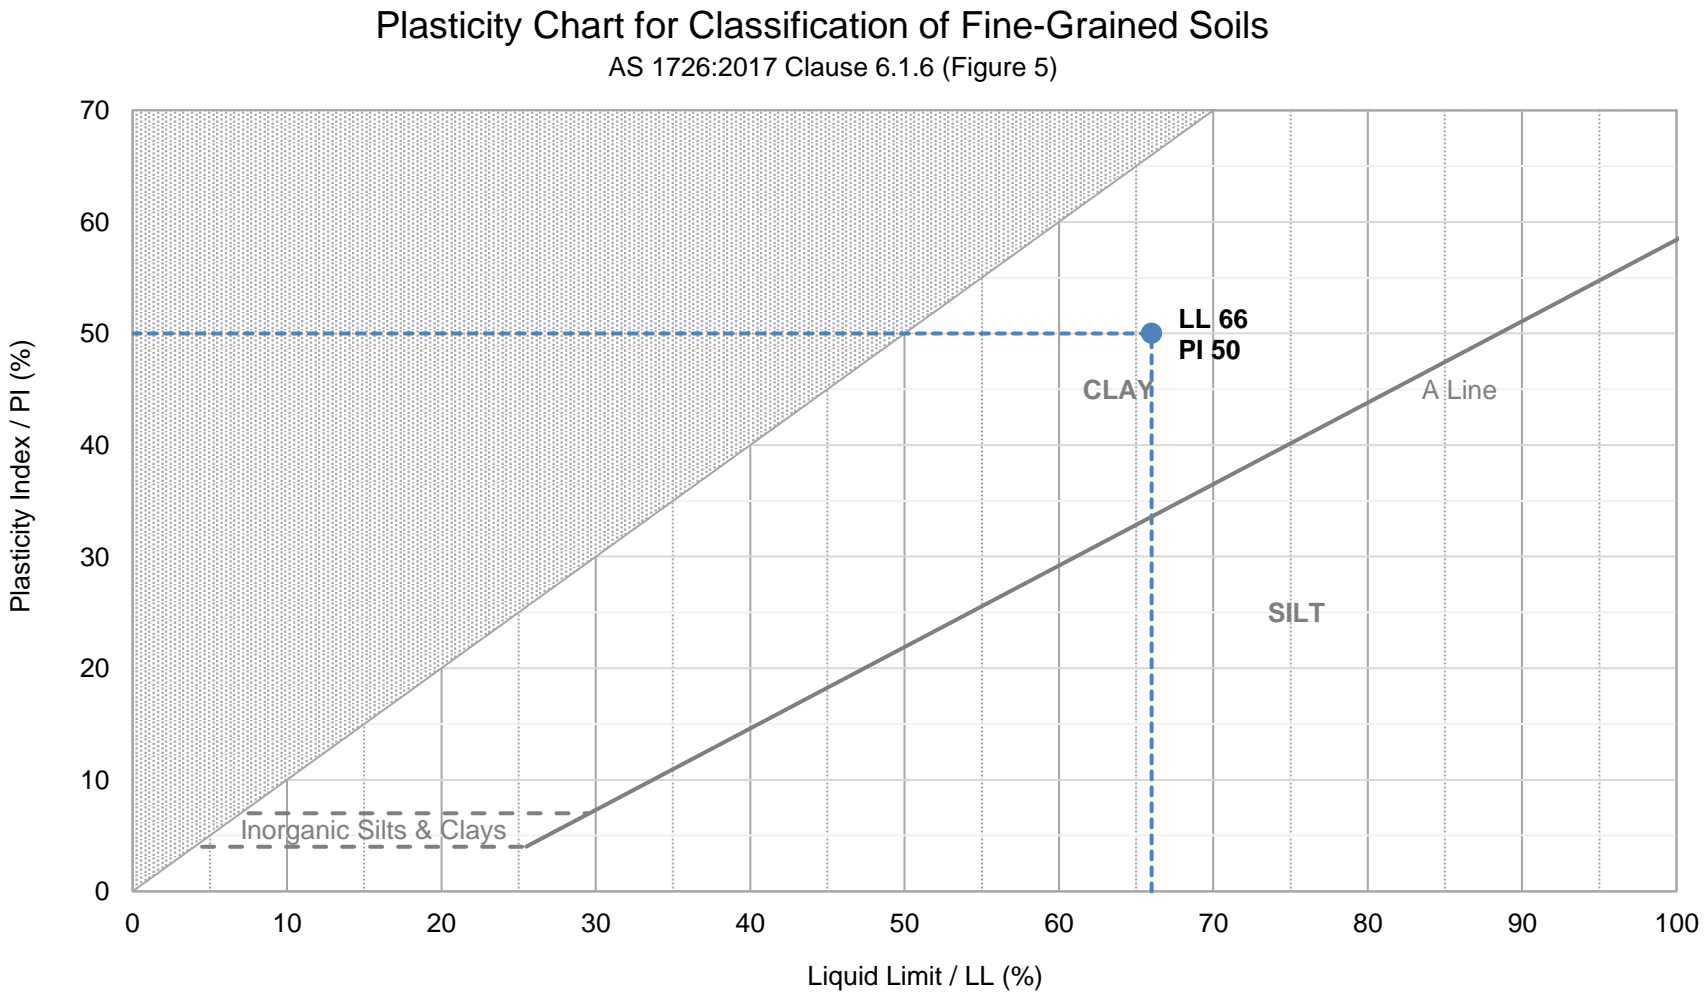
SOIL CLASSIFICATION REPORT

Client	WSP Australia Pty Ltd	Source	BH04 2.00-2.50m
Address	Level 27, 680 George St, Sydney NSW 2000	Sample Description	Silty CLAY
Project	Dalmeny Public School (PS206292)	Report No.	S89770-PI
Job No.	S23428-1	Lab No.	S89770
Test Procedure	<div><div><div><input checked="" type="checkbox"/> AS1289 3.1.1</div><div>Liquid Limit - Four point Casagrande method</div></div><div><div><input type="checkbox"/> AS1289 3.1.2</div><div>Liquid Limit - One point Casagrande method</div></div><div><div><input checked="" type="checkbox"/> AS1289 3.2.1</div><div>Plastic Limit - Standard method</div></div><div><div><input checked="" type="checkbox"/> AS1289 3.3.1</div><div>Calculation of the Plasticity Index</div></div><div><div><input checked="" type="checkbox"/> AS1289 3.4.1</div><div>Linear Shrinkage - Standard method</div></div></div>		
Sampling	Sampled by Client - results apply to the sample as received	Date Sampled	25/09/2023

Preparation	Results
Method of Preparation	Liquid Limit / LL (%)
History of the Sample	Plastic Limit (%)
	Plasticity Index / PI (%)
	Linear Shrinkage (%)
	Condition upon Drying

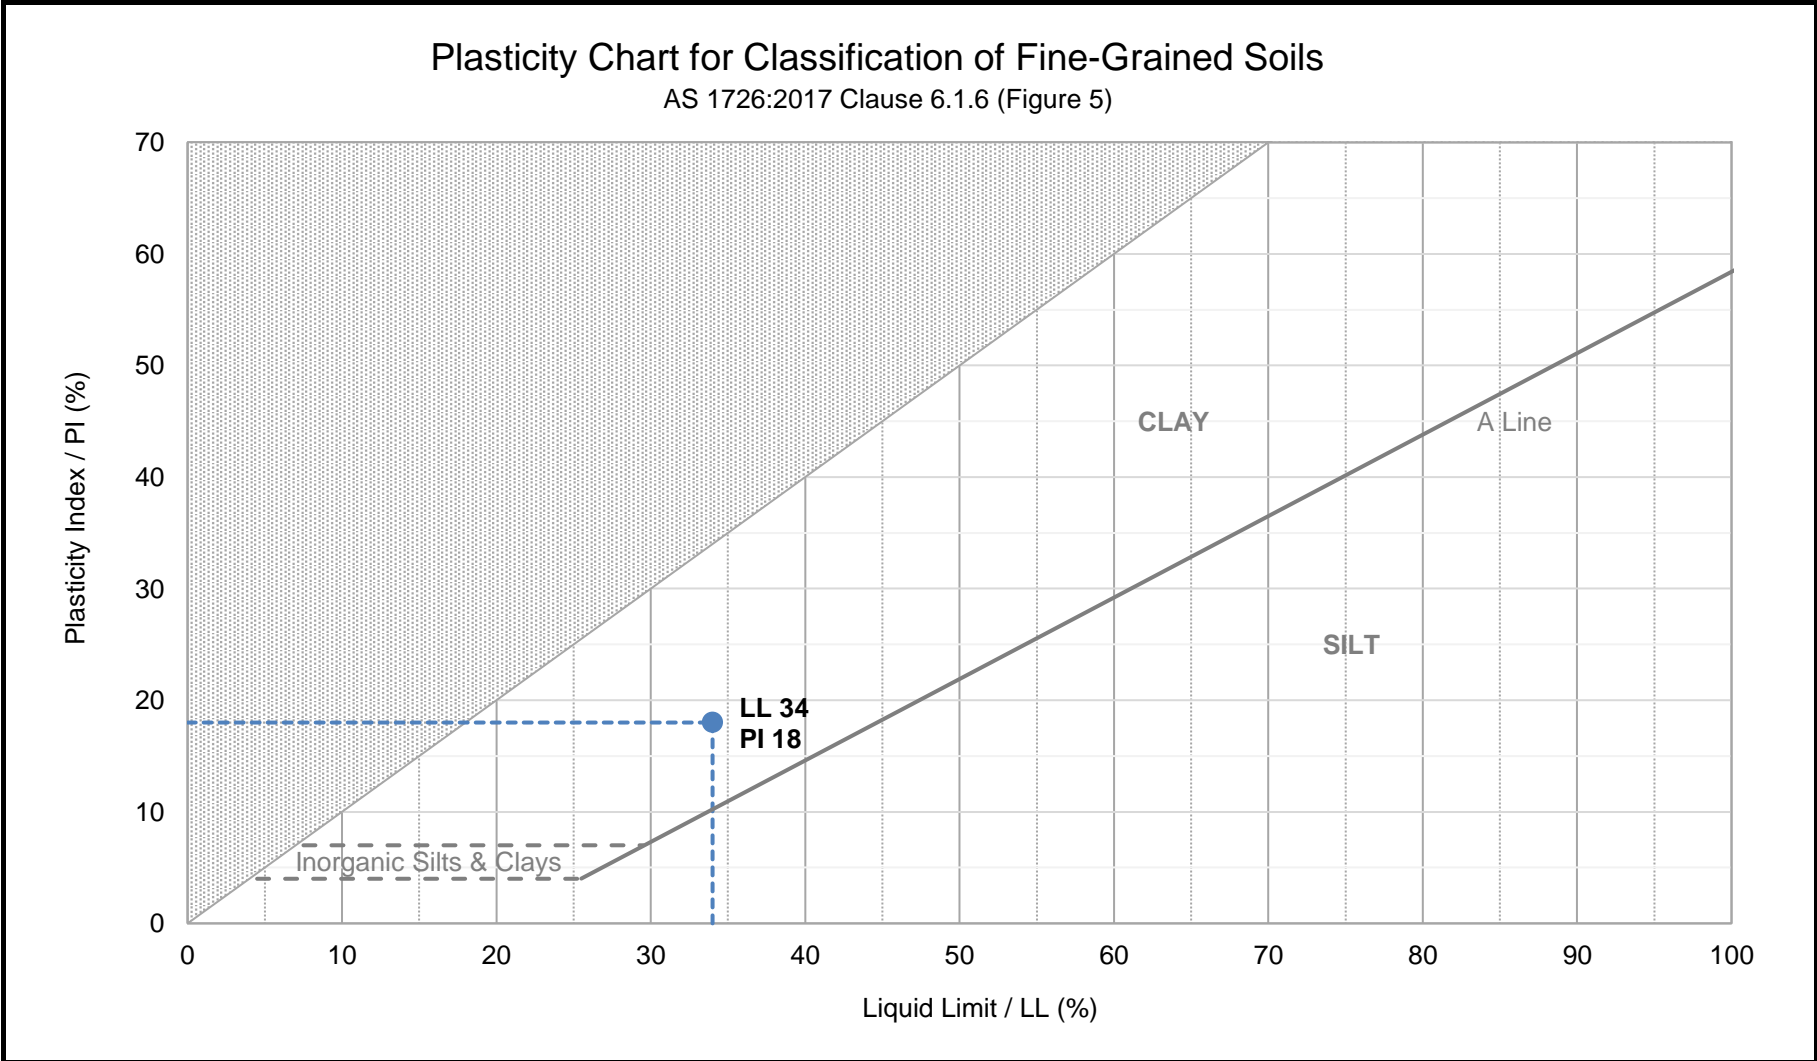
SOIL CLASSIFICATION REPORT

Client	WSP Australia Pty Ltd	Source	BH05 2.50-2.95m
Address	Level 27, 680 George St, Sydney NSW 2000	Sample Description	Silty CLAY
Project	Dalmeny Public School (PS206292)	Report No.	S89768-PI
Job No.	S23428-1	Lab No.	S89768
Test Procedure	<div><div><input checked="" type="checkbox"/> AS1289 3.1.1</div>Liquid Limit - Four point Casagrande method</div> <div><div><input type="checkbox"/> AS1289 3.1.2</div>Liquid Limit - One point Casagrande method</div> <div><div><input checked="" type="checkbox"/> AS1289 3.2.1</div>Plastic Limit - Standard method</div> <div><div><input checked="" type="checkbox"/> AS1289 3.3.1</div>Calculation of the Plasticity Index</div> <div><div><input checked="" type="checkbox"/> AS1289 3.4.1</div>Linear Shrinkage - Standard method</div>		
Sampling	Sampled by Client - results apply to the sample as received	Date Sampled	25/09/2023
Preparation	Prepared in accordance with the test method	Date Tested	12/10/2023

Dry Sieved	34
Oven Dried	16
	18
	9.0
	Linear

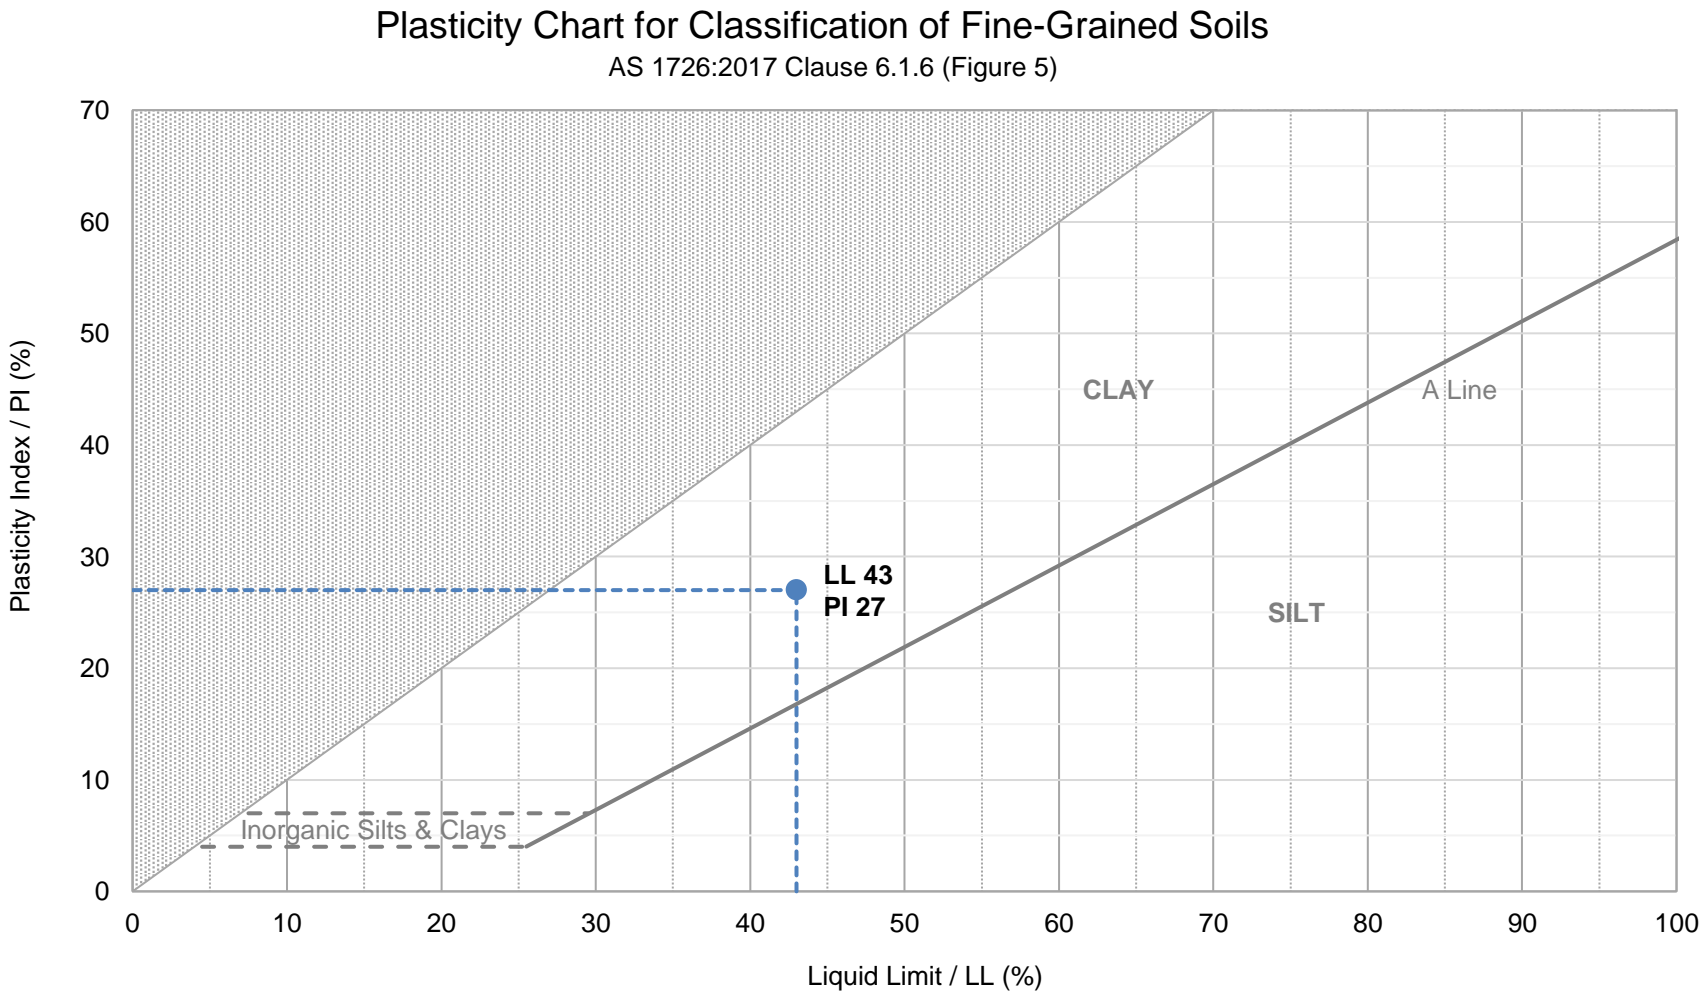
SOIL CLASSIFICATION REPORT

Client	WSP Australia Pty Ltd	Source	BH08 2.50-2.95m
Address	Level 27, 680 George St, Sydney NSW 2000	Sample Description	Silty CLAY
Project	Dalmeny Public School (PS206292)	Report No.	S89769-PI
Job No.	S23428-1	Lab No.	S89769
Test Procedure	<div><div><input checked="" type="checkbox"/> AS1289 3.1.1</div>Liquid Limit - Four point Casagrande method</div> <div><div><input type="checkbox"/> AS1289 3.1.2</div>Liquid Limit - One point Casagrande method</div> <div><div><input checked="" type="checkbox"/> AS1289 3.2.1</div>Plastic Limit - Standard method</div> <div><div><input checked="" type="checkbox"/> AS1289 3.3.1</div>Calculation of the Plasticity Index</div> <div><div><input checked="" type="checkbox"/> AS1289 3.4.1</div>Linear Shrinkage - Standard method</div>		
Sampling	Sampled by Client - results apply to the sample as received	Date Sampled	25/09/2023
Preparation	Prepared in accordance with the test method	Date Tested	12/10/2023

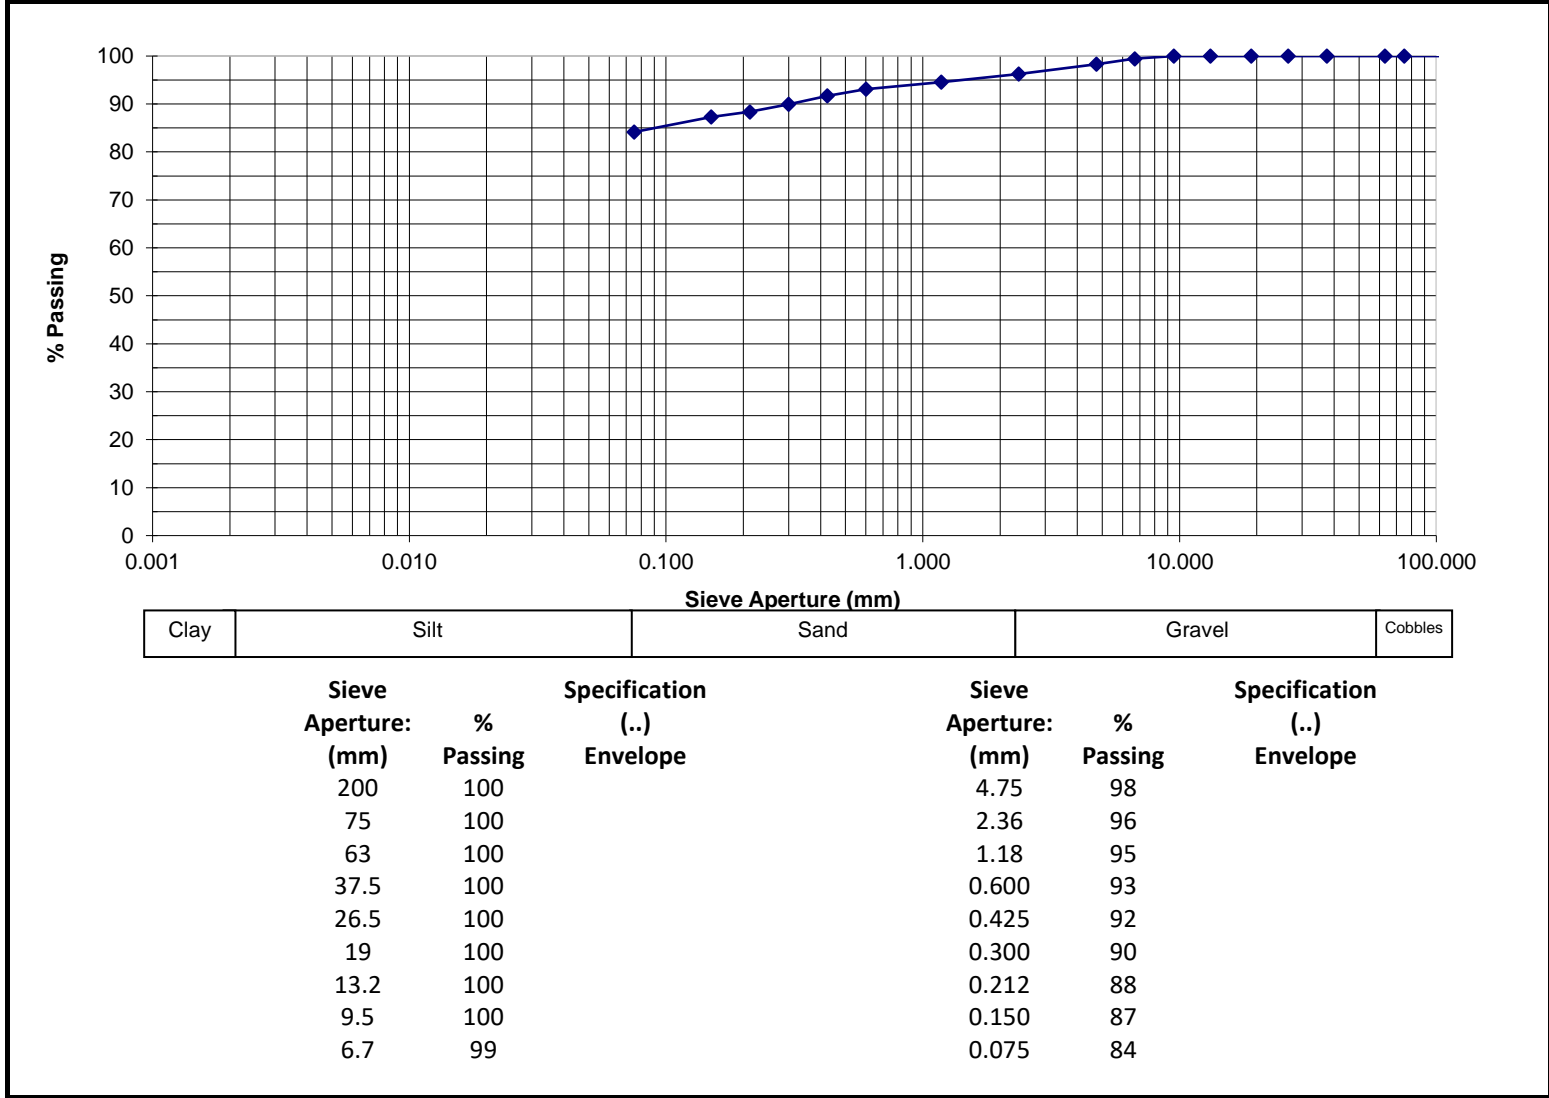
Client	WSP Australia Pty Ltd	Source	BH06 2.00-2.50m
Address	Level 27, 680 George St, Sydney NSW 2000	Sample Description	Silty CLAY, trace of Sand and Gravel
Project	Dalmeny Public School (PS206292)	Report No	S89767-PSD
Job No	S23428-1	Lab No	S89767

Test Procedure	AS 1289.3.6.1 - Particle size distribution of a soil		
Sampling	Sampled by Client - results apply to the sample as received	Date Sampled	25/09/2023
Preparation	Prepared in accordance with the test method	Date Tested	11/10/2023
