ARBORICULTURAL IMPACT ASSESSMENT
&
TREE PROTECTION SPECIFICATION

REF: L&Co24013 | 25 March 2025 | v2.3

SITE ADDRESS | Dalmeny Public School, 1612 Dalmeny Dr, Prestons NSW

PREPARED FOR | Department of Education (DoE)

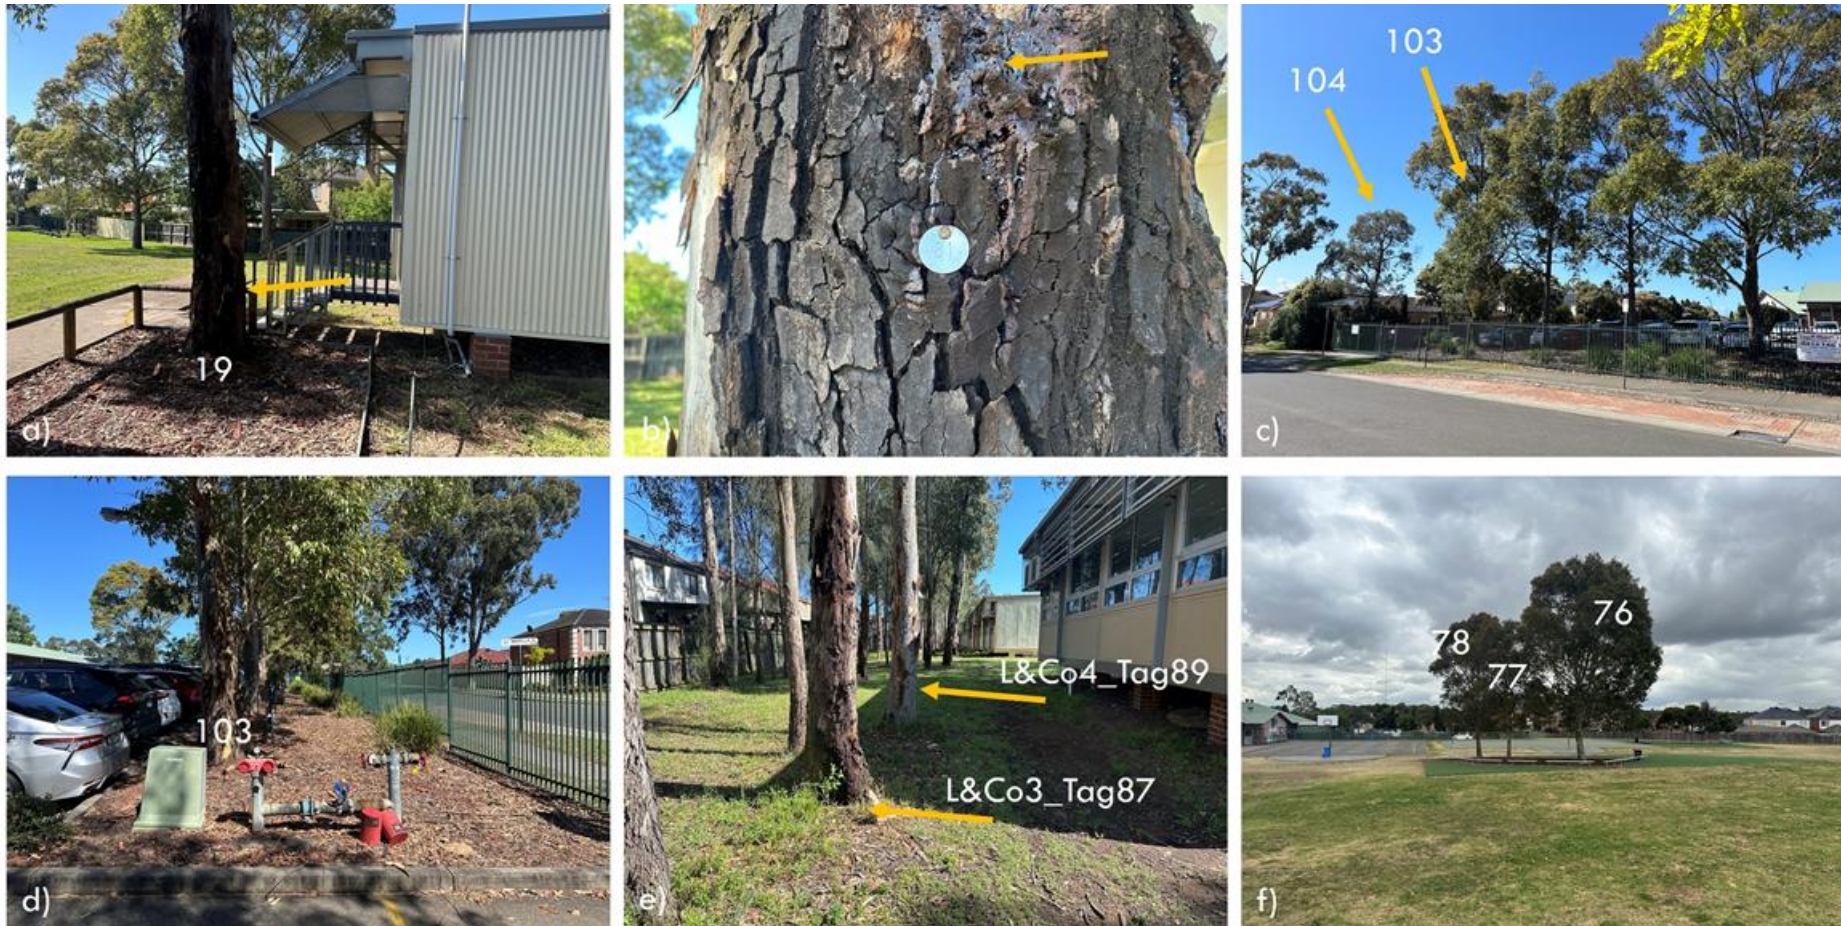
14.0 APPENDIX 9 | PLATES

a-b) Showing Tree 19 with borer damage to trunk. c) Showing Trees 103 & 104 from Dalmeny Drive. d) Showing Tree 103. e) Showing Trees L&Co 3 & 4. f) Showing Trees 76.77 & 78.

- 4.5 **Tree 103**
- 4.5.1 Tree 103 was identified as *Corymbia maculata* (Spotted Gum) and was allocated a High Landscape Significance Value and a Retention Value of *Consider for Retention*.

- 4.5.4 Refer to Appendix 4 for further detail.
- 4.5.5 Removal and replacement with a healthy advanced size specimen would replace the loss of amenity within a medium timeframe.
