**REPORT TO  
HEALTH INFRASTRUCTURE**

**ON  
DETAILED SITE INVESTIGATION**

**FOR  
EXPANSION PROJECT**

**AT  
MT DRUITT HOSPITAL, 75 RAILWAY STREET,  
MT DRUITT, NSW**

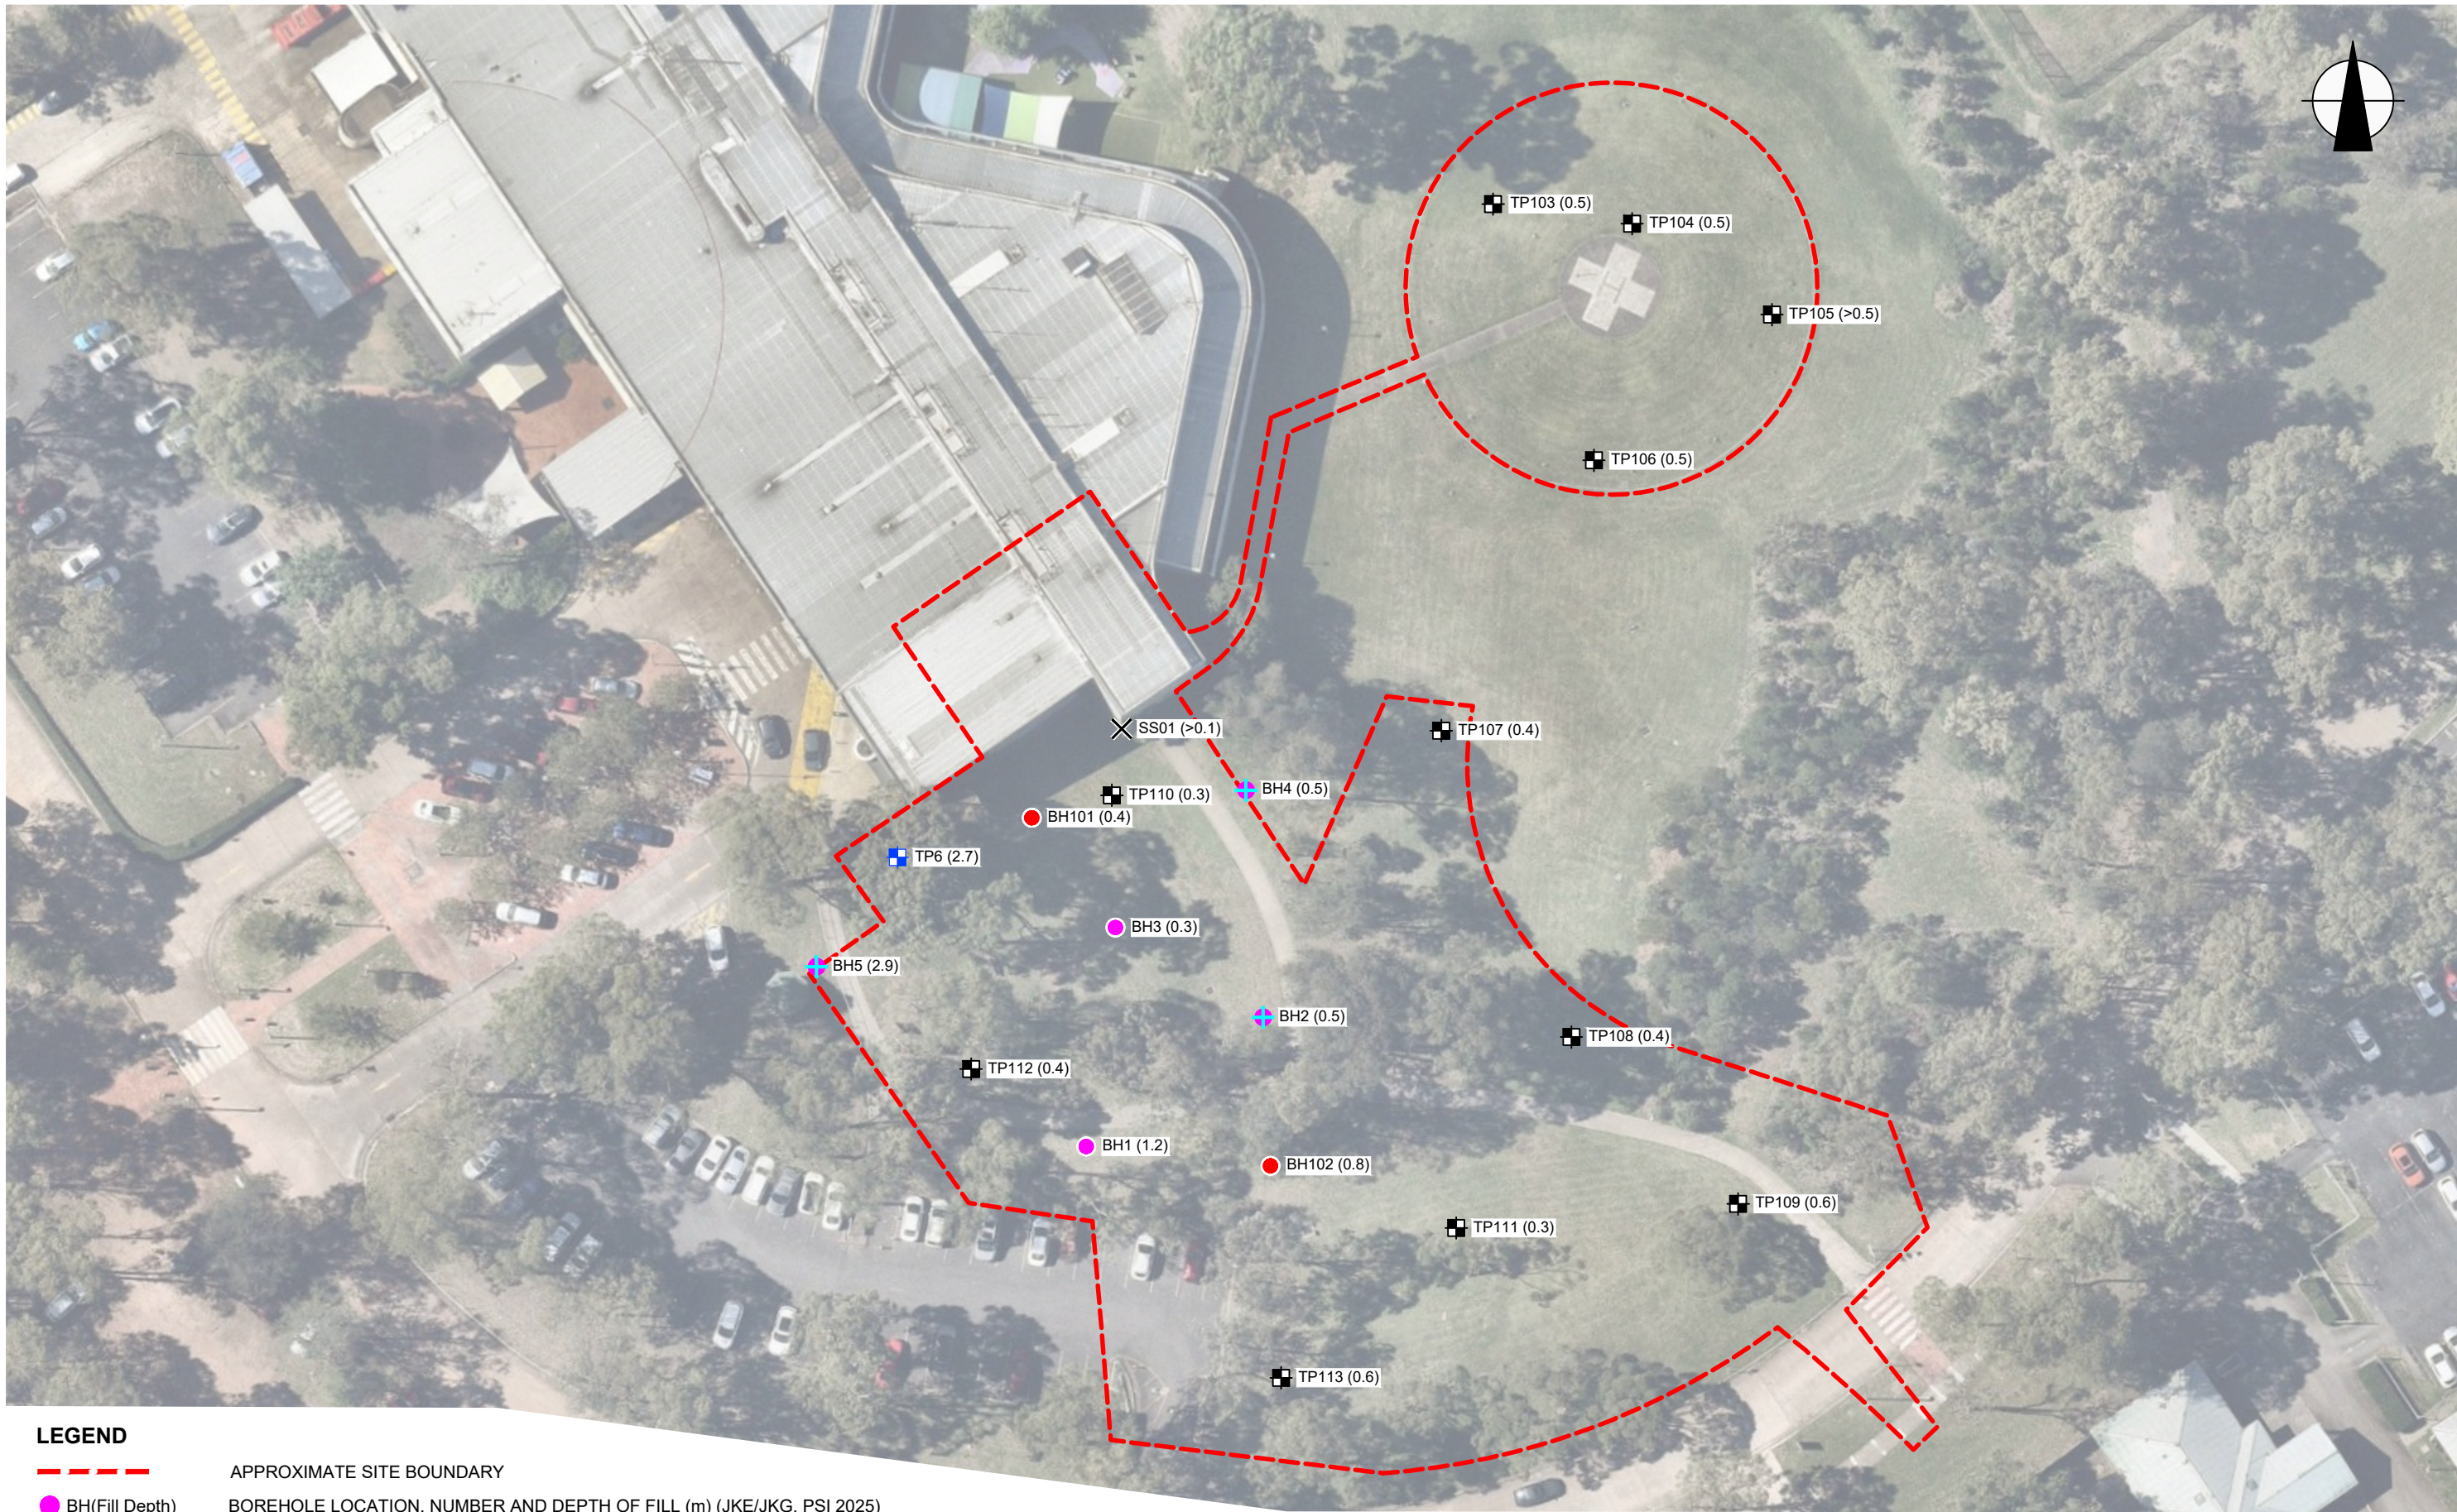
- APPROXIMATE SITE BOUNDARY
- BH(Fill Depth) BOREHOLE LOCATION, NUMBER AND DEPTH OF FILL (m) (JKE/JKG, PSI 2025)
- BH/MW(Fill Depth) BOREHOLE AND GROUNDWATER MONITORING WELL LOCATION, NUMBER AND DEPTH OF FILL (m) (JKE/JKG, PSI 2025)
- TP(Fill Depth) TEST PIT LOCATION, NUMBER AND DEPTH OF FILL (m) (JKE/JKG, PSI 2025)
- BH101 JKG BOREHOLE LOCATION, NUMBER AND DEPTH OF FILL (m)
- TP103 JKE TEST PIT LOCATION, NUMBER AND DEPTH OF FILL (m)
- × SS01 JKE SURFACE SOIL LOCATION, NUMBER AND DEPTH OF FILL (m)

| Report | High level summary |
|---|---|
| Preliminary Site Investigation (PSI), JKE 2025 <sup>6</sup> | <p>The PSI included a review of existing site information, and soil sampling from one test pit and five boreholes. The PSI sample locations are shown on Figure 2 in Appendix A. It is noted that the project boundary at the time of the PSI was smaller and has since been expanded to form the site applicable to the JKE DSI.</p> <p>The sampling locations encountered fill to depths of approximately 0.3m below ground level (BGL) to 2.9mBGL, underlain by clayey residual soils. The fill typically comprised inclusions of ironstone and igneous gravel, slag, clay nodules, ash, roots and root fibres. No odours or staining were observed in the fill material during fieldwork. No fibre cement fragments (FCF)/asbestos containing material (ACM) was encountered in or on the fill material during fieldwork.</p> <p>A selection of soil samples was analysed for the CoPC identified in the CSM. Elevated concentrations of the CoPC were not encountered above the adopted SAC and asbestos was not detected in any of the soil samples analysed. There were no unacceptable risks identified that triggered the need for remediation.</p> <p>The report concluded that a DSI is required to characterise the fill and address the data gaps identified during the investigation.</p> <p>Following the Desktop and the PSI, the extent of the proposed development area changed and a new site boundary was established. This increased the site area and the changes to the site area are considered in the context of the DSI.</p> |
