# 2 – 4 Kayuga Close, Caves Beach

## Geotechnical Investigation Report

NSW Government Health Infrastructure

17 March 2026

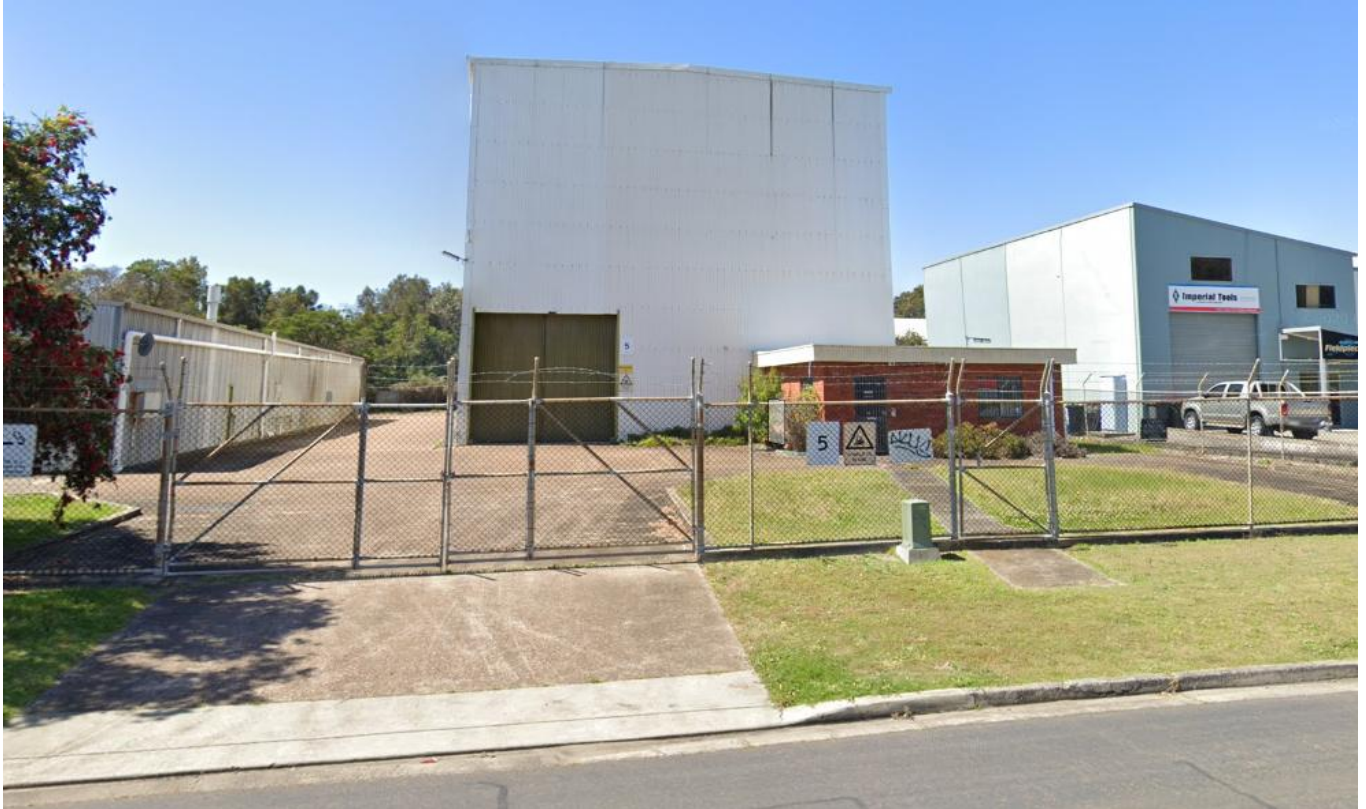
*Figure 1 Site location Caves Beach*

The site is located in Caves Beach, New South Wales. Site investigations works were undertaken along the proposed ambulance station. The site has two warehouse with some grass areas and hardstand to support movement of heavy vehicles. The site is relatively flat with limited exposed geological features. General photos of the site location are shown in Figure 1.

NSW Government Health Infrastructure (HI) has engaged GHD Pty Ltd (GHD) to undertake a Geotechnical Investigation at 2-4 Kayuga Close, Caves Beach NSW 2281 (the site), as part of a geotechnical assessment to support redevelopment and planning of the site. The NSW Health Infrastructure (HI) is planning to design and construct new ambulance station at the proposed site. The site currently comprises of two on grade warehouses, two grassed areas with trees adjacent Kayuga Close with the remainder of the site covered in hardstand as presented in Figure 1.
