# **New Primary School in Worrige**

## **Arboricultural Impact Assessment**

**Department of Education**

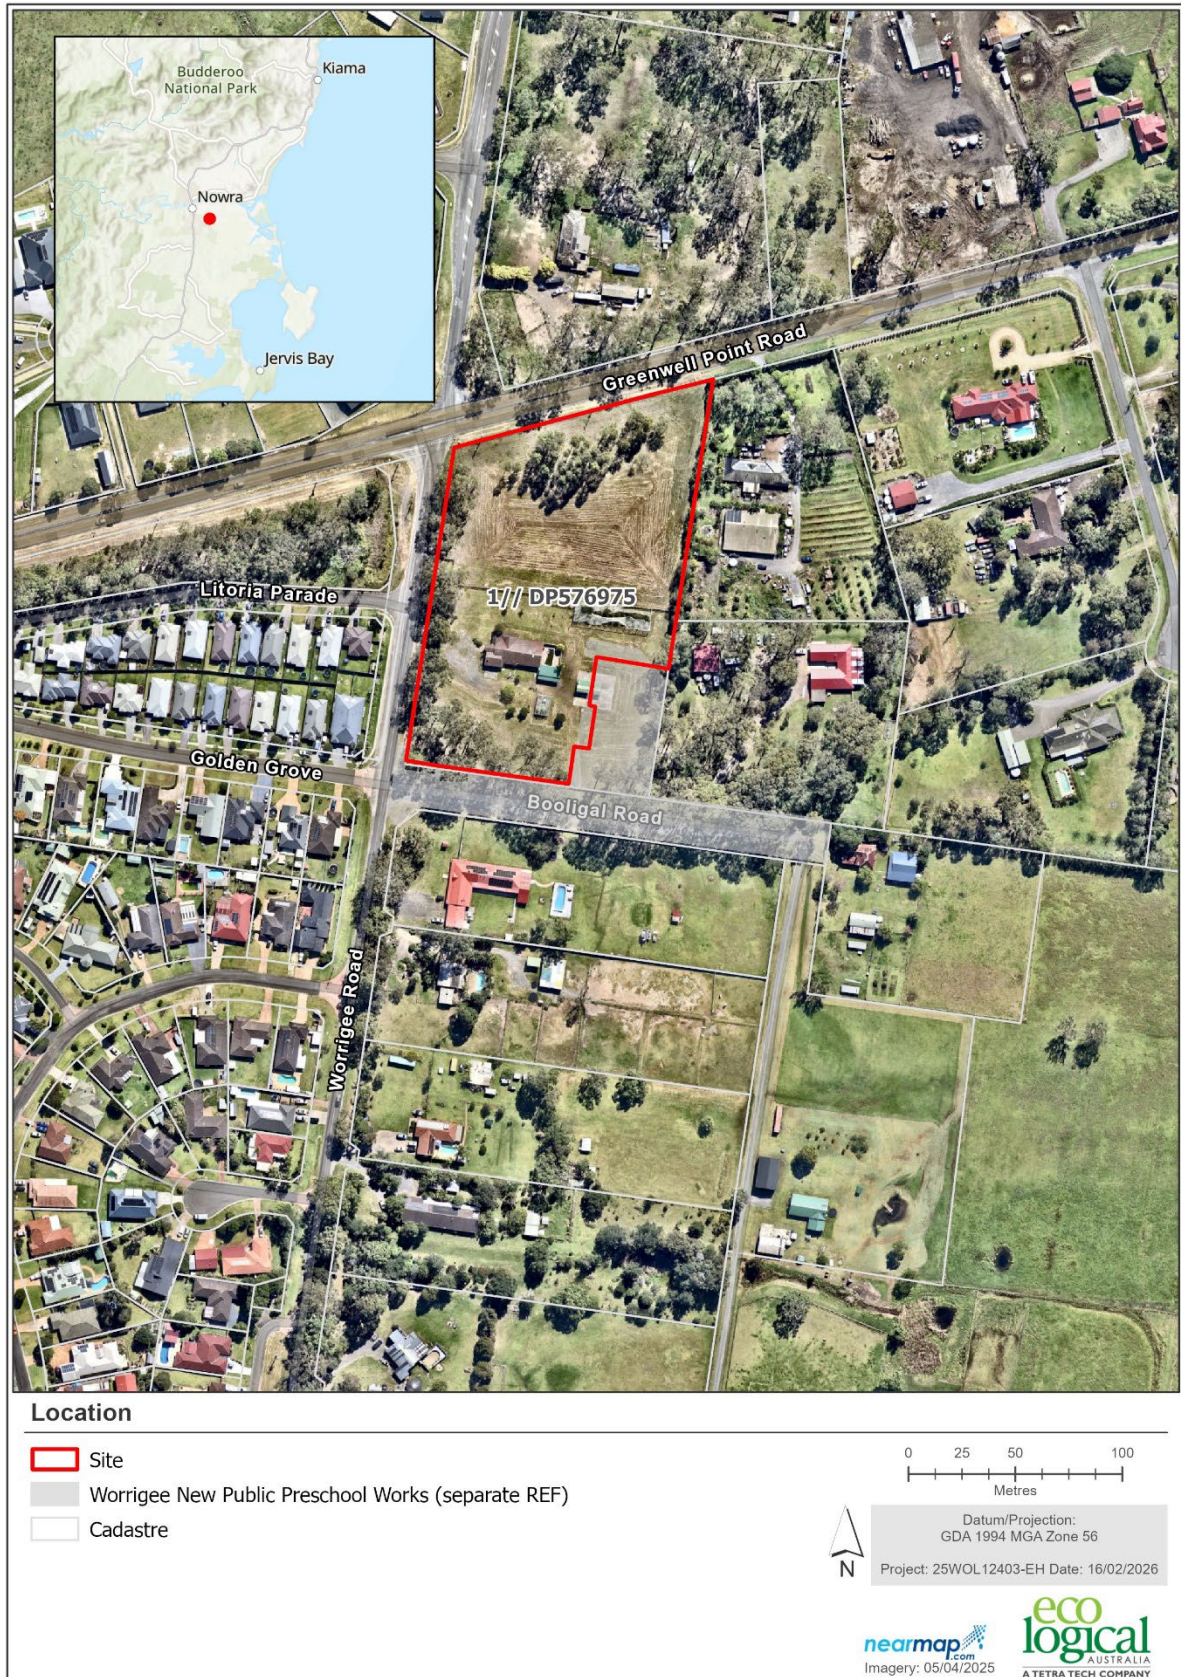
Figure 2: Location

The site is known as 9 Worrigee Road, Worrigee. The site has a frontage of 125.23m to Greenwell Point Road, 149.87m to Worrigee Road and 114.89m to Booligal Road (including the preschool frontage). The site is legally described as Lot 1 in Deposited Plan 576975 and is 2 hectares (by title). Offsite works are also proposed in the adjacent road reserves. Figure 2 provides an aerial photograph of the site.

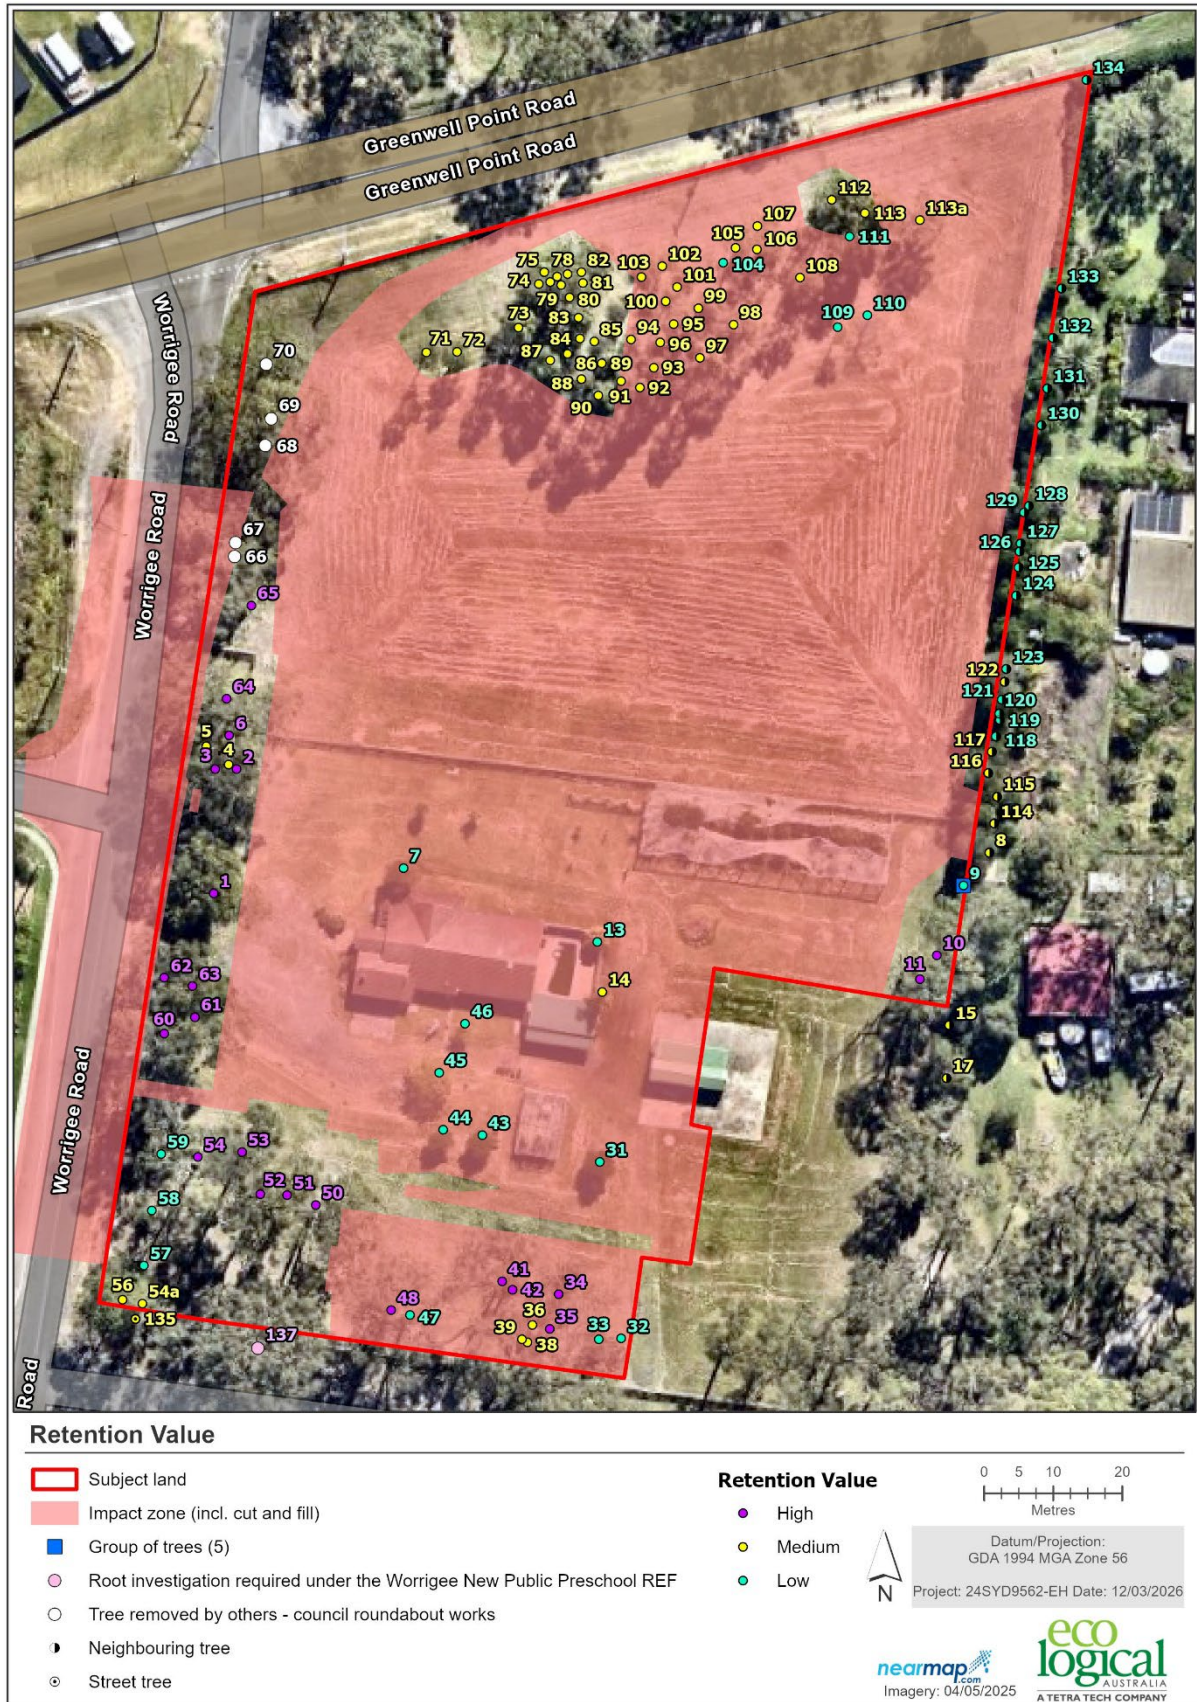
Figure 7: Retention values

- **Retention-incompatible:** Trees that are subject to major or moderate encroachment from the proposed development to the extent whereby tree retention is incompatible under the current design if the current plans are approved. Dead trees may also be recommended for removal by the arborist, regardless of the extent of impact. All tree removal must comply with guidelines specified in Section 4 of this report and is subject to regulatory approval.
