GEOTECHNICAL ASSESSMENT - PROPOSED STAIR REFURBISHMENT & BIKE STORAGE CAGE

**REPORT TO
MUNJARRA CO-OP SKI LODGE LIMITED**

**ON
GEOTECHNICAL ASSESSMENT**

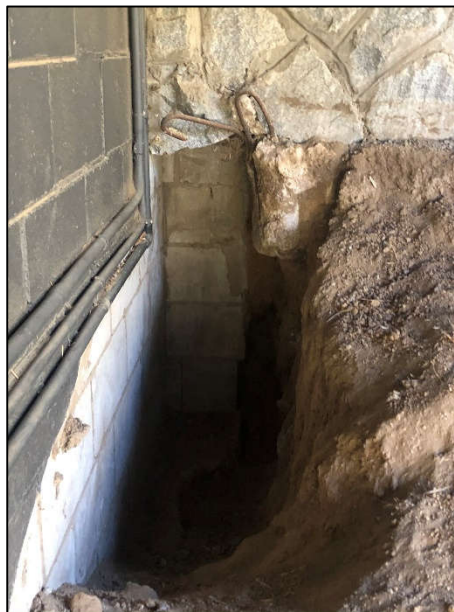
Weathered granite bedrock was exposed within the sides and base of the test pits below about 0.2m depth, as well as at the ground surface on the western side of the existing staircase over the lower portion of the site. Refer to Plates 2 and 3 below.

Plate 2: TP2 (Looking south).

The granite was generally extremely weathered and of hard (soil) strength, and locally was assessed to be highly weathered and of very low strength. In TP2, some granite cobbles and boulder sized 'corestones' (less than about 0.3m size) were observed in the western side of the test pit. Hand penetrometer readings in the sides and base of the test pits were greater than 600kPa.
