**REPORT TO
MUNJARRA CO-OP SKI LODGE LIMITED**

**ON
GEOTECHNICAL ASSESSMENT**

**FOR
PROPOSED STAIR REFURBISHMENT
& BIKE STORAGE CAGE AT MUNJARRA LODGE**

**AT
13 BOBUCK LANE, THREDBO, NSW**

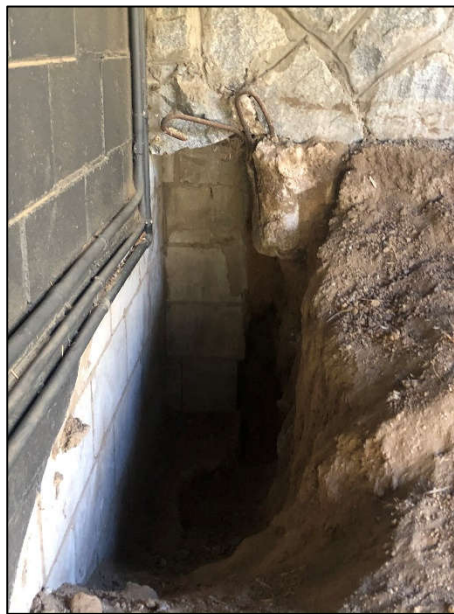
Plate 2: TP2 (Looking south).

The granite was generally extremely weathered and of hard (soil) strength, and locally was assessed to be highly weathered and of very low strength. In TP2, some granite cobbles and boulder sized 'corestones' (less than about 0.3m size) were observed in the western side of the test pit. Hand penetrometer readings in the sides and base of the test pits were greater than 600kPa.

The test pits revealed that the mortared granite sub-floor wall of the lodge was supported by a shallow concrete strip footing at about 0.3m depth founded in extremely weathered granite bedrock.
