## Site Classification Summary Report

| <b>Client</b> | The Trustee for Elmerino Investments Trust | <b>Project No.</b> | 216804.00 |
| <b>Project</b> | Proposed Extensions | <b>Date</b> | 22 Aug 2023 |
| <b>Address</b> | 20 Candle Heath Road, Perisher Valley | <b>Doc No.</b> | R.001.Rev1 |

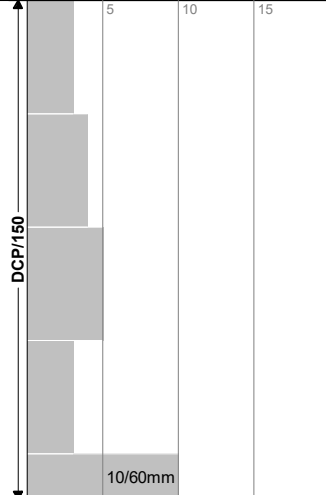
| CONDITIONS ENCOUNTERED | | | | | | | | | | | | | | SAMPLE | | | | TESTING AND REMARKS | | | |
| GROUNDWATER | RL (m) | DEPTH (m) | DESCRIPTION OF STRATA | GRAPHIC | ORIGIN (#) | CONSIS. (°) | DENSITY (°) | MOISTURE | REMARKS | TYPE | INTERVAL | DEPTH (m) | TEST TYPE | RESULTS AND REMARKS | | | | | | | |
| 08/12/22, No free groundwater observed | 1747 | 0.0 | TOPSOIL/FILL/ (CL) Silty CLAY; dark brown; low plasticity; with rootlets | | TOP and FILL | NA | | <PL | | | | | DCP/150 | | 5 | 10 | 15 | | | | |
| | | | 0.7-1.0m: some anthropogenics observed, possible trench within pit | | probably RES possibly FILL | (L TO MD) | | M | | | | | | | | | | | | | |
| | | 1.3 | Test pit discontinued at 1.30m depth<br>Auger & bucket refusal on cobbles and boulders | | | | | | | | | | | | | | | | | | |

**Pit 1:** Low plasticity silty clay topsoil fill to 0.1 m depth, low plasticity sandy gravelly clay fill to 0.4 m depth, then silty sandy gravel (possible fill) to 1.1 m depth overlying low to medium plasticity gravelly sandy clay to the auger/bucket refusal depth of 1.3 m. It is noted that some anthropogenic inclusions were observed between 0.7 – 1.0 m depth, indicative of either a fill layer or a possible backfilled trench within the greater test pit.
