THE RITZ

203-223 LEURA MALL, LEURA, NSW

STONE WALLS – SUPPLEMENTARY REPORT

August 2022

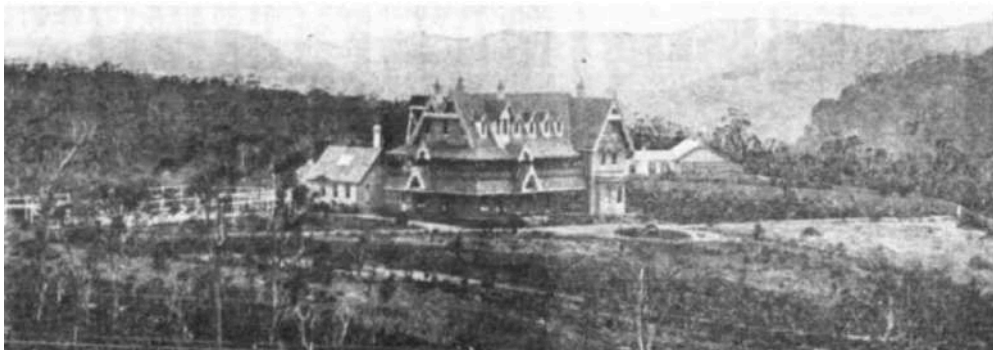
Figure 2.1 The earliest known visual record of The Ritz as built is this photograph published in 1896. Note the well-treed backdrop. The building to the right of the Coffee Palace is outside of the site

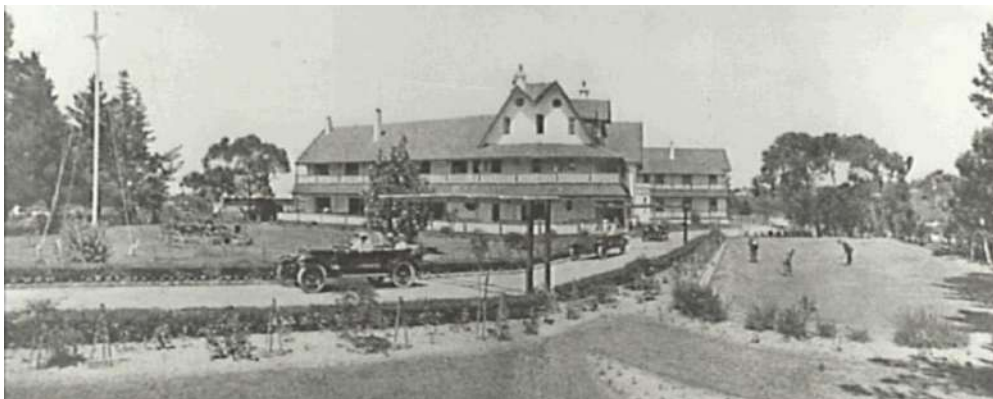
Figure 2.4 This panoramic photograph by Albert G Fowler probably dated 1910.

The image recorded new the landscaping reported in an account published in May 1914. At right is the croquet lawn. No retaining walls visible though the ground has been leveled

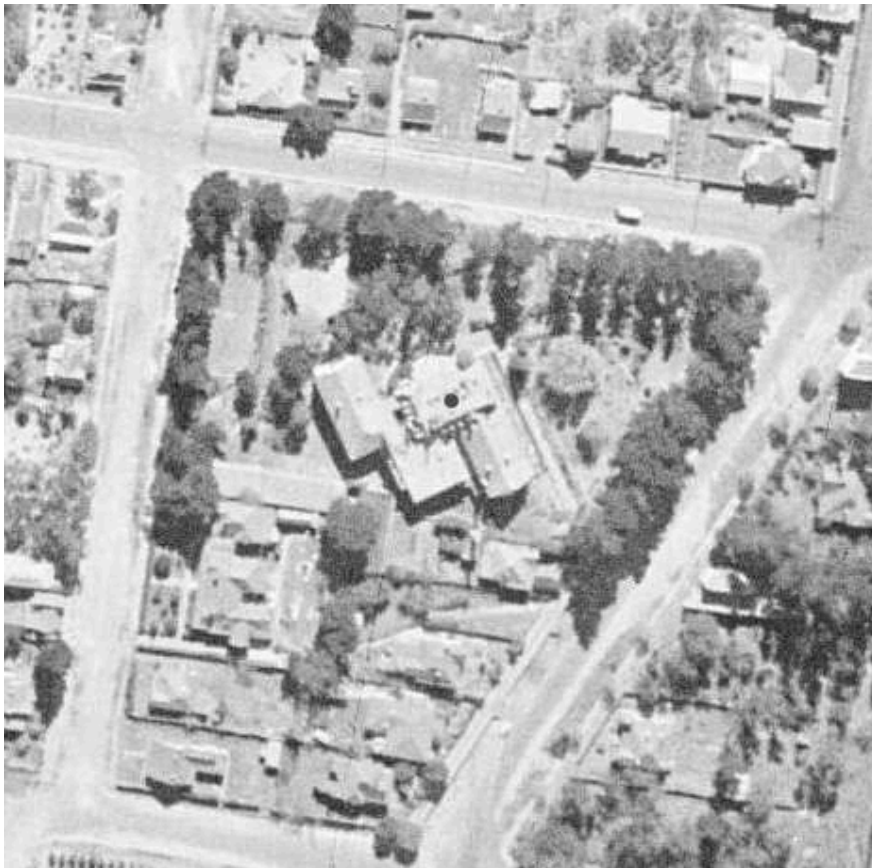
Figure 2.8 1943. Note the perimeter trees. The croquet lane /tennis court appears to have planted been with trees

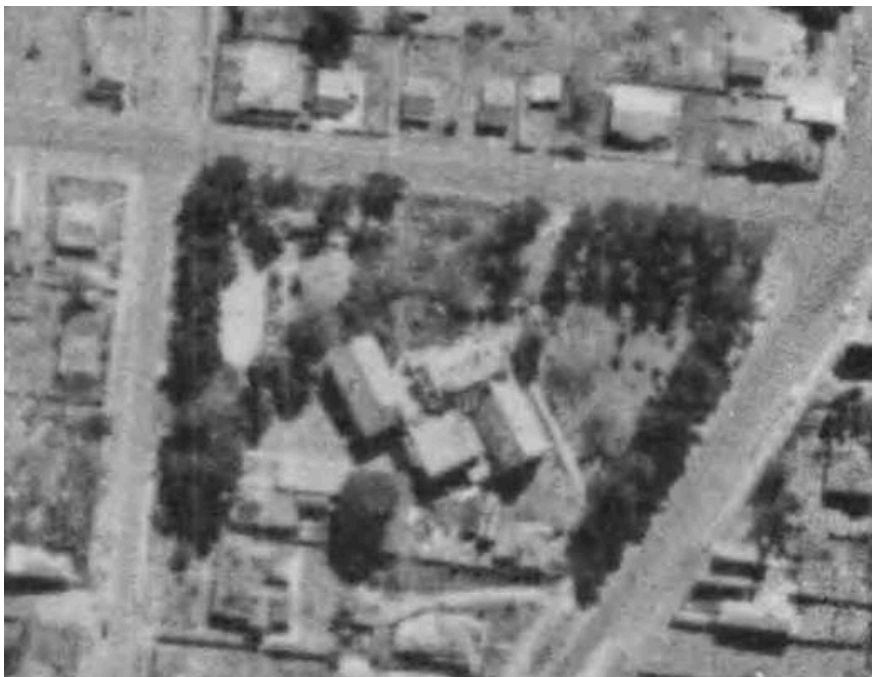
Figure 2.9 1958. The area to the east of the Bloome's cottage seems to have been cleared and the drive relocated off Megalong Street

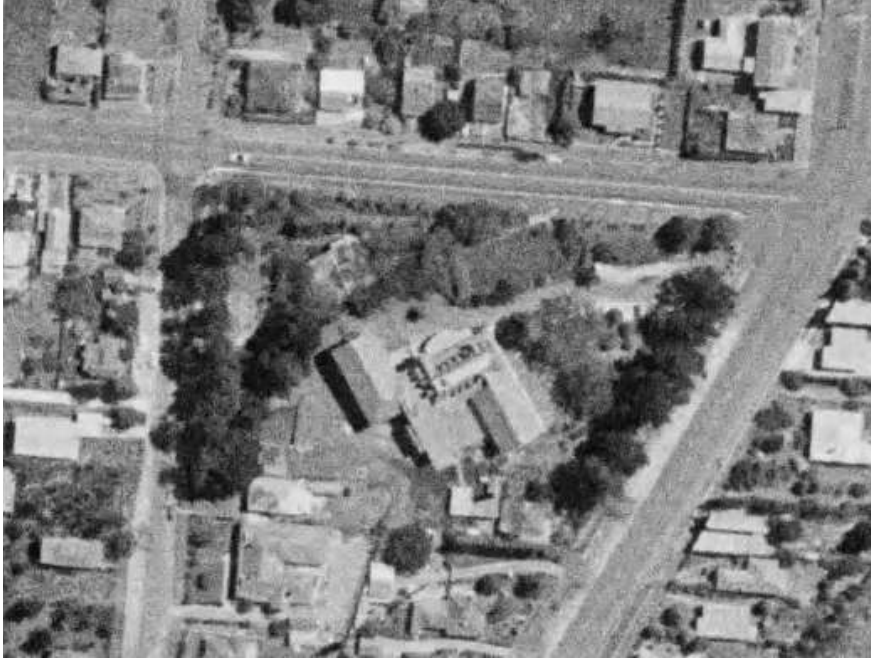
Figure 2.10 1975. The croquet lawn has been reinstated

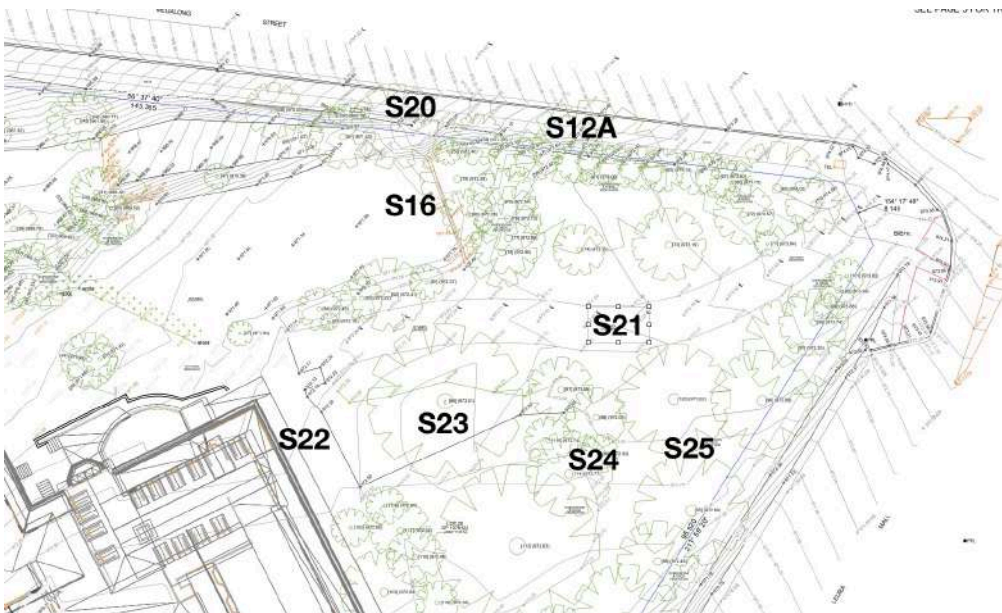
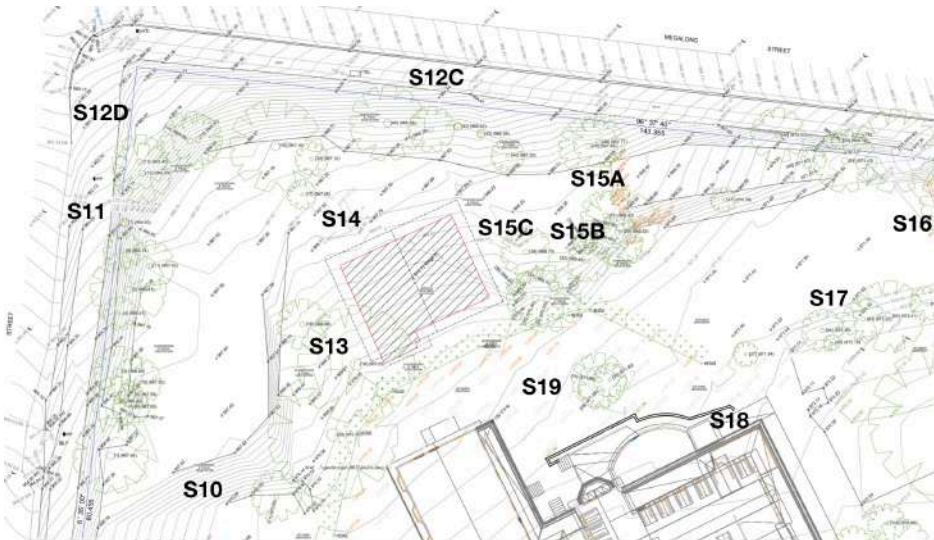
Figure 3.1 Stone Walls Location Plan – Sub numbers added for clarity

RANKING	KEY	ITEM	Note
HIGH	S10	EMBANKMENT	The embankment led to the formation of the tennis court
	S12	DRY STONE WALLS	The dry stone walls to the perimeter embankments may have been a prominent feature of the site but appear to have been largely removed (or never built)
	S15	DRY STONE WALLS	Likely dating from the construction of the manager's cottage now partly mortared
	S16	DRY STONE WALLS	Likely dating for the reformation of the croquet lawn

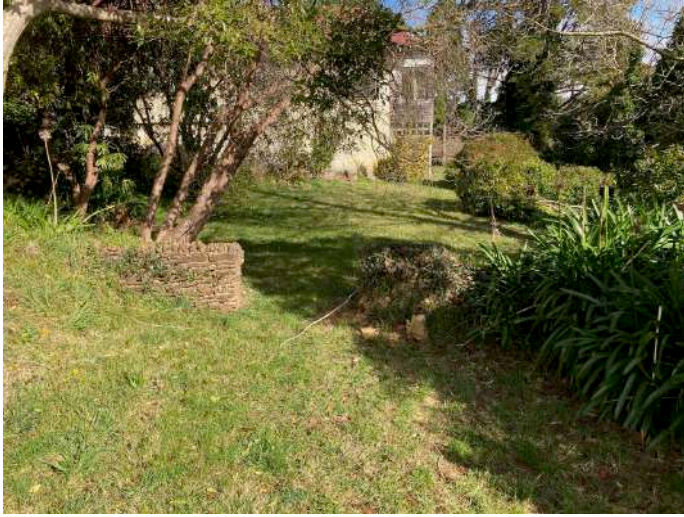
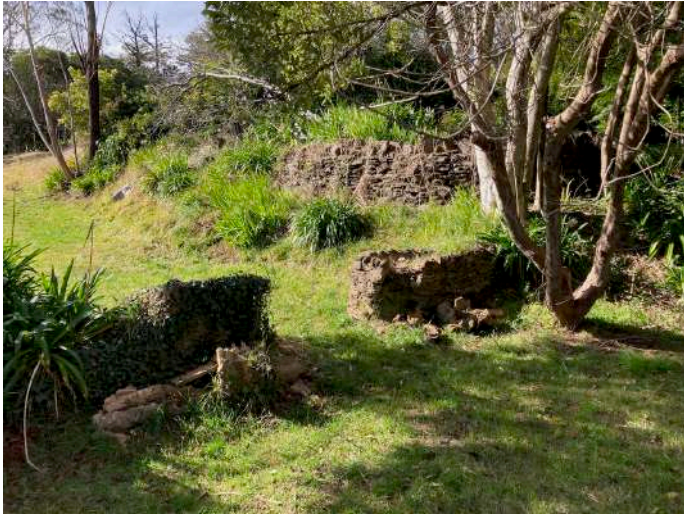
Type	Low height, dry stone wall with mortar repairs. Appears to have been a raised planter
Length	7.0 metres
Height	750mm
Condition	Moderate
Treatment	Carefully dismantle and remove mortar
	Rebuild to former detail (loose laid) with projecting cap surround
	New footing if required

REF	WALL	TREATMENT
S16	Croquet Lawn Retaining Wall	Dismantle, remove mortar, rebuild with new section on new footing if required
S15	Manager's Garden Entry Wall	Dismantle, remove mortar, rebuild on new footing if required
S15	Manager's Garden Retaining Wall	Retain as is
S15	Manager's Garden Walls	Retain as is
S12A	Remnant Embankment Wall	Retain as is and repair to suit new layout
S20	Remnant Embankment Wall	Retain as is
S12B	Remnant Embankment Wall	Retain as is
S12C	Remnant Embankment Wall	Retain as is
S12D	Remnant Embankment Wall	Retain as is and piece in new work if affected by tree removal

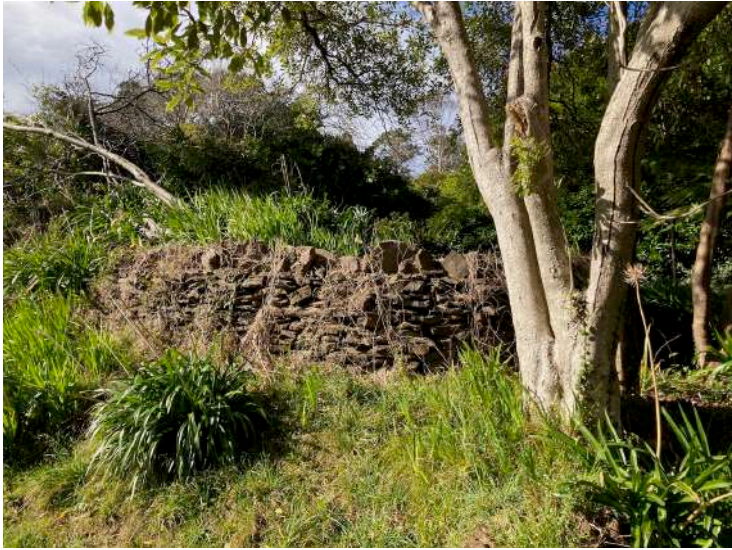
S15	Manager's Garden Retaining Wall

Type	Low height, dry stone wall
Length	6.0 metres
Height	1100mm
Condition	Moderate
Treatment	Retain as is

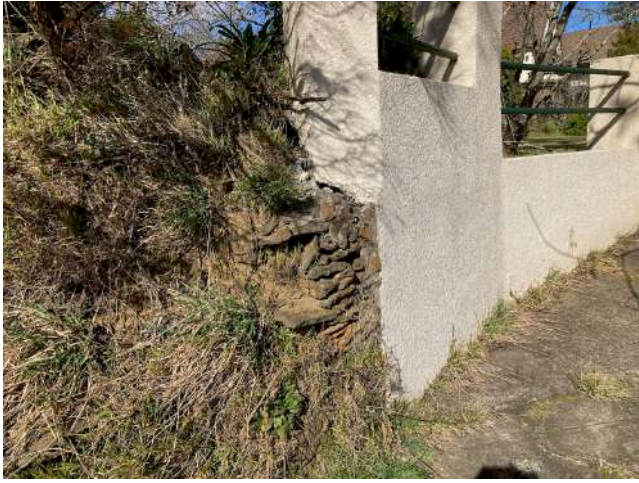
S12A	Remnant Embankment Wall

Type	Low height, dry stone retaining wall. May have been built to retain the croquets lawn but part removed for ramp.
Length	400 -1500mm
Height	800mm approx
Condition	Moderate
Treatment	Retain as is and feather in new work to match where ramp removed
S20	Remnant Embankment Wall

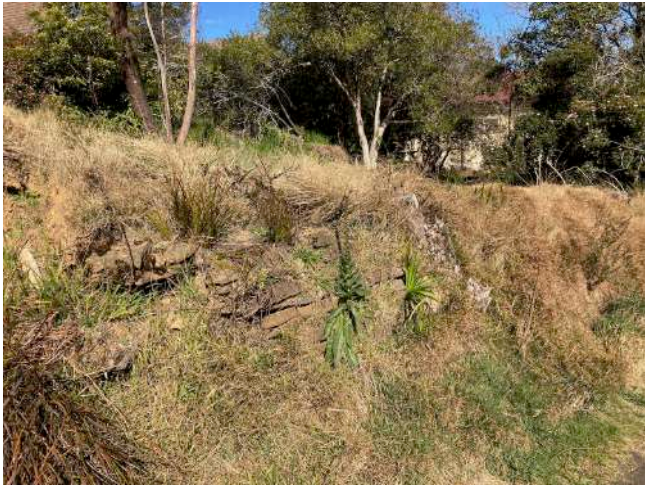
Type	DRY stone retaining wall (collapsed). May have been built to retain the croquets lawn but part removed for ramp.
Length	3.0mm
Height	800mm approx
Condition	Poor
Treatment	Retain as is

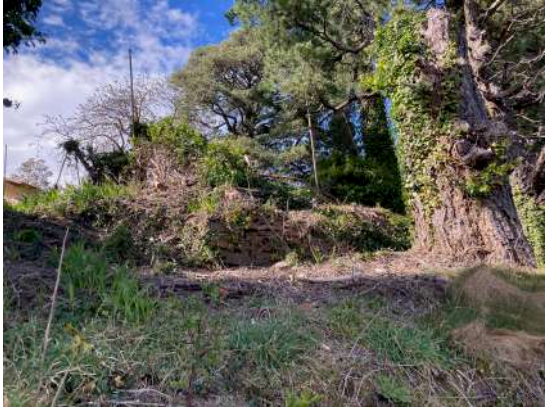
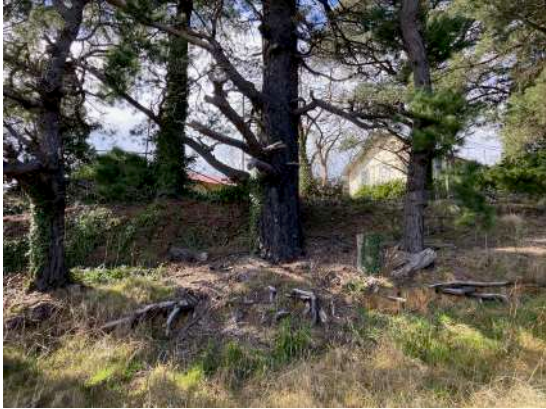
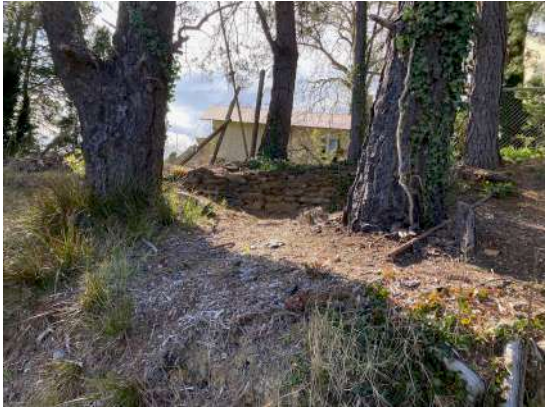
S12D	Remnant Embankment Wall

Type	Low height, dry stone retaining wall. May have been built to retain the tennis court
Length	30 metres
Height	Varies 700-1200mm
Condition	Moderate
Treatment	Retain as is and piece in new work to match if affected by tree removal
