Report on
Detailed Site Investigation (Contamination)

Proposed Gosford Regional Library
123A Donnison Street, Gosford

Project 83343.03
April 2021

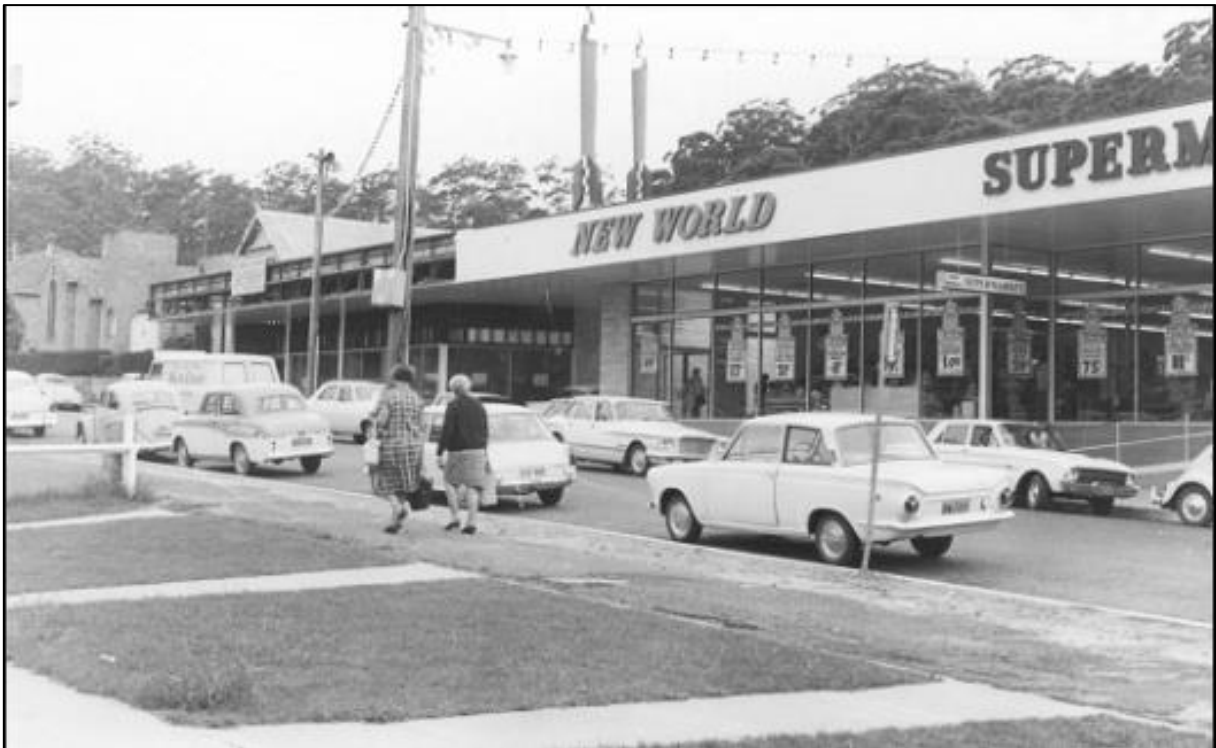
Figure 1: Photograph of the site (dated 3 September 1967), taken from the northern side of Donnison Street facing south-east. The existing Uniting Church is visible in the background (left). (Source: www.trove.nla.gov.au)

As part of the previous PSI (DP, 2018), a search of the National Library of Australia (www.trove.nla.gov.au) was completed. A single photograph of the site was retrieved dated 1967. The photograph identifies a Coles New World Supermarket on the site and a construction site (possibly a commercial (retail) building) on the neighbouring site to the east. Figure 1 is a copy of the photograph.

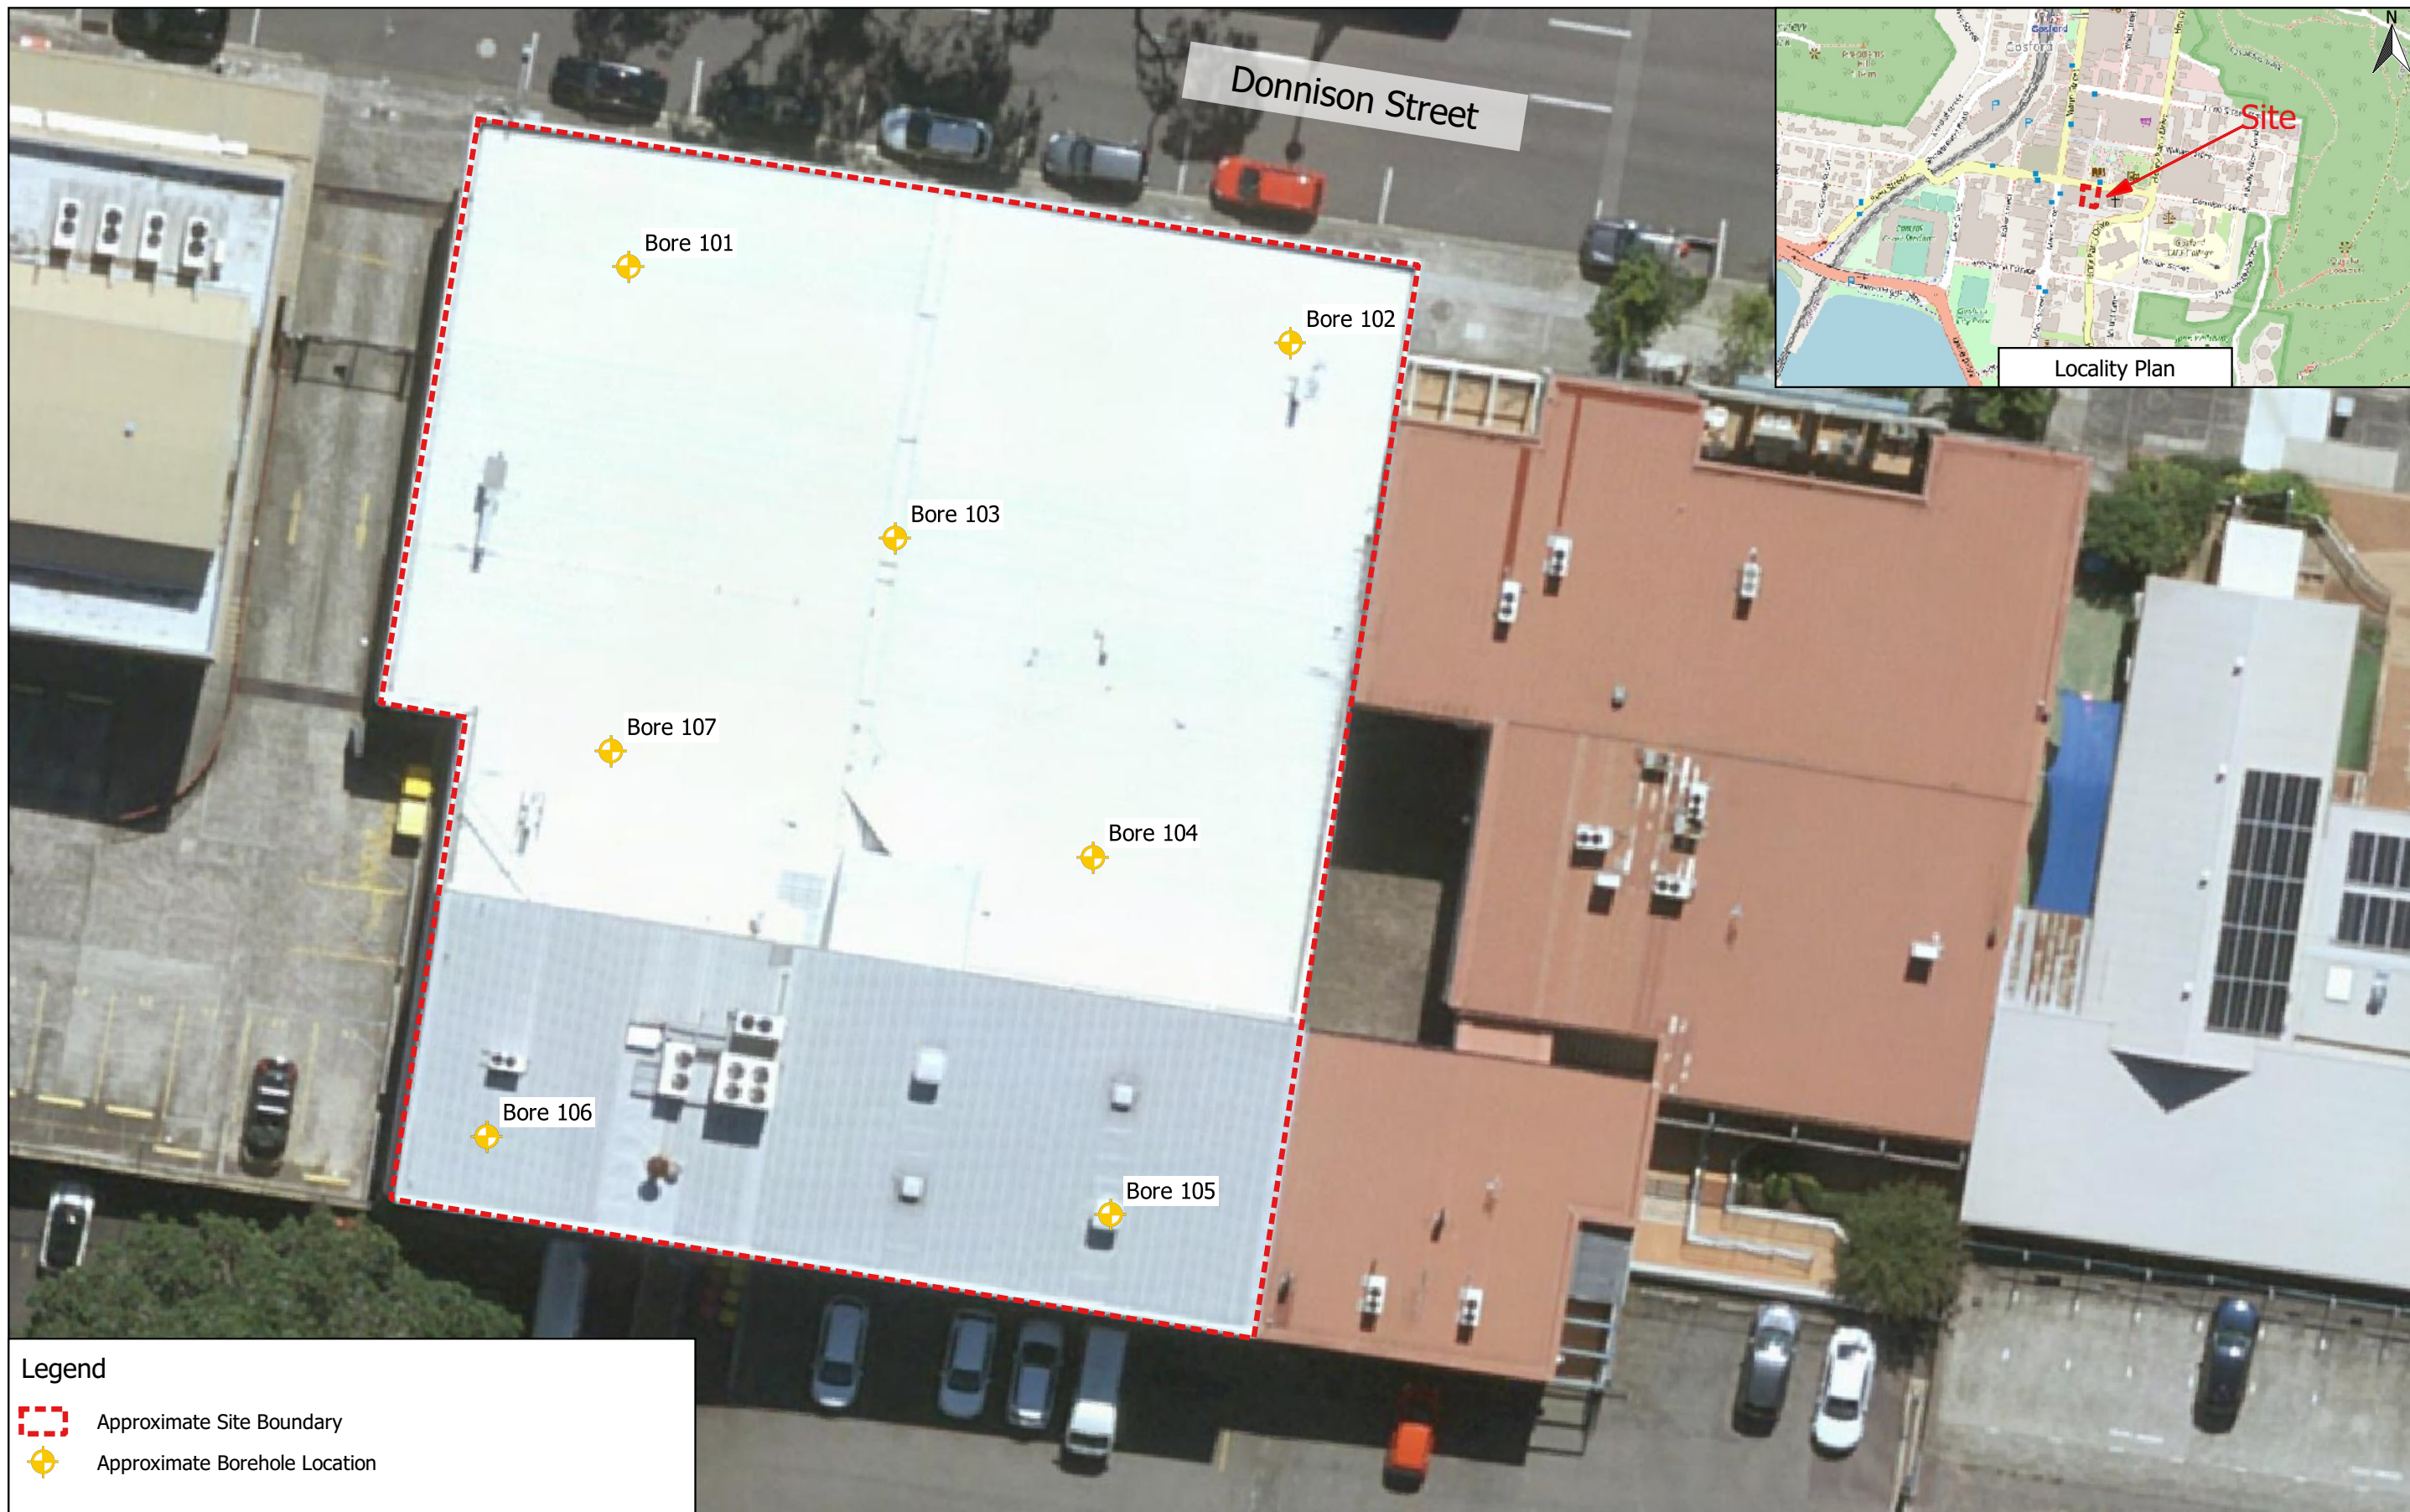
Drawing 1

- Approximate Site Boundary
- Approximate Borehole Location
